Bat Survey Report

Site: Trinity Barns, Donnington, Moreton-in-Marsh,
Gloucestershire, GL56 0XZ

Client: Kate and Jane Molloy

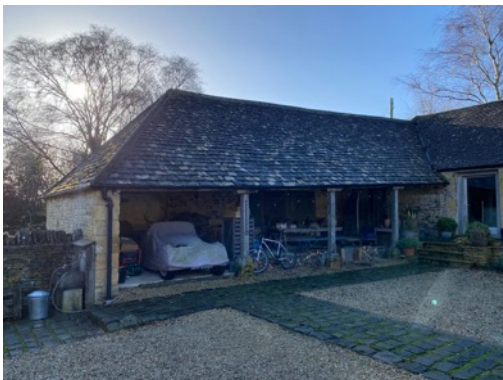
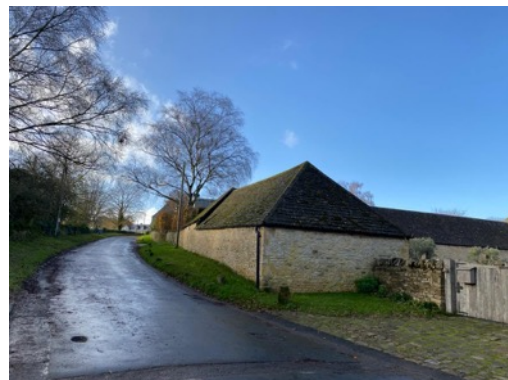
Figs. 1 & 2 Cart shed

The survey site comprised a stone cart shed with a hipped tiled roof (Figs. 1 and 2).

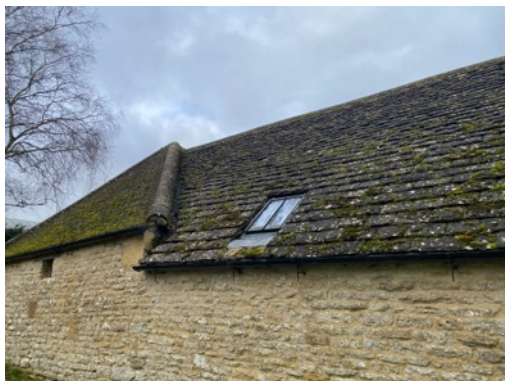
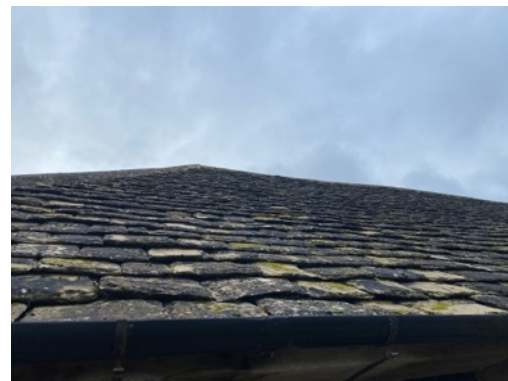
Figs. 3 & 4 Ridge and roof tiles

The ridge and hipped ridge tiles were intact throughout and all tightly sealed with cement. The roof tiles were generally in good condition, with none missing, broken or dislodged, although the stone nature created gaps (Figs. 3, 4, 5 and 6).

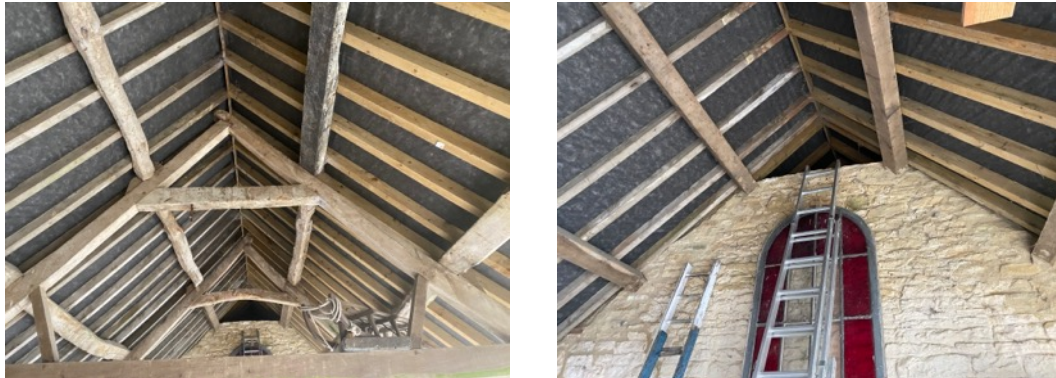
Figs. 7 & 8 Interior of barn and gap into roof void

Internally the cart shed was open to the underside of the roof which was lined with tarred felt (Figs. 7 and 8). The interior was brightly illuminated through the open front and no evidence of bat activity or occupation was found. However, the end wall at the western end of the building was not quite full height and there was a small gap which allowed access into a roof void over the adjoining barn (Ref. Figs. 7 and 8).

Although not part of the licence, it is also proposed to retain the bat roost in-situ by closing off the small gap into the roof void and creating a purpose-built bat entrance through the roof.

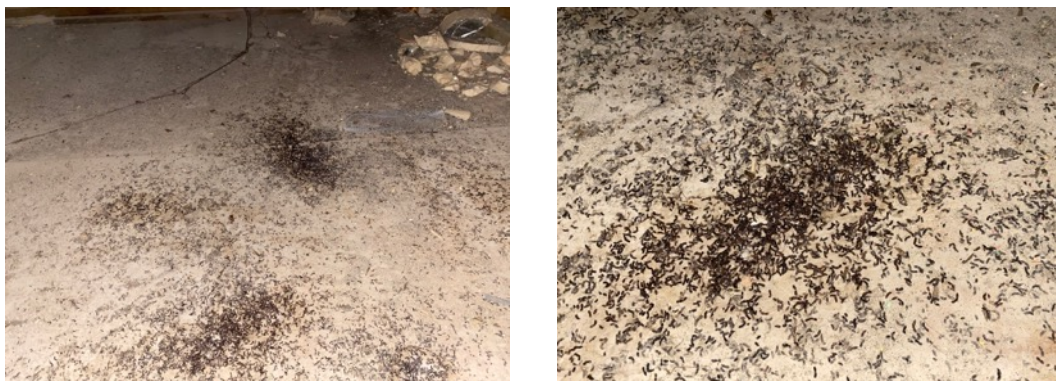
Figs. 9 & 10 Bat droppings

The small roof void was also lined with tarred felt. Beneath the plumb cut were several hundred bat droppings which ranged in age but it appeared some had been deposited within the last year (Figs. 9 and 10). The shape, size and location of the droppings were consistent with those deposited by a Lesser Horseshoe Bat. A sample of droppings has been sent for DNA analysis.

To confirm the species and level of bat use within the cart shed a minimum of two nocturnal surveys should be undertaken between May and September 2023.

Since the proposed works will cause the loss of the bat roost, a licence from Natural England will be required. If the suspected low status of the roost is confirmed by the nocturnal surveys, then the site will be eligible for registration under Natural England's Bat Mitigation Class Licence (BMCL) scheme.

Mitigation measures will include a ‘toolbox talk’ by a Registered Consultant (RC) to contractors about bats and what to do if one is unexpectedly encountered, a pre-works inspection of the roof void by the RC, supervision of the destructive roof works by the RC, the latter undertaken by hand, and the provision of a suitable bat box on a retained tree in the garden in which to relocate a bat if one is discovered during works.

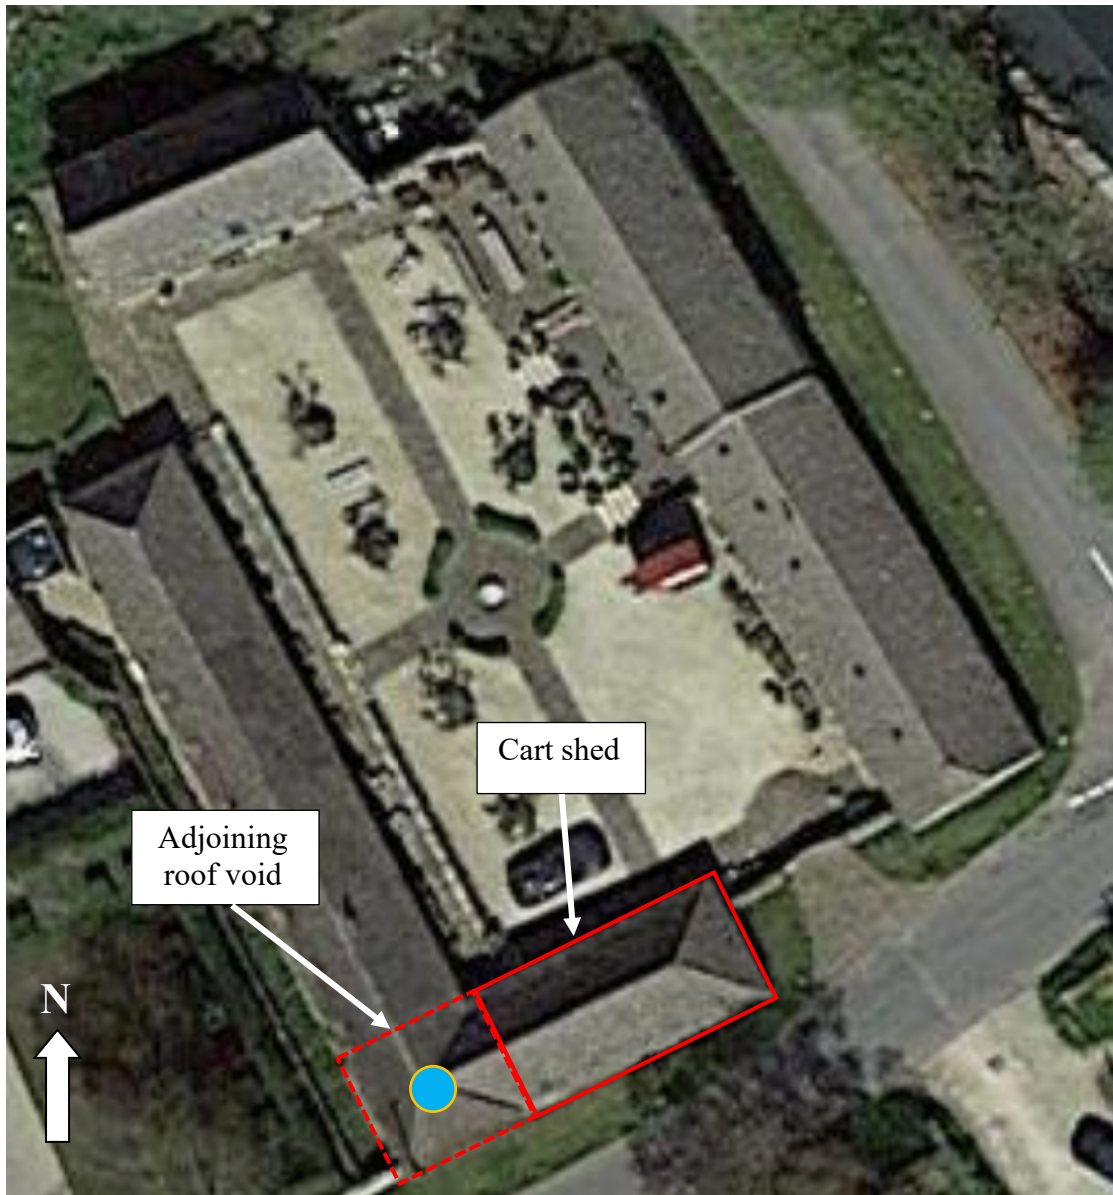
Appendix 3: Location of bat droppings

The location of the droppings is shown in appendix 3.

Lesser Horseshoe Bat droppings
