Bat Roost Characterisation and Mitigation Report

Old Apple Farm, Barrow Hill, Barrow,
Suffolk

Carried out for:

Abrehart Ecology

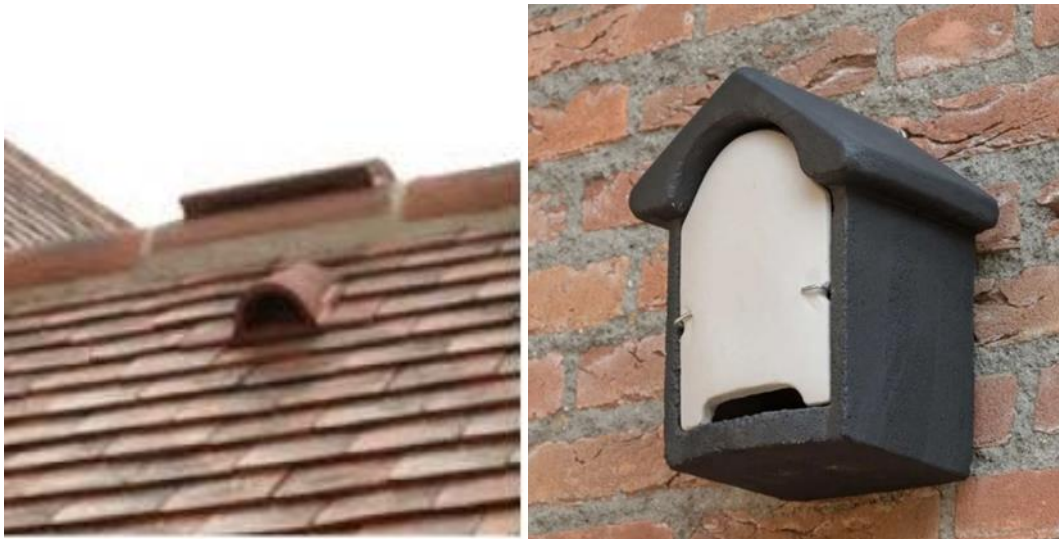
- 7.1.6 Below are example images of enhancement features. Boxes should be sited at least 3m from ground level and be clear of obstructions – allowing for a clear flight path to the box entrance i.e., not obscured by tree limbs or foliage. All features shown below do not require maintenance as the design encourages droppings to fall out of the bricks or access features. Bat roosts are protected from disturbance and so should be left undisturbed once installed – unless maintenance/remedial works are carried out by a suitably licenced ecologist at correct times of year – this should be discussed with an ecologist prior to being undertaken.

- 7.1.4 The addition of bat roost features, such as access tiles, ridge access, or bat boxes (both external and integral) will retain and increase roosting opportunities for bats in the local area. This may be a condition of the licence, and any information provided for that would supersede the details below; however, this provides an indication of possible features and planting schemes that would benefit bats.

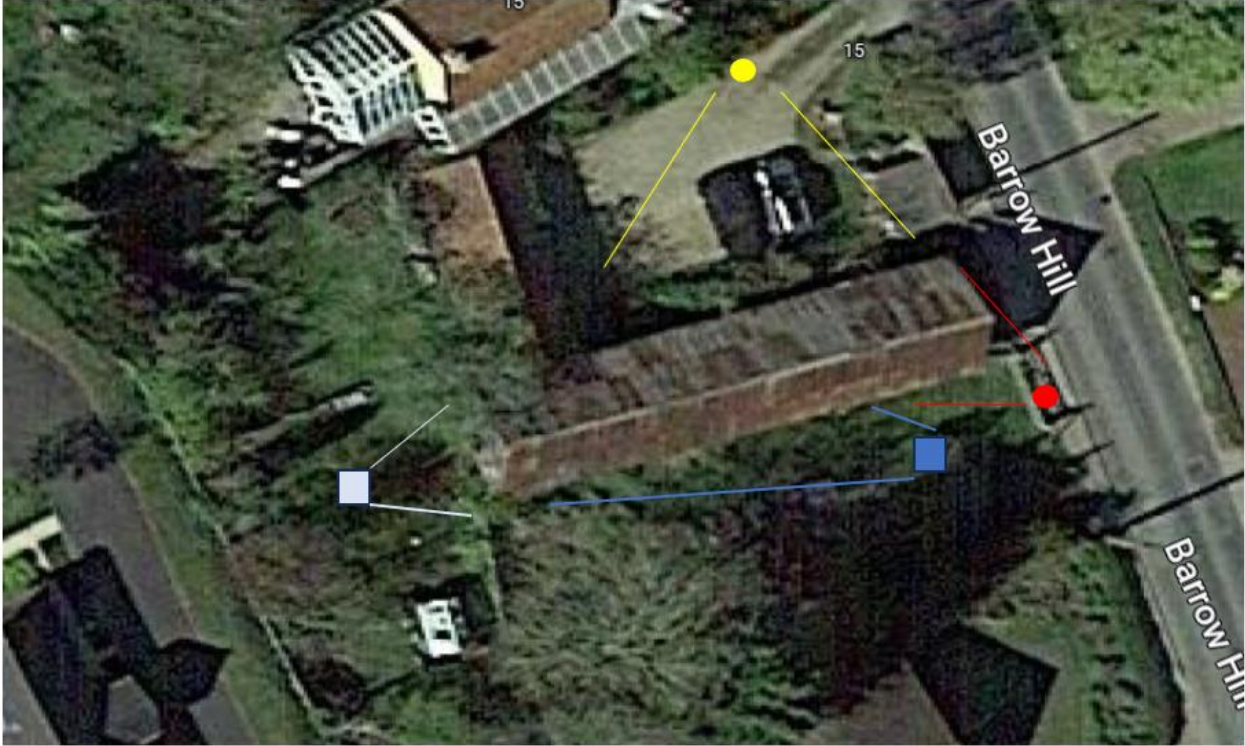
Point	Surveyor/-camera
04/05/2023	
● (Yellow)	SK
● (Red)	AK
■ (Blue)	Static 5 and camera 1
■ (Light Blue)	Static 6 and camera 2

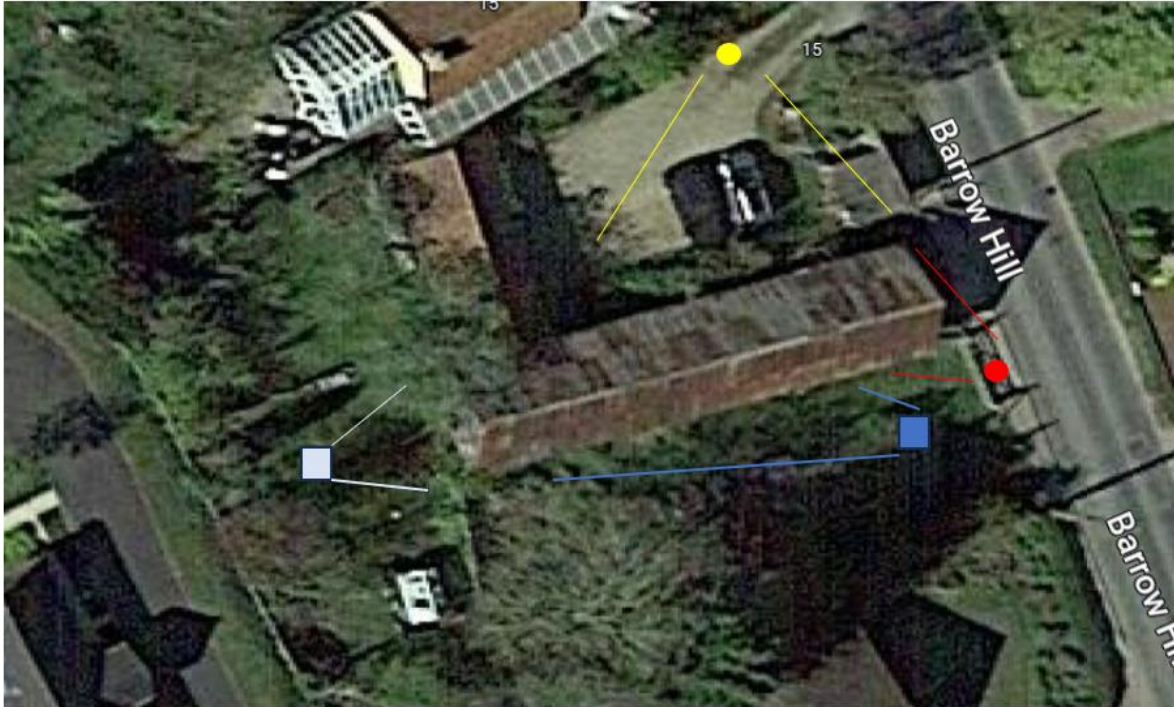
Point	Surveyor/-camera
08/06/2023	
●	SK
●	AK
■	Static-4-and-camera-2
■	Static-3-and-camera-1

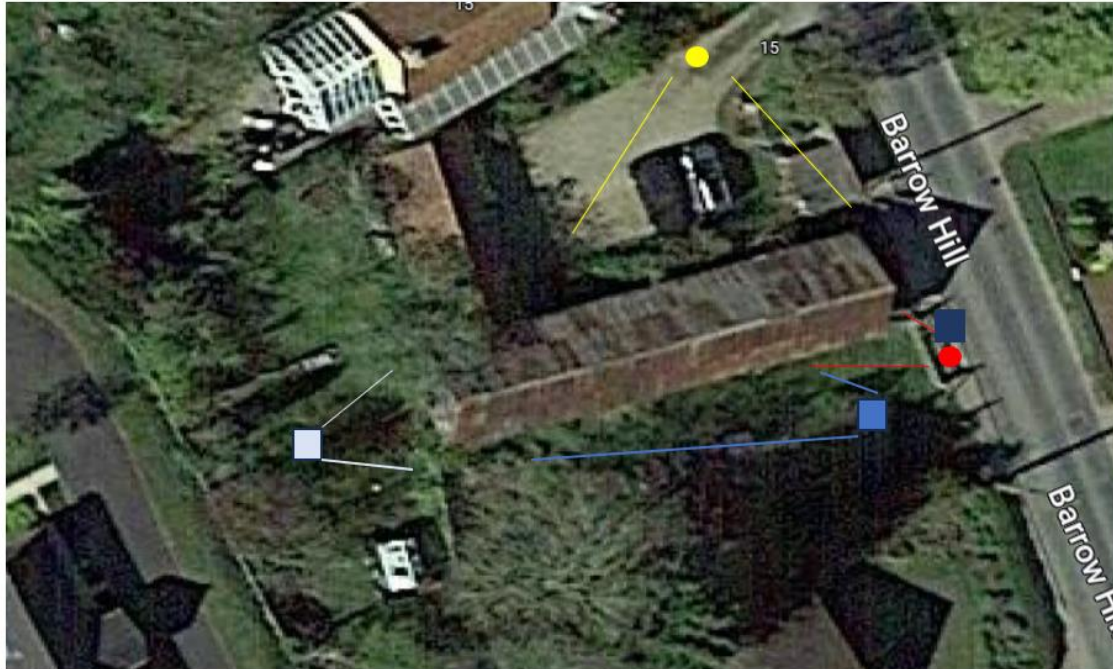
Point	Surveyor/-camera
28/06/2023	
●	TJ
●	AK
■	Camera 1 and static 4
■	Camera 3 and static 6
■	Camera 4

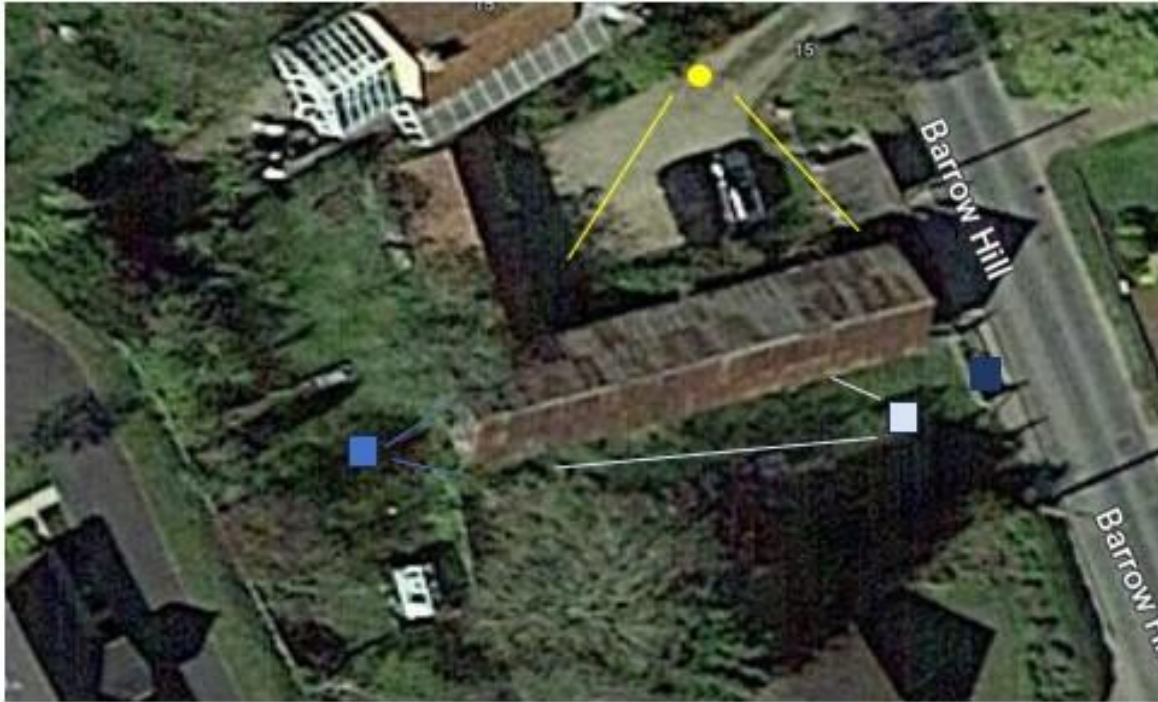
Point	Surveyor / camera
08/08/2023	
●	AK
■	Camera 1 and static 7
■	Camera 2 and static 3
■	Camera 3 and static 5

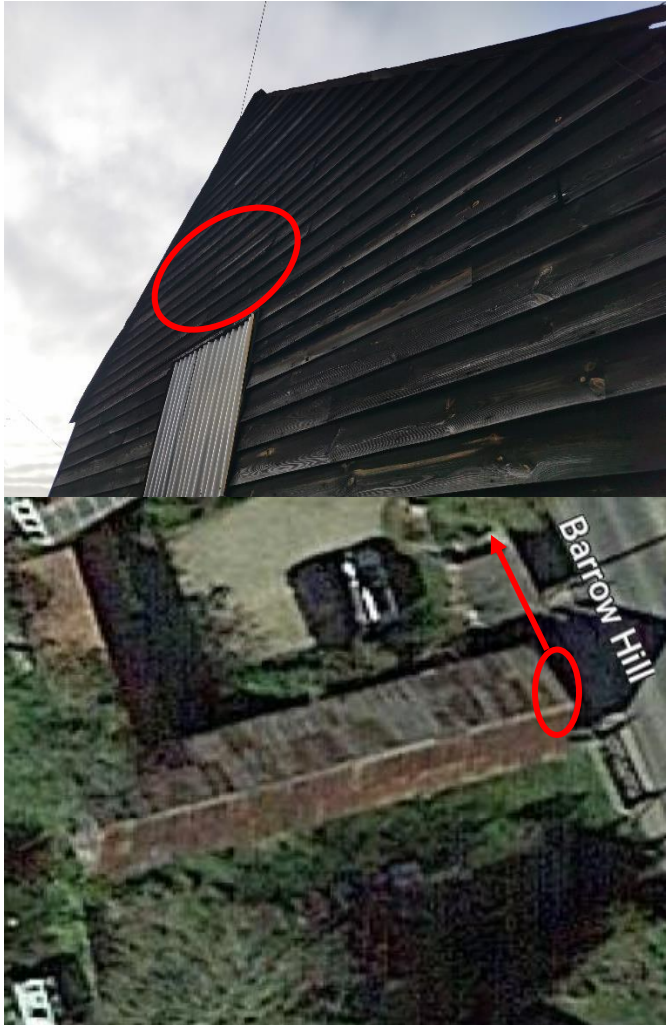
6.1.8 Surveyors recorded **a single common pipistrelle emerge** from the eastern aspect of the barn from under the timber cladding.

Bat emergence: 08/06/2023 – Common pipistrelle at 21:43

- 7.1.2 The proposals comprising are likely to disturb and destroy potential bat roosts within the Site. Therefore, an application for a low impact bat class license (CL21) will be required.
