cornwall  
environmental  
consultants LTD

Bat and Barn Owl Assessment  
Blue Horizon  
Trewen Road  
Budock Water  
Falmouth  
TR11 5EB

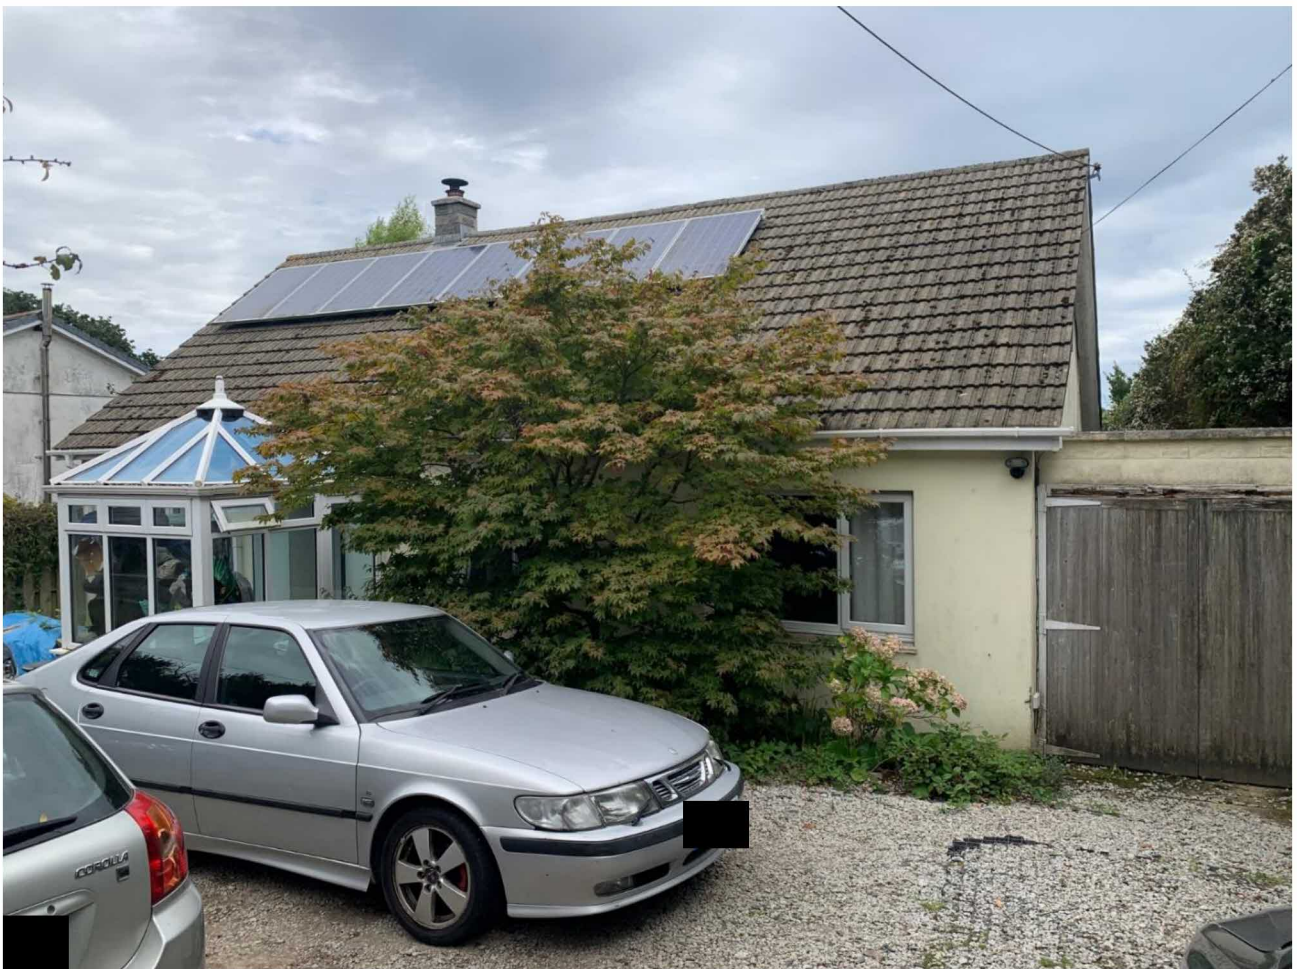
*Figure 1: Western Elevation of Building Assessed*

The property assessed is a detached residential bungalow with a flat roof extension on the eastern elevation. It is constructed from rendered block cavity wall and the roof covering is concrete tiles underlined with bitumen felt. There are UPVC soffits on the main section of the building and UPVC fascias on the flat roof extension. The flat roof extension has a roofing felt liner (figures 1, 2, 3).

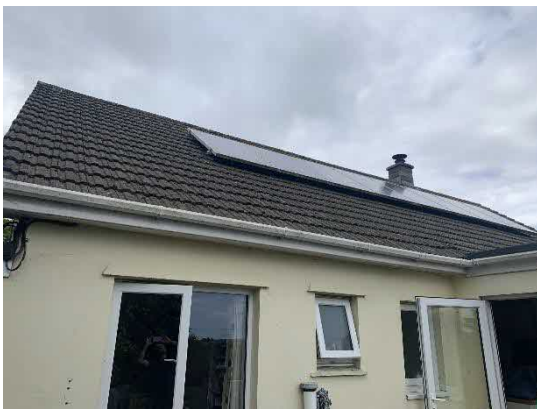
*Figure 2: Eastern elevation*

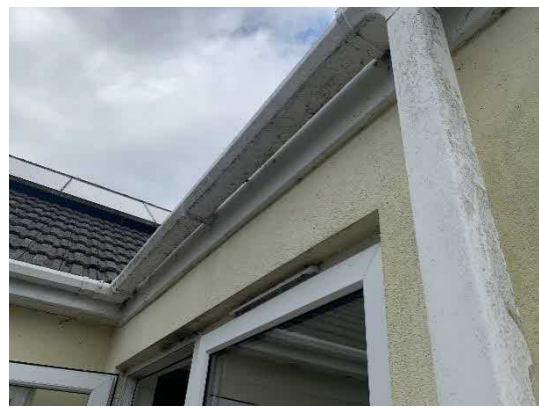
A search of the exterior of the building showed well-sealed soffits, roof tiles in good condition and well-sealed fascia boards on the flat roof extension (figure 3).

*Figure 3: Well sealed fascia, flat roof extension*

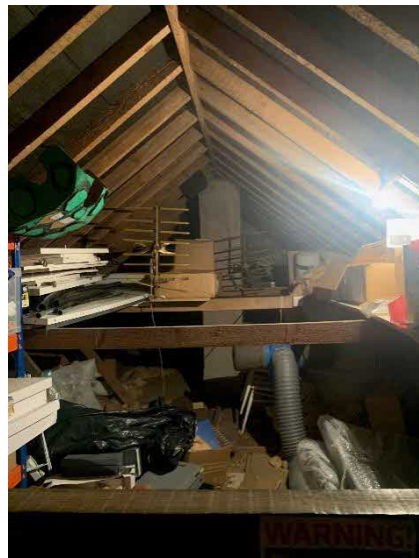
The interior of the loft is approximately 2.5m high, semi boarded, insulated with mineral wool insulation and has shelves installed for storage. The loft was searched, including the stored goods, rafters, gable ends and loose insulation (figure 4). The bitumen felt liner was pressed lightly in several sections to check for bats roosting within the batten space. No evidence of use by bats was noted at the time of this assessment.

*Figure 4: Loft interior*

Although no current evidence of roosting bats was found it cannot be assumed that bats are not present when works commence. Care should therefore be taken during the work as bats could roost unseen deep within crevices in the structure, particularly under ridge tiles, beneath wall plates, or between or above lintels. If any bats are discovered during the work they must not be handled: works must stop immediately and advice sought from CEC (tel 01872 245510).
