Phase 2 Geo-Environmental Site Investigation Report
9 Harper's Lane, Presteigne, LD8 2AN
Mr Alex Dufort

Report Number: E23890-SI

Phase 2 Geo-Environmental Site Investigation Report

9 Harper's Lane, Presteigne, LD8 2AN

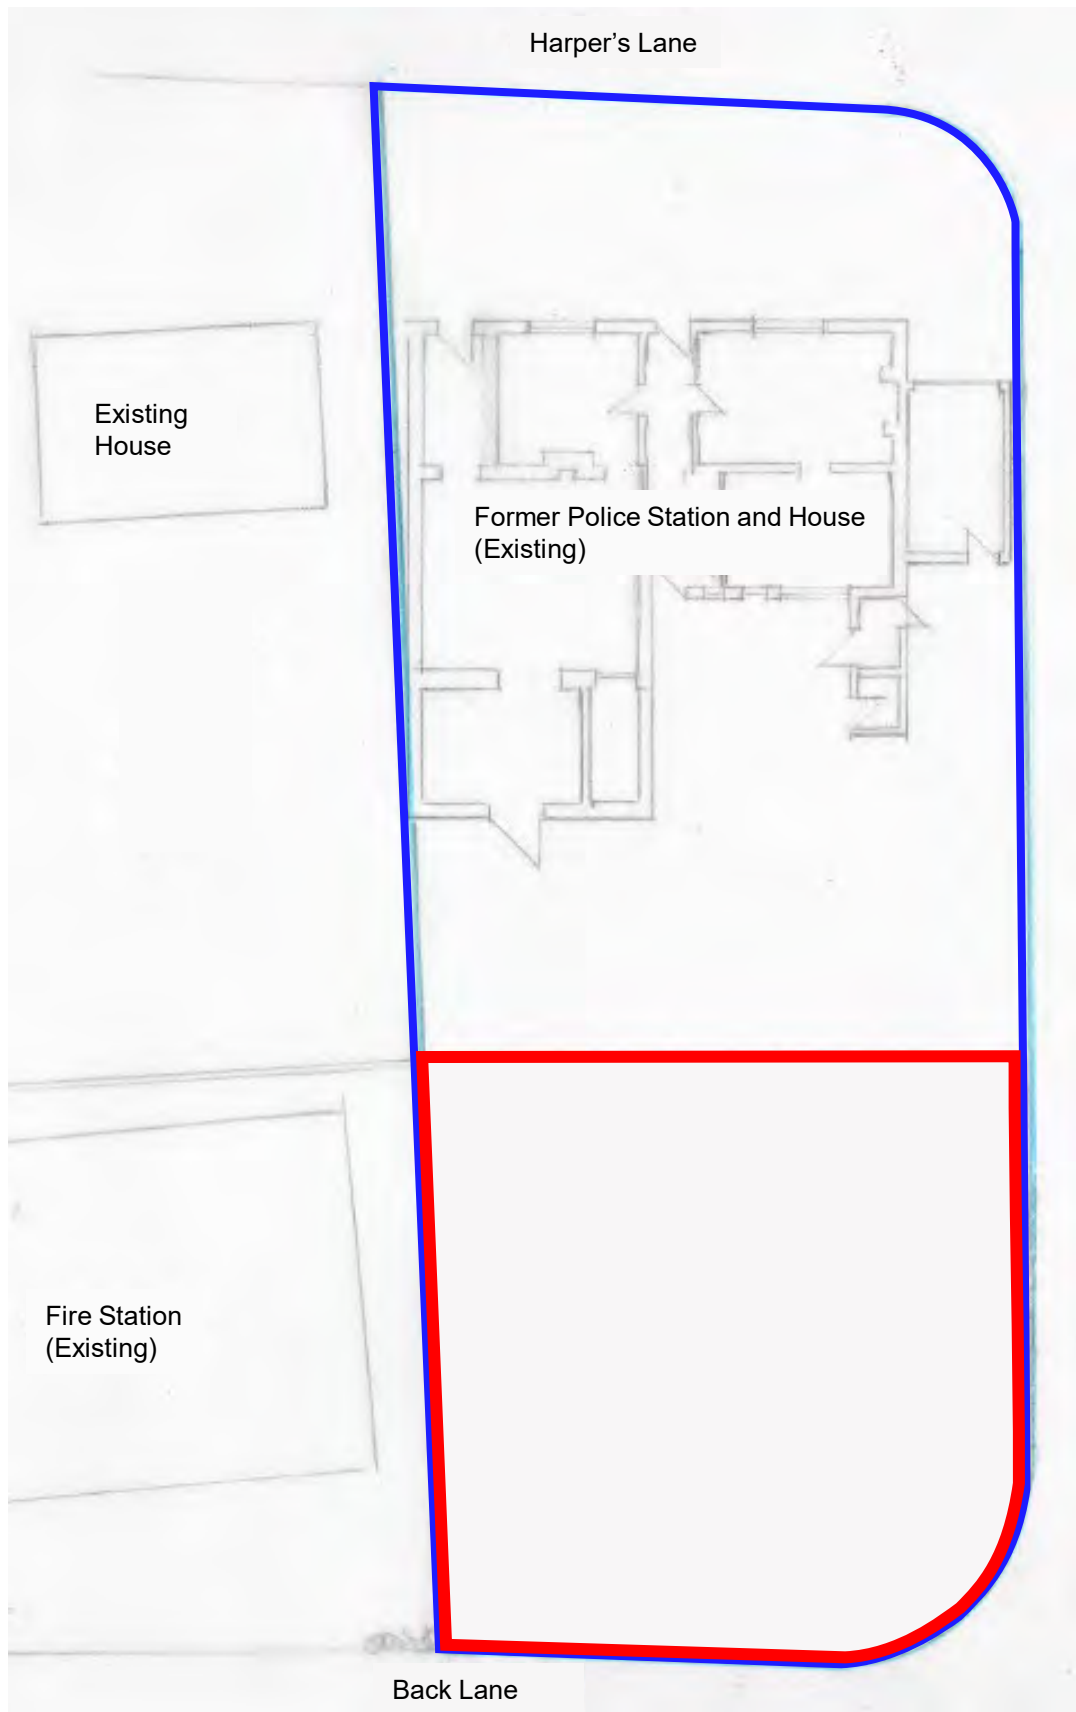
Project Number:	E23890
Site:	9 Harper's Lane, Presteigne, LD8 2AN.
Drawing Title:	Existing Site Layout Plan

Extract taken David Colwell Design Drawing: AD 3, dated 6th December 2019.

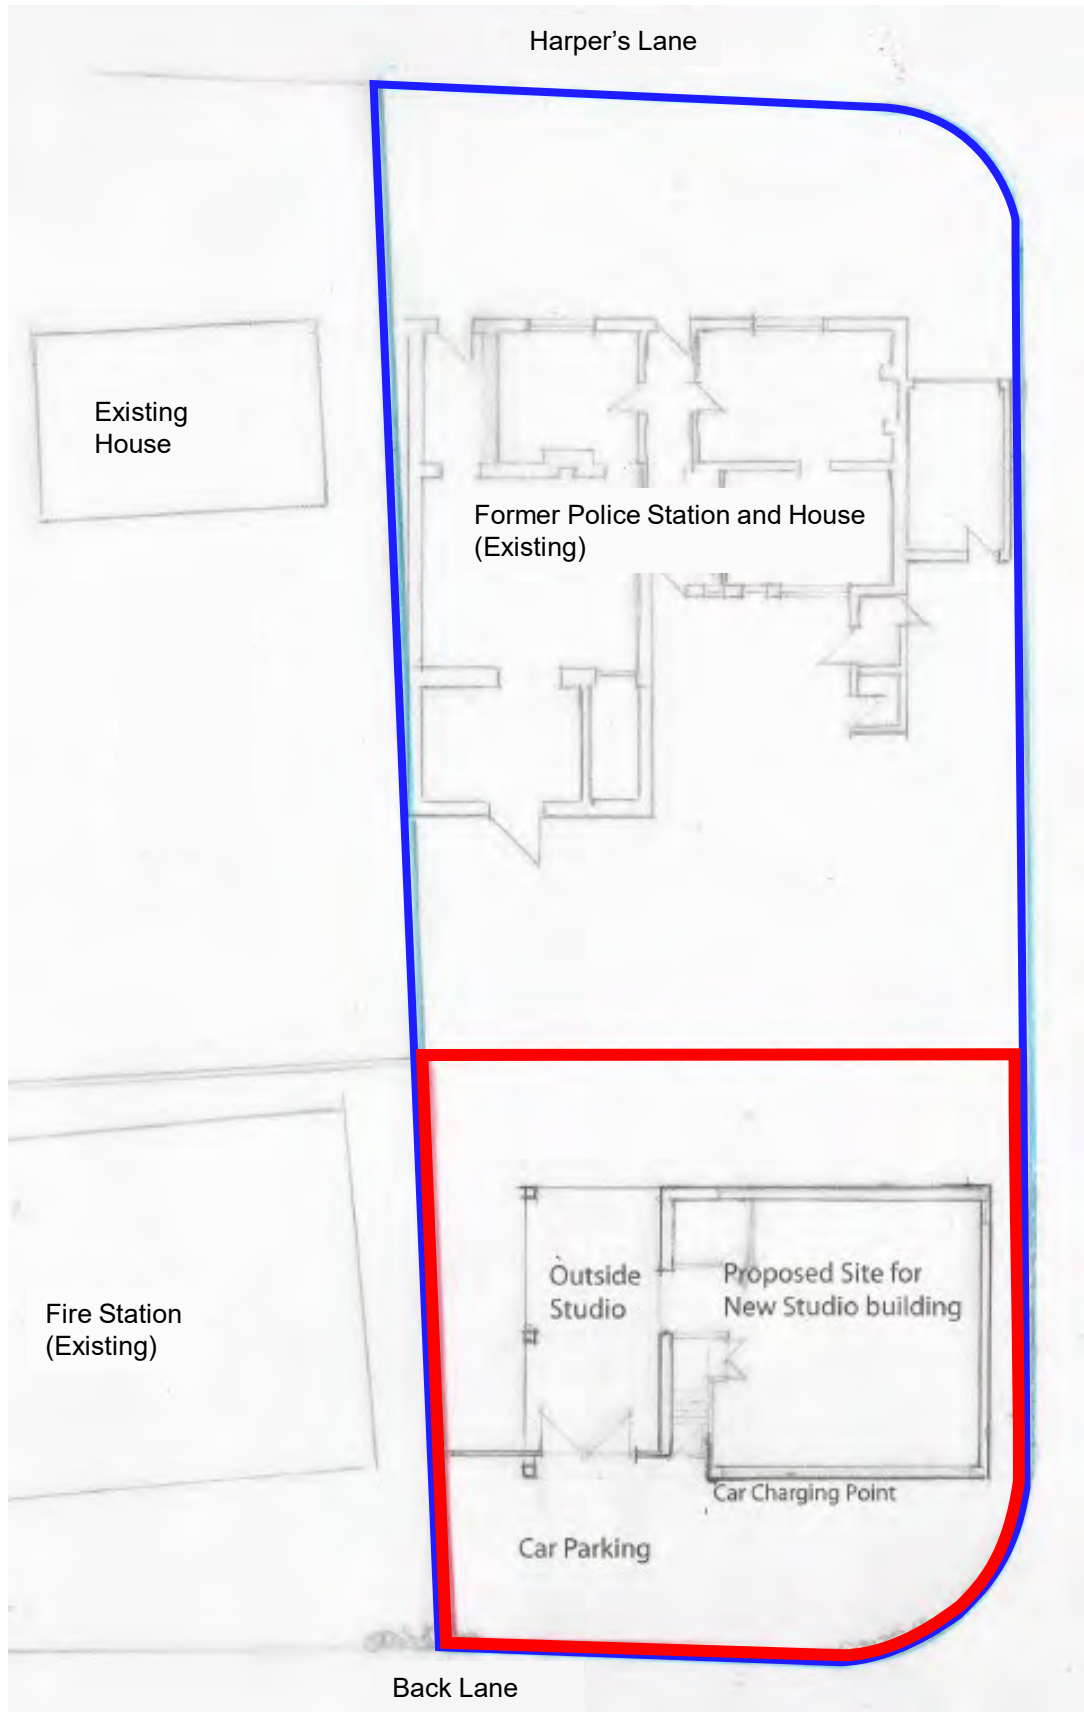
Project Number:	E23890
Site:	9 Harper's Lane, Presteigne, LD8 2AN.
Drawing Title:	Proposed Site Layout Plan

- Proposed Development Boundary.
- 9 Harper's Lane Site Boundary.

The following advice and recommendations are based on constructing a two-storey studio building and extension to the existing former police station building. A proposed development layout plan is included in Appendix A. From assessment of the nature of the ground conditions and the type of proposed structures, it is considered that the situation falls within EC7 Geotechnical Category 2.

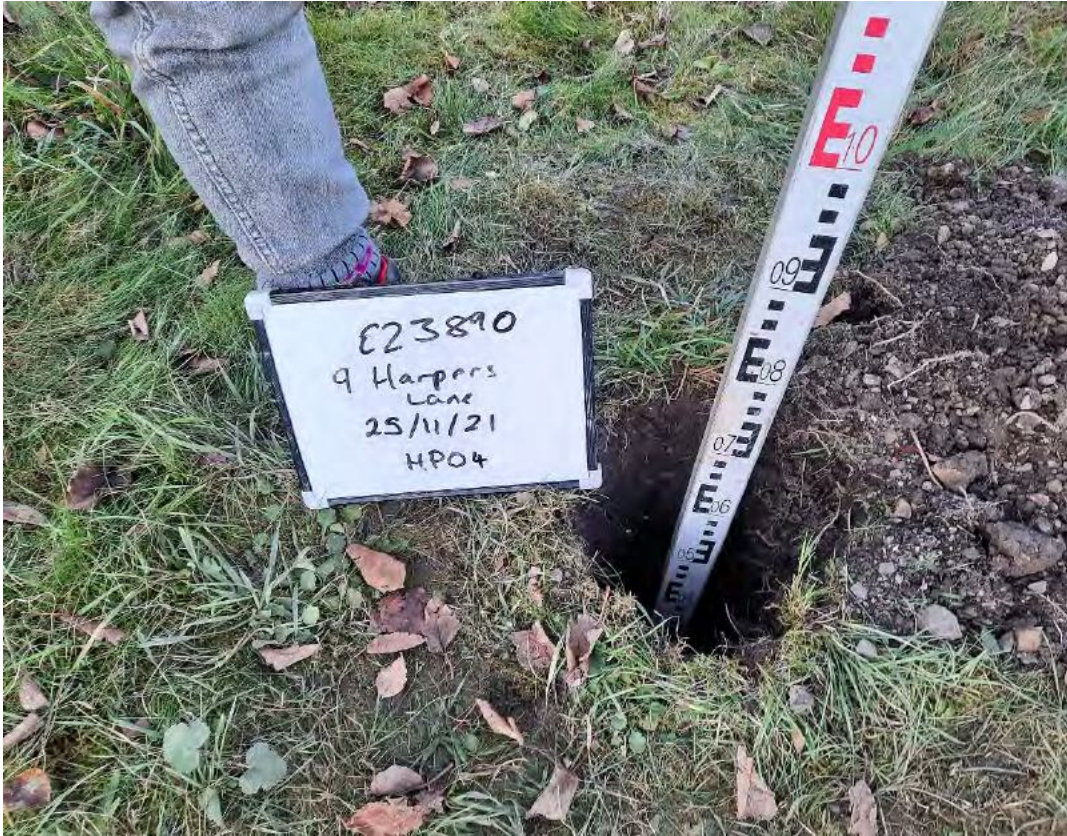
Photo 7: Hand Pit HP04

The location for hand pit HP04 puts it directly beneath the building footprint for the proposed artist studio. During preliminary site clearance and foundation construction works for the studio, it is expected that the Made Ground soils containing the slightly elevated lead will be removed for off-site disposal. Therefore, it is considered that the potential risk from the elevated lead poses a very low risk to the proposed development and future site users.
