Emergence Survey Report – Bats GCN eDNA Survey Mammal Survey

Site Location	Chiltern View Barn, Water Lane, Ford, Aylesbury, HP17 8XD
Document reference	CE4092-02 <i>This document should be read in conjunction with the Preliminary Ecological Appraisal completed on the 8th December 2022, document reference: CE4092</i>
Date of survey	<u>Bats</u> Emergence Survey – 23 rd May 2023 (All Buildings) Emergence Survey – 8 th June 2023 (All Buildings) Emergence Survey – 1 st July 2023 (All Buildings) Emergence Survey – 26 th July 2023 (Building Two Only) <u>GCN eDNA</u> – 5 th June 2023 – Negative Result <u>Mammal Survey</u> – 23 rd May 2023 to 1 st July 2023
Report by	Garry Smith – Senior Ecologist Signature

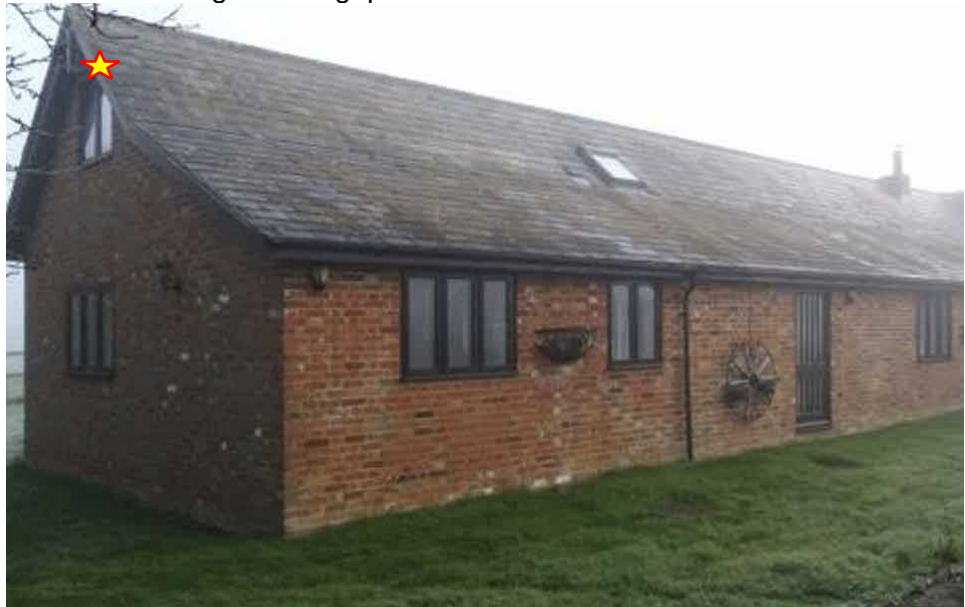
Roost 2 – Emerged from gap between the brickworks and soffit

Roost 2 – Common Pipistrelle (1 x max count) within West gable which will suffer total loss during development.

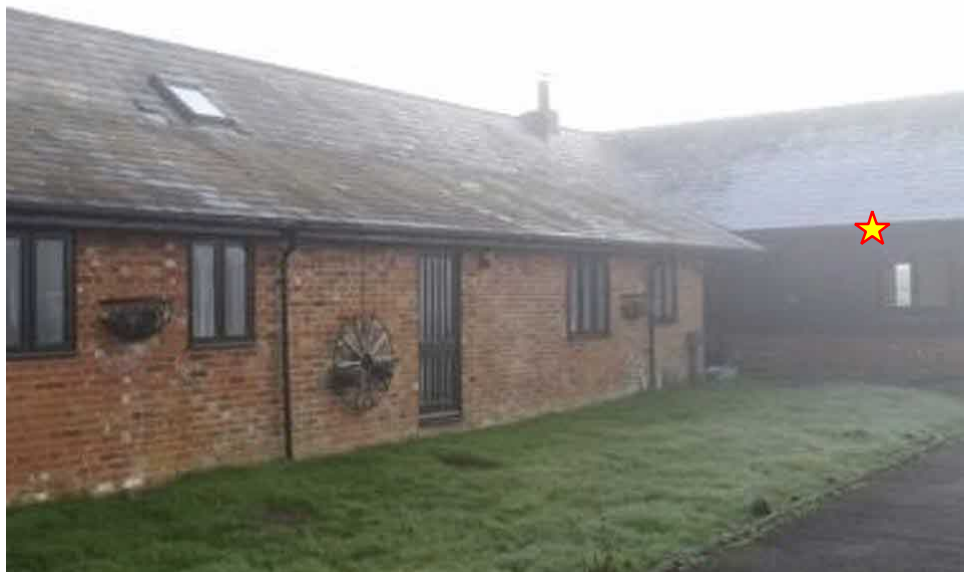
Roost 3 – Emerged from lower roof coverings between fascia and tiles

Roost 3 – Common Pipistrelle (1 x max count) within lower West facing roof coverings which will suffer total loss during development.

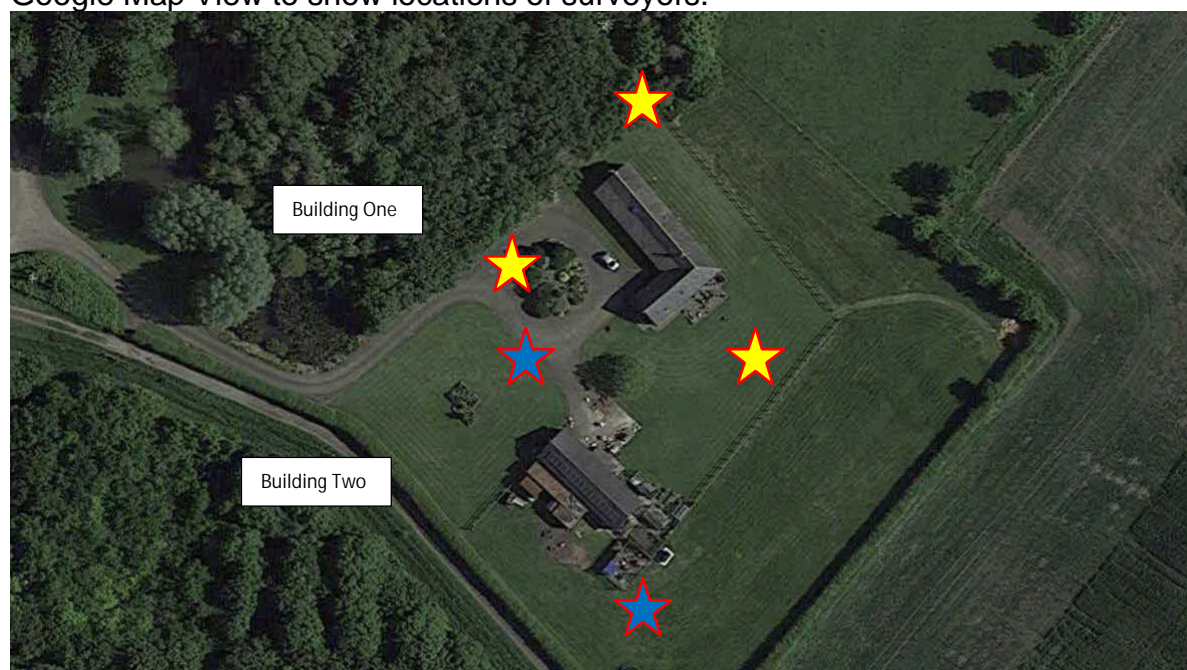
Google Map View to show locations of surveyors.

Point	Time	Species	Activity
Four	05:01 to 05:16	Whiskered	13 bats emerged into gap between the vertical timbers and fascia of the West facing gable of building two.

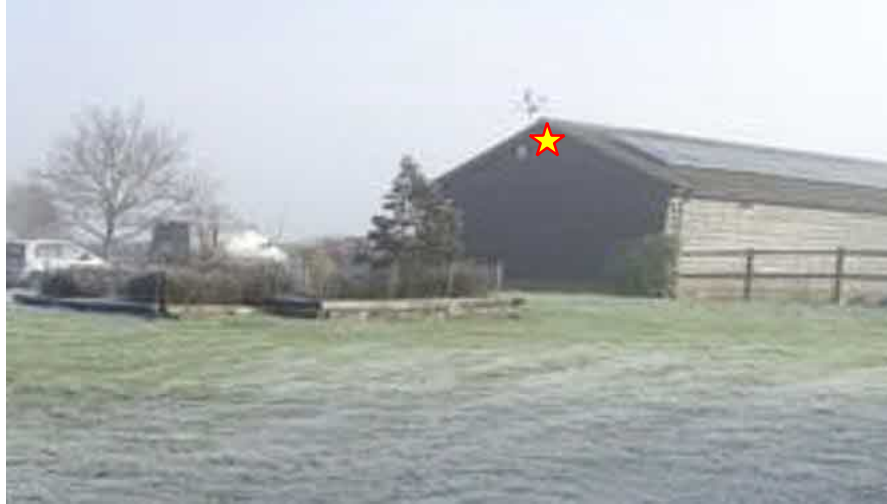
Roost Four – Re-entry into gap between the vertical timbers and fascia of the West facing gable of building two.

Roost 4 – Whiskered (13 x max count) within West facing gable.

No development works or maintenance works to building two will be carried out without prior assessment of any impacts which may offer disturbance to roost one or four. If disturbance to roost one or four is likely to take place, then further licenced mitigation would need to take place.

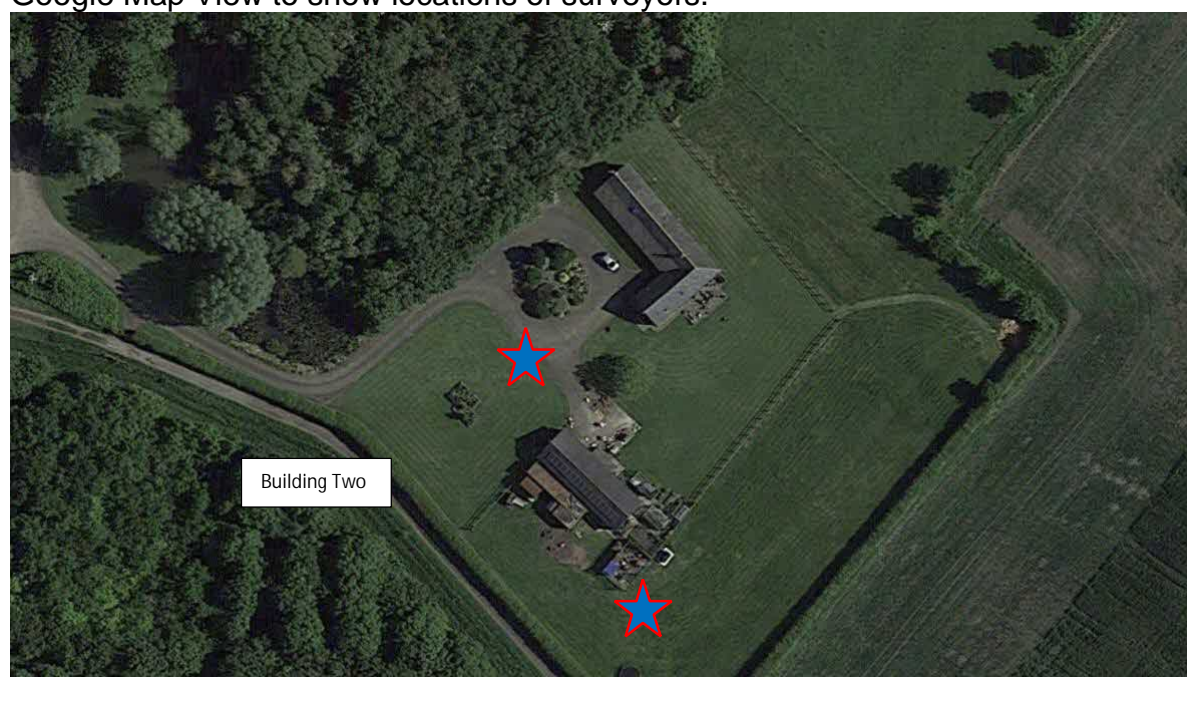
Google Map View to show locations of surveyors.

No roosting activity recorded for building two during the survey times noted.

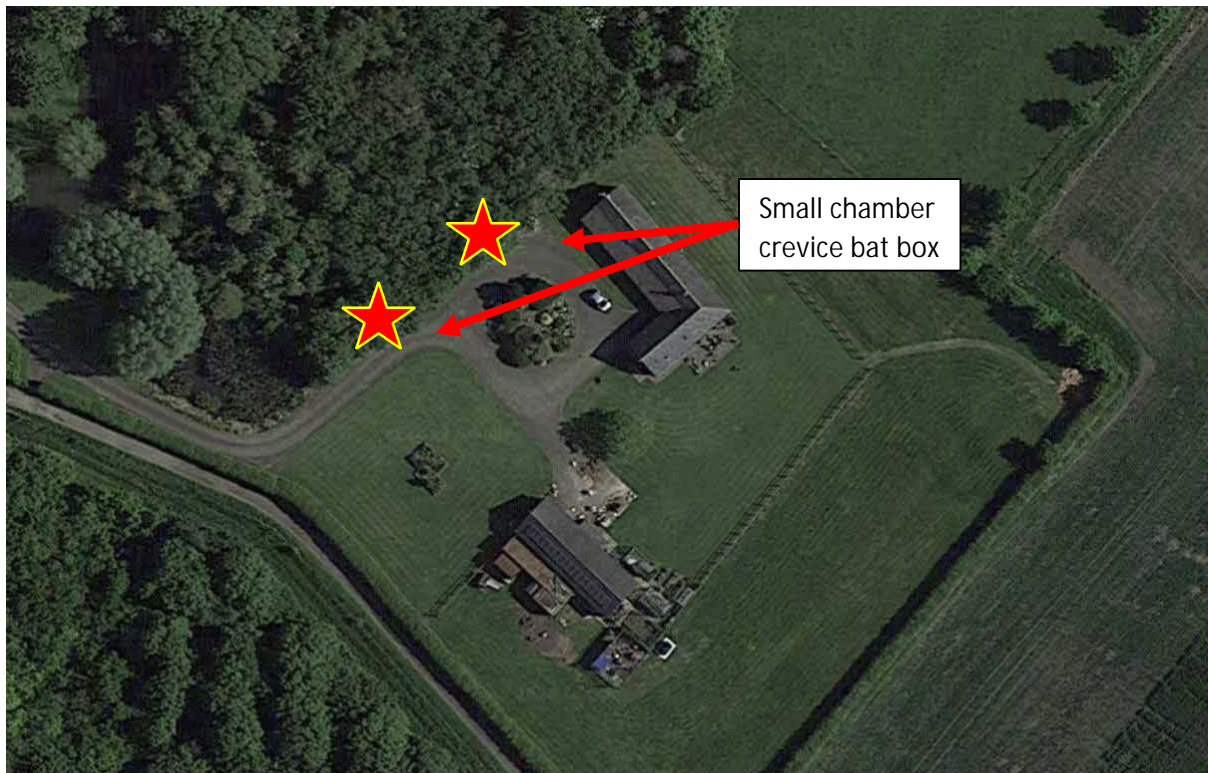
Bat box location within the site

Two bat boxes will be installed within the site and remain as a permanent fixture. This will be two crevice style boxes.
