**Bat Survey Report for  
Corner Cottage,  
Windrush,  
Burford, OX18 4TS**

**21<sup>st</sup> June 7<sup>th</sup> July and 15<sup>th</sup> September 2023**

Report Number: 37323-01 NKM Assoc

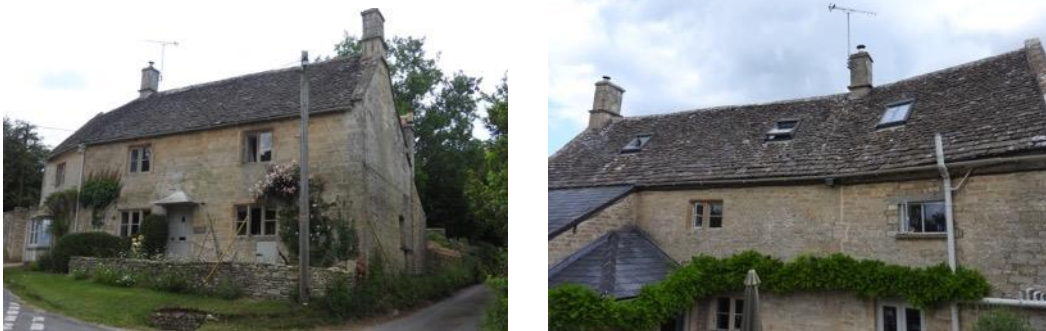
The survey site comprised of a detached pitched roofed building (Figs. 1 and 2).

**Figs. 1 & 2 Front and rear aspects of Corner Cottage**

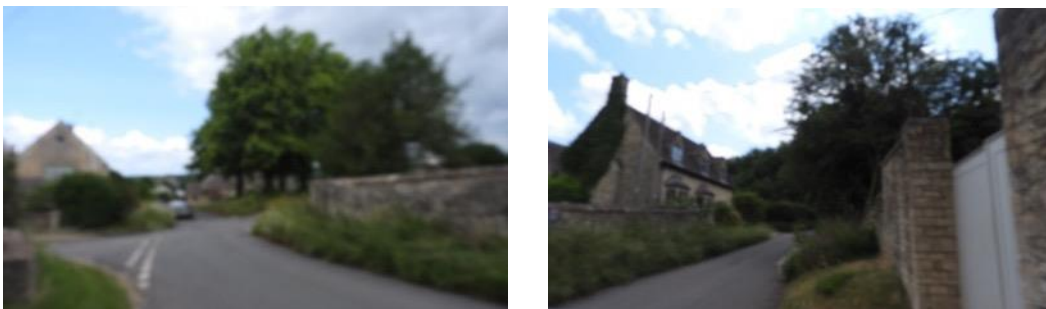
**Figs. 3 & 4 Views to the front to the north (L) and south (R)**

The front of the cottage opened on to a road with grass verges on either side and the village church directly opposite. Mature trees were noted on the village green and to the south (Figs. 3 and 4).

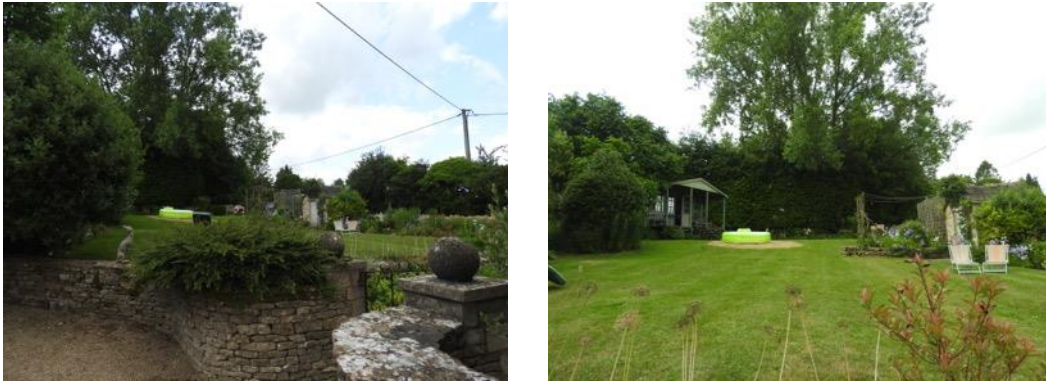
**Figs. 5 & 6 Views of the rear garden**

The rear garden was laid to lawn with mixed species hedgerows on its boundaries. Mature trees were observed at the rear of the garden. (Figs. 5 and 6).

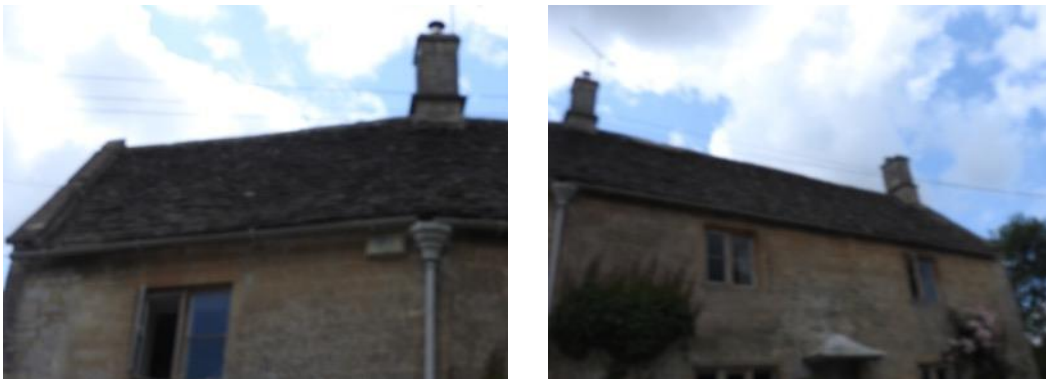
The ridges were intact and sealed, whilst lifted and missing roof tiles were observed on slopes to both front and rear (Figs. 7 – 10).

**Figs. 7 & 8 Ridges and roof tiles to the front**

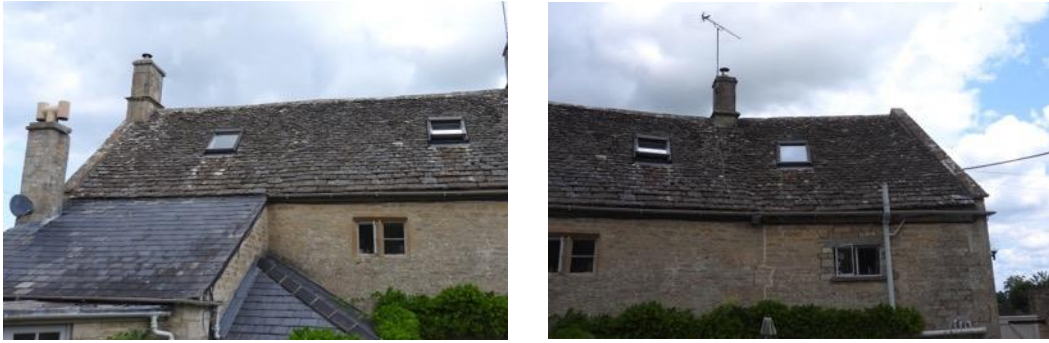
**Figs. 9 & 10 Ridges and roof tiles to the rear**

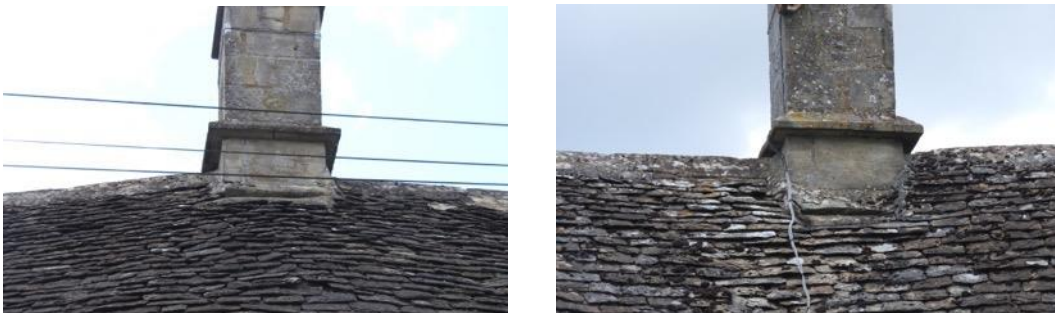
The chimneys bases were sealed with mortar to their adjoining roof tiles (Figs. 11 – 14).

**Figs. 11 & 12 Sealed chimney bases**

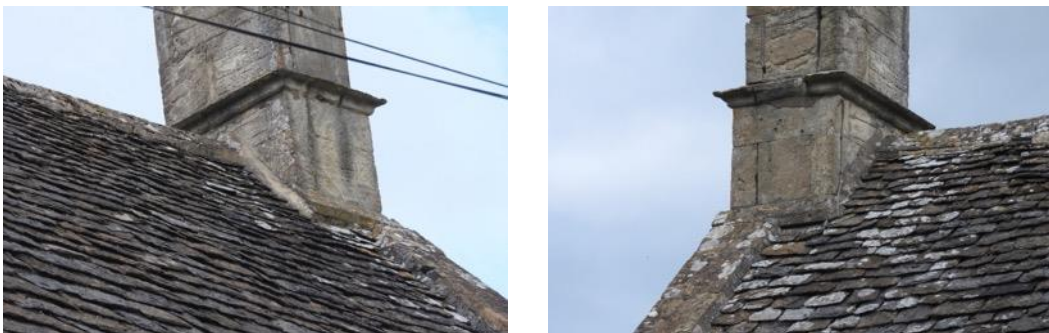
**Figs. 13 & 14 Sealed chimney bases**

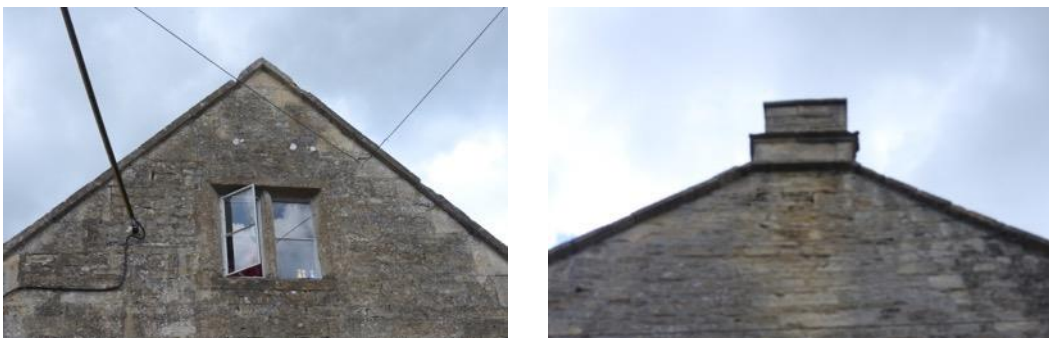
The gables were sealed with coping stones tightly fitting to the gable wall plates (Figs. 15 & 16).

**Figs. 15 & 16 Sealed Gable ends**

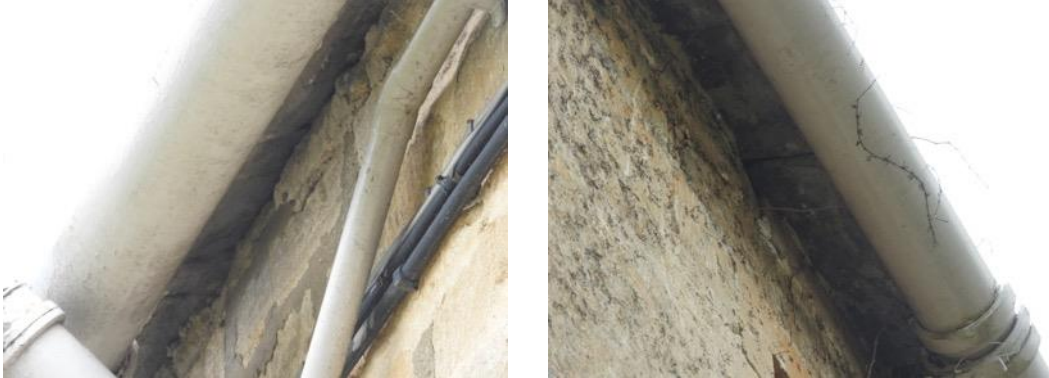
The eaves were finished with the roof ends fitting against the wall plates all round, small gaps were observed but these were not considered large enough for bat occupation (Figs. 17 & 18).

**Figs. 17 & 18 Eaves**

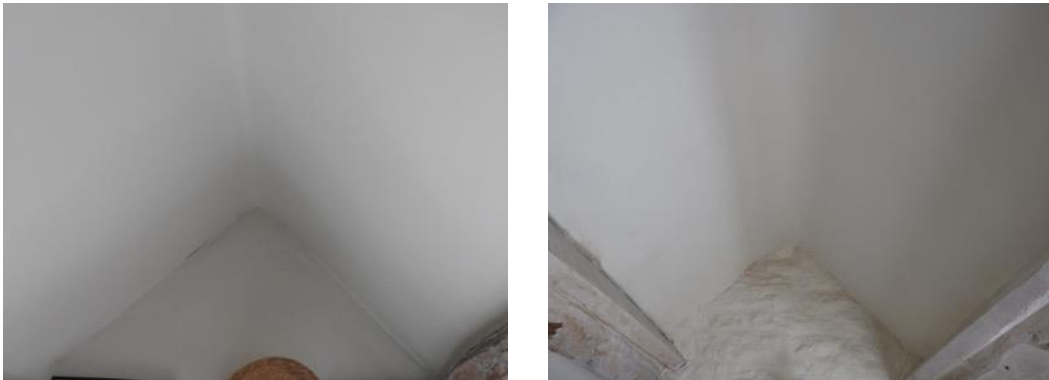
Internally the roof voids had been converted and were vaulted to the dry board lined underside of the roofs (Figs. 19 and 20).

**Fig. 19 Vaulted roof voids**

Light penetrated the converted roof voids through the windows. No evidence of bat occupation was discovered inside the cottage.

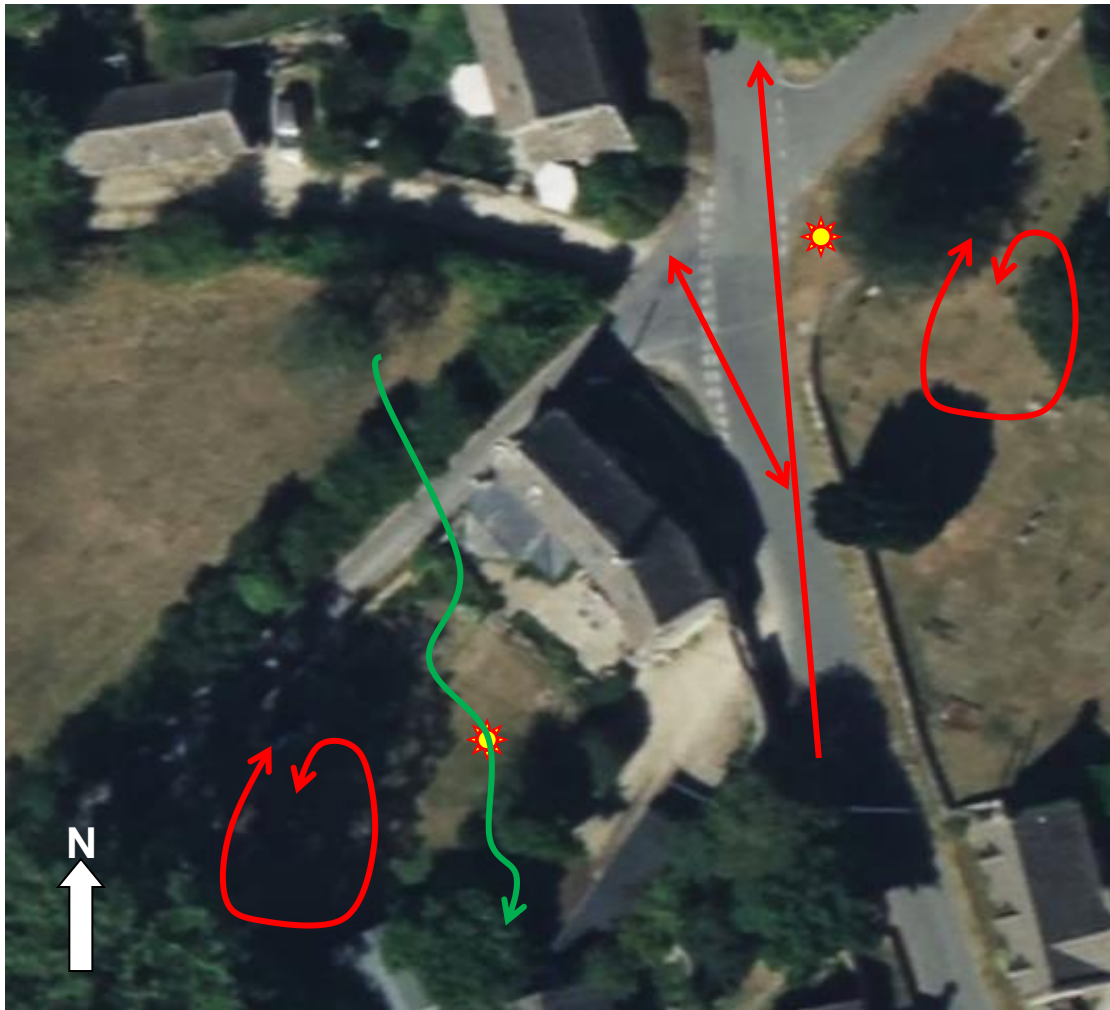
Plan 1 Bat flight paths at emergence on 7<sup>th</sup> July 2023

Common Pipistrelles and Noctules flew round and over the site. No bats emerged from Corner Cottage.

Time	Observation
21:38	Noctule flew over the rear garden north to south
21:44	Noctule flew over the church yard – not seen
22:07	Common Pipistrelle heard in the church yard
22:12	Common Pipistrelle heard in the church yard
22:15	Common Pipistrelle flew south to north up the lane in front of the cottage
22:20	Common Pipistrelle flying up and down the lane in front of the cottage
22:27	Common Pipistrelle heard in the church yard
22:35 – 22:38	Common Pipistrelle heard in the rear garden

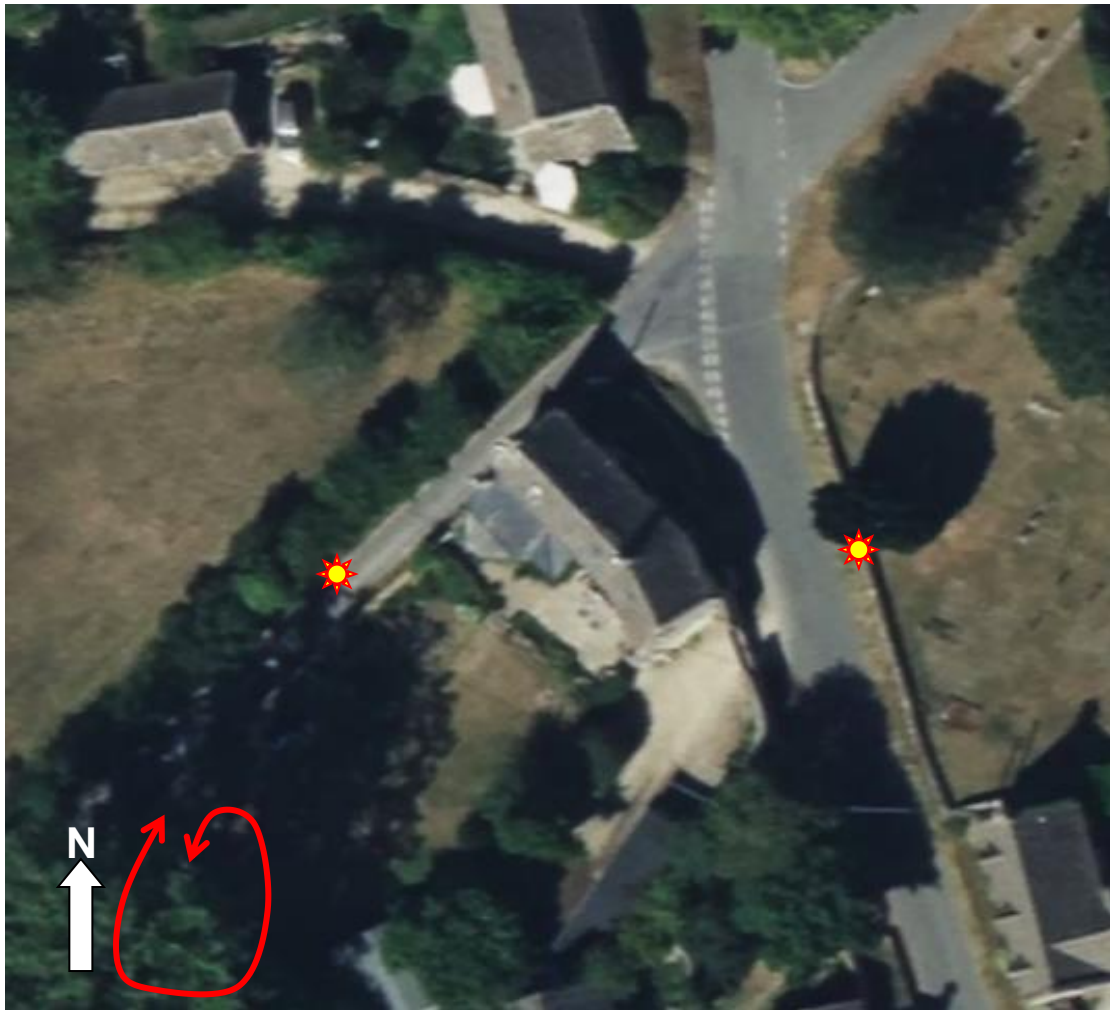
**Plan 1 Bat flight paths at dawn return 15<sup>th</sup> September 2023**

A Common Pipistrelle flew to the rear of the rear garden. No bats went to roost in Corner Cottage.

Time	Observation
05:58 – 06:00	Common Pipistrelle flying to the rear of the rear garden

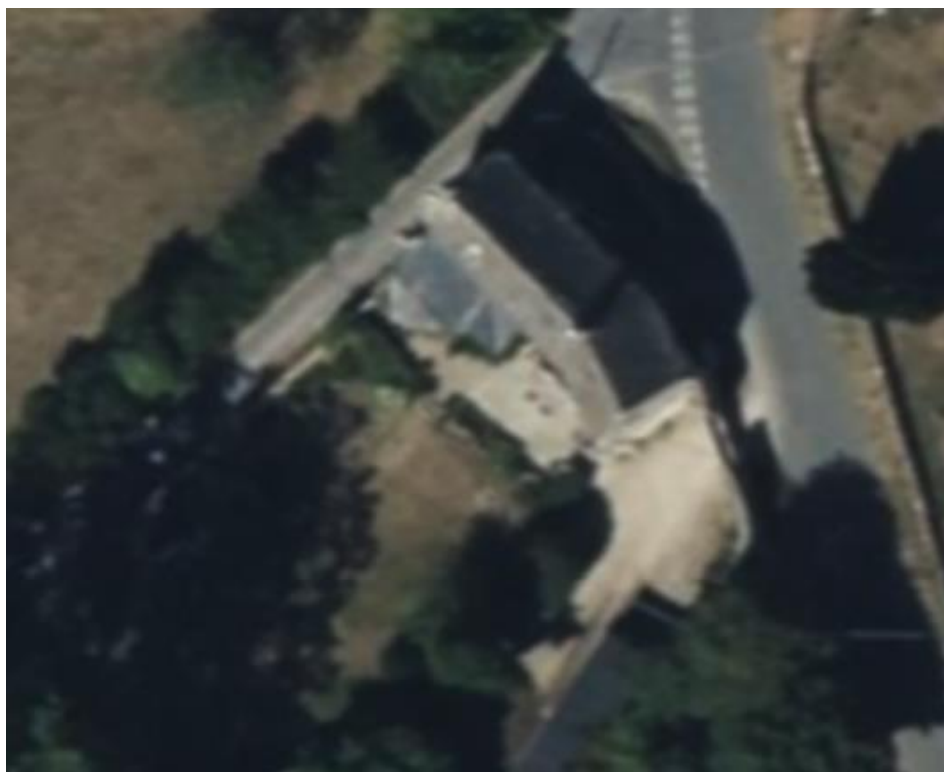
**Appendix 2: Site layout**

The layout of the site is shown in the aerial photograph in Appendix 2.
