Sefton House, Thruxton

Preliminary Roost Assessment

September 2023

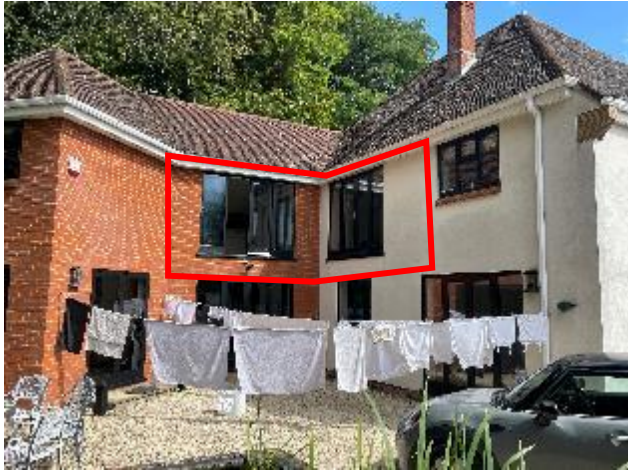
Photo 1 – building 1 viewed from the south with the area where works are proposed outlined in red.

The main house was in very good repair and no PRF were recorded. On this basis the southern elevation was assessed to have **NEGLIGIBLE** bat roost potential.

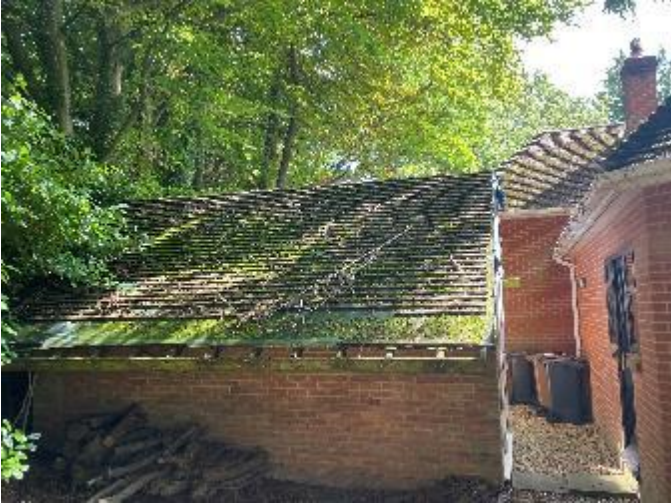
Photo 2 – building 2, unclad roof with covering of detritus

The outbuilding's roof was unclad, as such no PRF were recorded and the building was assessed to have **NEGLIGIBLE** bat roost potential.

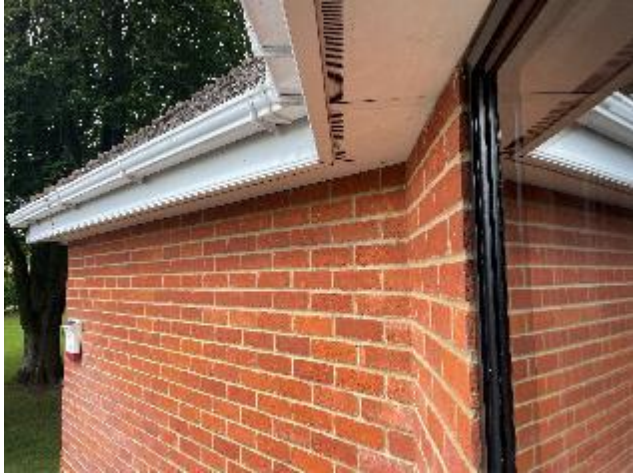
Photo 3 – building 1 – view of the underside of the soffits

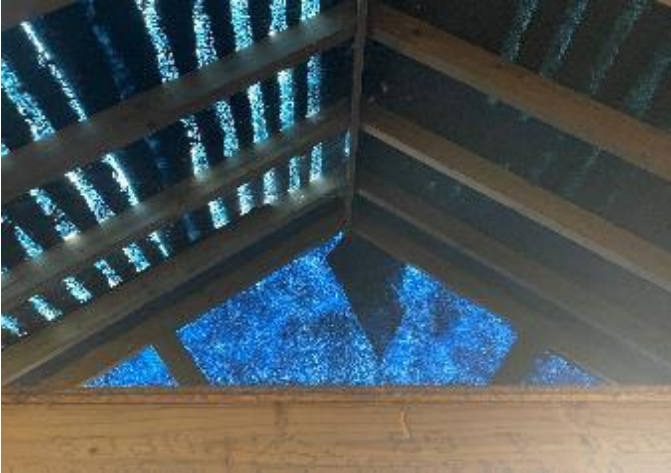
Photo 4 – internal view of the underside of the roof of building 2
