Report : Bat and Nesting Bird Assessment:
House at Park Farm,
The Fish, Hopesay, Craven Arms SY7 8HG

Reference : SA/2942/23.1

Date : 18 September 2023

Proposed development : Construction of an extension on to part of the northwest elevation of the House

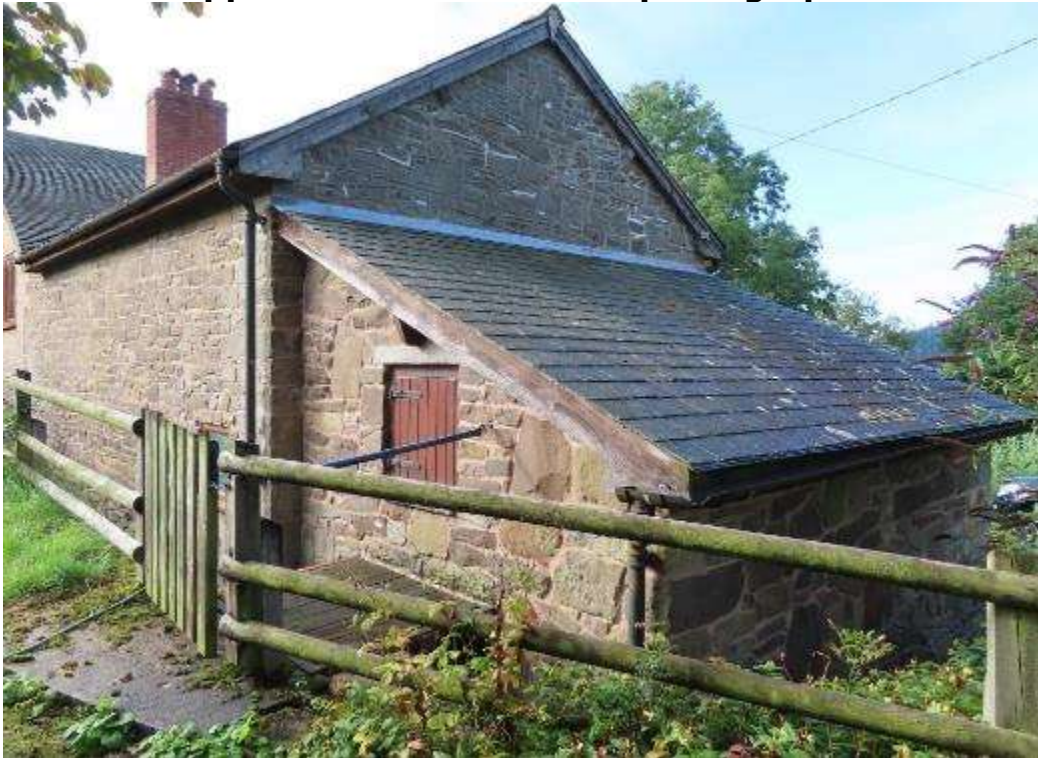
Photograph 1. Exterior.

Left: part of the Northeast elevation of the main, two-storey, section.
Upper centre: part of the Northwest elevation of the main, two-storey, section.
Lower centre: Northeast elevation of the single-storey 'lean-to'.
Right: Northwest elevation of the single-storey 'lean-to'.

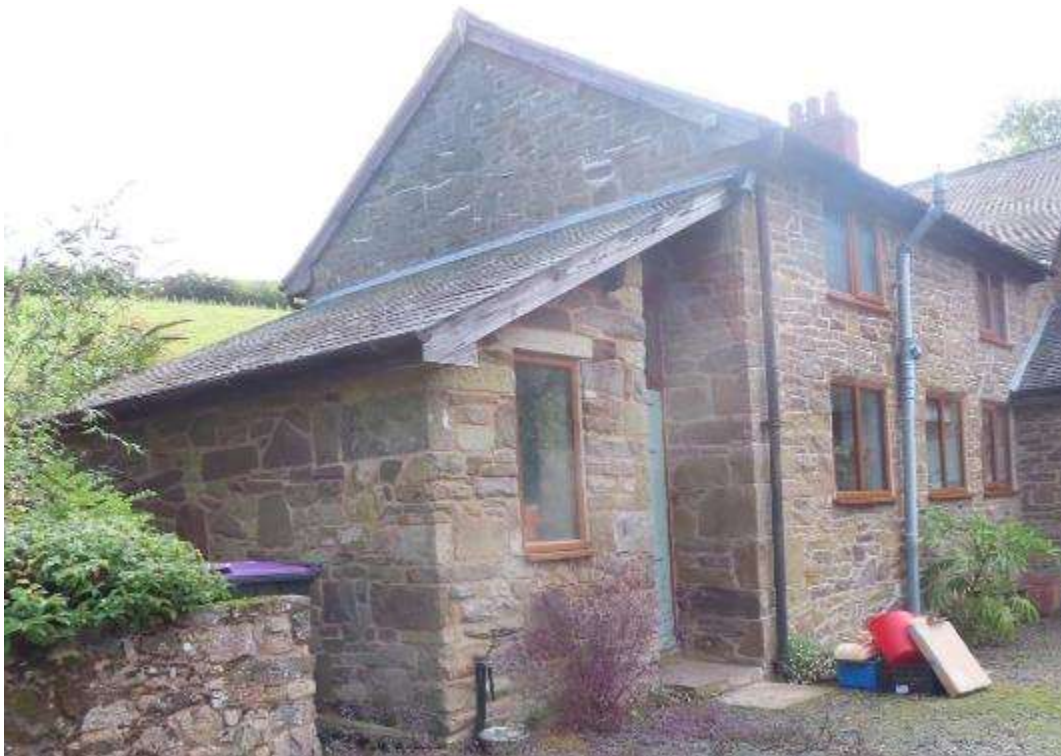
Photograph 2. Exterior.

Lower left: part of the Northwest elevation of the 'lean-to'.
Lower centre: Southwest elevation of the 'lean-to'.
Upper centre: Northwest elevation of the main, two-storey, section.
Right: Southwest elevation of the main, two-storey section.

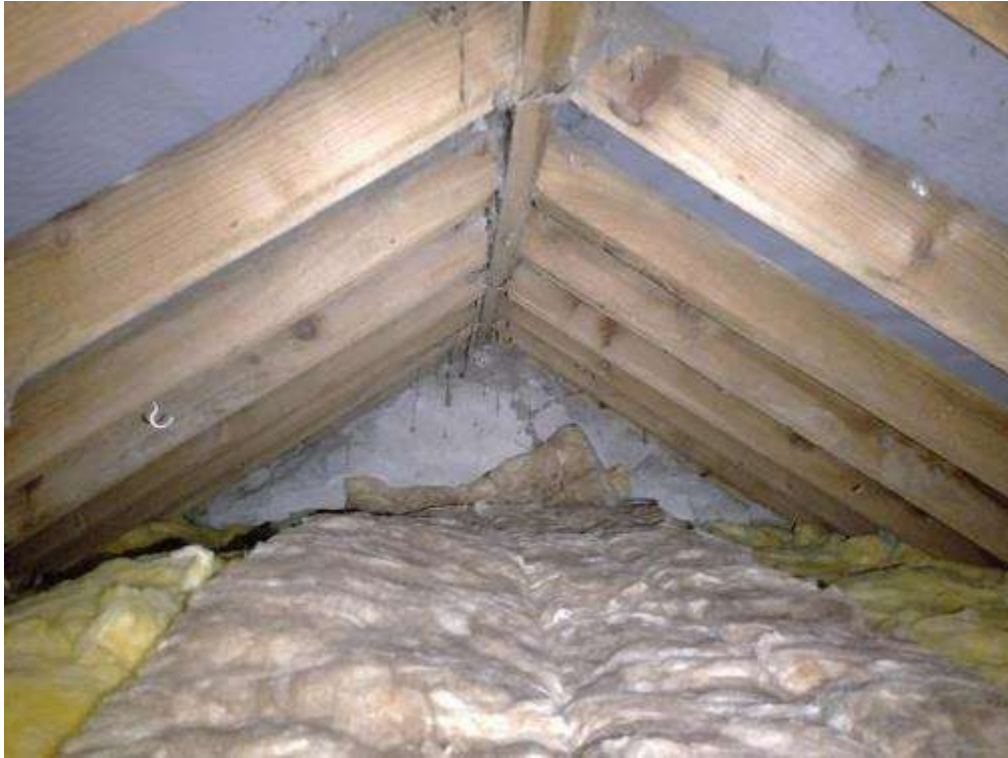
Photograph 3. Interior.

View within the northwest-end roof-space of the main, two-storey section.
Looking northwest from southeast.

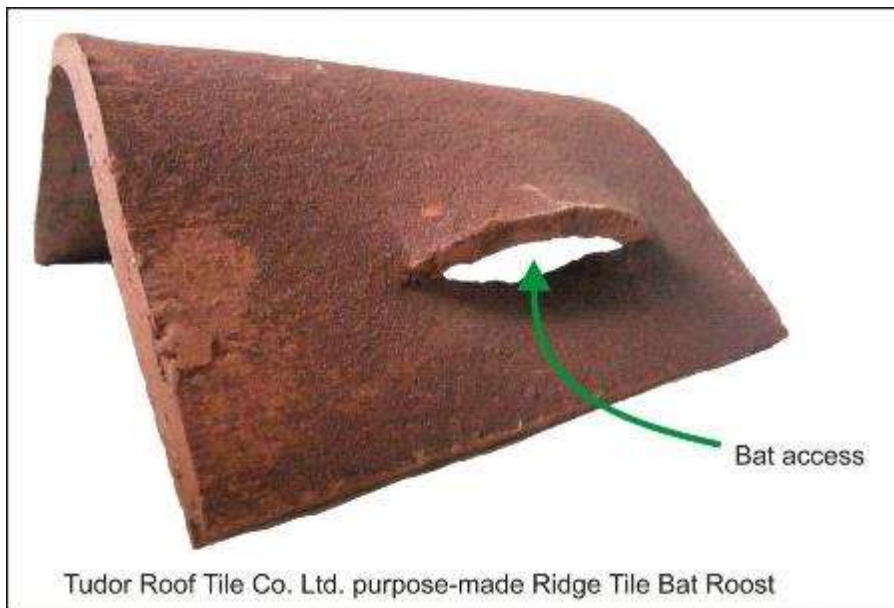
Purpose-made ridge tiles with bat-access openings are available commercially. For example, the handmade 'bat access ridge tile' produced Tudor Roof Tile Co. Limited, Dengemarsh Road, Lydd, Kent, TN29 9JH.

A picture of the Tudor Roof Co. Limited purpose-made ridge tile bat roost is shown below:
