Preliminary Bat Roost Assessment

**Court Farm Cottage, Fox and Pin Lane, Nowton,
Bury St Edmunds, IP29 5LP**

Project number:	Title:	Revision:	Issued:
REP21035	Bat Roost Assessment of Court Farm Cottage, Fox and Pin Lane, Nowton, Bury St Edmunds, IP29 5LP.	Final	15 th September 2021

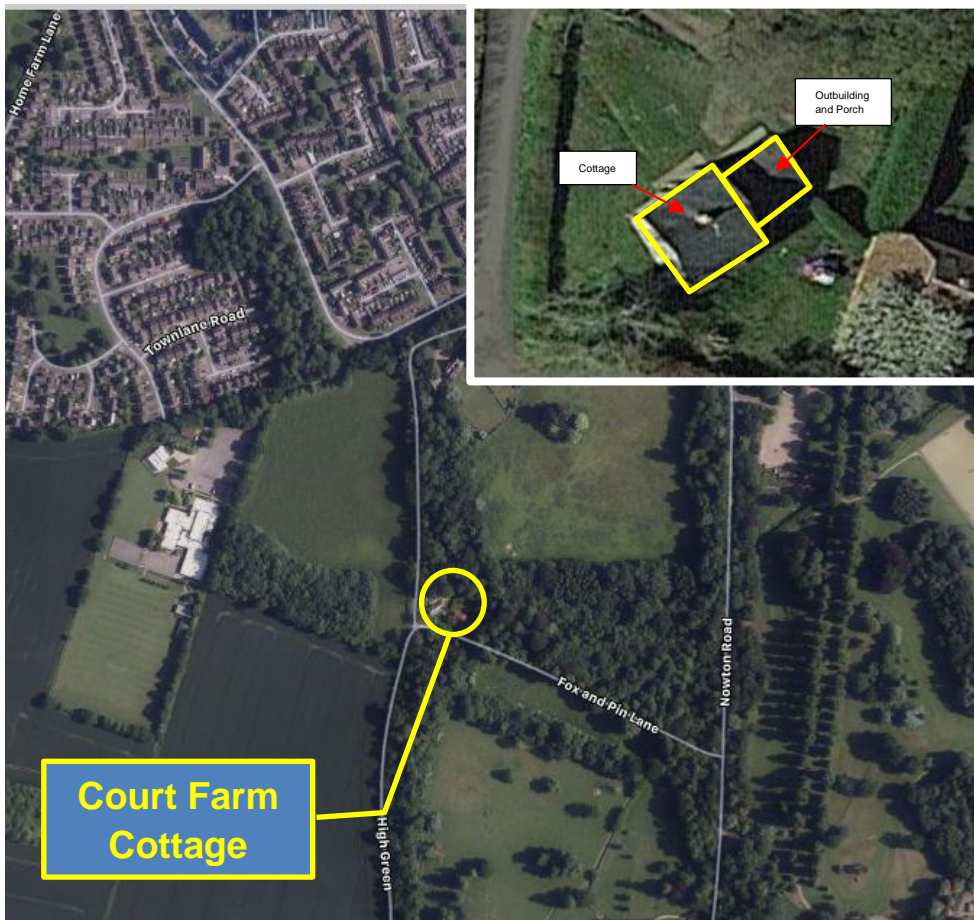
Figure 2.1: Location of the Cottage and site context.

The Cottage (formerly two estate-workers Cottages) is immediately surrounded by woodland and scattered trees. A single, detached residential property lies adjacent to the eastern boundary of the garden (Figure 2.1). Nowton Park lies 300m to the east, with associated parkland, woodland and water bodies. The River Lark runs approximately 1.2km to the east. The wider countryside is predominantly arable farmland.

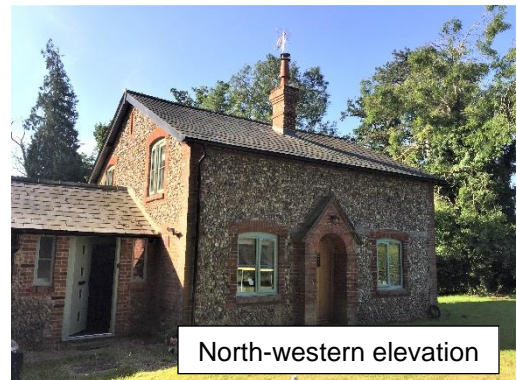
Double-story cottage (previously two semi-detached cottages) with brick and flint walls and gabled double-pitch, slate roof. The former estate cottages, built in the 1870's, underwent complete renovation and conversion to a single dwelling in 2016-2017. The external walls (flint and brickwork) were very well pointed and sealed, with no notable cracks, gaps or missing mortar.

The roof was in very good condition and well-maintained: Slates and ridge tiles were intact and well-sealed with no lifting slates or notable gaps. The gable-ends were well-sealed: Barge boards appeared new, intact, and well-sealed to the walls. The join between the Cottage gable wall and porch roof was intact cement. Lead flashing on the single chimney was mainly flush with the slates, with some minor lifting (circled - inset photo). All windows were replaced during the renovation and well-sealed into surrounds.

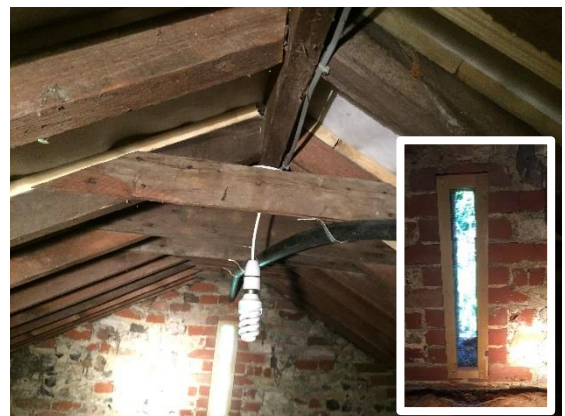
The internal roof space was approximately 1m in height (floor to ridge), with modern roof timbers (no gaps), and internally lined with a breathable roofing membrane which was intact with no tears or holes.

Limited flight potential for bats internally, due to shallow pitch and narrow roof space.

Each gable end had a large air-brick, which was sealed with a fine mesh (inset photo). Potential for void-roosting bats was reduced due to lack of space for free-flight space, internally draughty,

lack of crevices and potential roosting opportunities, and high light levels. No bat droppings were recorded, or other evidence of bats having accessed the void.

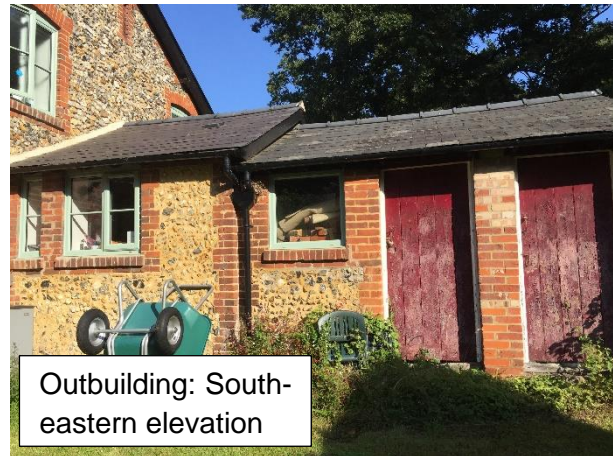
Outbuilding: South-eastern elevation

Single-storey porch and unheated outbuilding directly adjoined but not inter-connected internally. The porch extended from the north-east-facing cottage gable end, joining below eaves/roof-height.

Shallow, double-pitched slate roofs - well-sealed slates and ridge tiles with no gaps (re-roofed – including the timbers in 2016/17).

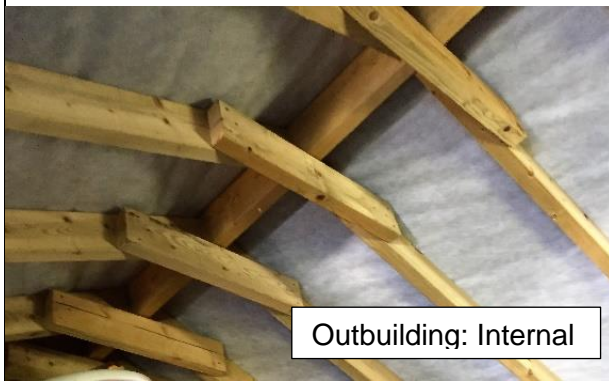
Outbuilding: Internal

The porch had a false ceiling and small, shallow (<1m void) which was inaccessible (no loft-hatch). The outbuilding was open to the roof timbers with no loft-void. Roofs were internally lined with breathable membrane. Internally, light levels were high due to windows. Conditions for roosting bats were negligible due to lack of dark crevices or other potential roost features. No bat droppings were recorded, or other evidence of bats having accessed the outbuilding or porch.

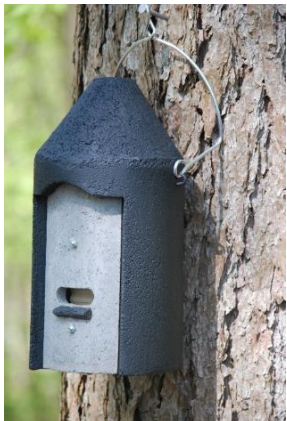
<p>Schwegler 2F (for pipistrelle bats)</p> <p>Multi-purpose bat box for pipistrelles – tree-mounted. Manufactured from long-lasting Woodcrete, a blend of wood, concrete and clay which will not rot, leak, crack or warp, and will last for at least 20 - 25 years.</p>

Bat boxes on suitable mature garden trees are also suggested, in line with obligations for all planning applications to provide a net gain for wildlife. Woodcrete boxes, such as Schwegler 2F for pipistrelle bats, and 2FN for larger bats, would be suitable for positioning in trees. These boxes are constructed of wood fibres, clay and cement and are more durable and long-lasting than wooden alternatives. Bat boxes should be located at least 5m above the ground and facing south-east to south-west, to receive sun for part of the day, close to boundary vegetation and with open flight access into the boxes.

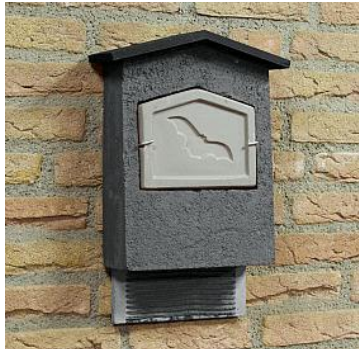
<p>Bat boxes for Buildings (externally-mounted):</p> <p>Chillon Woodstone Bat Box:</p> <p>A large crevice style bat box made from long-lasting woodstone with a wooden back plate for attachment. The internal space is 35mm deep and can accommodate up to 15 pipistrelle bats. Dimensions: 29 x 44 x 9 cm</p>

Additional Bat boxes will help towards Suffolk Biodiversity Action Plan targets and enhancement, as encouraged through the NPPF (National Planning Policy Framework; DCLG, 2019). An integral bat box on the south-east-facing upper wall of the new extension should be considered: This could be a bespoke bat-roosting opportunity built into the fibre-cement weather-board cladding (see Table 4.1), or an externally mounted bat box; the Schwegler 1FF or the Beaumaris Woodstone Bat Box would be suitable for positioning on the external walls of the Cottage.

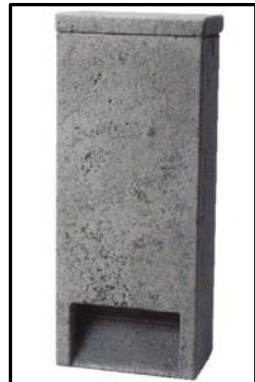
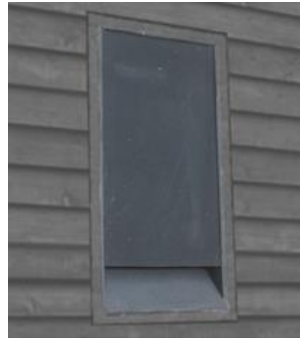
<p>Roosting Box for Buildings: Built-In (Integral)</p> <p>e.g., Schwegler 1FR Tube, Integrated Eco Bat Box, or similar and approved.</p>

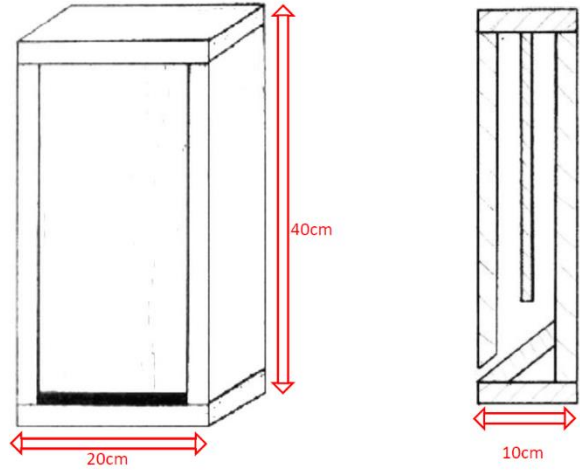
<p>Bespoke Crevice-Roosting Box</p> <p>Designed to fit beneath cladding on external walls of buildings.</p>
