**Bat Survey Report for
Outbuilding,
Rose Cottage,
High Street, Blockley,
Moreton-in-Marsh, GL56 9HF**

NKM Associates

Outbuilding, Rose Cottage on High Street, Blockley - Bat Survey Report

Report Number: 36723-01 NKM Assoc

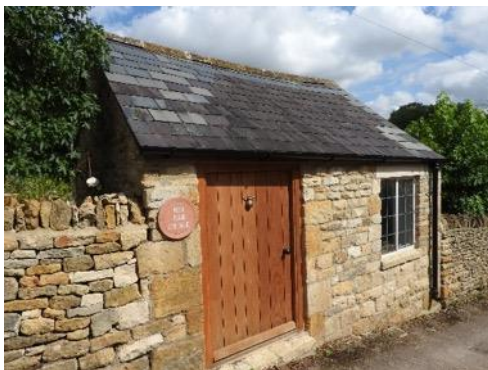
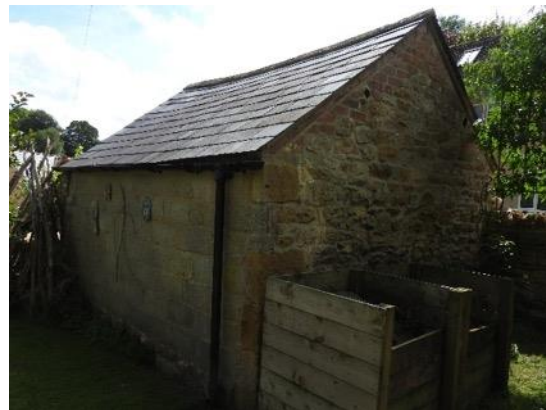
Figs. 1 & 2 Front View (L) and rear view (R)

The Survey site comprised a detached pitched roofed outbuilding (Figs, 1-2).

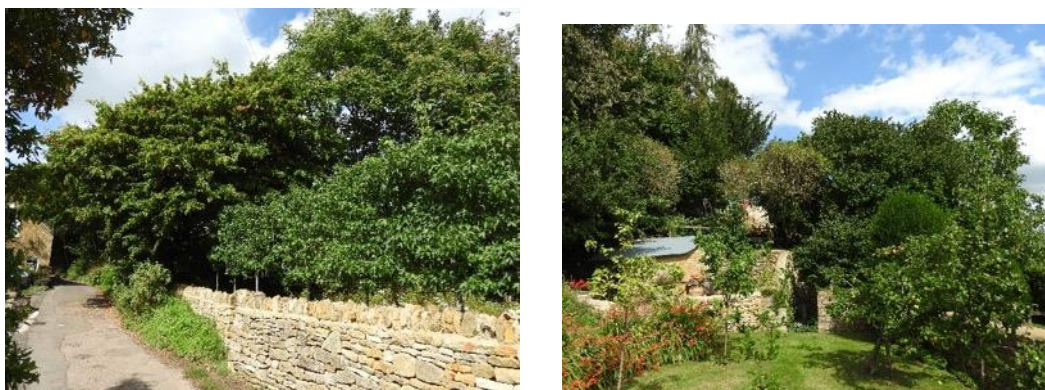
To the front of the outbuilding was a narrow lane, with houses and garages and mature trees on the opposite side of the lane (Fig. 3). The rear garden was laid to lawn with mixed planted vegetation (Fig. 4).

Figs. 3 & 4 Lane to the front of the building (L) and rear garden (R)

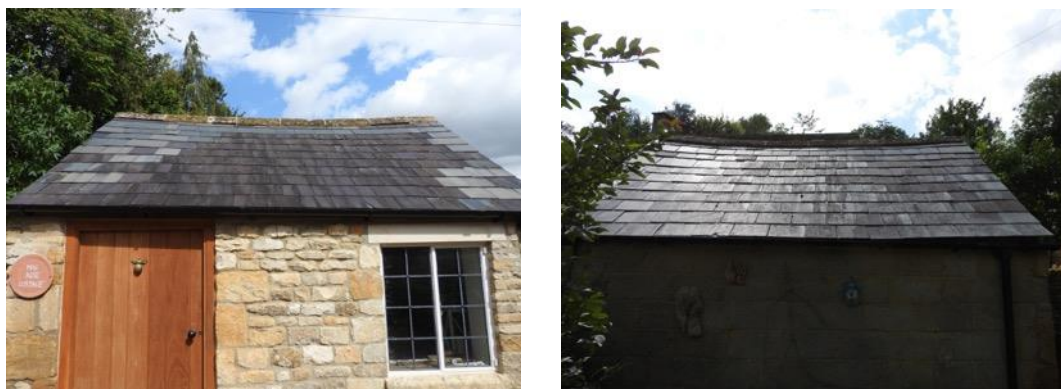
Figs. 5 & 6 Ridge and roof tiles to the front (L) and rear (R)

The ridge was intact and sealed, all the roof tiles were tightly overlapping (Figs. 5 and 6).

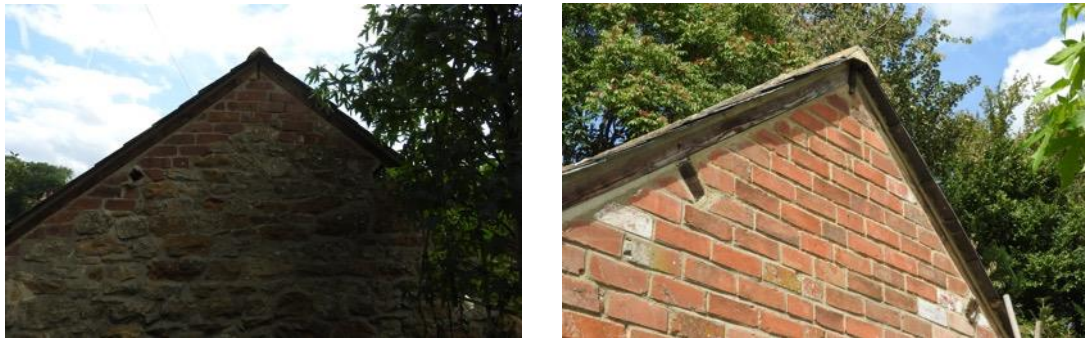
Figs. 7 & 8 Sealed gables

The gables were sealed with the roof verges cement sealed to the gable barge boards (Figs. 7 and 8).

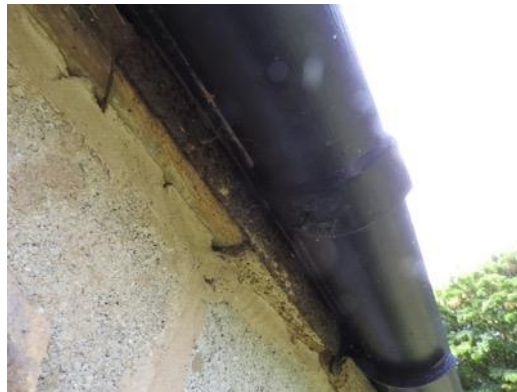
Fig. 9 Tightly fitting fascia board

The eaves of the cottage were finished with tightly fitting fascia boards (Fig. 9).

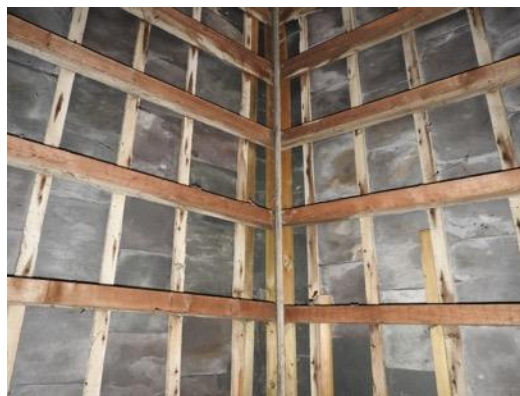
Fig. 10 Lightly cobwebbed ridge

Internally the outbuilding was open to the unlined roof. The ridge and gable ends were lightly cobwebbed (Figs. 10 - 12).
