# **Preliminary Ecological Appraisal and Nocturnal Bat Survey Report**

Cherry Tree Cottage  
Coln St Aldwyns  
Gloucestershire  
GL7 5AD

**August 2023**

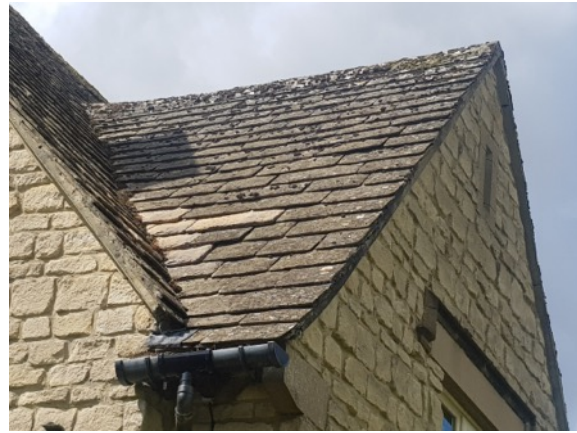
Photo 2: B1 - Raised tiles

- 3.14 B1: Externally, features that were considered to offer value to crevice dwelling species of bat that utilise the external fabric of buildings for roosting and provide potential ingress points for void dwelling species were limited to the gaps and crevices under and between the imitation Cotswold tile-stones. No gaps were noted in the stonework of the elevations.

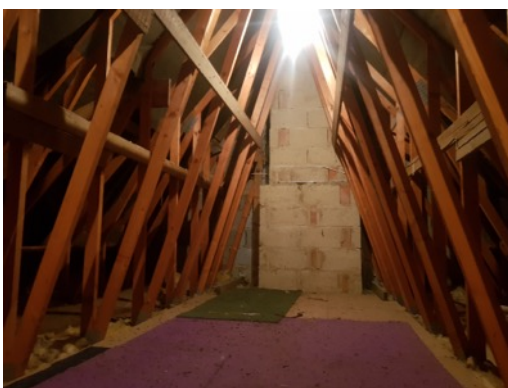
Photo 5: B1 - Interior view of loft void

- 3.15 Internally, the loft void located within the pitched roof of the building features an exposed W-truss timber roof structure with the tiles being underlined with bitumen felt. No daylight ingress was noted; however, areas of damaged underlining were discovered beside both walls at the apex of the roof. The building interiors of the ground and first floors were considered to be inaccessible by bats.

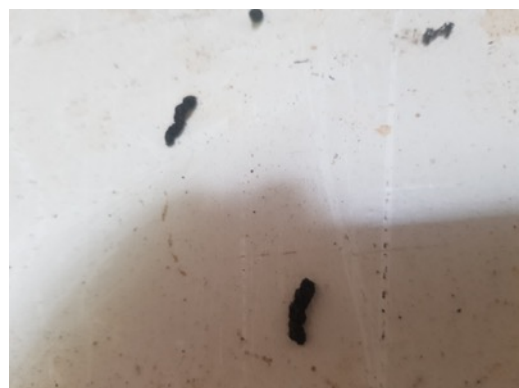
Photo 6: B1 - Scattered bat droppings on floor of loft

- 3.16 Several hundred medium-sized scattered bat droppings of various ages were found on the floor within the loft void during the assessment of the building.

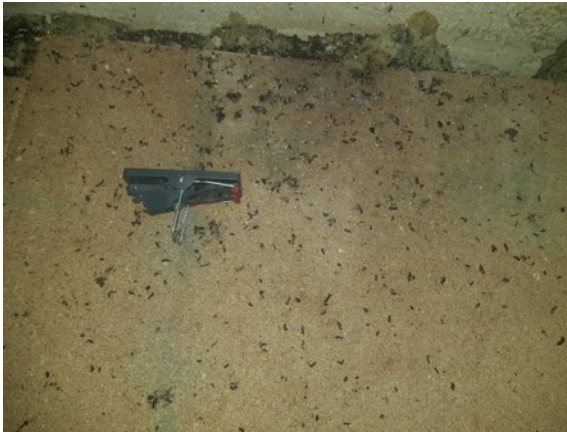
**Photo 7: B1 - Scattered bat droppings on floor of loft**

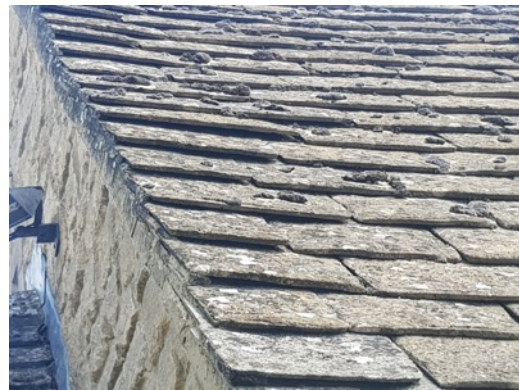
**Photo 10: B2 - Raised tiles**

- 3.17 B2: Externally, features that were considered to offer value to crevice dwelling species, that utilise the external fabric of buildings for roosting and provide potential ingress points for void dwelling species were limited to the gaps and crevices under and between the imitation Cotswold tile-stones. No gaps were noted in the stonework of the elevations.

- 4.6 **B2:** Due to the presence of a single raised tile, **the single storey element of the residential dwelling was considered to hold low roosting potential**. Therefore, **one nocturnal survey was undertaken** to ascertain presence/absence of bats, with one surveyor used to cover the north facing aspect of the roof.
- 4.7 **B3:** The garage annexe **is considered to hold low roosting potential** due to a low number of raised tiles. Therefore, it was recommended that prior to any works commencing, **one nocturnal survey was undertaken** to ascertain presence/absence of bats, with two surveyors used to cover these features.

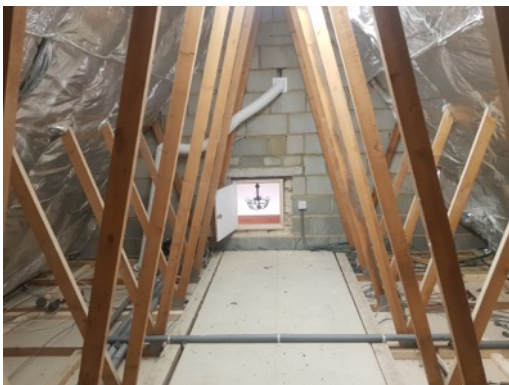
**Photo 11: B2 - Interior view of loft void**

- 3.18 Internally, the loft void located within the pitched roof of the building features an exposed W-truss timber roof structure with the tiles being underlined with foil-backed insulation. No daylight ingress was noted that may highlight potential entry points and the ground floor of the building was considered to be inaccessible by bats.

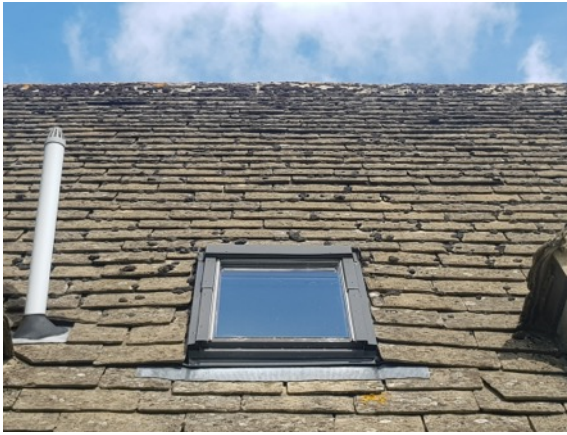
Photo 73: B3 - Raised tiles

- 3.19 No bats, droppings or further evidence of bat presence was discovered during the assessment of the building.
- 3.20 B3: Externally, features that were considered to offer value to crevice dwelling species of bat that utilise the external fabric of buildings for roosting and provide potential ingress points for void dwelling species were limited to the gaps and crevices under and between the imitation Cotswold tile-stones. No gaps were noted in the stonework of the elevations.

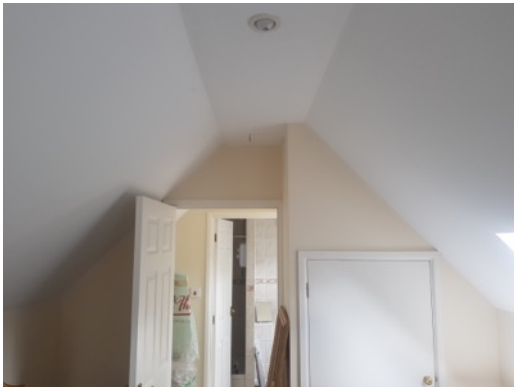
Photo 15: B3 - Internal view showing roof open to the apex

- 3.21 Internally, no loft void is present as the roof of the building is open to the apex internally and the roof spaces present within the eaves were well sealed and fully boarded with no daylight ingress noted that may highlight potential entry points and the building's interior, including the ground floor garage, was considered to be inaccessible by bats.
