GEOTECHNICAL SITE INVESTIGATION REPORT

26 HIGH STREET BURWELL CAMBRIDGESHIRE CB25 0HB

Reference Number 3309/Rpt 1v2 September 2023

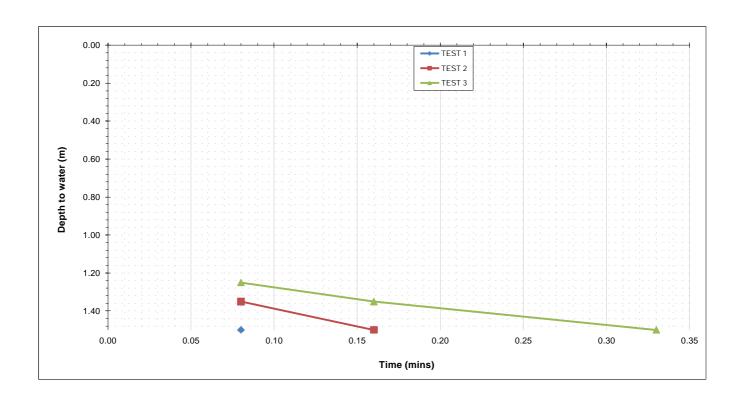
0.08	1.50	0.08	1.35	0.08	1.25	
			0.16	1.50	0.16	1.35	
					0.33	1.50	
All three tests completed during the day.							
Strata							
0.00m - 0.30m Made Ground - Dark brownish grey slightly gravelly, slightly sandy, silty CLAY with occasional bricks. 0.30m - 1.50m Structureless light cream CHALK composed of silty sandy GRAVEL. (Grade Dc)							
Effective Storage Depth	m	0.15		0.25		0.25	
75% Effective Storage Depth	m	0.11		0.19		0.19	
(i.e. depth below GL)	m	1.34		1.26		1.26	
25% Effective Storage Depth	m	0.04		0.06		0.06	
(i.e. depth below GL)	m	1.41		1.39		1.39	
Effective Storage Depth 75%-25%	m	0.08		0.13		0.13	
Time to fall to 75% effective depth	mins	0.02		0.04		0.09	
Time to fall to 25% effective depth	mins	0.07		0.10		0.21	
V (75%-25%)	m3	0.04		0.06		0.06	
a (50%)	m2	0.72		0.88		0.88	
t (75%-25%)	mins	0.05		0.06		0.12	
SOIL INFILTRATION RATE	m/s	1.67E-02		1.89E-02		9.47E-03

DESIGN SOIL INFILTRATION RATE, f 9.47E-03
