**GEO-ENVIRONMENTAL SITE INVESTIGATION
REPORT**

**26 HIGH STREET
BURWELL
CAMBRIDGESHIRE
CB25 0HB**

**Reference Number 3309/Rpt 2v1
September 2023**

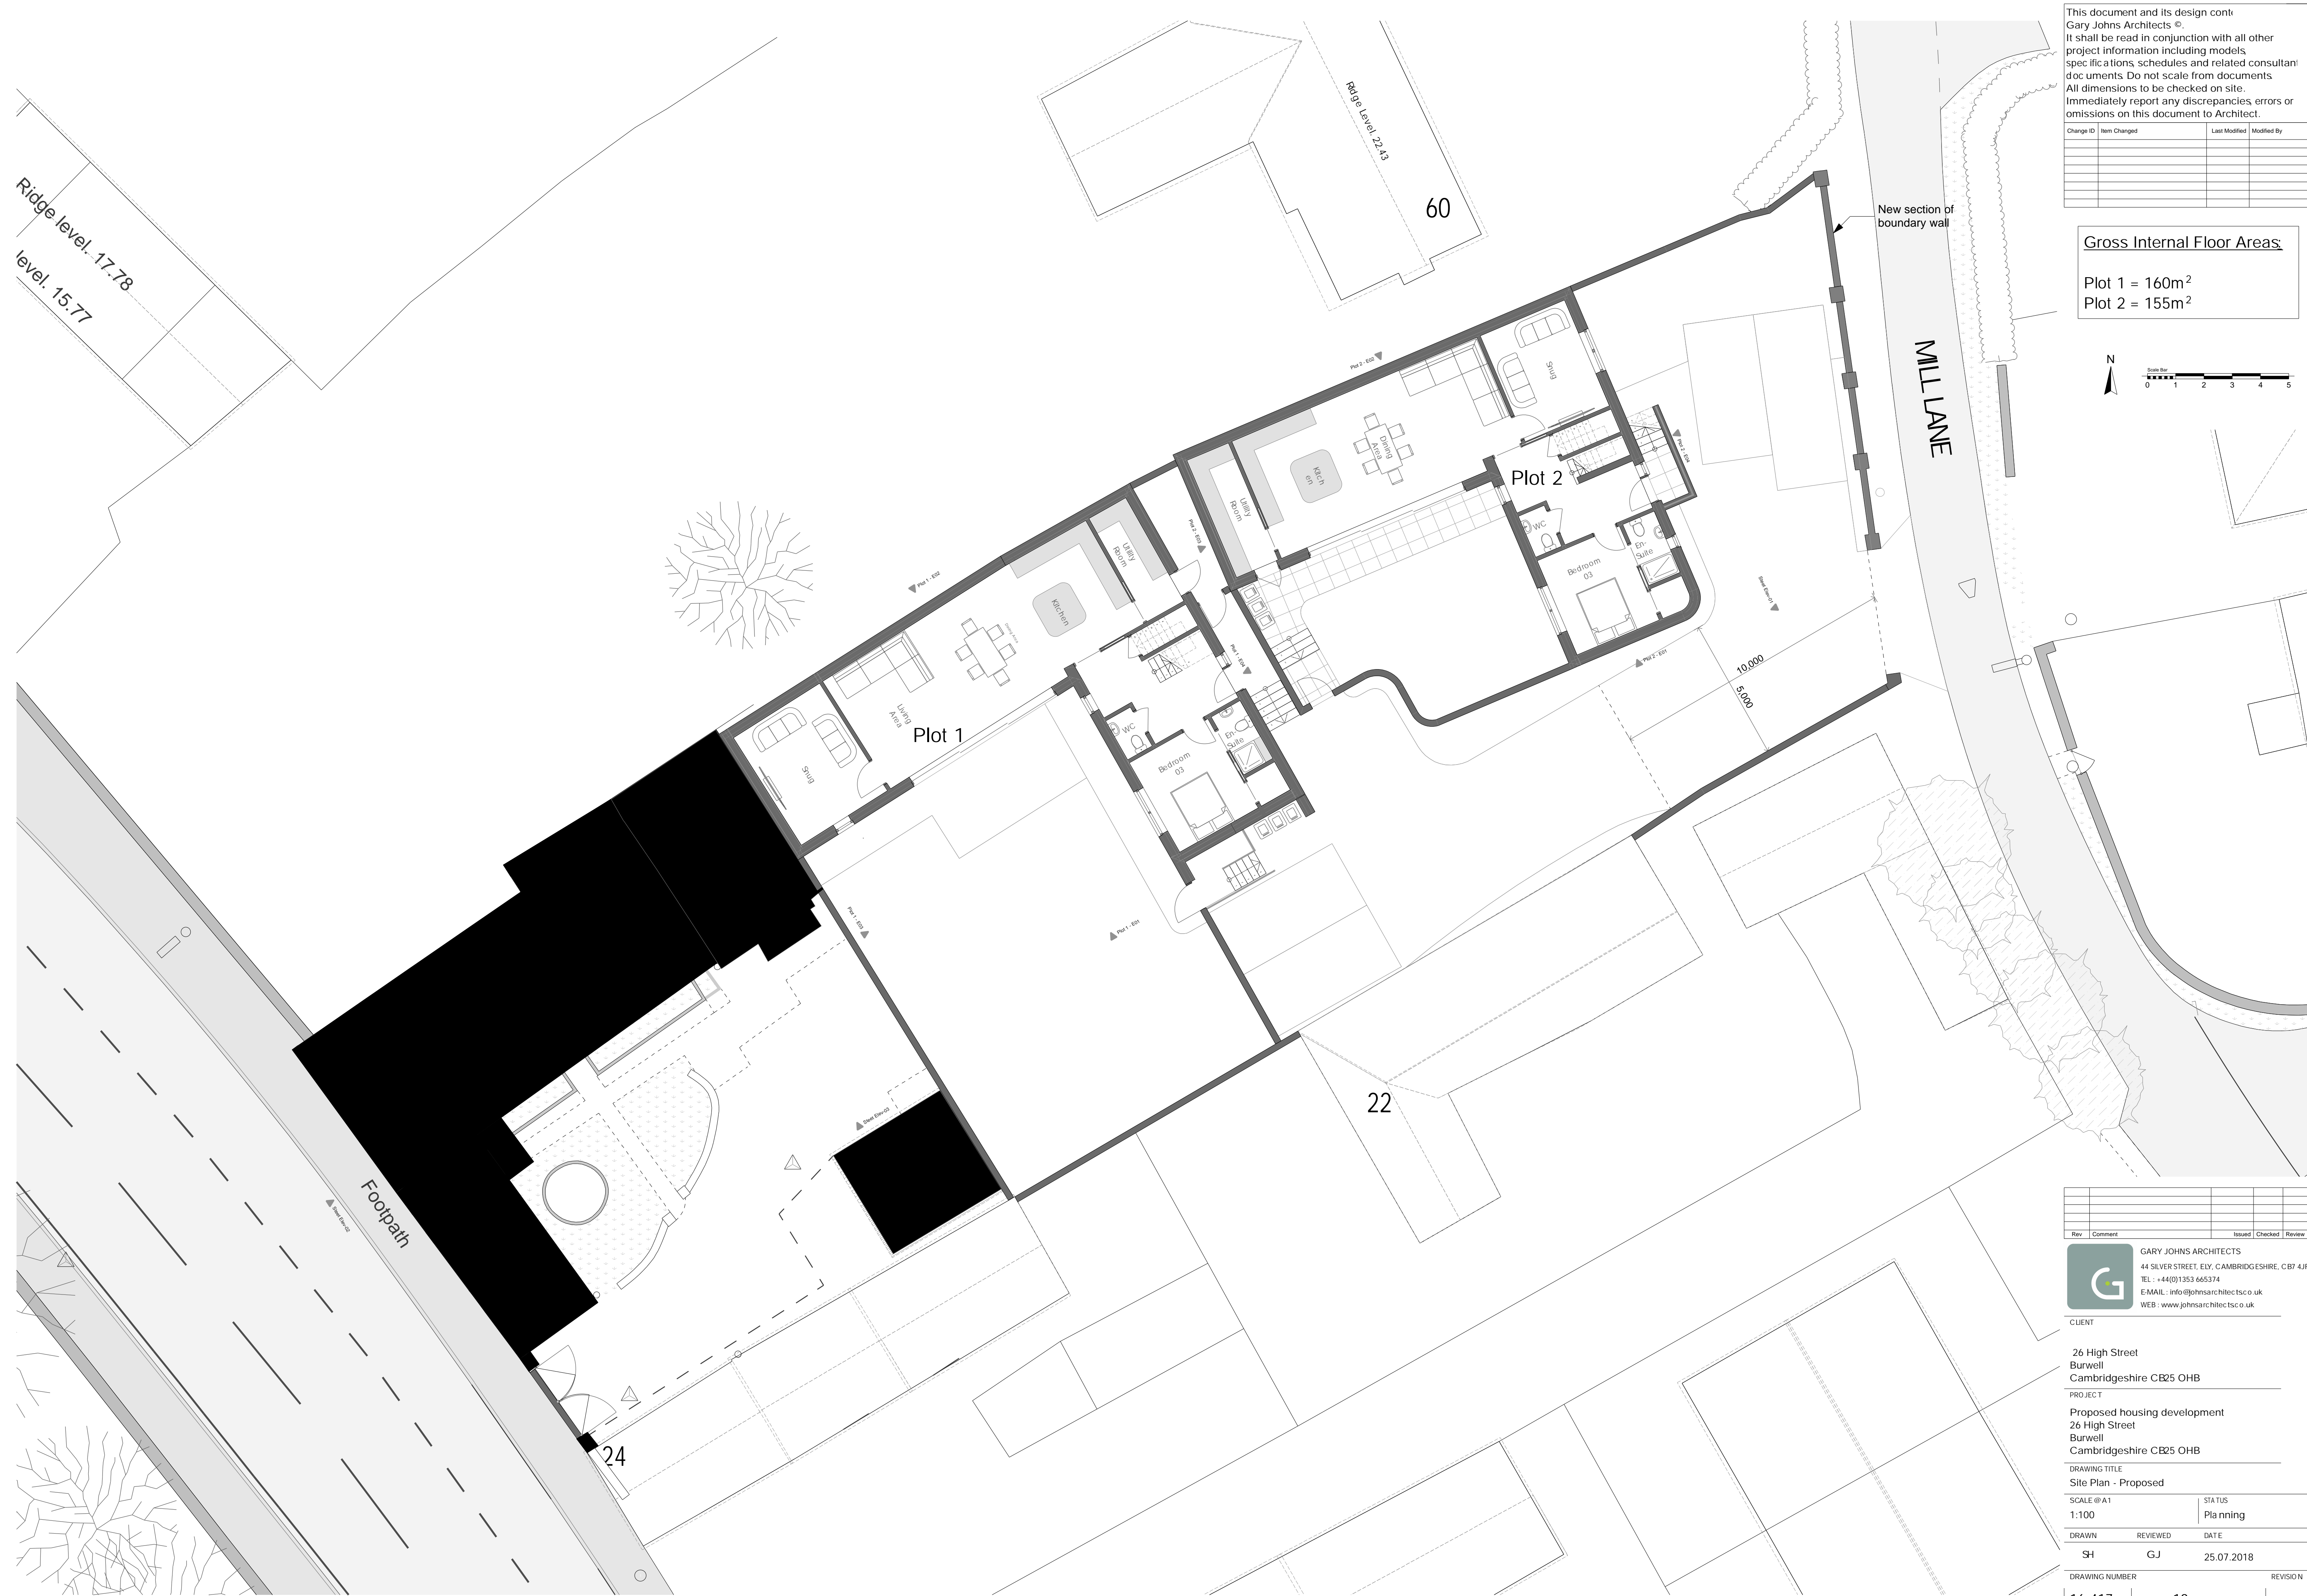
It is proposed to redevelop the site for residential usage consisting of two dwellings with associated gardens and parking. The proposed development is shown on drawing number 16-417 10 rev D prepared by Gary Johns Architects. The proposed development layout is presented in Appendix II.

Gross Internal Floor Areas:
 Plot 1 = 160m²
 Plot 2 = 155m²
