**Five Oaks
Fressingfield Road
Stradbroke**

**Ecological Impact
Assessment**

**Prepared by
Glaven Ecology**

Reference: 320-2200-GE-HB

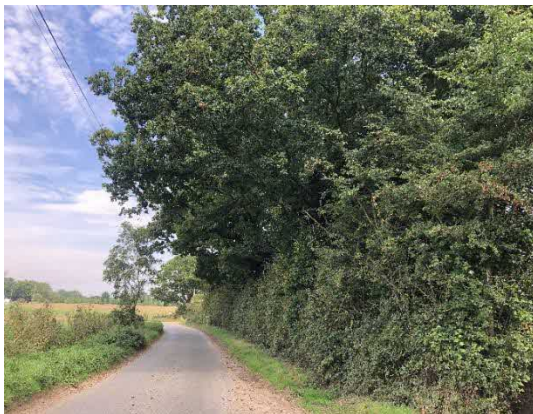
Figure 1: Western boundary looking north

2.2.3 The western boundary bordered Fressingfield Road and was a native hawthorn *Crataegus monogyna* hedgerow (Figure 1) with bramble *Rubus fruticosus* and dogrose *Rosa canina* with four mature oak *Quercus robur* trees. This is considered a UKBAP priority habitat as it is continuous with at least one woody native species and over 20m in length.

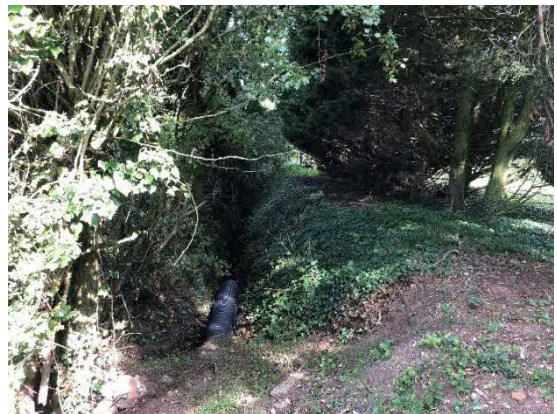
Figure 2: Western boundary ditch looking north

2.2.3 Adjacent to the hedge there was a steep sided ivy *Helix hedera* covered drainage ditch (Figure 2) with approximately one inch of water. A line of mature Leylandii trees were on the Site side of the ditch.

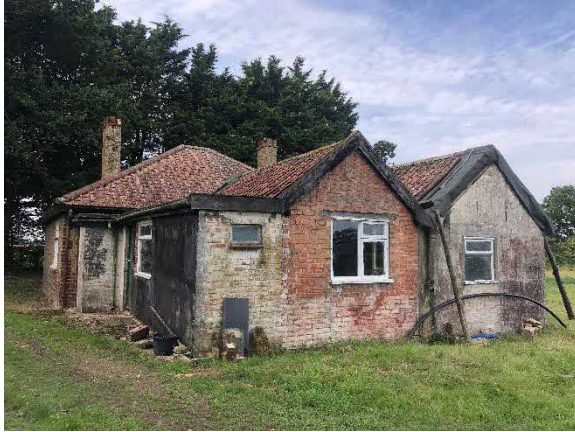
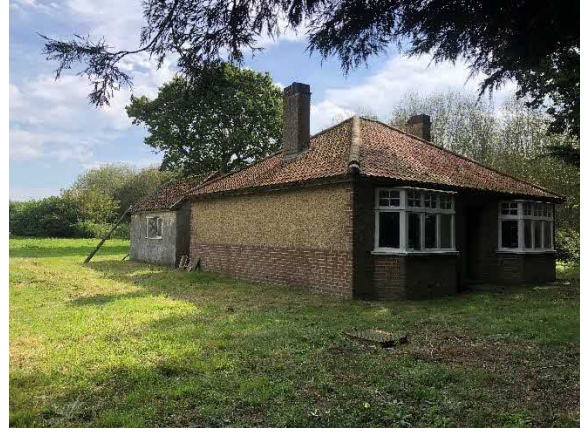
Figure 5: Building looking north-west

5.2.23 The building was constructed of brick with pebble dash design with a hipped roof with pantiles (Figures 5&6). There were two areas with pitched rooves to the rear connected by a flat rooved area that wrapped around the southern pitch. There was a chimney on the northern and southern aspects of the hipped roof.

4.3.10 There were a few visible cracks in the brickwork on the exterior of the building. Doors and windows were well sealed. There were some gaps where the wooden soffit boards met at each corner.

4.3.10 The tiles were of an interlocking design on the hipped roof and appeared well fitted, although some cement was missing from the ridge as was one ridge tile on the northern aspect. A few bricks had fallen from the southern chimney and had created a hole in the southern aspect of the roof. There was evidence of this being patched.

4.3.10 There were raised tiles on the pitched roof and gaps around the ridges. The eastern end of one pitch and the western end of another were patched with felt. There was a small hole in the gable end of the southernmost pitch and above the corner where the flat roof tied into the hipped roof area.

2.2.3 Full mitigation for bat roosts present within the building will be determined as result of further surveys. Three nocturnal surveys for bats are recommended to be carried out on the building to characterise the roost present. These can be carried out between May and September with of the surveys carried out between May and end of August. An EPSM licence will be required for the works to proceed.

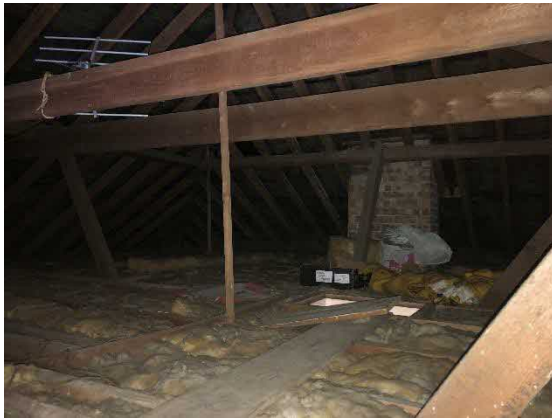
Figure 7: Hipped roof loft space looking north

4.3.10 The main loft space in the hipped roof (Figure 7) was open where part of the ceiling had collapsed.

4.3.10 The machine cut timber frame appeared well fitted and in good condition as was the brickwork of the chimneys. There were cobwebs throughout the framework.

4.3.10 The lining was generally well sealed with a hole near the southernmost chimney where the tiles had broken.

4.3.10 The loft was insulated throughout and there were scattered bat droppings visible.

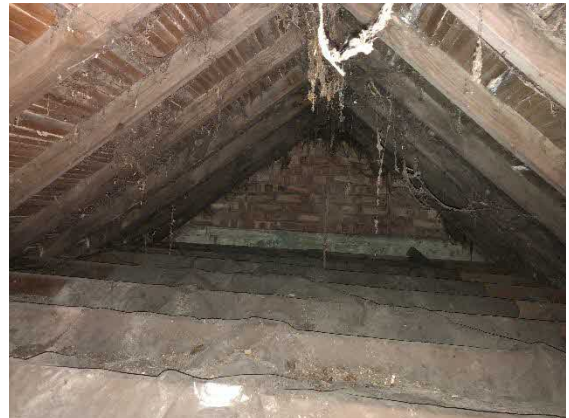
Figure 8: Loft space looking west

5.2.31 There was an accessible loft space within the southernmost pitched roof (Figure 8). This had machine cut timber frame with battens. There was light visible through here and through a hole in the brickwork at the eastern gable end. The floor was covered in plastic and there were dense cobwebs throughout.

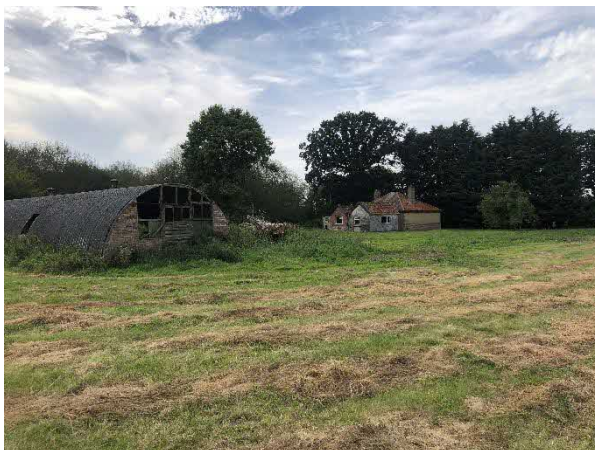
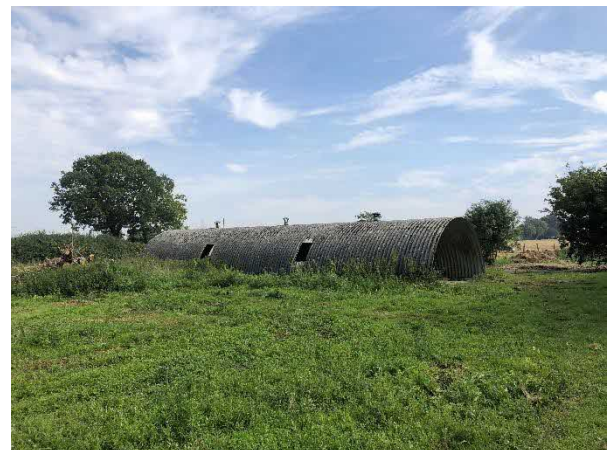
Figure 9: Nissan hut looking south-west

4.3.10 There was a Nissan hut constructed of corrugated asbestos sheeting at the eastern end of the application boundary (Figures 9 &10). The northern end was bricked with a window although most of the glass was missing. The floor was concrete and well swept.
