Condition Survey Elevation
Scale 1:50

Highclere Castle - Render Repairs		DRAWING NO
Highclere Estate		4007-011
LISTED BUILDING CONSENT	DRAWN	CHECKED
	JH	SPF
		SCALE
		As Shown @ A1

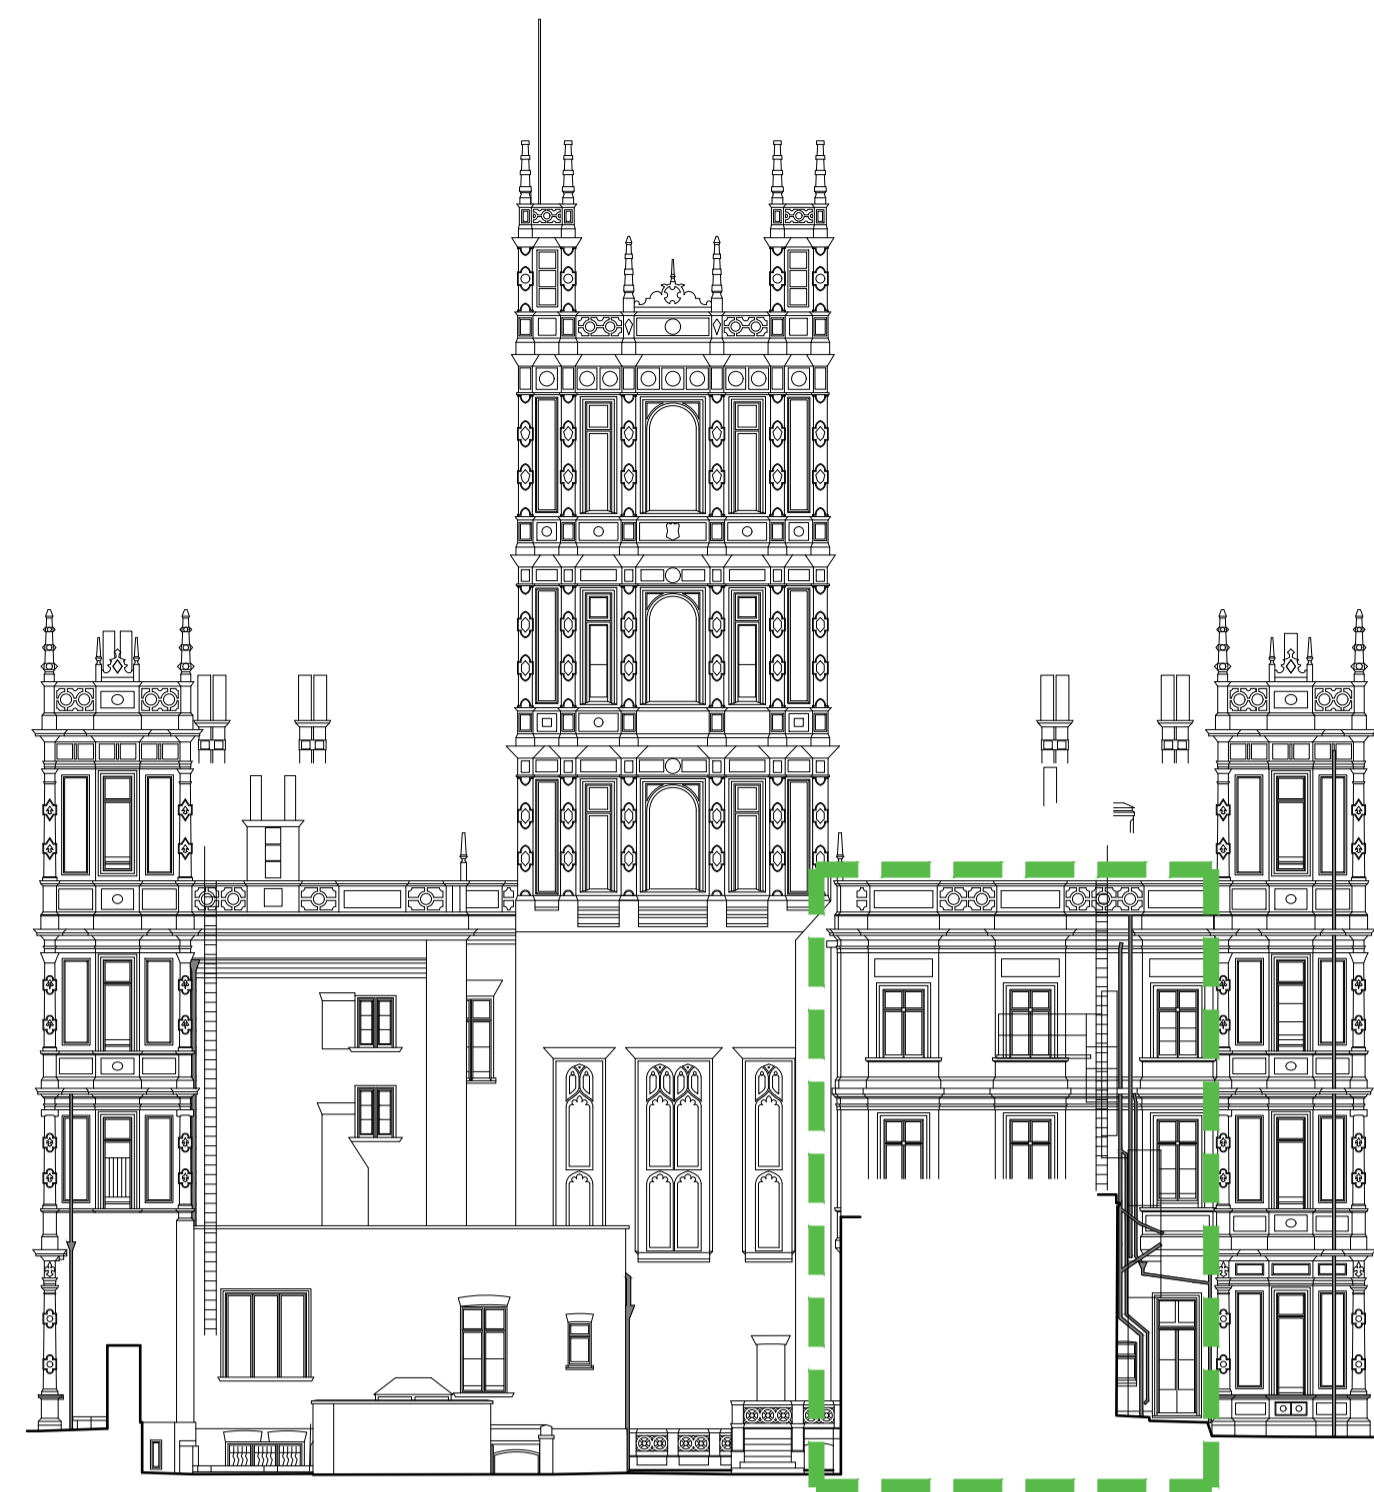
Key Elevation (West)
Scale 1:200

- Area of Proposed Works
-

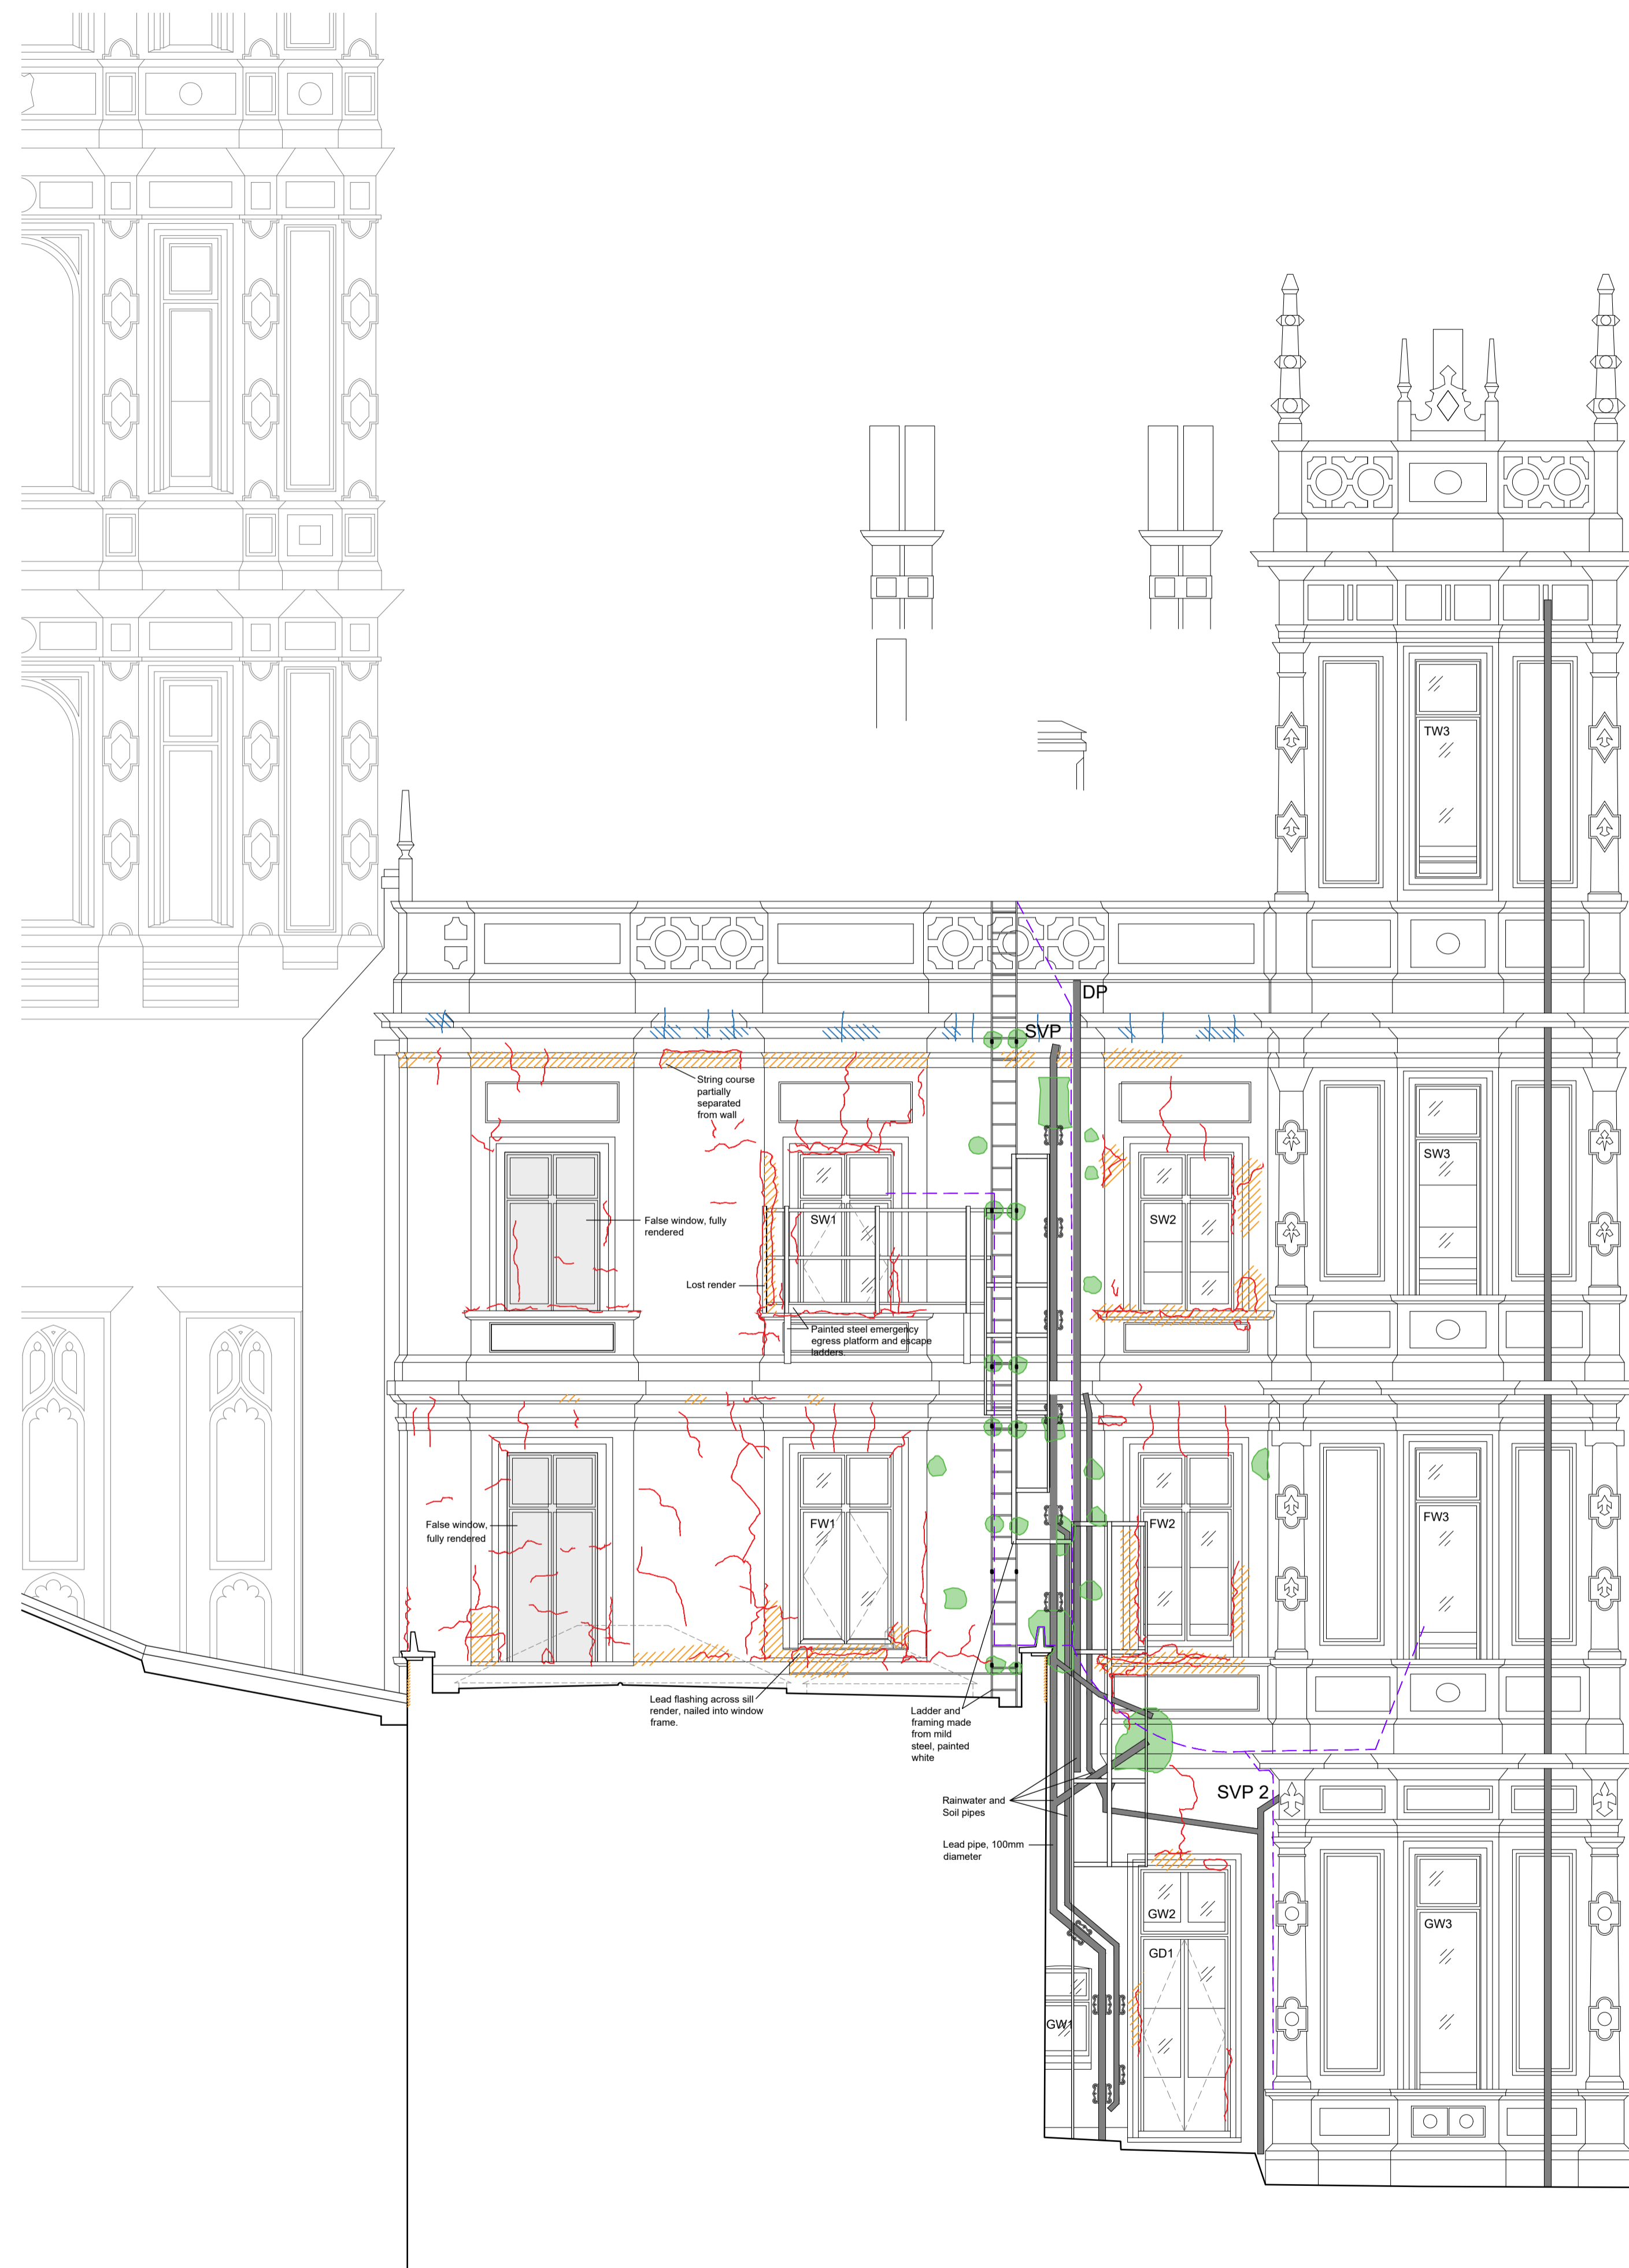
- Crack in render over 1mm wide (including fabric erosion up to 3mm wide pieces)
-

- Lost/delaminating render
-

- Patch repair from 20th Century
-

- Stone damage (erosion)
-

- Cables trailing across facade

- Windows GW1, GW2, FW1, FW2, SW1 & SW2 all framed in timber, painted white.
