# BAT SURVEY REPORT

**Five Acres, Wallingwells Lane, Wallingwells  
Worksop, Nottinghamshire**

**Produced by:** Protected Species Surveys  
**Contact:** Email: [protectedspssurveys17@gmail.com](mailto:protectedspssurveys17@gmail.com)  
**Client:** Clay Architectural Designs  
**Location:** **Five Acres, Wallingwells Lane, Wallingwells, Worksop**  
**Date:** July 2023

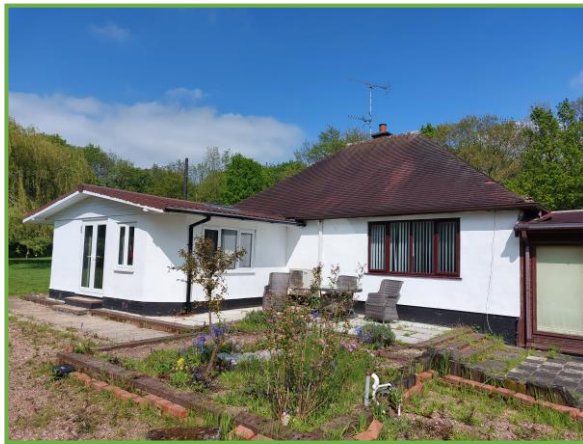
- 3.1 Building 1 (B1) comprised a single-storey, brick-built rendered detached bungalow with a hipped clay tiled roof (photo 1). Other features of note comprised a brick chimney and lead flashing. A single-storey extension with a shallow pitched roof adjoining the north-western aspect of the bungalow. A single-storey rendered entrance porch with flat roof adjoined the north-eastern aspect. The building well maintained with potential bat access points limited to gaps within missing mortar of the hipped tiles and occasional gaps in the roof tiles. No external evidence of use by bats was identified during the survey.

**Photo 1: View of Five Acre bungalow with single-storey extension.**

- 4.4 Five Acres bungalow (B1) was considered to offer low potential to support roosting bats due the presence of occasional gaps via missing mortar of the hipped roof tiles and gaps in the clay roof tiles. Therefore, in accordance with industry guidelines (BCT, 2016), a single nocturnal bat survey was carried out on 23<sup>rd</sup> June 2023.

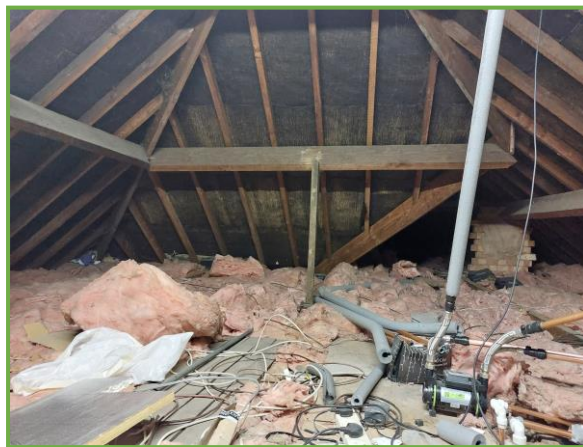
- 3.2 A roof void was present which was lined with bitumen underfelt throughout (Photo 2). The roof was uncluttered with loft insulation present. A light was fitted within the roof void for storing items within the loft. No internal evidence of use by bats was identified during the survey. The building was considered to offer **low** potential to support roosting bats.

**Photo 2: View showing roof void and underfelt.**

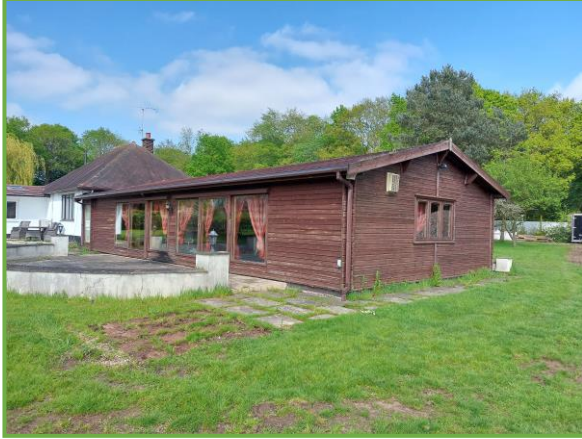
- 3.3 Building 2 (B2) was a single-storey, timber swimming pool building with a shallow pitched slate effect roof (photo 3). Barge boards were present. The building appeared well-maintained with no obvious gaps observed from the ground level PRA. No external evidence of use by bats was identified during the survey.

**Photo 3: View of timber constructed swimming pool building (B2).**

- 4.3 The PRA comprised an internal and external building survey categorised the timber constructed swimming pool (B2) as offering negligible potential to support roosting bats. As such bats are not considered a statutory constraint to the demolition of the building.

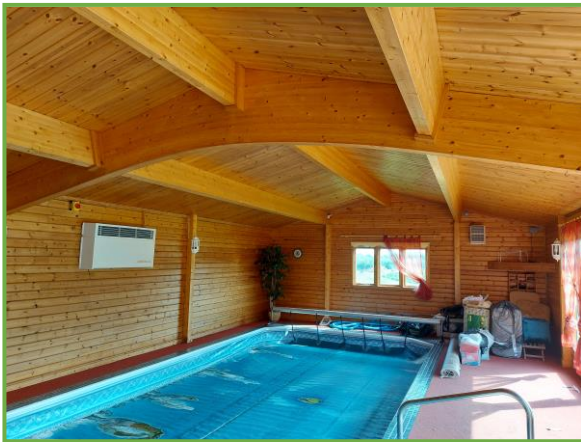
- 3.4 Internally no roof void was present with timber sarking underlining the shallow pitched roof (photo 4). No internal evidence of use by bats was identified during the survey. The building was considered to offer **negligible** potential to support roosting bats.

**Photo 4: Internal view of B2**

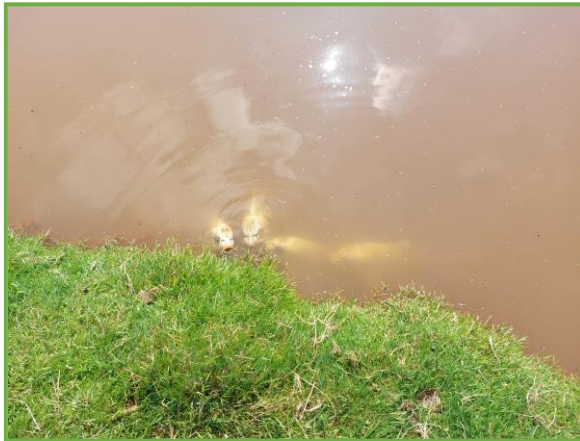
- 3.6 The on-site lake was checked for its suitability to support Great Crested Newt (GCN) during the initial PRA. The lake is heavily stocked with ornamental carp (photo 5) and considered unsuitable to support GCN..

**Photo 4: View of ornamental carp in the on-site lake**

- 4.7 Due to the high density of ornamental carp observed, the on-site waterbody is not considered suitable to support GCN and therefore not considered a statutory constraint to the proposed works.
