Natural
Infrastructure
Consultants

Arboricultural Impact Assessment

VERSION: V1 DATE: July 2023
REF NO: 230713 1719 AIA V1

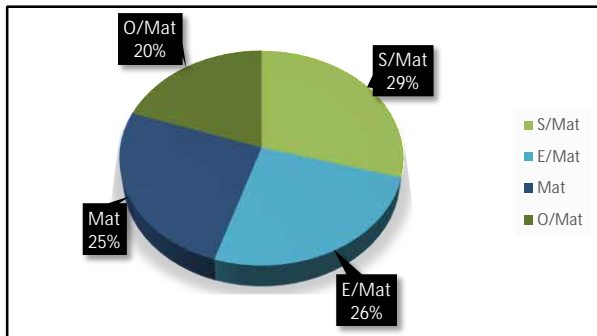
Age Distribution of the Tree Population

The distribution of age category across the tree population is useful for understanding expected longevity and can be used for determining mitigation, management and replacement.

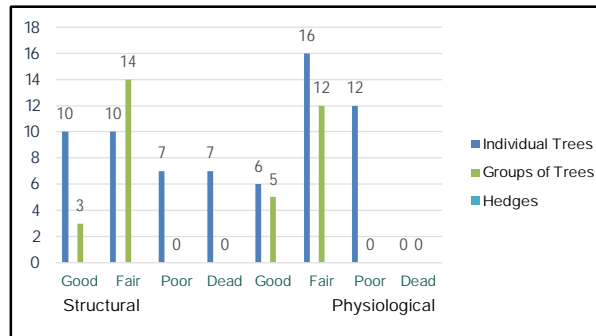
Distribution of Physiological and Structural Conditions across the Tree Population

Physiological condition provides an indication of the vitality of the tree. Structural condition is related to the presence of defects that can lead to failures.

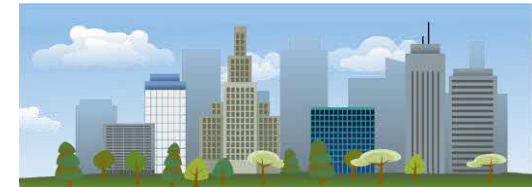
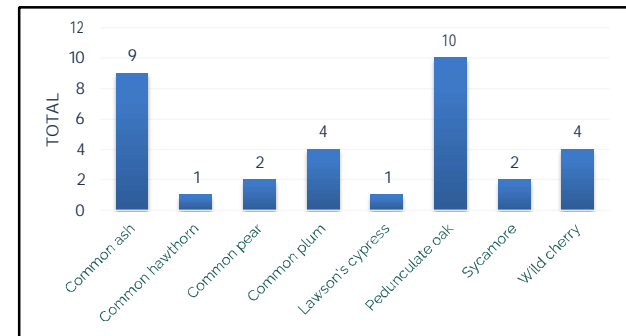
Species Composition of the Individual Tree Population

The proportions of any given family, genus, species, and cultivar which make up the total individually recorded tree population across the Site.

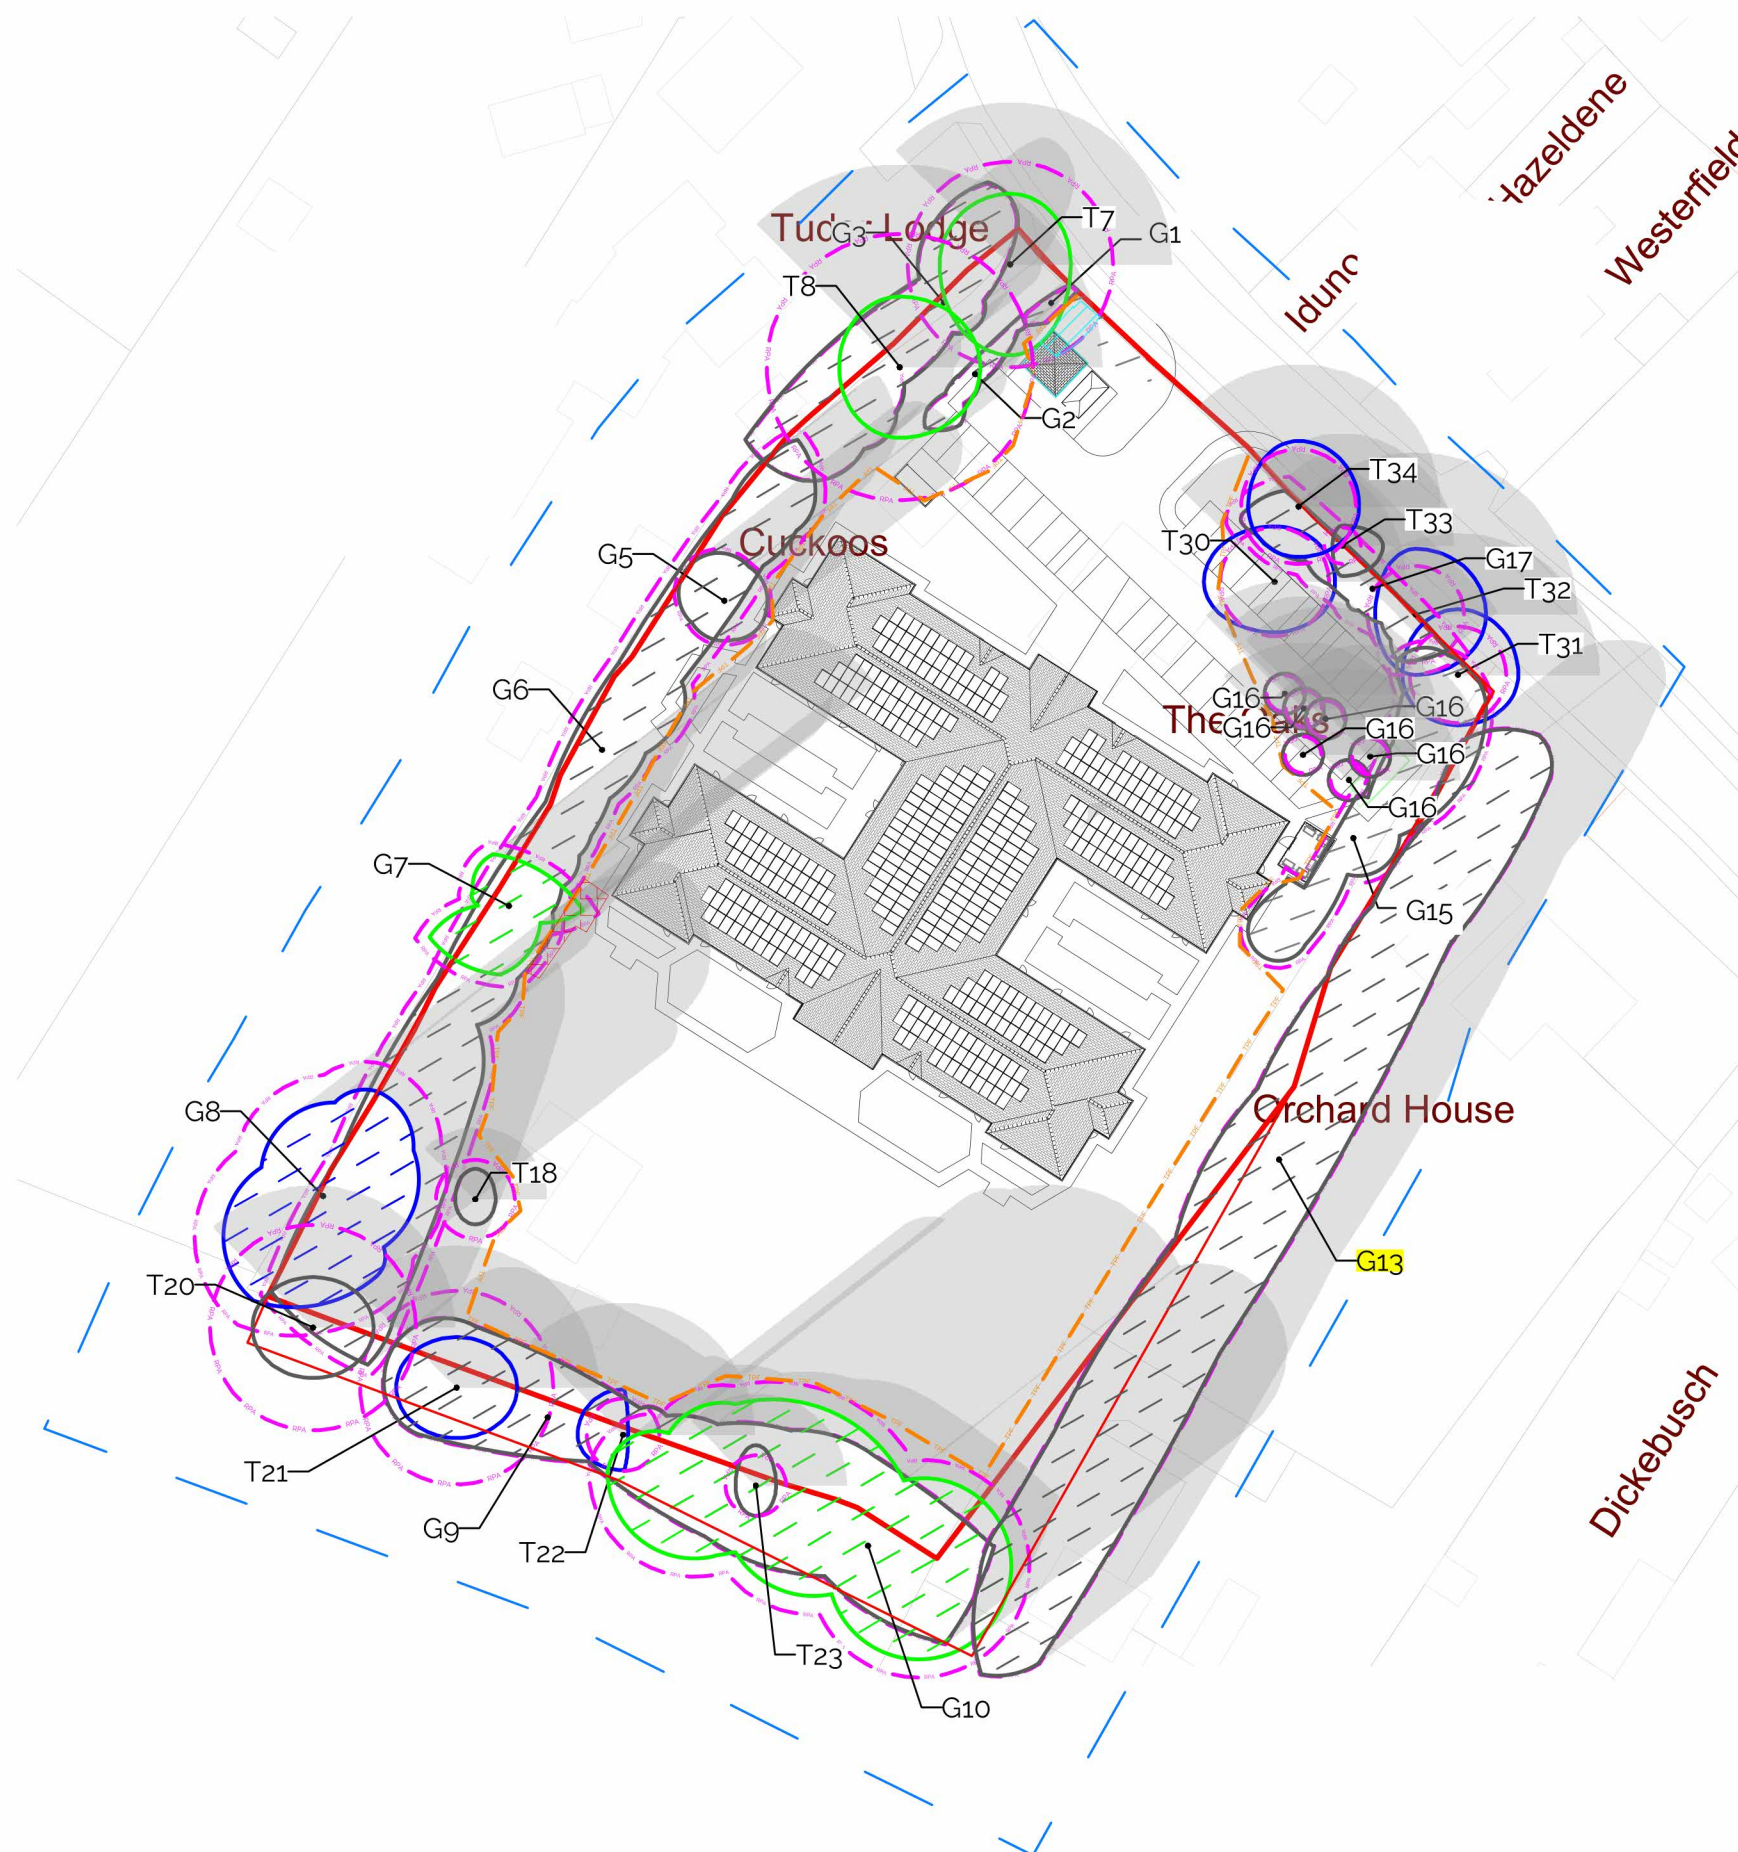
Drawing file reference	DWG No
230713 1719 TPP V2	1 of 1

Client: **DRAFT**
Project: The Oaks, Leek, Derbyshire
Title: Tree Protection Plan

- 9.1.4 An indicative draft Tree Protection Plan has been provided; however, this is subject to alteration following a final decision notice and a detailed method statement should be provided as part of a robust planning condition.

- 9.1.6 It is recommended that a suitable competent arboriculturist, undertakes the site supervision and monitoring works.
- 9.1.7 For tree and root protection measures to work effectively all personnel associated with the construction process must be familiar with the Tree Protection Plan.

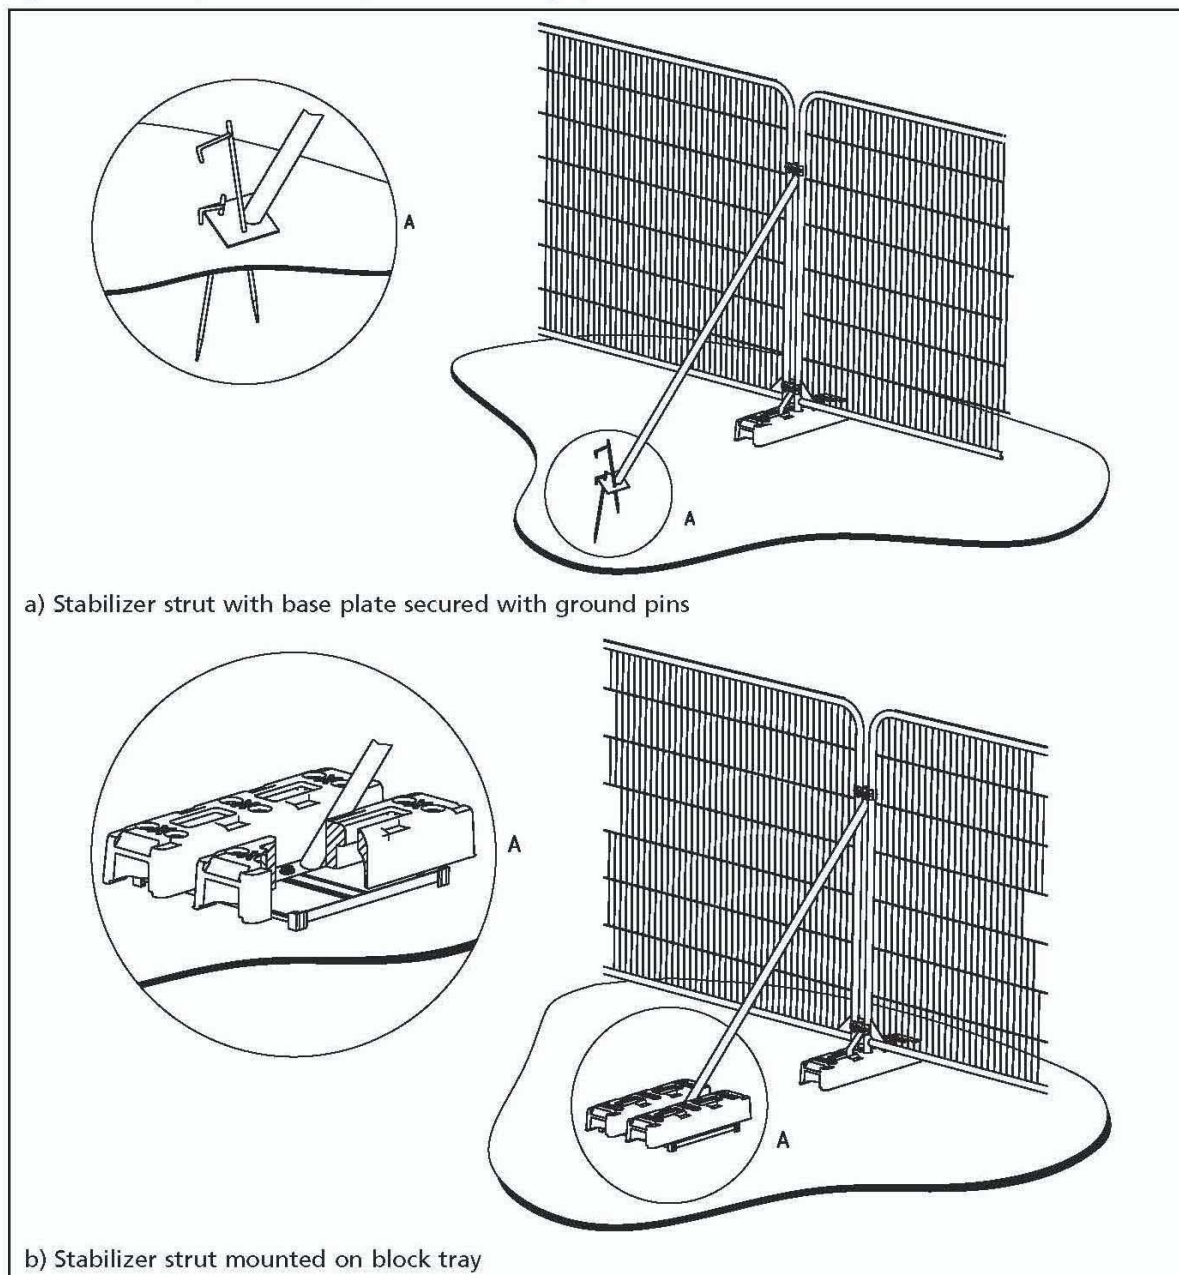
Figure 3 Examples of above-ground stabilizing systems
