Geoenvironmental Appraisal

Land at Clacton Road, Weeley Heath For LNT Care Developments Ltd

Report no: 4762/1

Date: August 2023

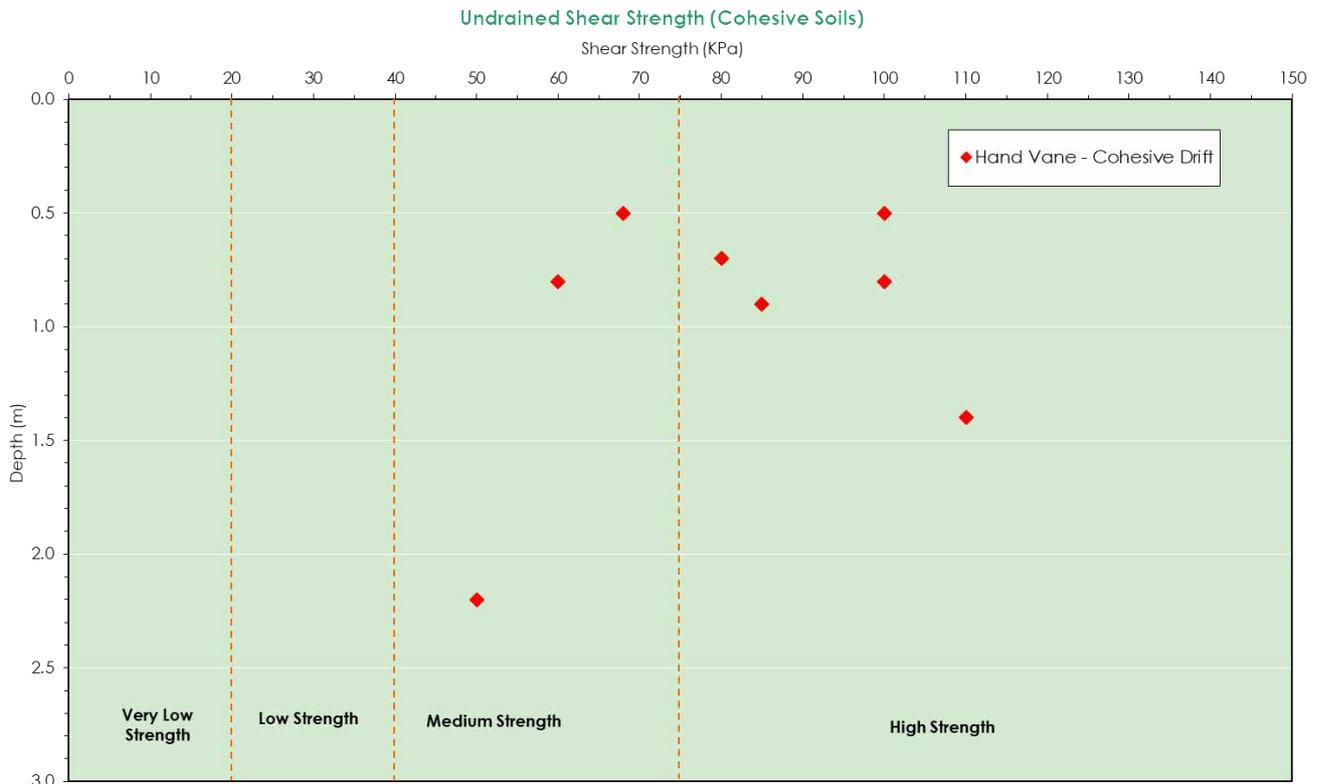
13.5.2 The results are summarised within the plot below which shows the undrained shear strength (Su) of the Cohesive Drift is typically greater than 55kPa.

13.5.3 The plot below provides a summary of undrained shear strengths.

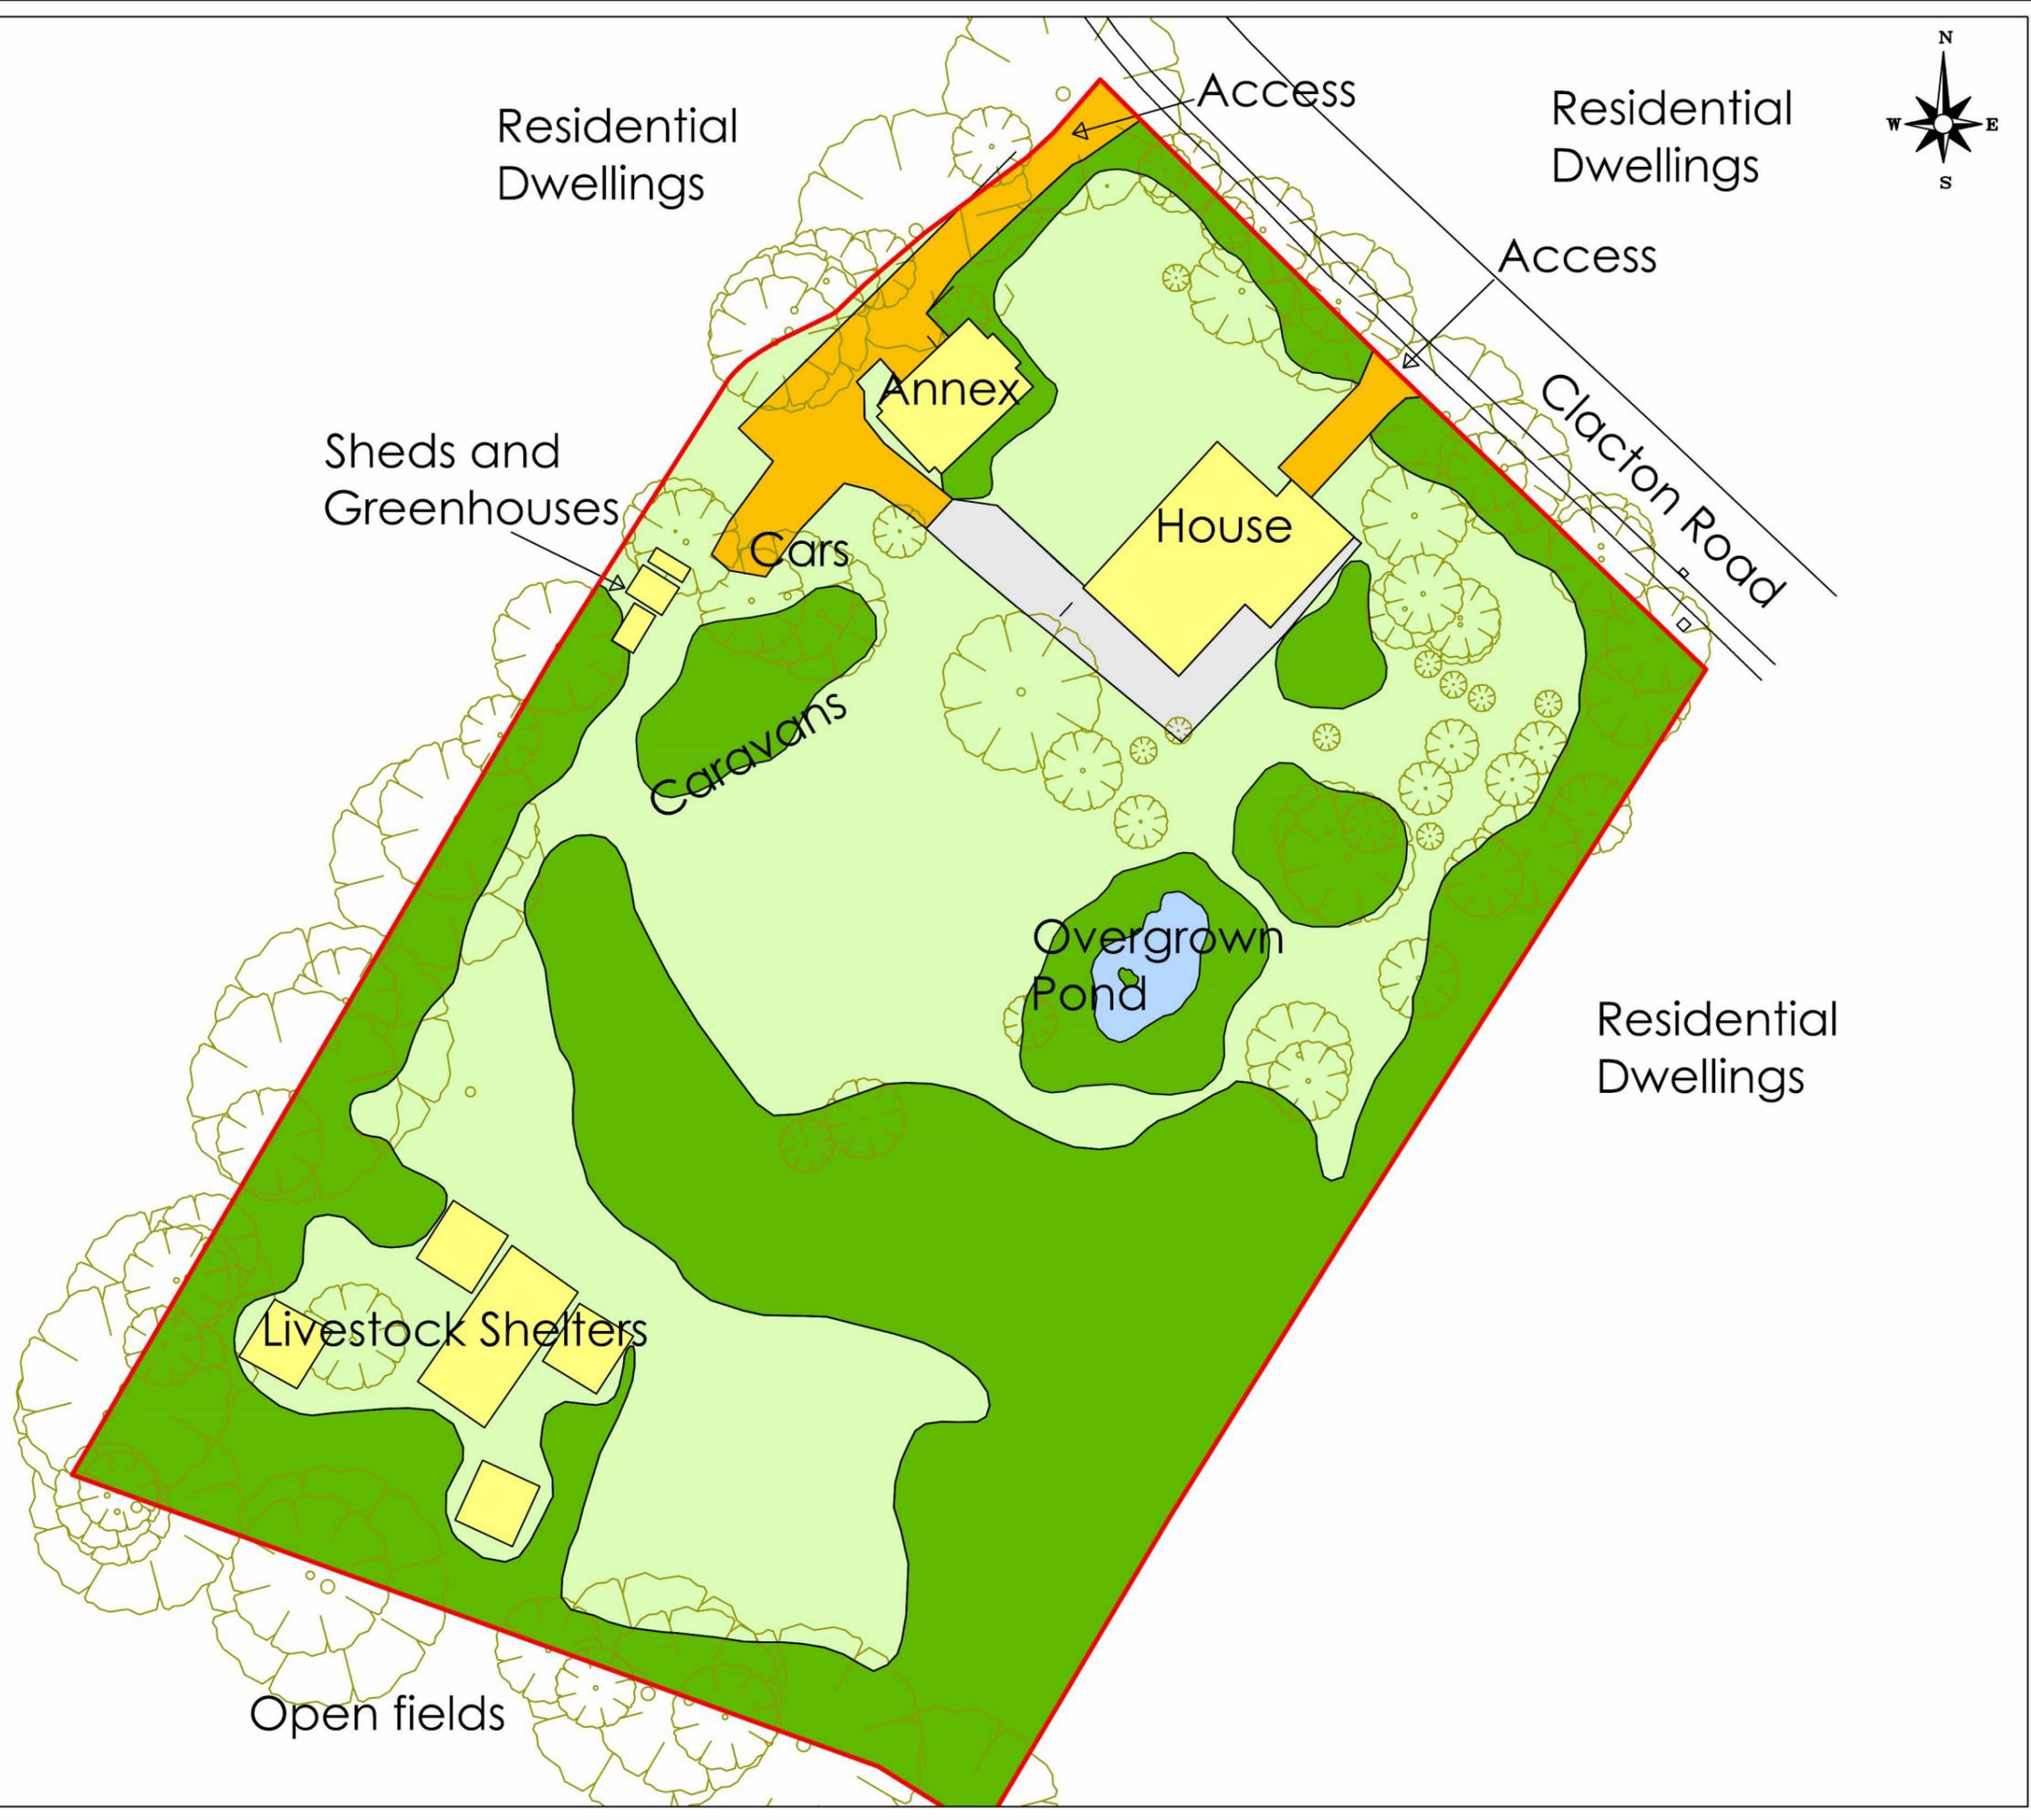
SITE FEATURES

- GRASSED AREAS
- OVERGROWN AREAS
- TREES
- POND
- BUILDINGS
- GRAVEL SURFACING
- PAVING
- APPROXIMATE SITE BOUNDARY

- 8.3.1 It is apparent from a review of historical OS Plans (see Section 3) and the site visit that buildings have been present on approximately 5% of the total site area. Drawing 4762/3 shows the footprints of the existing structures.
- 8.3.2 Constraints associated with existing buildings, ongoing use and underground utilities have prevented trenching to identify and assess the nature/extent of buried obstructions. However, the existing buildings will have foundations (likely strips), and other below ground structures should be anticipated.

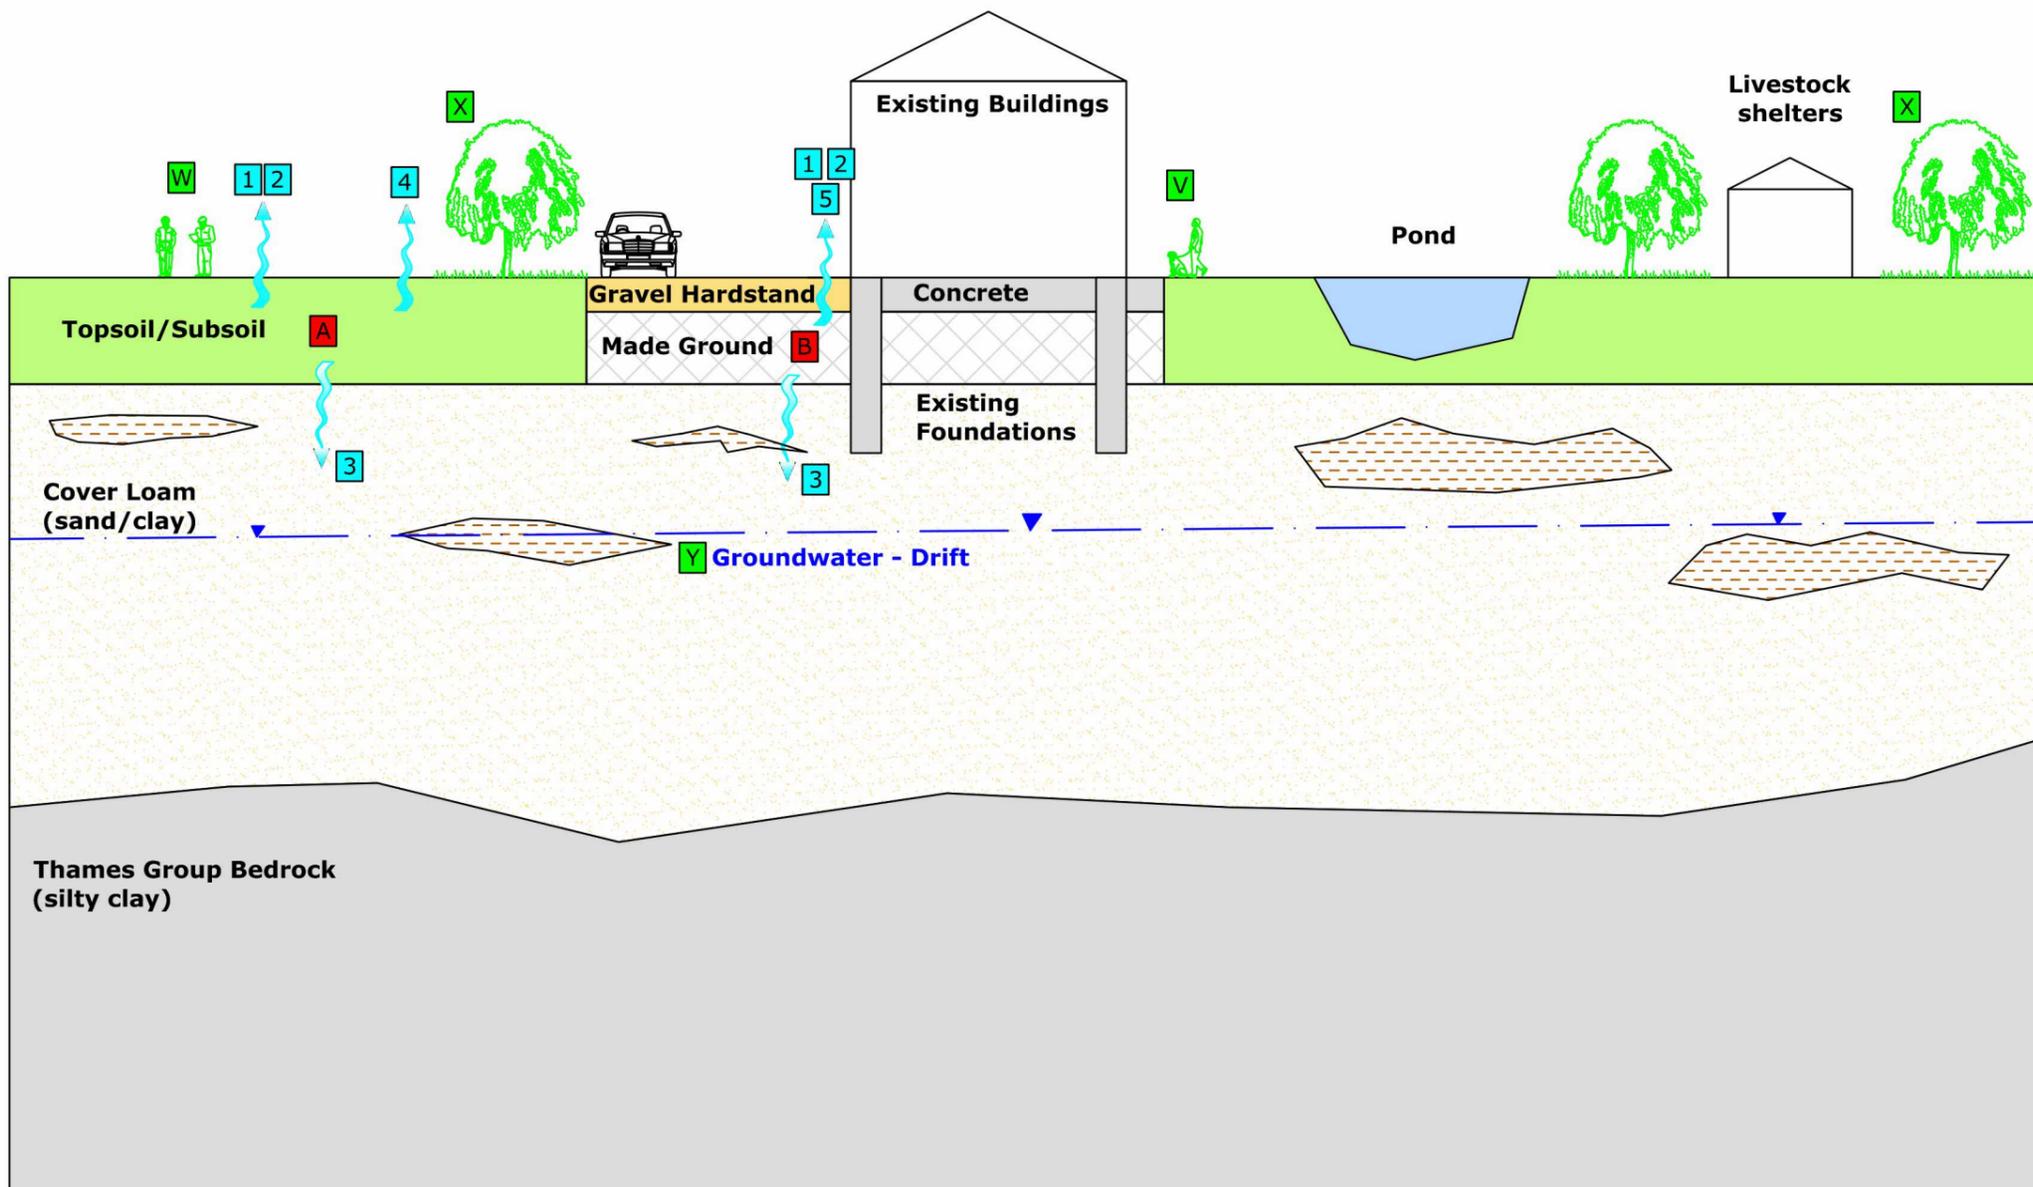
SOURCES	
A	TOPSOIL (INORGANICS & ORGANICS)
B	MADE GROUND (INORGANICS & ORGANICS)

PATHWAYS	
1	DERMAL CONTACT
2	INGESTION/INHALATION
3	LEACHING OF CONTAMINANTS
4	UPTAKE BY PLANTS
5	VOLATILISATION

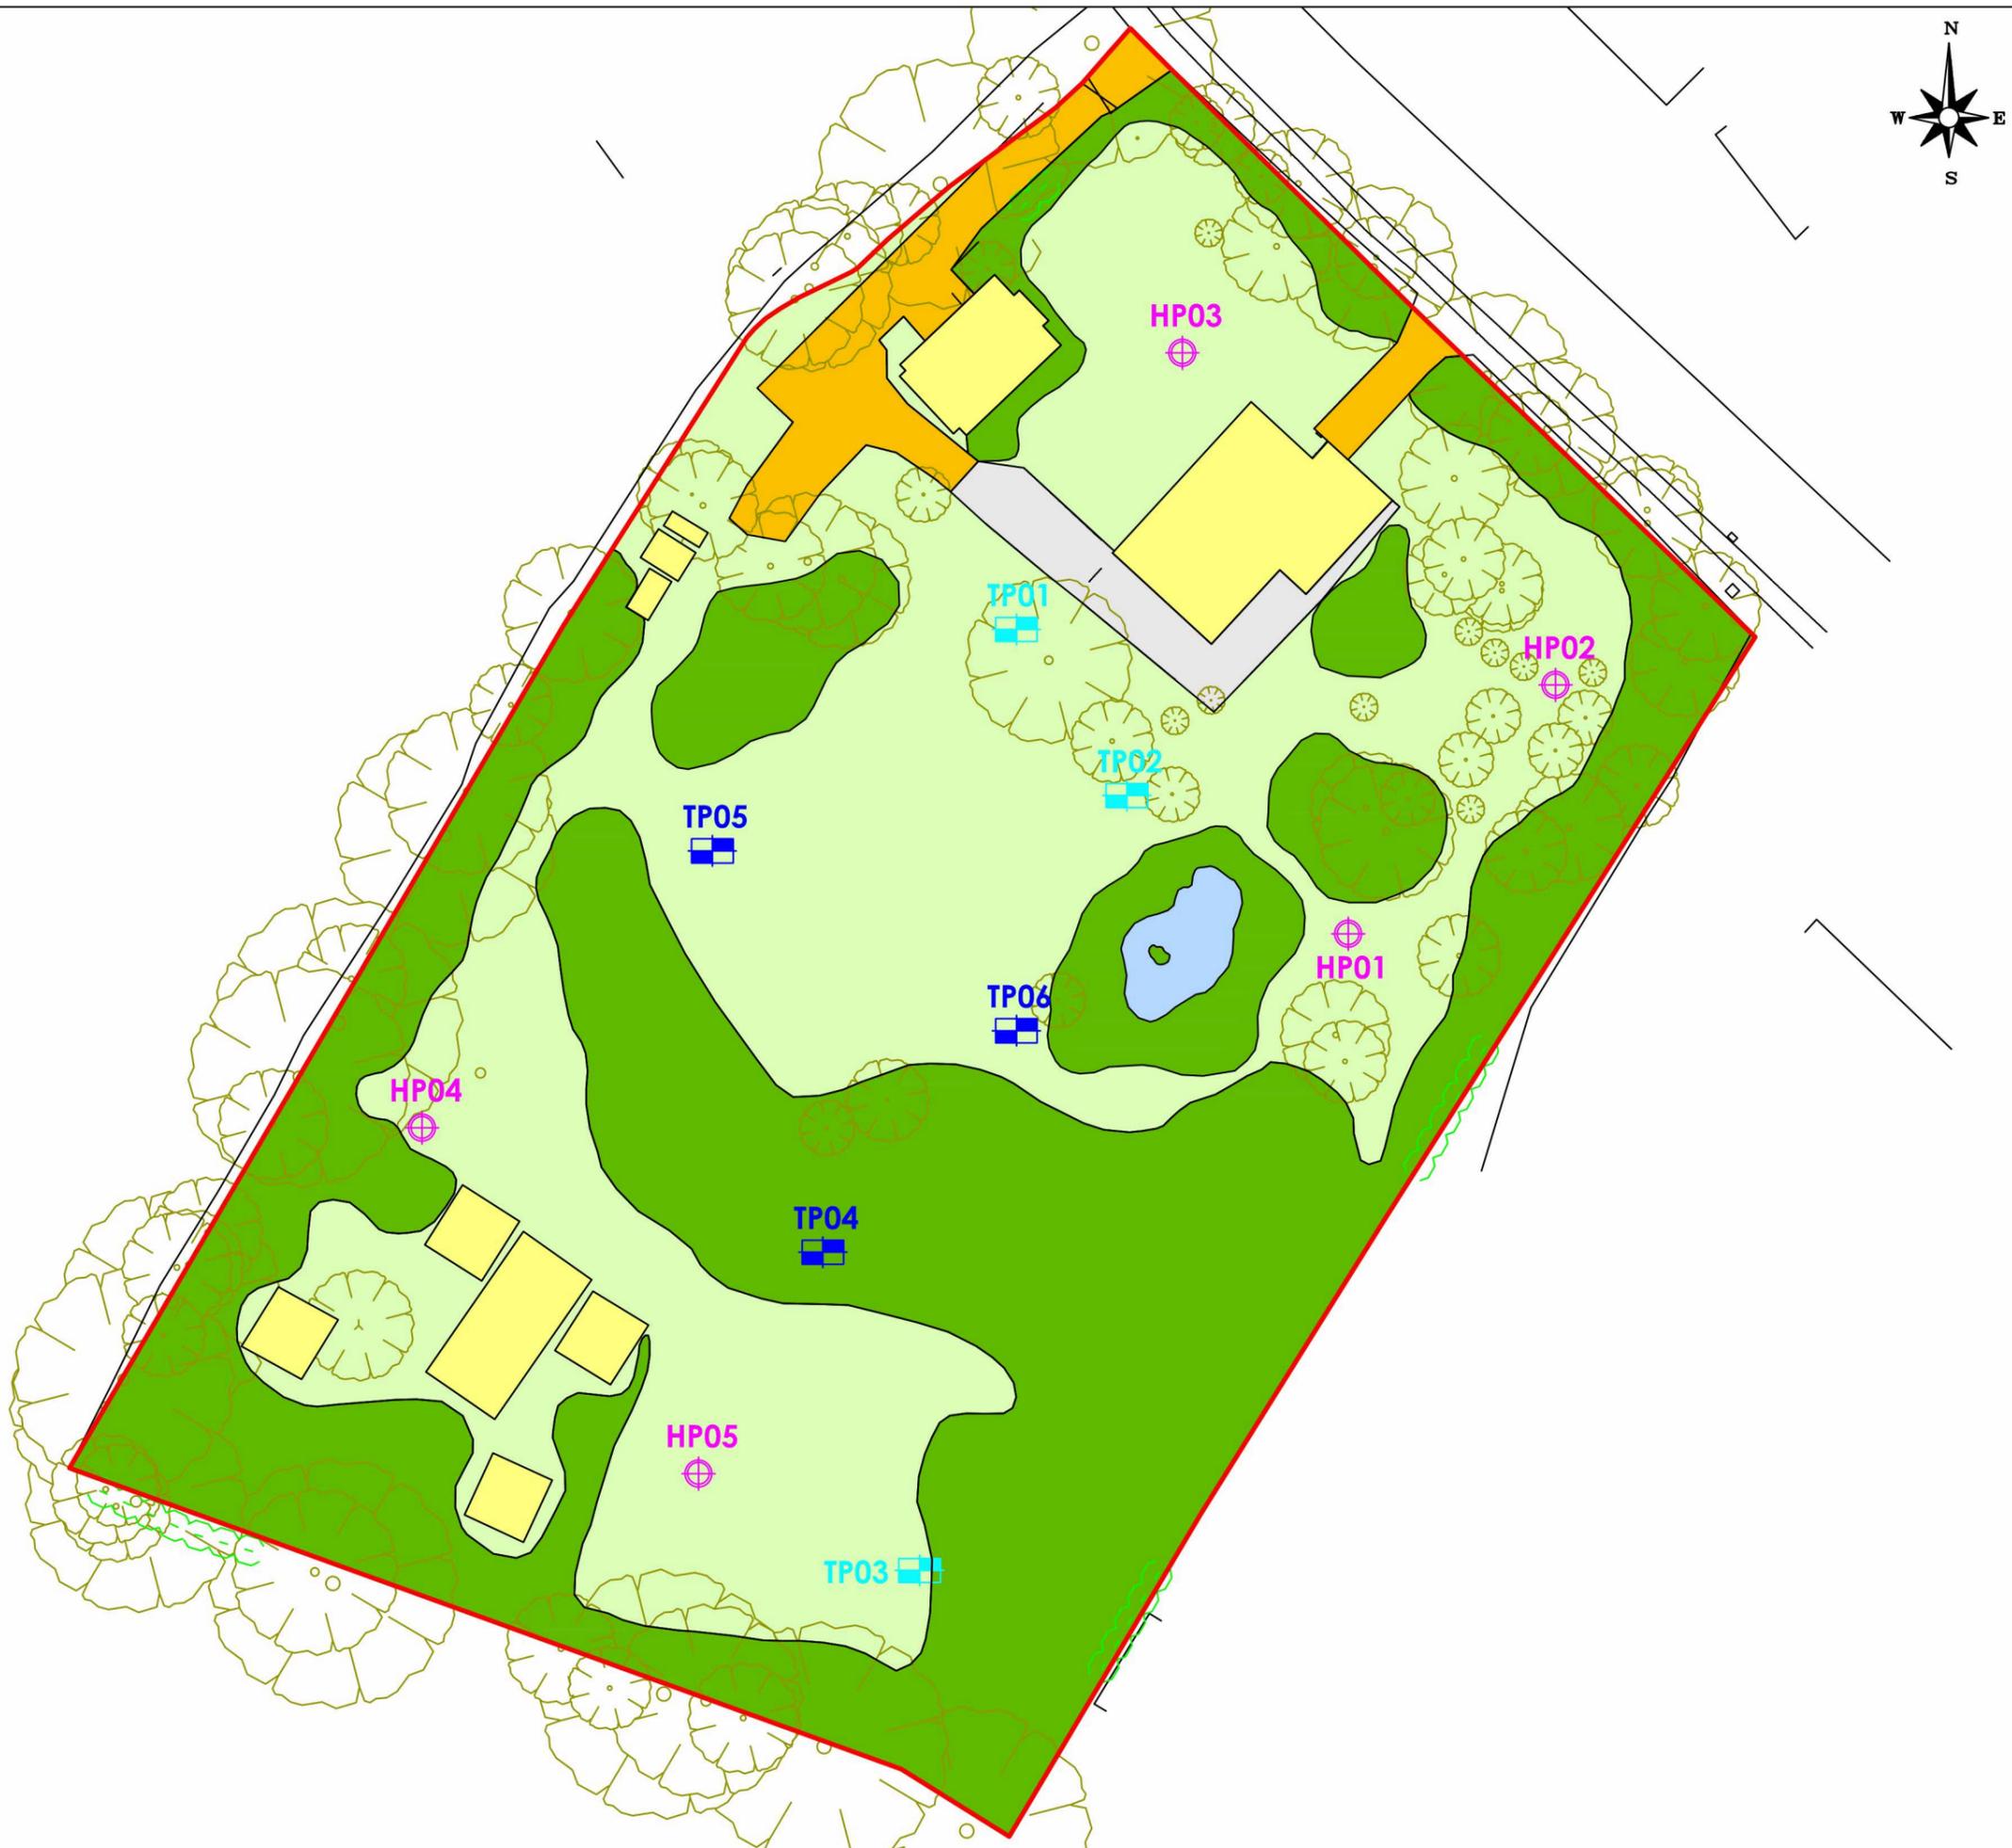
EXPLORATORY HOLE LOCATIONS BASED ON DATA FROM A HAND-HELD GPS (+/- 3M ACCURACY)

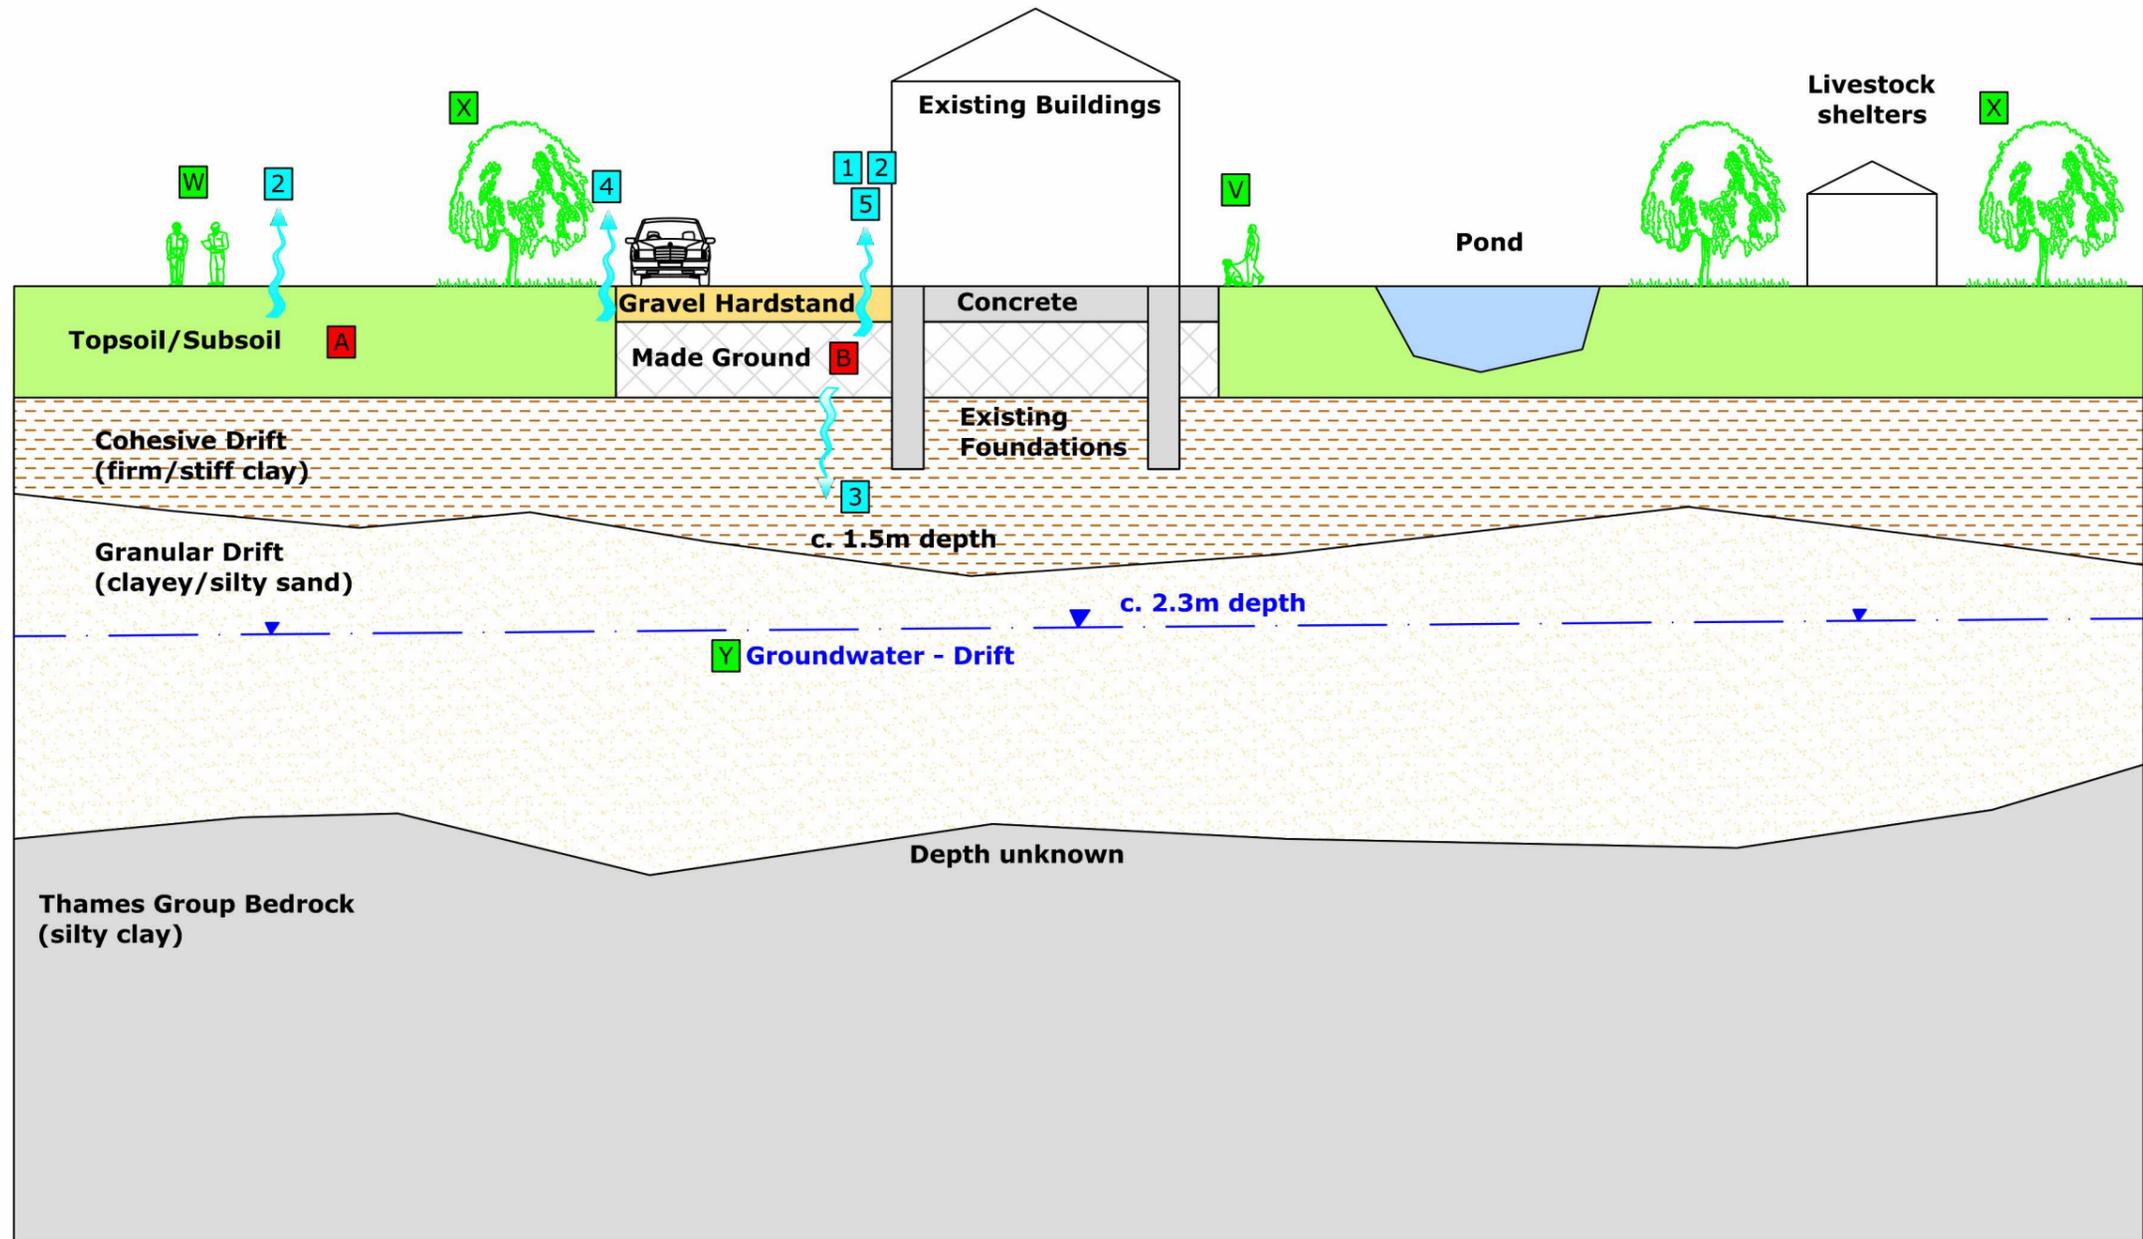
SOURCES	
A	TOPSOIL (ASBESTOS)
B	MADE GROUND (INORGANICS & ORGANICS)

PATHWAYS	
1	DERMAL CONTACT
2	INGESTION/INHALATION
3	LEACHING OF CONTAMINANTS
4	UPTAKE BY PLANTS
5	VOLATILISATION

10.4.19 A broken fragment of suspected asbestos-cement sheeting was noted in the Topsoil in TP05.

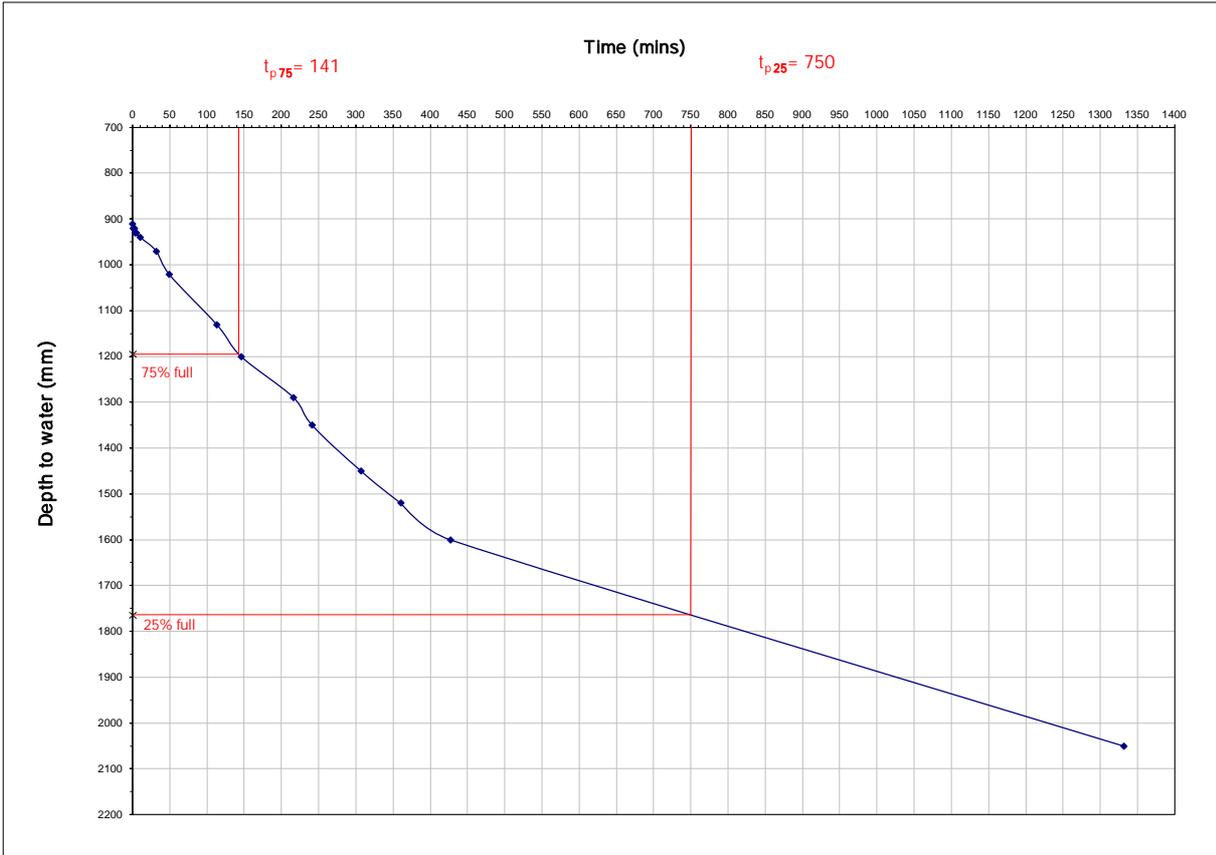
Read from the graph:		
t_{p75} (min)	=	141
t_{p25} (min)	=	750

Soil infiltration rate (pit filled with stone), f , (m/s) = 1.20E-06

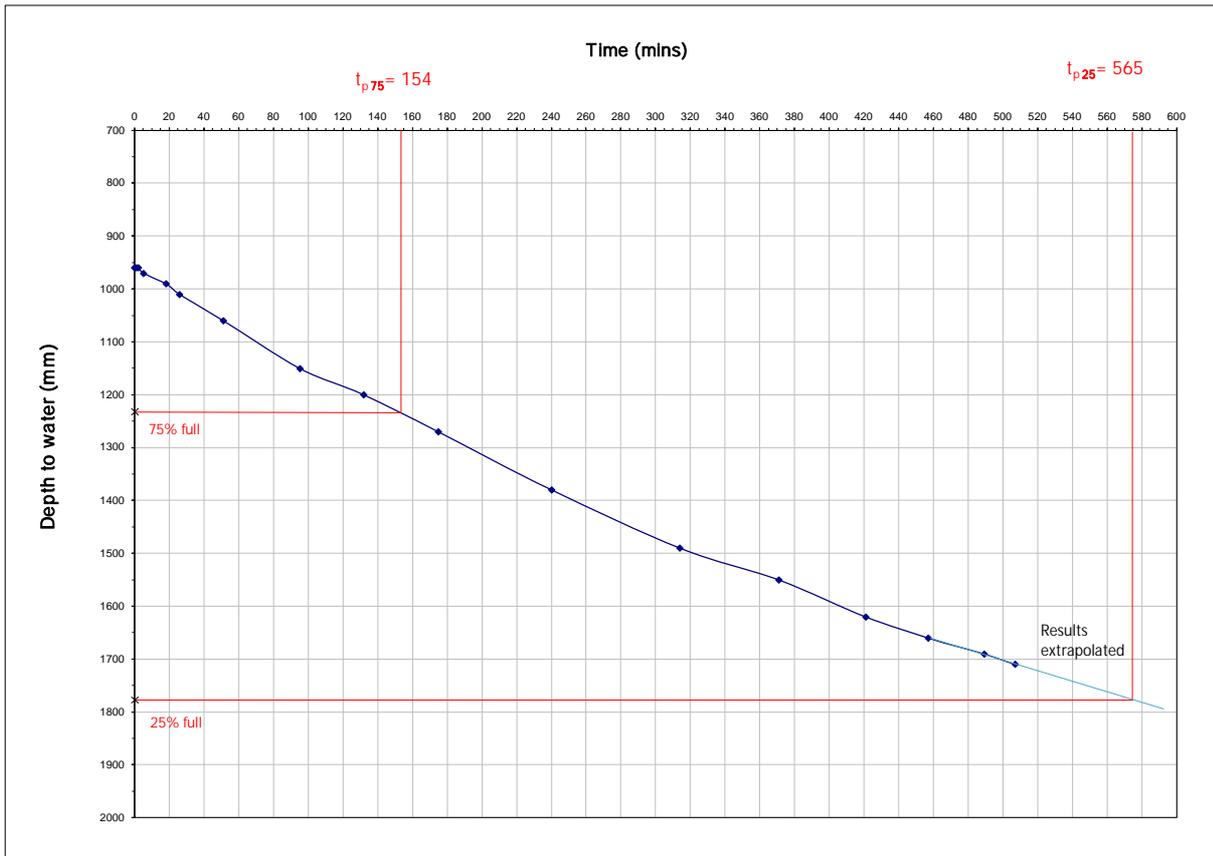
Read from the graph:		
t_{p75} (min)	=	154
t_{p25} (min)	=	565

Soil infiltration rate (pit filled with stone), f , (m/s) = $1.75E-06$

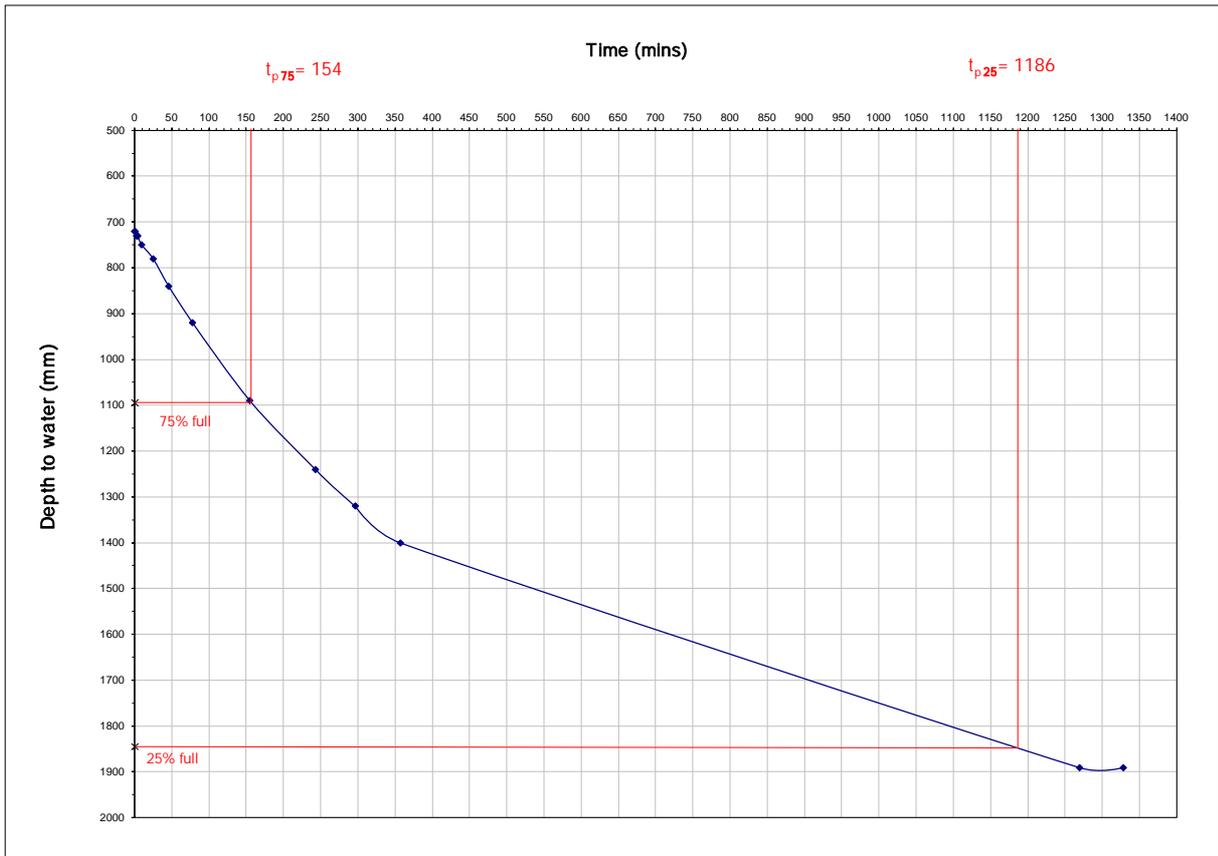
Read from the graph:		
t_{p75} (min)	=	154
t_{p25} (min)	=	1186

Soil infiltration rate (pit filled with stone), f , (m/s) = $7.59E-07$

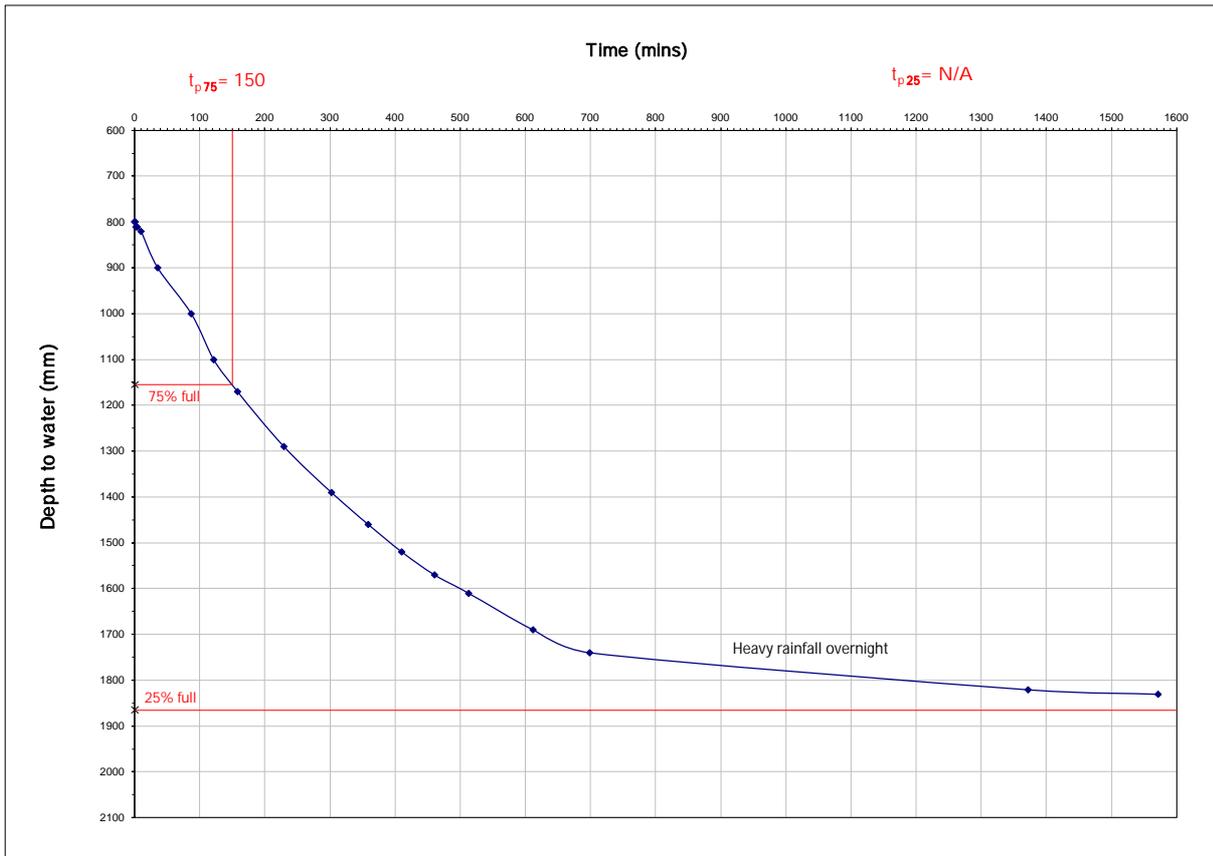
Read from the graph:			
t_{p75} (min)	=	150	
t_{p25} (min)	=	N/A

Test did not attain 25% Effective depth. Unable to calculate soil infiltration rate

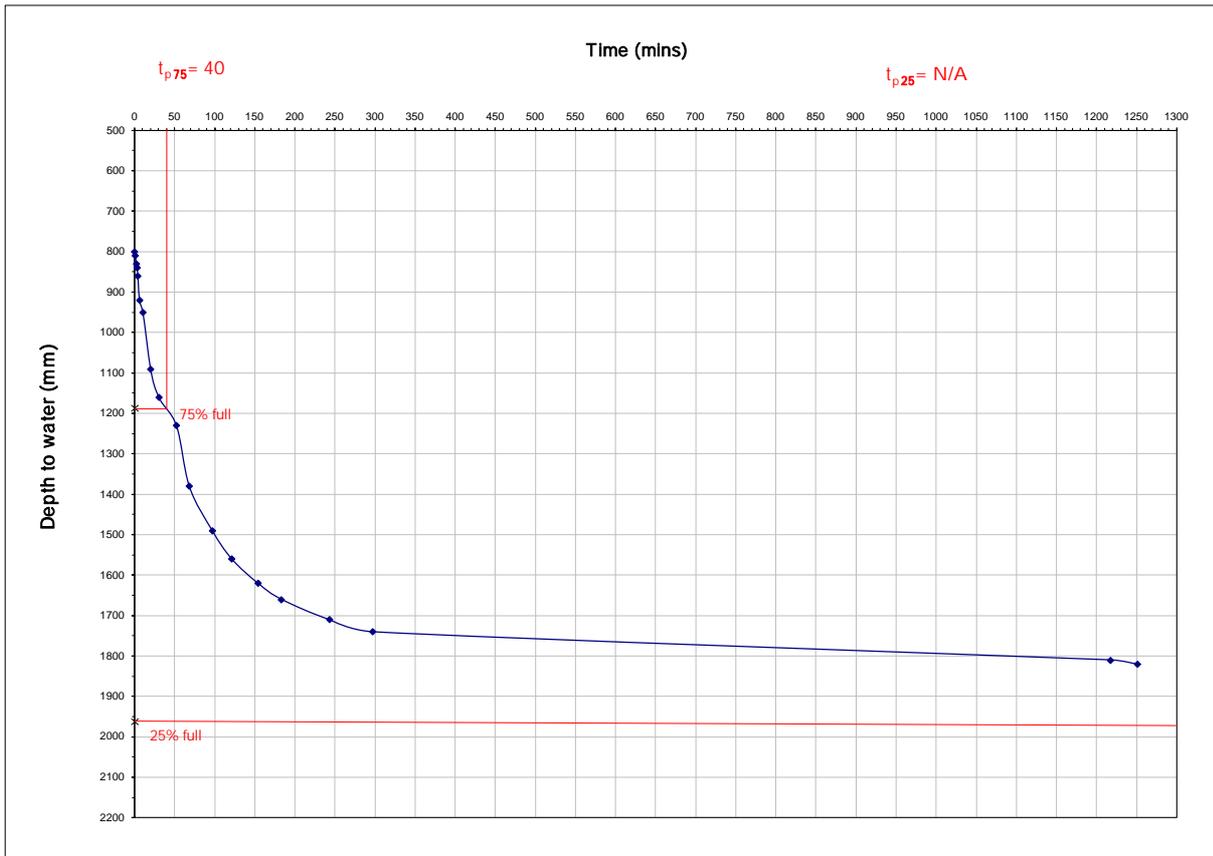
Read from the graph:			
t_{p75} (min)	=	40	
t_{p25} (min)	=	N/A

Test did not attain 25% Effective depth. Unable to calculate soil infiltration rate

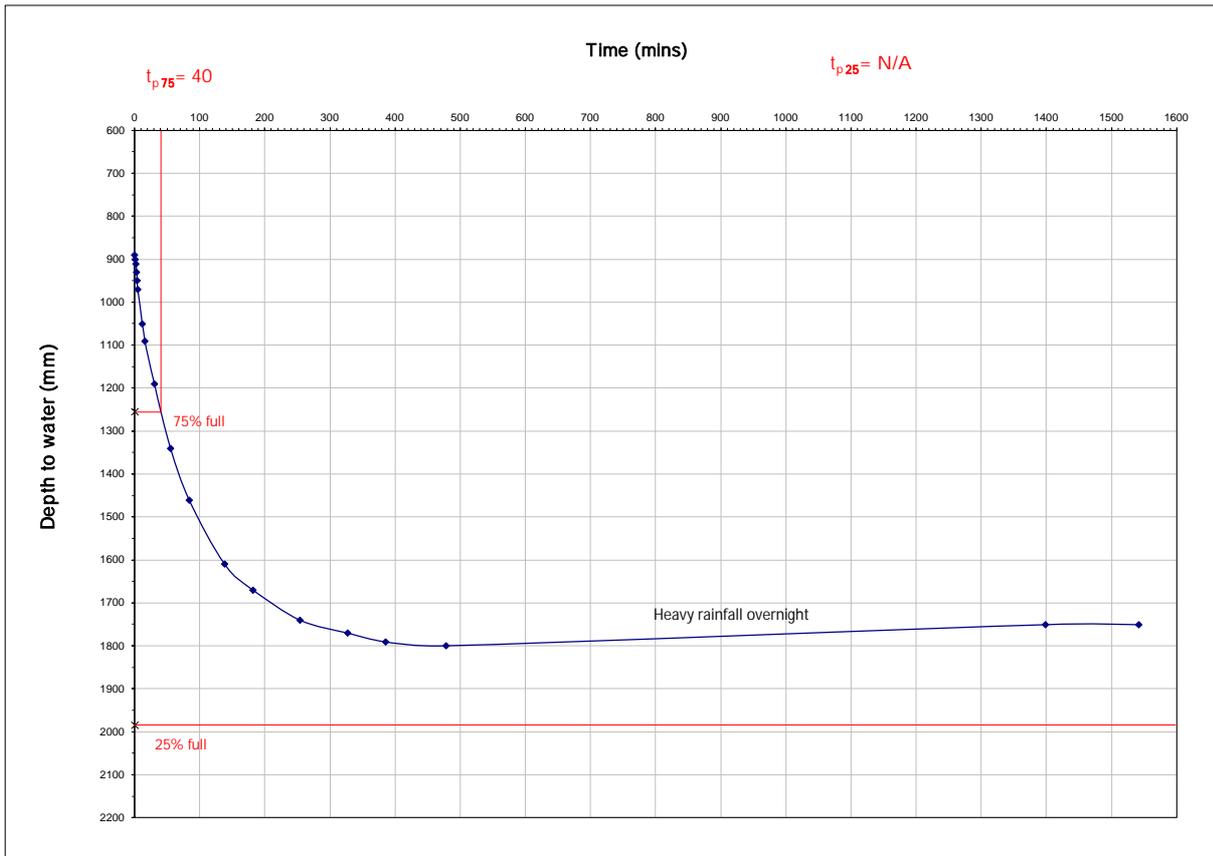
Read from the graph:			
t_{p75} (min)	=	40	
t_{p25} (min)	=	N/A

Test did not attain 25% Effective depth. Unable to calculate soil infiltration rate

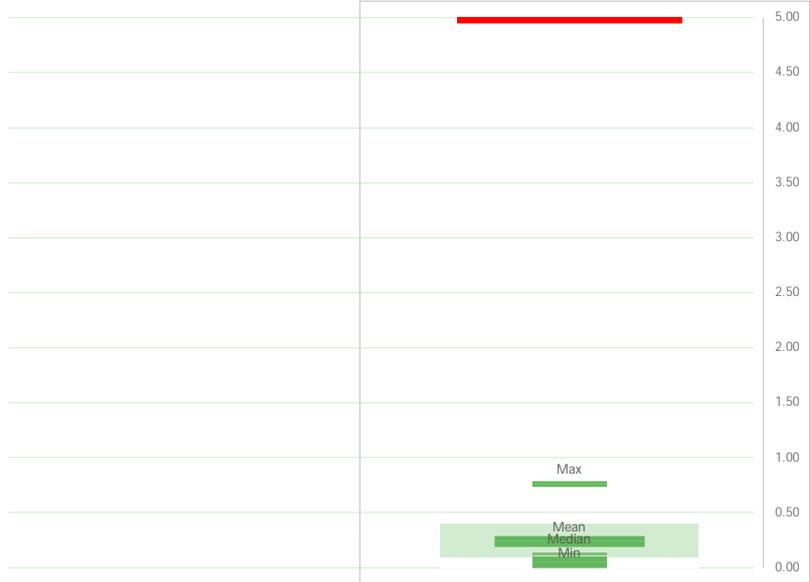
Topsoil: Dataset for B(a)P - Dot & Box Plots and Summary Statistics

Determinant	B(a)P
Critical concentration	5.00
No. samples	10.00
Max	0.76
Mean	0.24
Min	0.05
Median	0.13
Standard Deviation	0.23
Standard Error	0.07
T value	2.26
Upper Confidence Level (95%)	0.40
Upper Confidence Level (80%)	0.34
Lower Confidence Level (5%)	0.10
Transform data	Normal
Upper Confidence Level for chart	95%

Spatial distribution can show sampling clusters based on ground type it does not identify areas of contamination

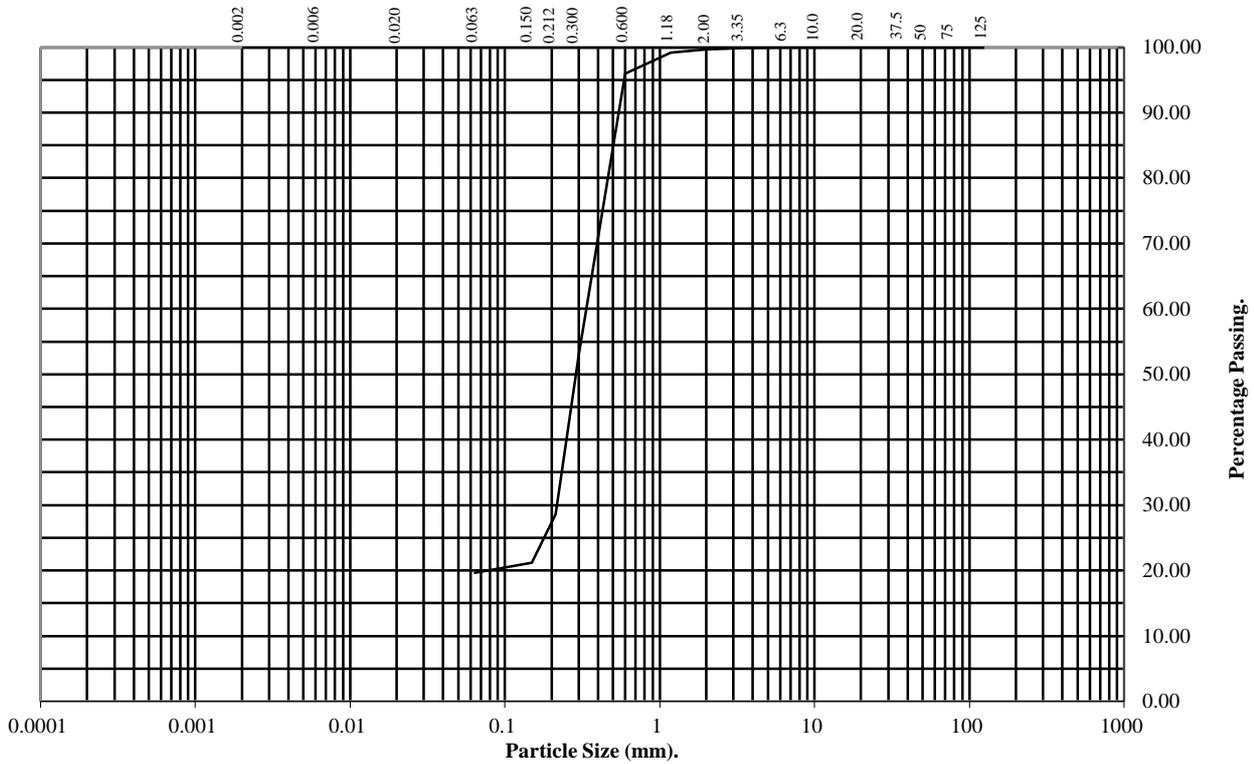
BS Test Sieve (mm)	Percentage Passing
125	100
75	100
50	100
37.5	100
20	100
10	100
6.3	100
3.35	100
2	100
1.18	99
0.6	96
0.3	53
0.212	29
0.15	21
0.063	20

Soil Fraction	Total Percentage
Cobbles	0
Gravel	0
Sand	80
Silt/Clay	20

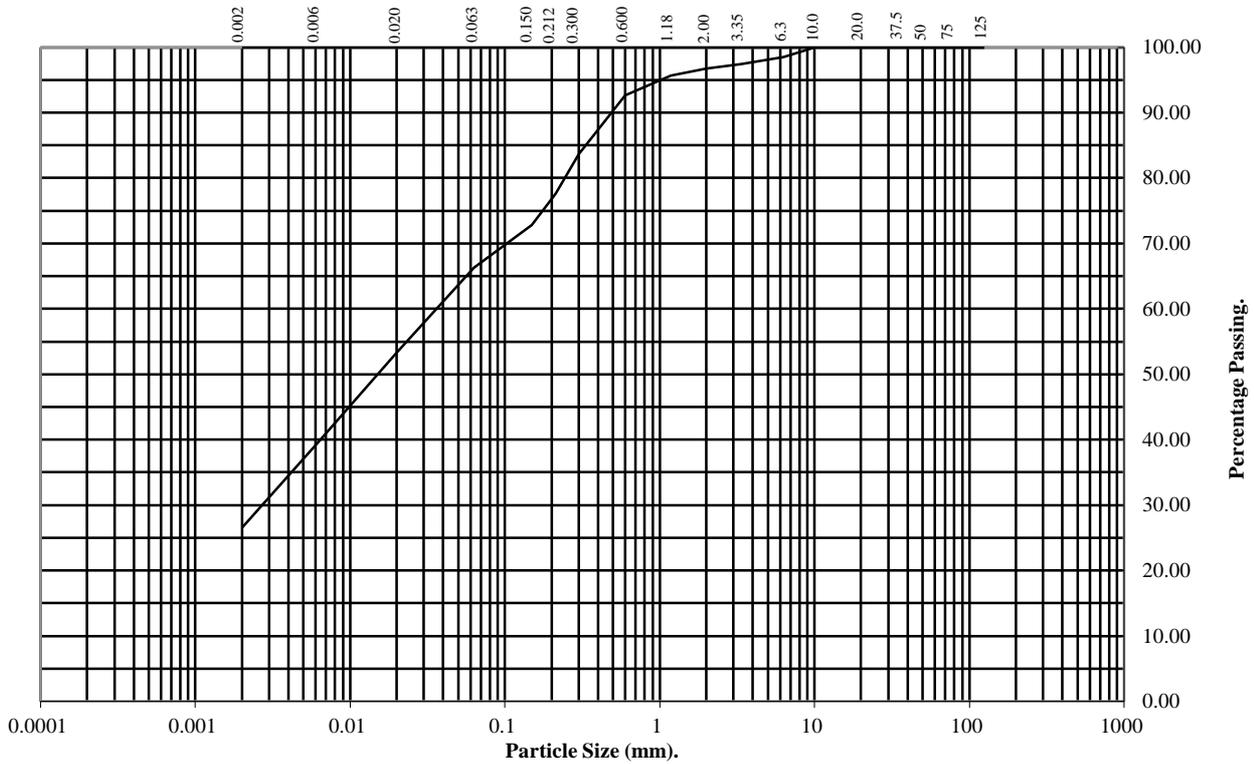
BS Test Sieve (mm)	Percentage Passing
125	100
75	100
50	100
37.5	100
20	100
10	100
6.3	99
3.35	97
2	97
1.18	96
0.6	93
0.3	84
0.212	78
0.15	73
0.063	66

Particle Diameter	Percentage Passing
0.02	53
0.006	39
0.002	27
