Geoenvironmental Appraisal

Land at Clacton Road, Weeley Heath For LNT Care Developments Ltd

Report no: 4762/1

Date: August 2023

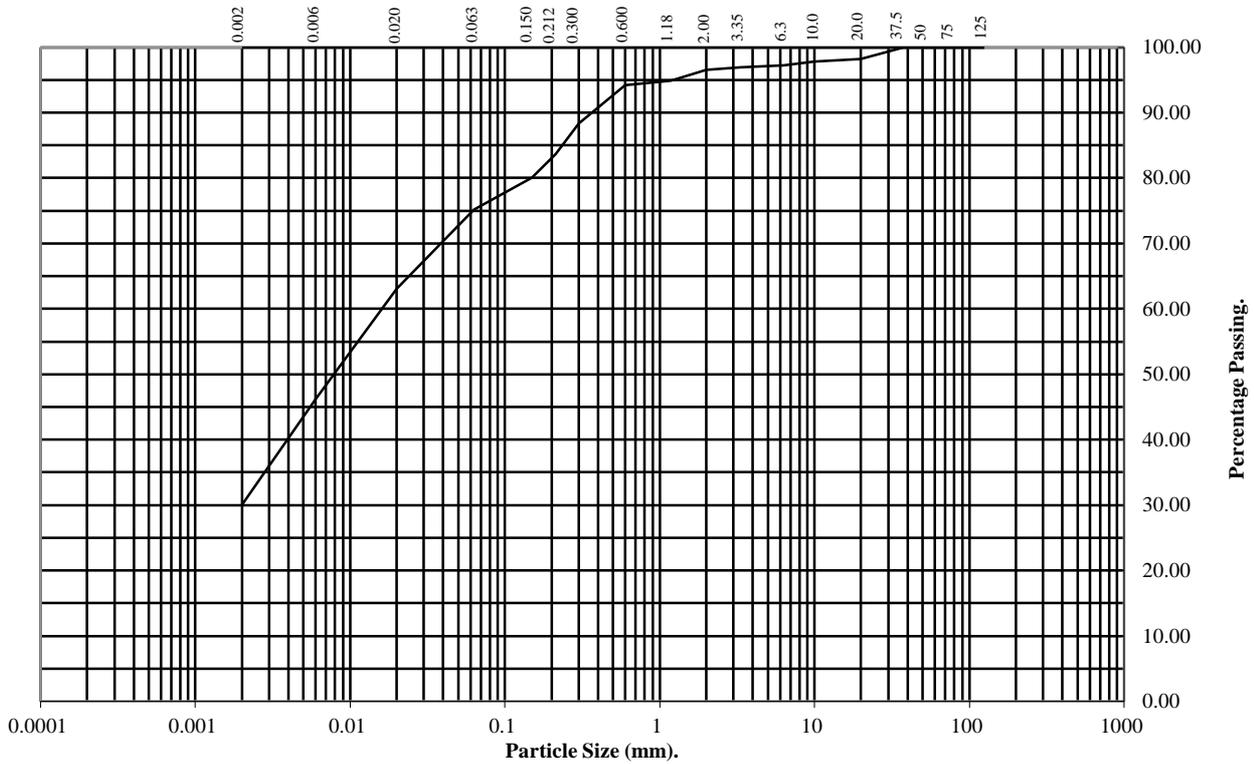
BS Test Sieve (mm)	Percentage Passing
125	100
75	100
50	100
37.5	100
20	98
10	98
6.3	97
3.35	97
2	96
1.18	95
0.6	94
0.3	88
0.212	84
0.15	80
0.063	75

Particle Diameter	Percentage Passing
0.02	63
0.006	46
0.002	30

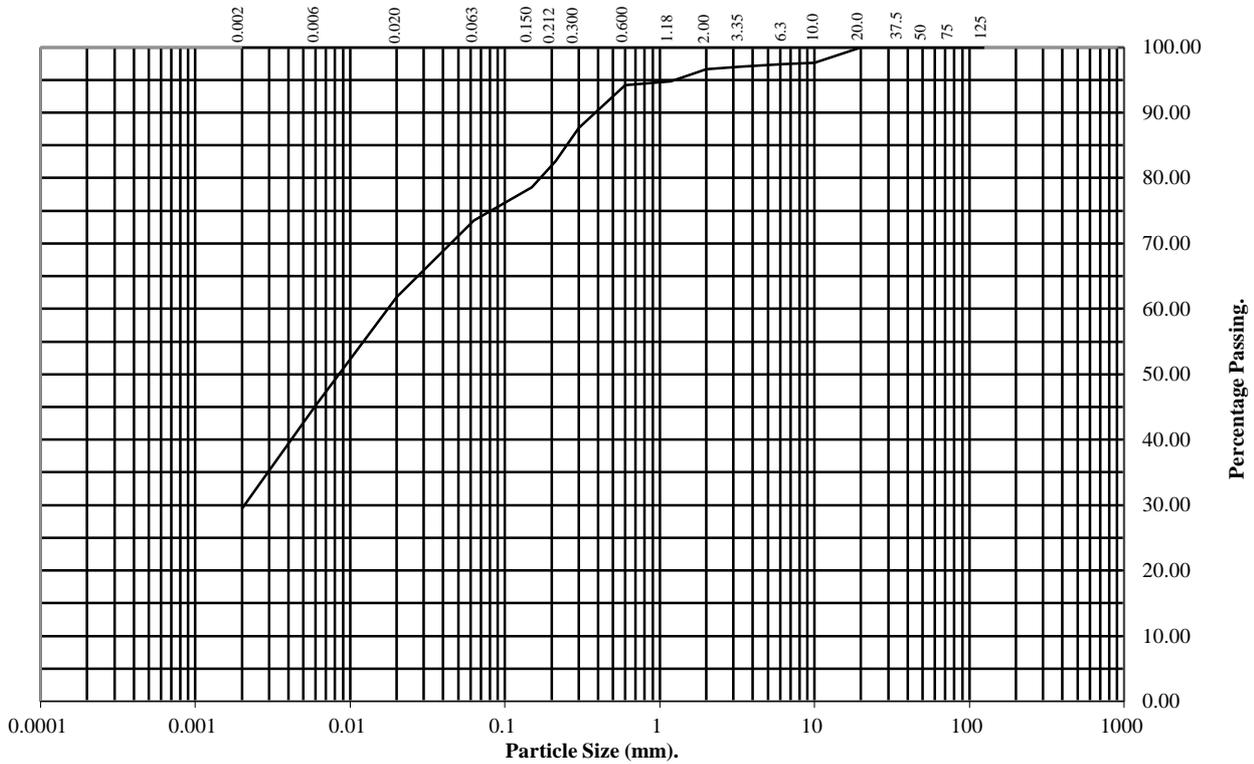
BS Test Sieve (mm)	Percentage Passing
125	100
75	100
50	100
37.5	100
20	100
10	98
6.3	97
3.35	97
2	97
1.18	95
0.6	94
0.3	88
0.212	83
0.15	79
0.063	74

Particle Diameter	Percentage Passing
0.02	62
0.006	45
0.002	29

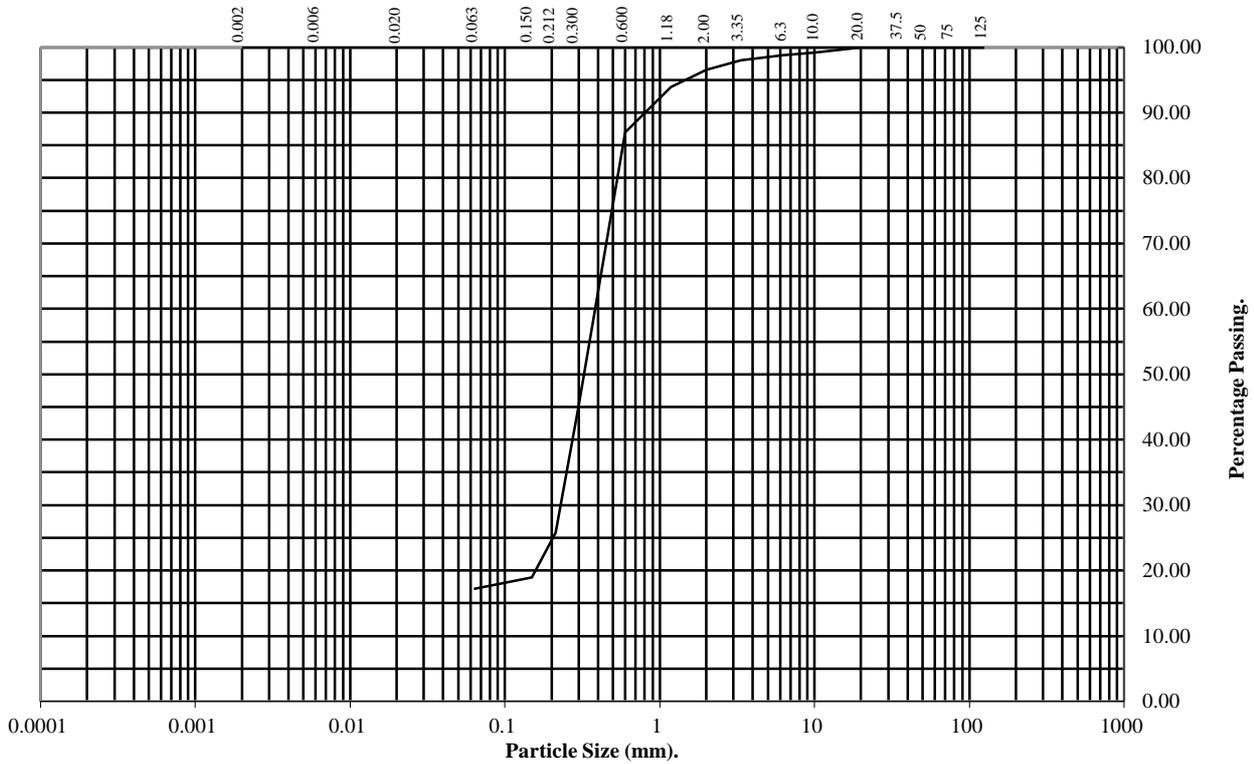
BS Test Sieve (mm)	Percentage Passing
125	100
75	100
50	100
37.5	100
20	100
10	99
6.3	99
3.35	98
2	96
1.18	94
0.6	87
0.3	45
0.212	26
0.15	19
0.063	17

Soil Fraction	Total Percentage
Cobbles	0
Gravel	4
Sand	79
Silt/Clay	17
