PHASE 2 ENVIRONMENTAL INVESTIGATION
of a site at
LAND TO REAR OF EAST HOUSE, HIGH ROAD,
GREAT FINBOROUGH
for
MACNAMARA DEVELOPMENTS LTD

Project No 2407
Report ref: 2407-P2E-1
Issued: 21 March 2023
Revision:

2407-P2E-1: Rear of East House, High Road, Great Finborough
McNamara Developments Ltd

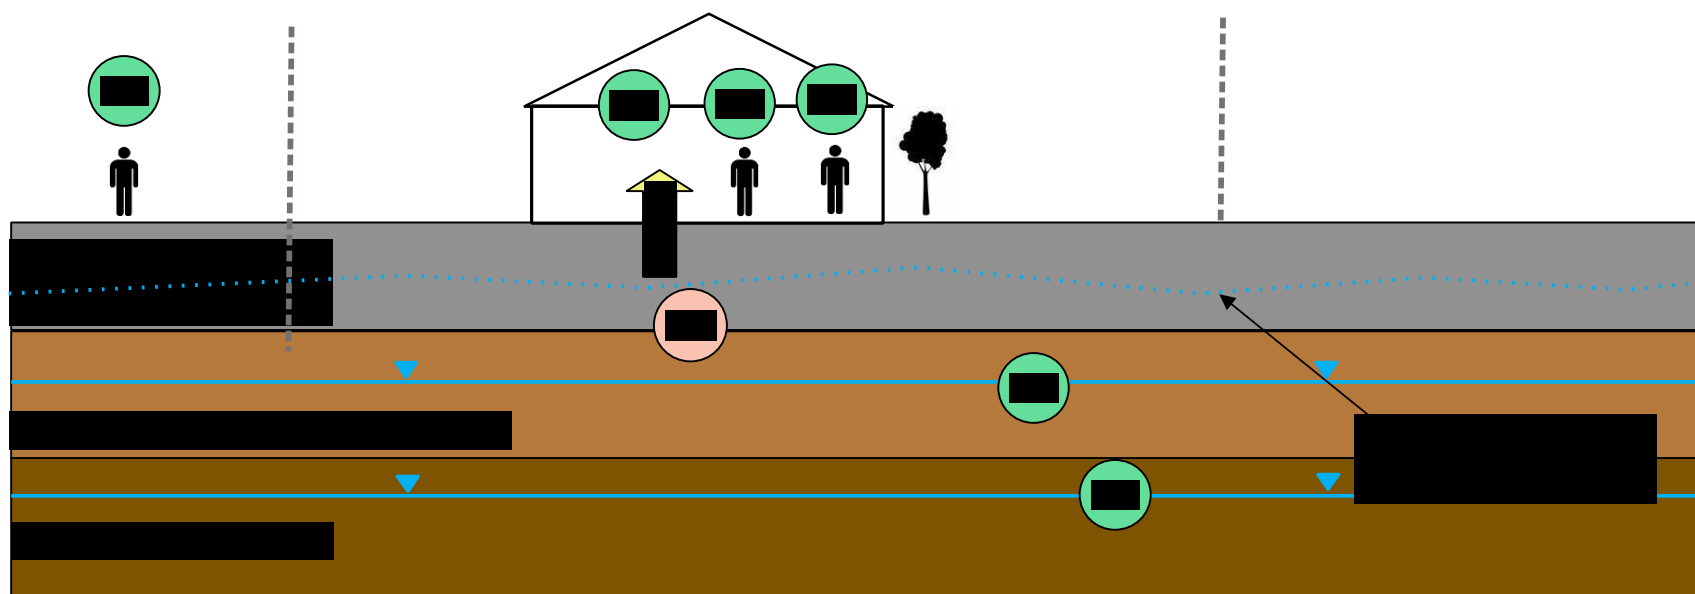
Schematic Conceptual Model

Sources	Pathways	Receptors
<p>1 Naturally Occurring Contaminants (On Site)</p>	<p>

Direct contact of soil with building materials</p>	<ul style="list-style-type: none"> i Site Users ii Ground Workers iii Neighbours iv Proposed Building v Secondary Undifferentiated Aquifer v Principal Aquifer

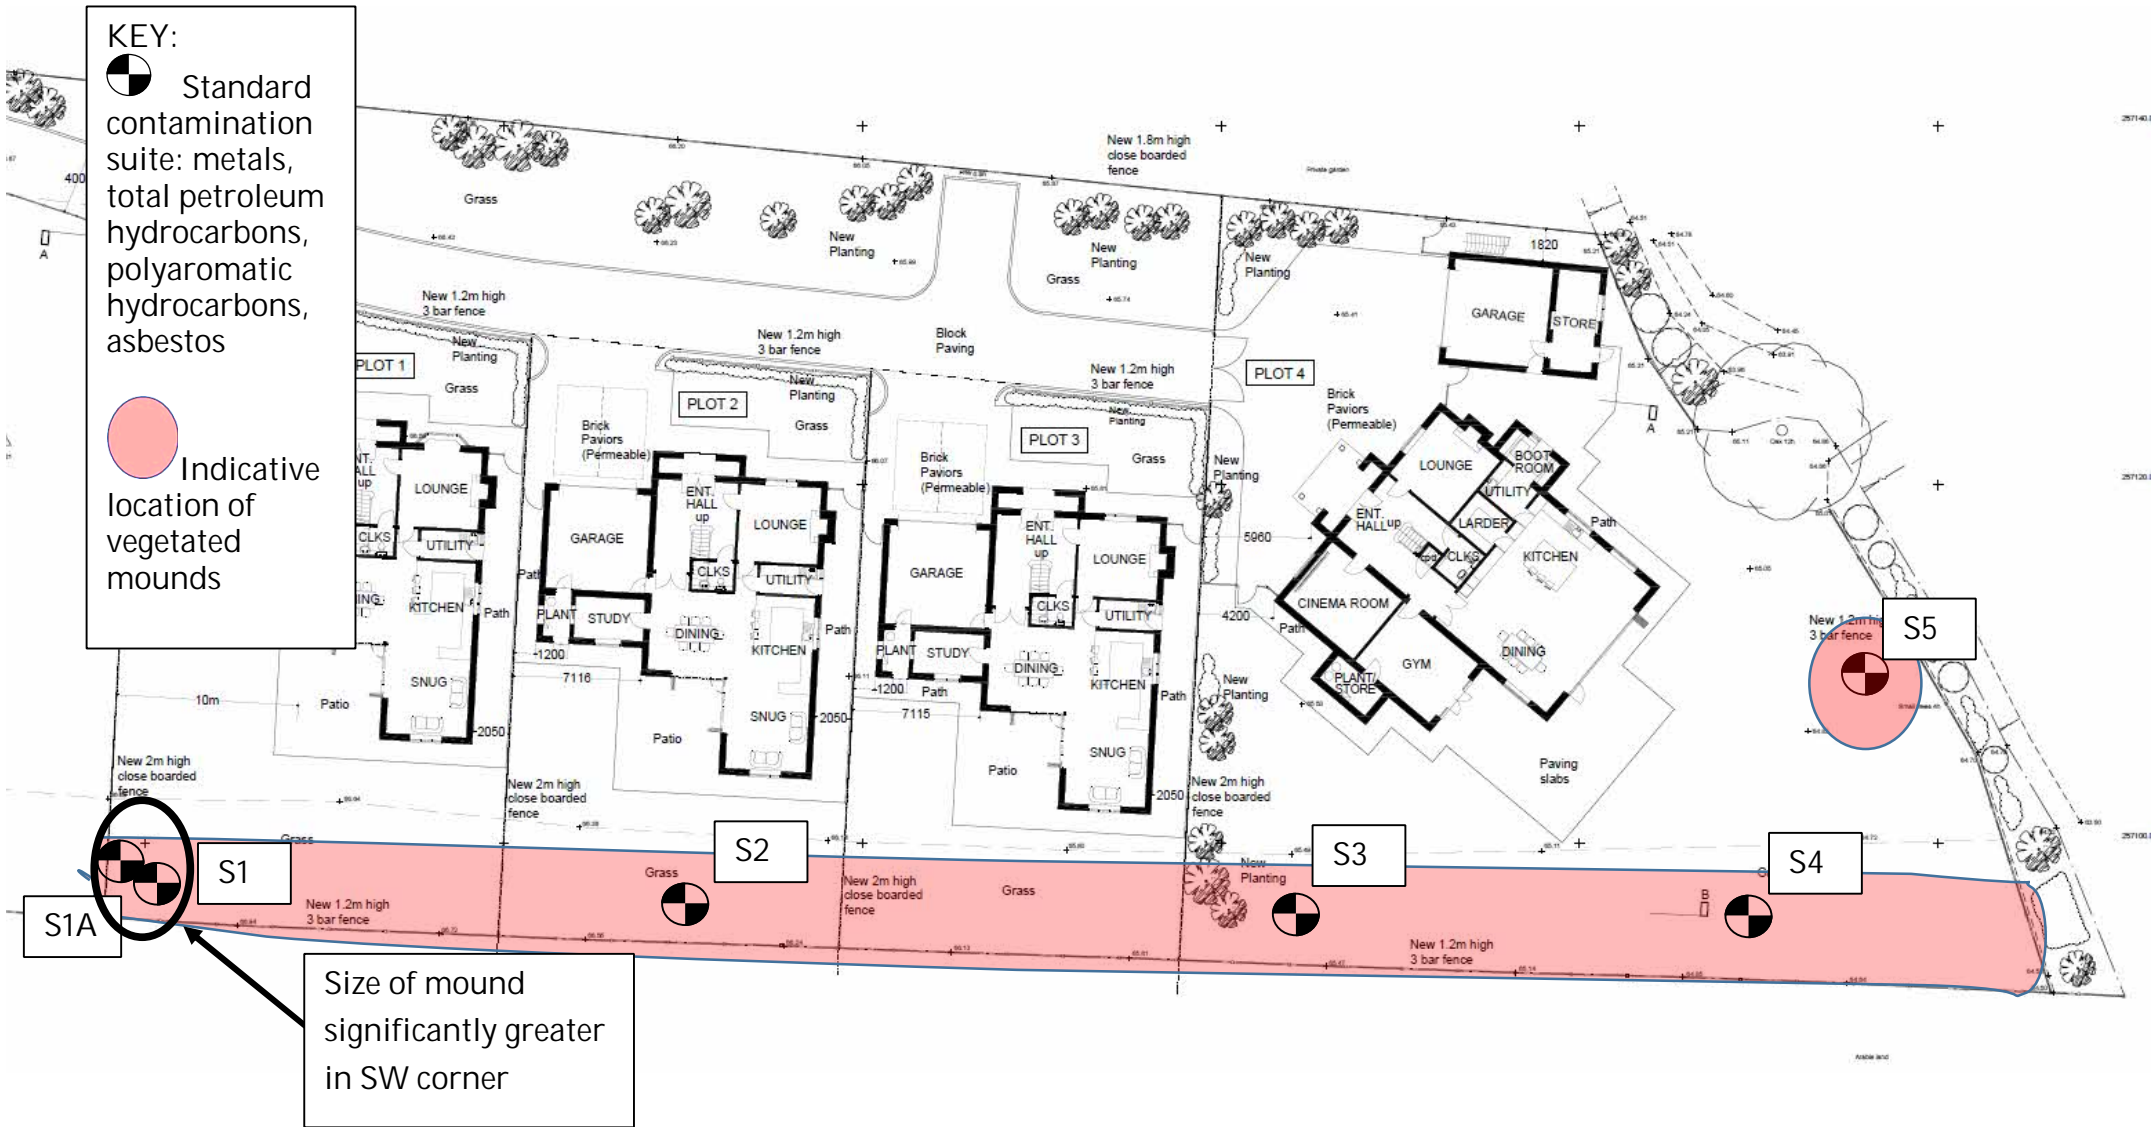
Standard contamination suite: metals, total petroleum hydrocarbons, polyaromatic hydrocarbons, asbestos

Indicative location of vegetated mounds

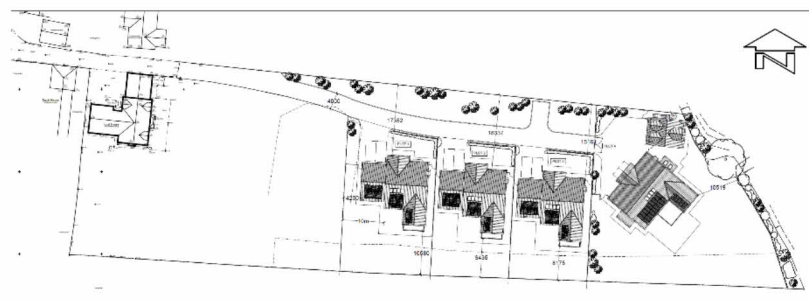
PROPOSED SITE PLAN

The drawing shows a residential development comprising 4 detached dwellings including parking facilities, communal soft landscaping and private gardens. Access to the development is gained via a dedicated entrance from High Road.

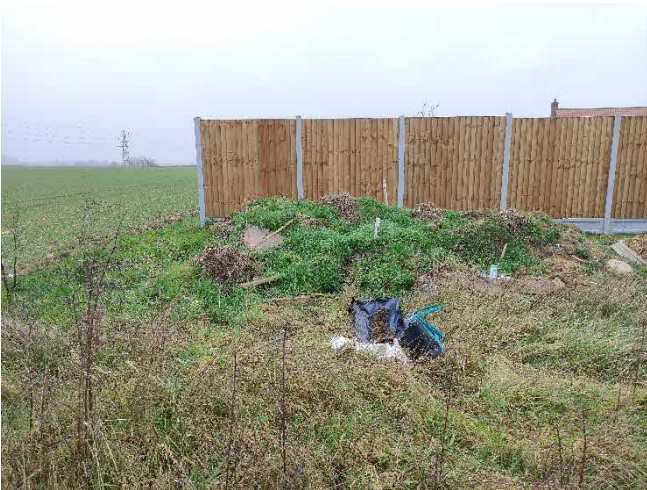
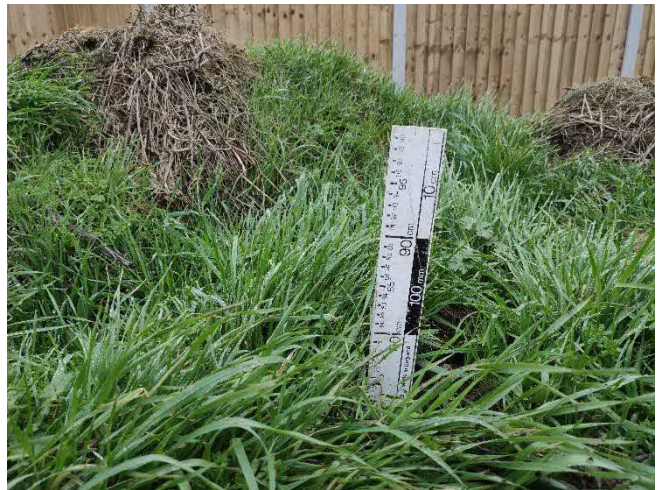
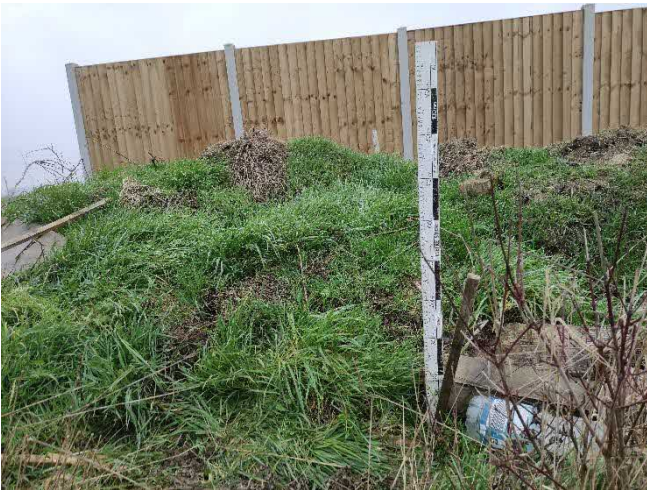
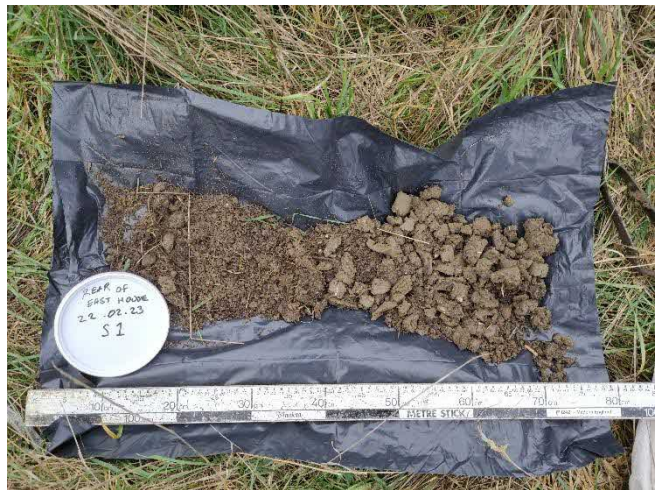
S1

Two samples (S1 and S1A) were taken from a much larger mound in the southwest corner of the site. The larger mound was approximately 700 -800mm higher in elevation than the general elevation of the vegetated mound. The remainder of the vegetated mound along the southern boundary was relatively consistent in elevation being approximately 100 -200mm higher in elevation relative to the general ground level of the site. Samples were spread evenly along the extent of the vegetated mound.

The composition of the mound material was found to mainly be comprised of topsoil and clay or silty clay. Apart from occasional brick fragments, no significant construction rubble or debris was noted within the ground.

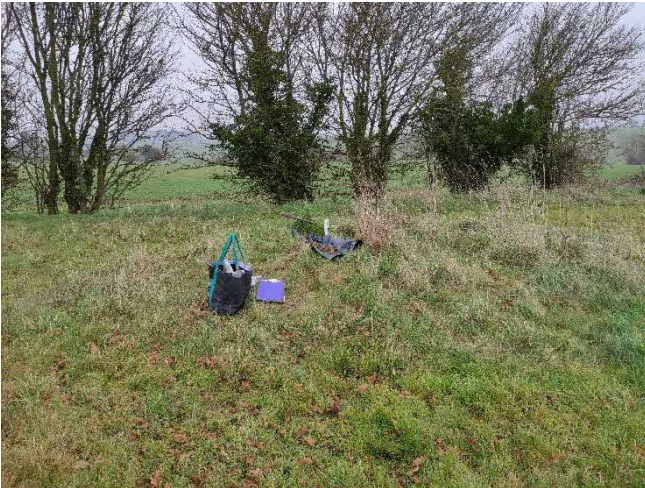
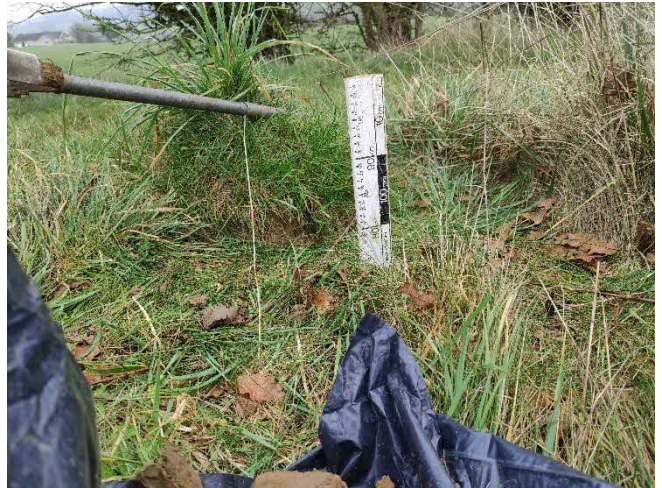
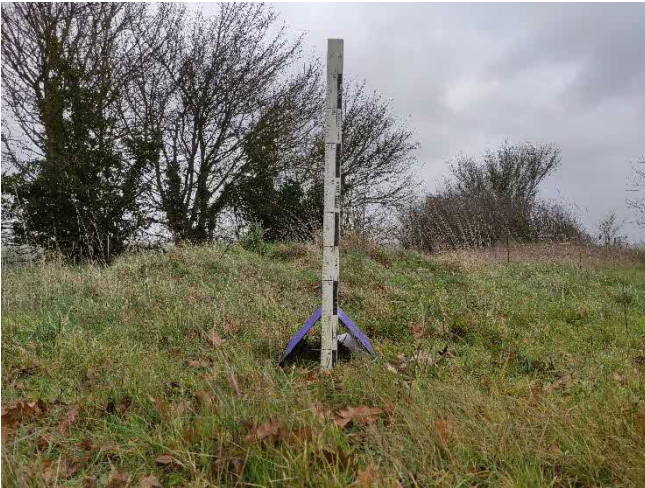
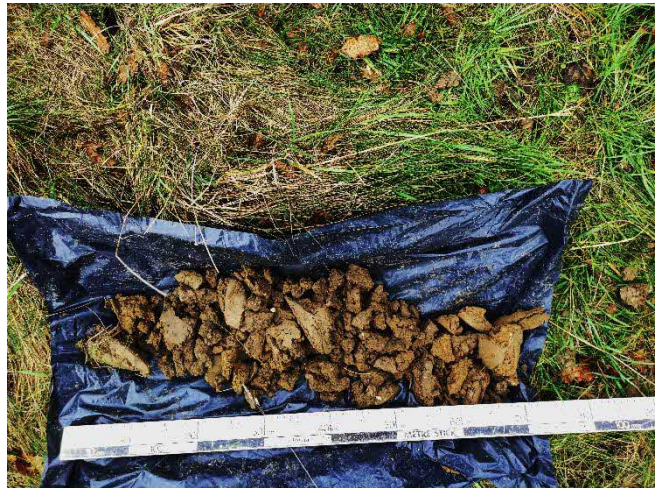
Sample S5 was located in a free-standing vegetated mound in the east of the site and just north of the mound running along the south boundary.
