Heritage statement
to support alterations to grade II listed
farmhouse and barn at
Carr Bottom Farm, Green Lane, Burley Woodhead, Ilkley

July 2023

STEPHEN HAIGH

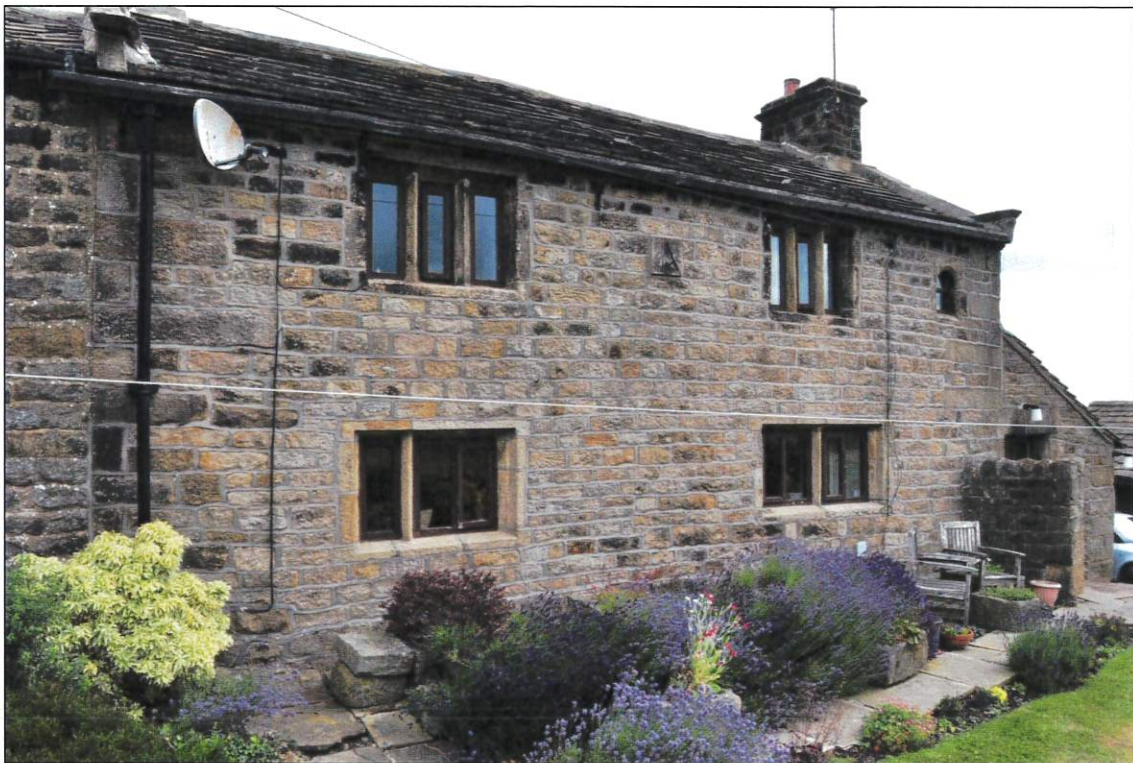
Photo 2: Farmhouse: south front

- 8.1 Carr Bottom is a seventeenth century, two-unit farmhouse with rear outshut, and later lean-tos and barn attached to its gables. All parts are of local gritstone (photo 2), and stonework within the west gable (now within the barn - photo 3) indicates that its front eaves were originally about 0.6m lower than at present; it may be that the roof was thatched originally, though there are no signs of any such change of pitch in the east gable. The front has four multi-light windows with some mullions removed, of which those on the first floor must have been enlarged to their present height. Between them is a sundial, dated 1724, possibly contemporary with that change. There is also an original, arched window at first floor level over the housebody fireplace, and moulded kneelers to the gables.

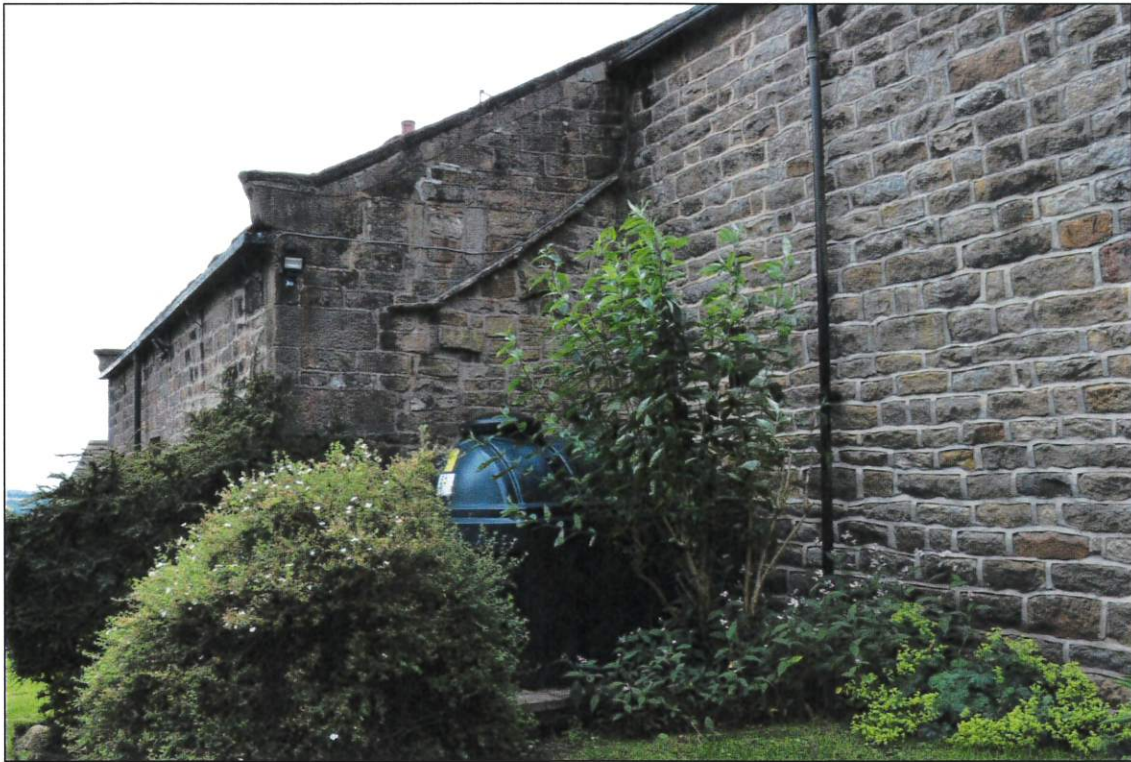
Photo 5: West end of outshut behind farmhouse; rear of barn to right

- 8.2 There are two lean-tos of different dates on the east gable (photo 4), and to the rear is an outshut, in whose west end is a continuation of the earlier, lower gable outline (photo 5). It implies the outshut was once a narrower structure.

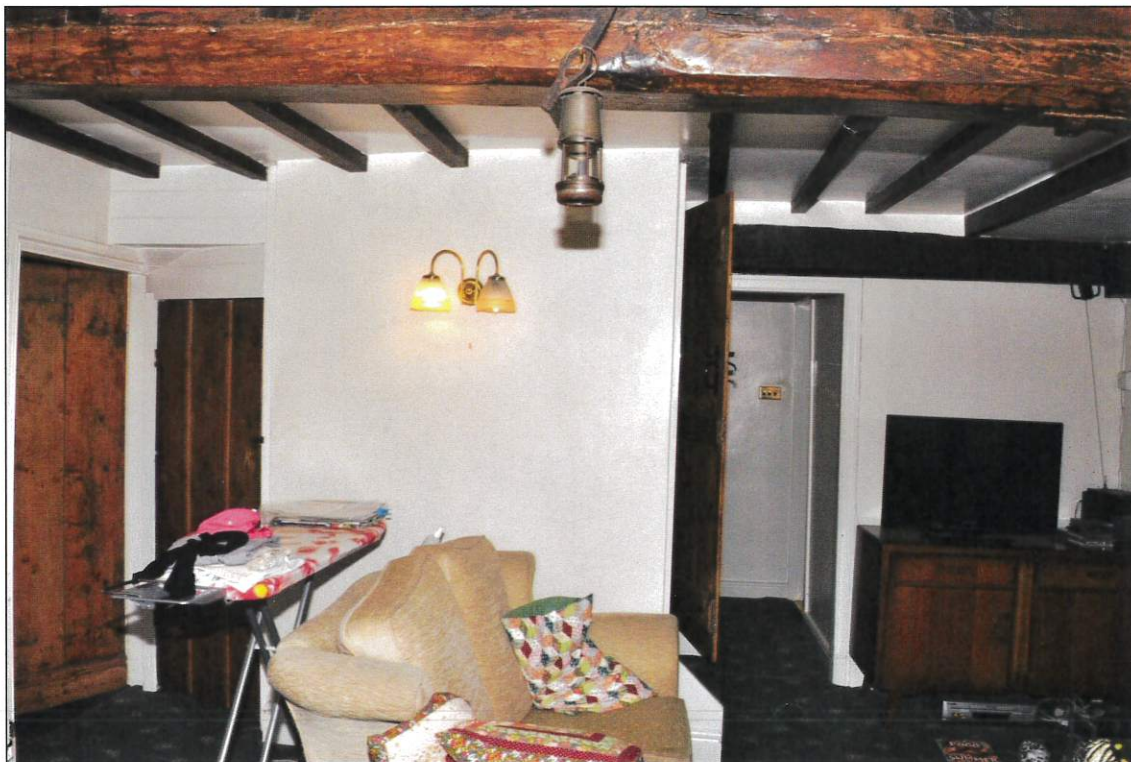
Photo 6: Living room/housebody, looking north; modern staircase projecting into room

- 8.3 The main part of the farmhouse is entered via a doorway in the east gable, now within the lean-to which contains the present kitchen; the door itself is relatively late and not the original external one. In the seventeenth century the main living room (housebody - photo 6) would have been entered at the side of a screen or "heck" enclosing the large fireplace, but as is usually the case, here the seventeenth century firehood has been replaced by a masonry stack, leaving only a scarf joint in the first floor spine beam as evidence of the former arrangement (photo 7). The present exposed joists are modern. A small salt or spice box set within the wall near the doorway is however a remnant of the earlier fireplace, although its panelled door appears to be eighteenth century.

- 8.4 The present staircase located at the rear of the housebody is modern, and enclosed within a blockwork wall. Between it and the north-east corner of the room is an oak beam, which seems to have been part of a partition between housebody and rear outshut. The west end of the beam is supported by a square stone pier, which rises to the roof, and implies that the outshut is aisle-like in origin.

- Removal of the modern staircase (to be replaced by one within the barn) would restore the housebody to its former size.
 - A new doorway would be created in the north-west corner of the parlour, one of the less sensitive parts of the building.

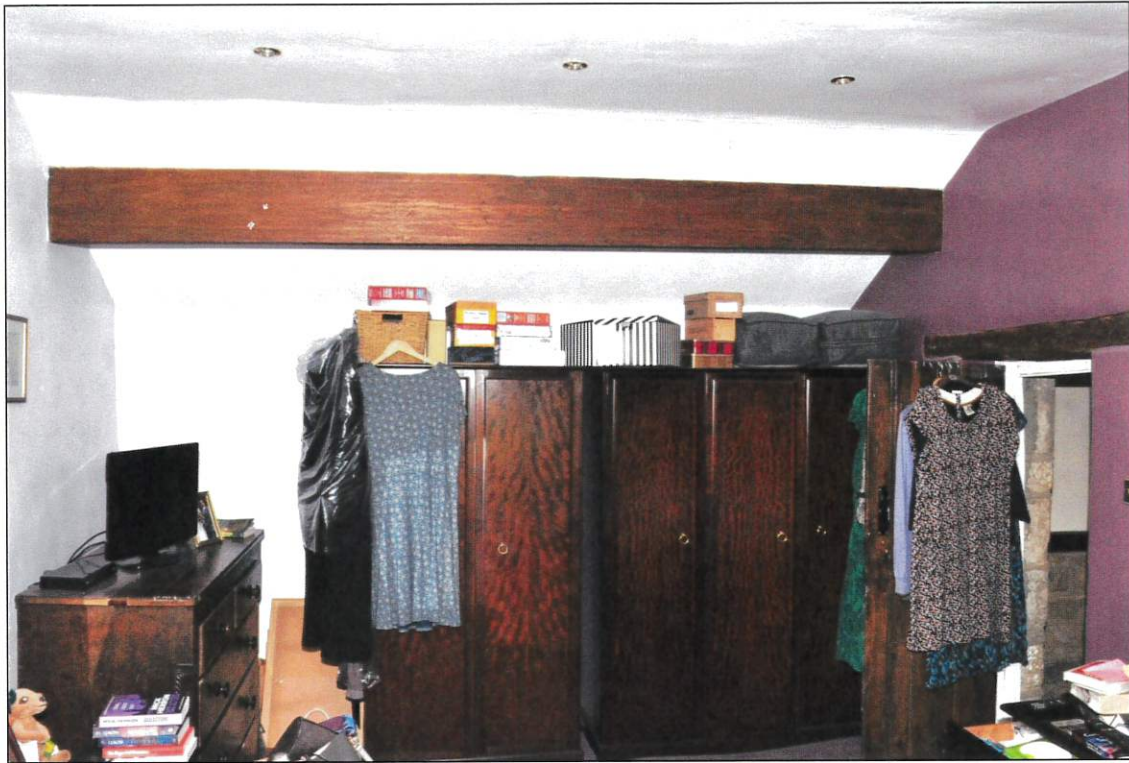
Photo 9: West bedroom, with historic door and modern purlin

- 8.7 The first floor consists of two bedrooms, separated by the masonry cross-wall containing a plank and batten door, with scratch mouldings indicative of a seventeenth or eighteenth century date (photo 9). Next to it, a small lobby has been created at the head of the modern staircase, to give independent access to both rooms from the landing. Both rooms rise into the roof space; the purlins are exposed, and all are of imported, square-sawn softwood. There is access from the east bedroom into the upper floor of the outshut, which serves only as storage space. One purlin here is oak, and contains evidence for re-use.

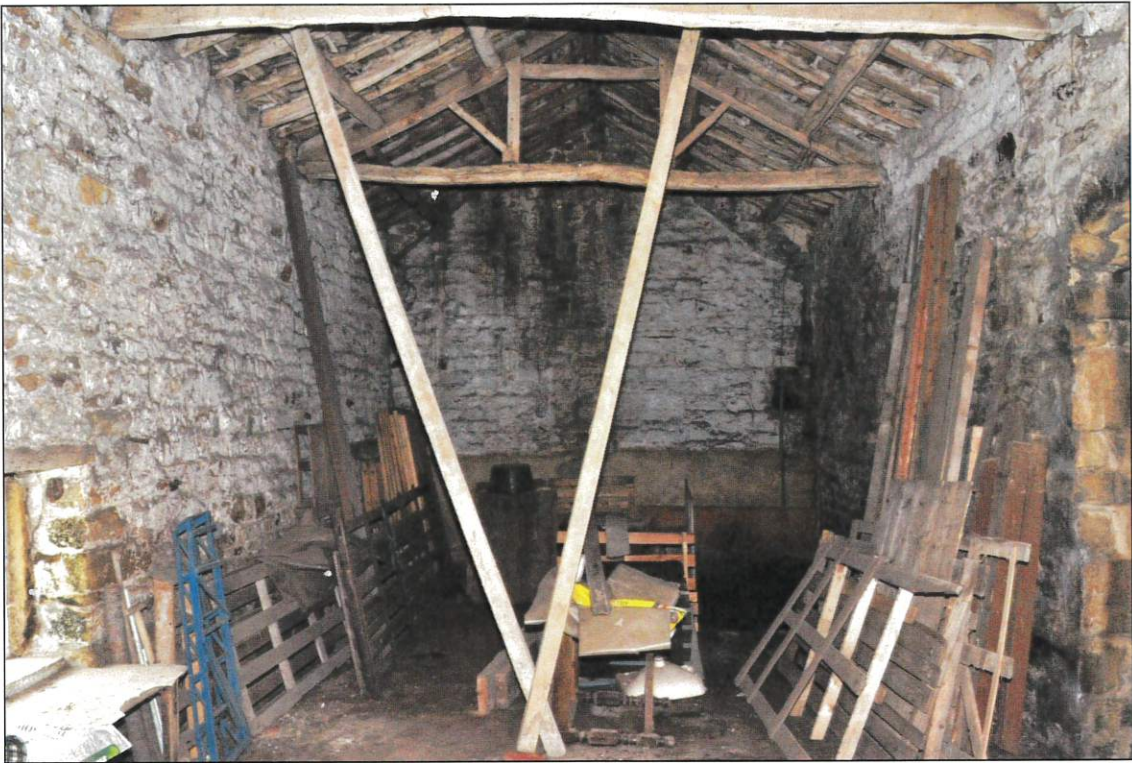
Photo 13: Barn interior, looking east towards farmhouse

- 8.9 The threshing floor within the barn remains visible, bounded by low stone kerbs to either side (photo 12), but there is no obvious evidence for any former animal stalls or hayloft, as is usually the case, and the interior comprises a single space, open to the roof (photo 13). The trusses are of pegged oak and queen-strut design, and some original, tusk-tenoned purlins survive, though a number of modern, softwood timbers have also been introduced. A small part of the roof at the north-west corner fell in recently, and a temporary repair has been effected there.

- The trusses would be retained.

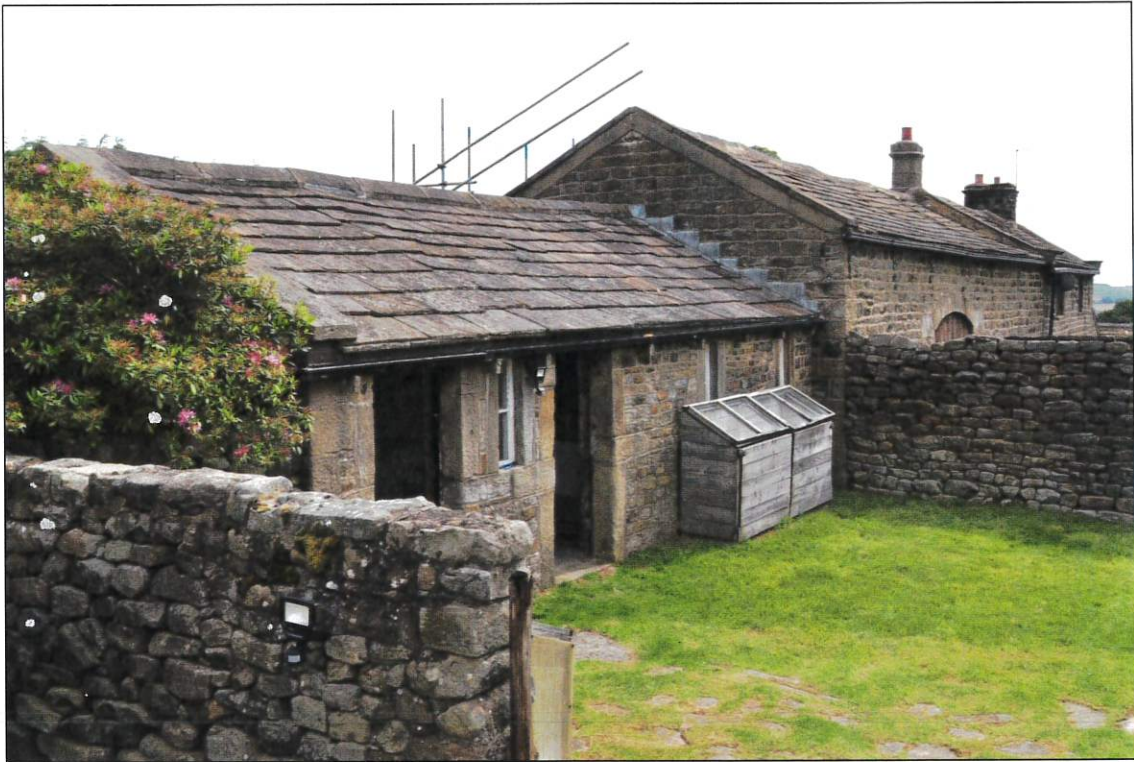
Photo 14: Mistal (ca.1900) at west end of barn

- 8.10 The single-storey extension at the west end of the barn (photo 14) dates from about the turn of the twentieth century, and its front elevation has doorways with tie-stone jambs and narrow upright windows, also between dressed jambs, so it is essentially traditional, but with a clearly later appearance than the barn. The larger east room has timber cattle stalls (perhaps original to it), which face onto a short feeding passage entered from the barn (photo 15). The smaller west room is a loose box or perhaps a stable.

10.4 Conversion of the mistal would require a new window in its rear elevation, and the removal of all fixtures from the interior, but given its relatively modern date, the significance of this building is relatively low, and the impact of these changes also low.
