**Bat Survey Report and Method Statement
European Protected Species (Bats)**

Reasonable Avoidance and Mitigation Measures

**Carr Bottom Farm,
Green Lane,
Burley Woodhead,
LS29 7BB**

14.08.2023

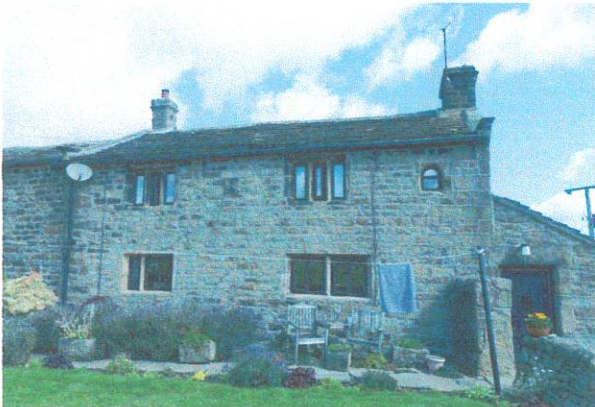
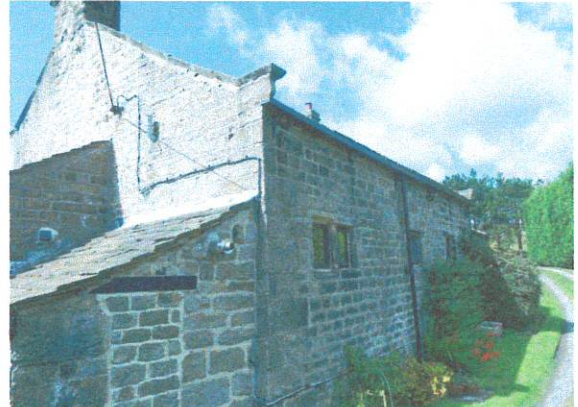
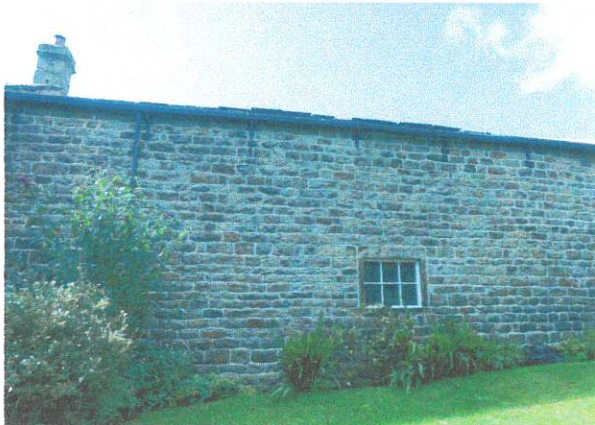
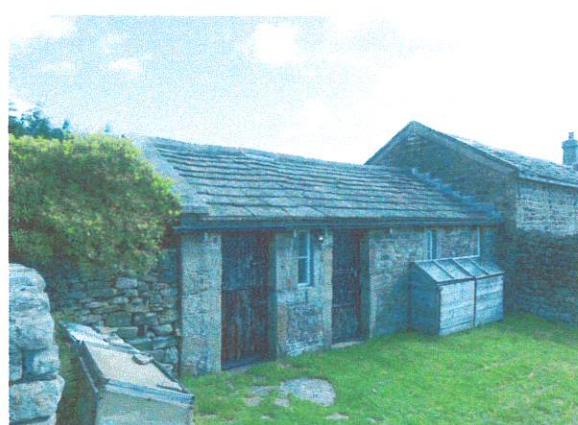
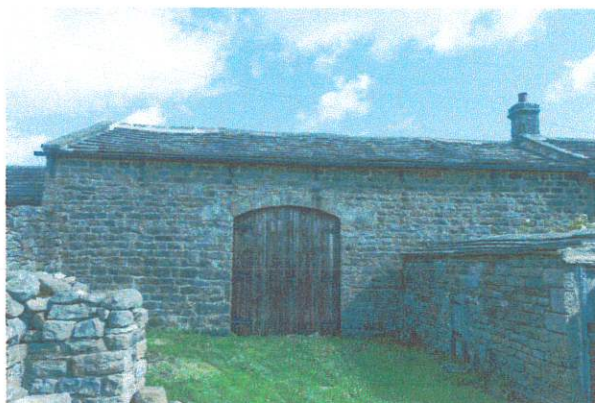
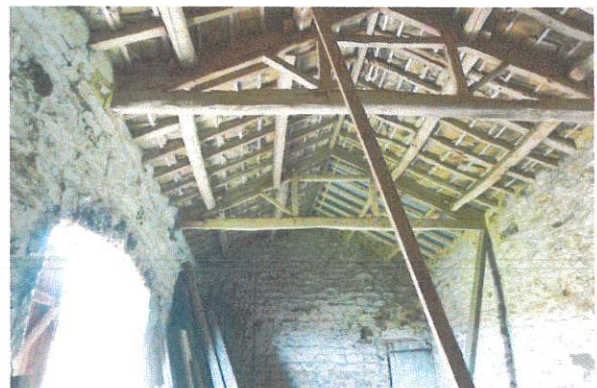
The property consists of a detached two storey stone built farmhouse with double pitched slate roof with an adjoining two storey barn, a single storey outbuilding is present on the northern barn gable.

Walls are generally well pointed, with no obvious cracks, gaps or crevices. Gable ends are pointed and well sealed at wall top level. The eaves are generally pointed and sealed although some gaps are present on the barn.

Farmhouse roof slates are generally close fitting, with no lifted, slipped or missing slates present. The barn has areas of slumping resulting in lifted slates. Ridge tiles are pointed and sealed. Roof slates are unlined and exposed to the interior.

The property was assessed as offering low bat roost potential when location was considered. No physical evidence to suggest use by bats was recorded within the building.

Roof work should take place following an evening temperature of +5c

Work to affected roof areas will take place under supervision of the batworker'.

Roof slates should be removed by hand where necessary.

In the unlikely event bats are found during works. The area should be carefully covered and work stop until the batworker can attend to assess the appropriate way forward.
