**Bat Emergence Survey Report**  
**Of**  
**The Old Rectory, Norton Road,**  
**Tostock,**  
**Suffolk**

On behalf of  
**Mr & Mrs Bowyer**

**September 2023**

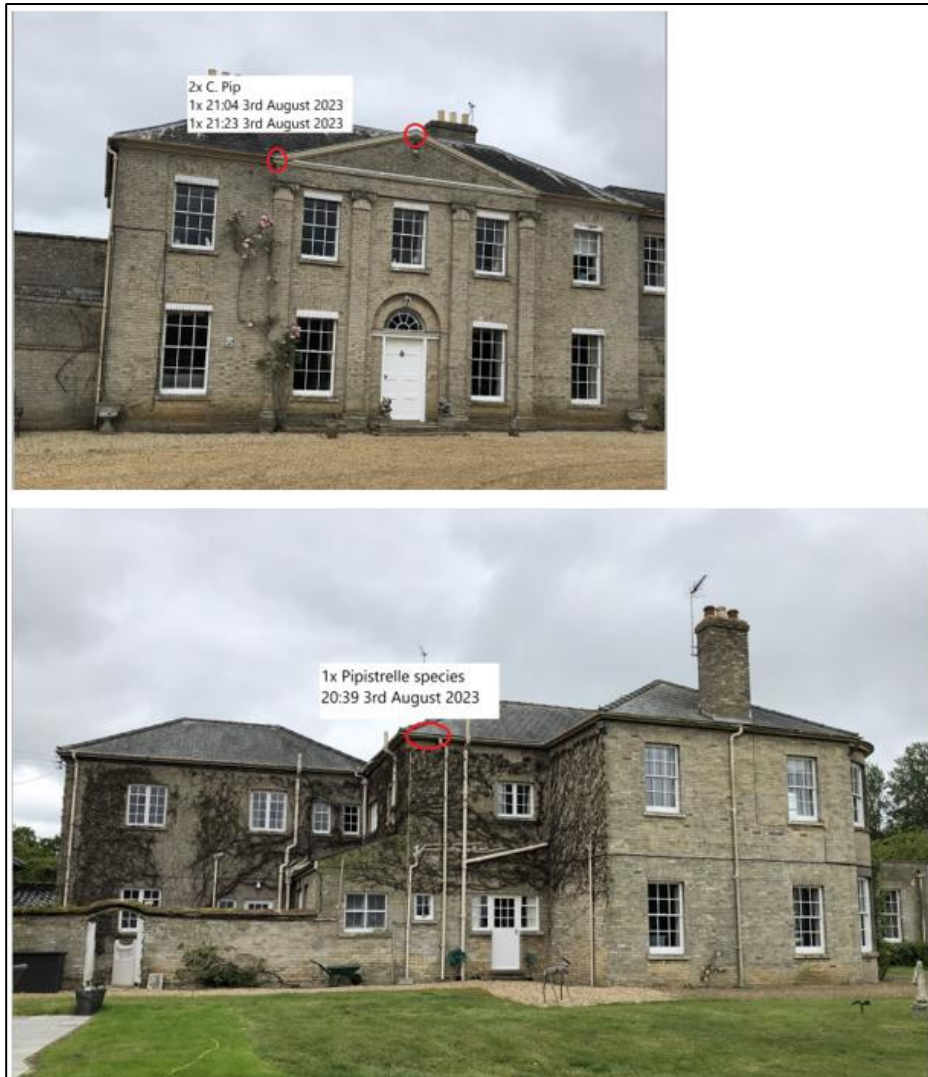
**Figure 2:** Emergence locations

- 3.3 During the survey, an emergence which was considered to be a pipistrelle species was recorded between the wooden soffit and drainpipe on the southern fascia of the building at 20:39 (5 minutes before sunset). Emergence points are noted below in Figure 2. Pulsar imaging of common pipistrelle emerging is shown below in Figure 3.

- 3.4 A single common pipistrelle was observed emerging from a hole in the wooden fascia on the front of the building at 21:04 (20 minutes after sunset) as shown in Figure 4.

- 3.5 A potential common pipistrelle was identified entering the building behind the light on the northern fascia of the building at 21:23 (39 minutes after sunset) however this is difficult to determine during the survey and through the recordings of the Pulsar thermal imaging camera due to the positioning of the light unit.

- 4.2 Two-day roosts were identified within the building; one common pipistrelle and one pipistrelle species emerging from the building during one survey visit (3<sup>rd</sup> August 2023).

- 4.3 A potential further day roost was identified within the building behind the lighting unit on the northern fascia however views during the survey and through thermal imaging assessment were obstructed by the lighting unit.

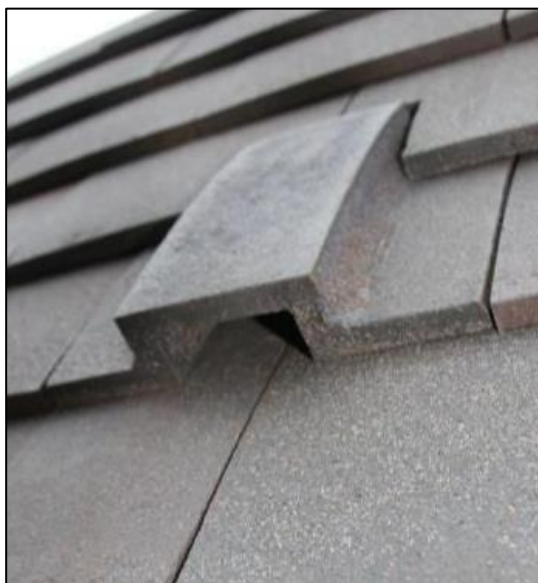
**Figure 4:** Possible Enhancements – Habibat access tile

- 4.9 Once the re-development is complete, additional enhancements could also be incorporated in the new builds to provide more roosting opportunities post-development; such as the Habibat access tile which consists of lead, clay or slate tiles, with a capped vent allowing access to roof felt or roof space providing roosting access for all species. Other box brands and types could be used but confirmation from an ecologist should be sought. Boxes should be placed facing between south-east and south-west.
