Bat Emergence Survey Report for Hudnalls Cottage, Hewelsfield, Gloucestershire

Commissioned by: Mrs C. Lai

Author: Ashley Butler MSc

Date: 15/9/23

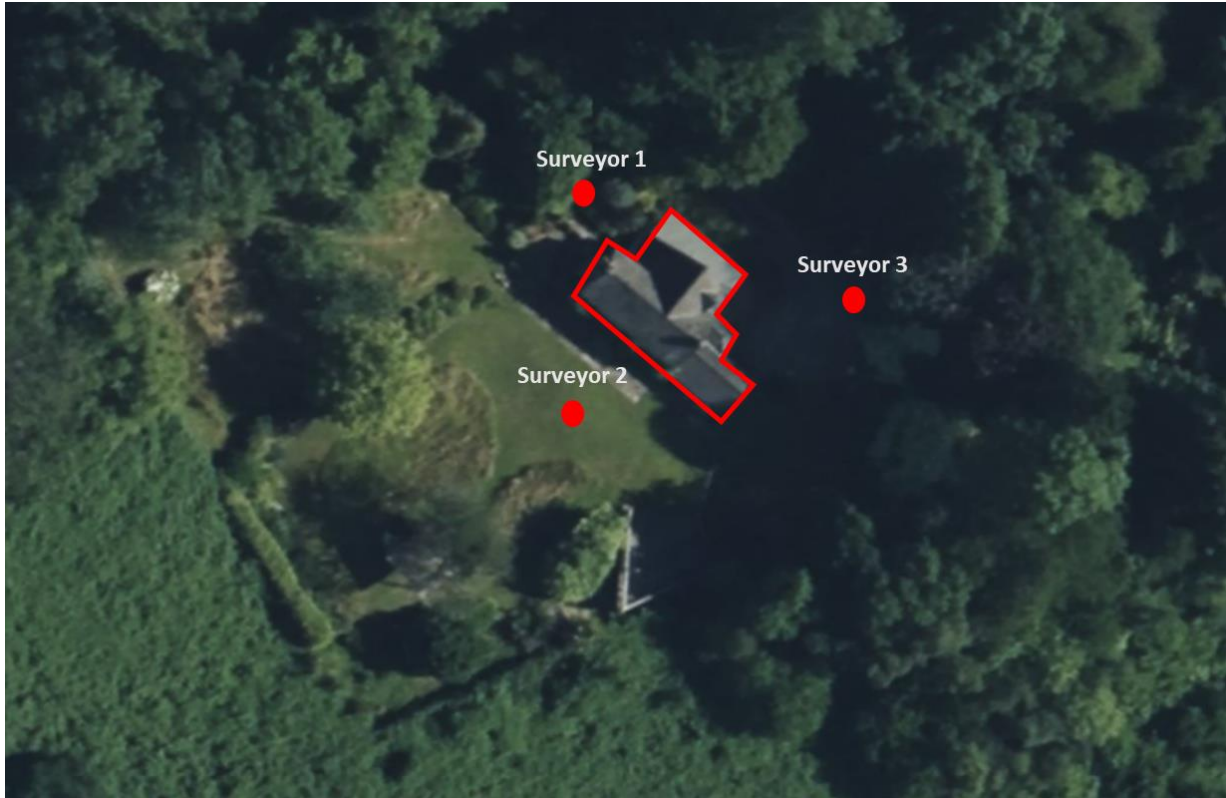
Figure 4: Site plan, showing the positions of surveyors (red dots) on the surveys

boards. The surveyors positioned themselves accordingly, at an appropriate vantage point in view of these interest features, and the locations of these are indicated in Figure 4. The dusk emergence survey commenced approximately 30 minutes before sunset and lasted approximately 2 hours, the optimum time for bats to emerge from a roost, in order to record any bats that may emerge from the building. The dawn survey commenced 1,5 hours before sunrise and lasted approximately 2 hours, covering the optimum time for bats to return to the building.

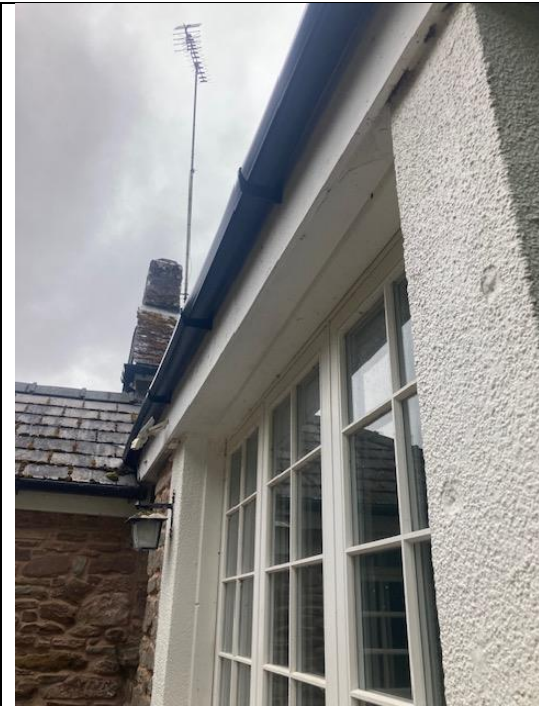
Plate 1 – Facias on southeast elevation of garage extension looking towards the porch

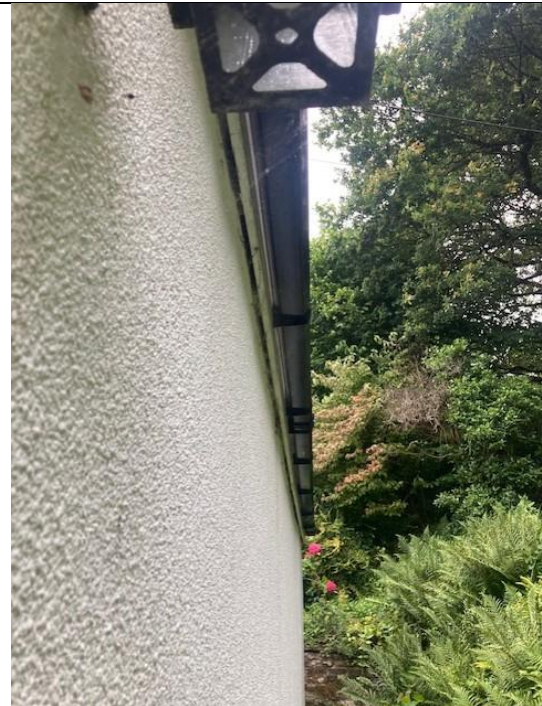
roosting within gaps behind the fascia boards; however, these gaps contained extensive cobwebbing, suggestive of no recent bat use (plate 2). The building has wooden doors which are well sealed and maintained in good condition, with no gaps noted. The windows are wooden framed and good condition with all window frames tightly sealed. There are 2 chimney stacks on the original cottage. The pointing on each stack is in good condition and the associated lead flashing is tight to the building.

Plate 2 – facias on the northeast elevation of the garage

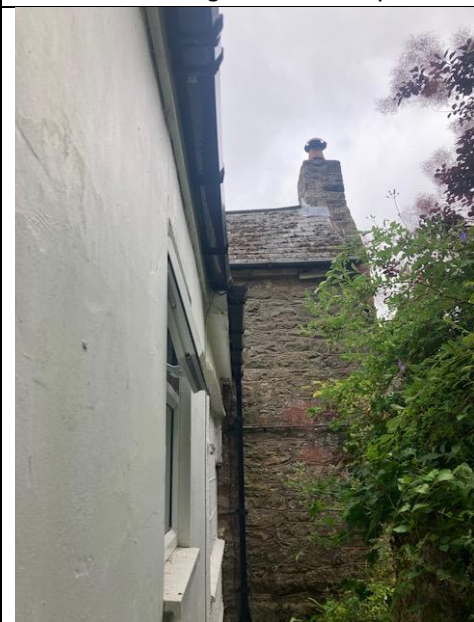
Plate 3 – facias on northwest elevation of garage and section 3 looking towards original cottage

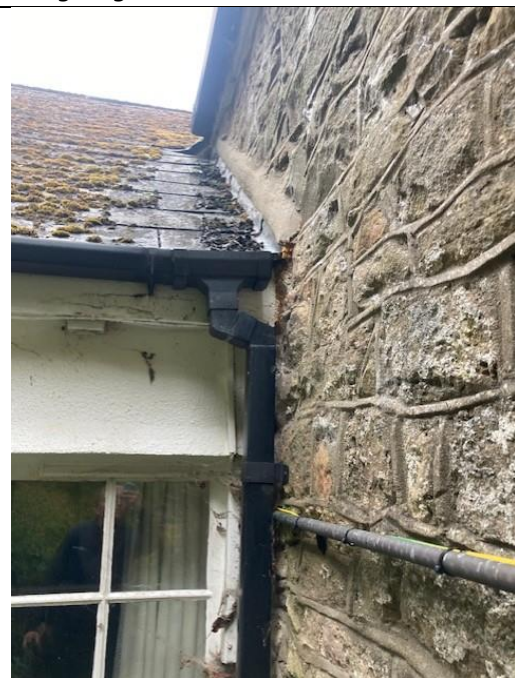
Plate 4 – Connection point of section 3 to original cottage. Location of bees nest

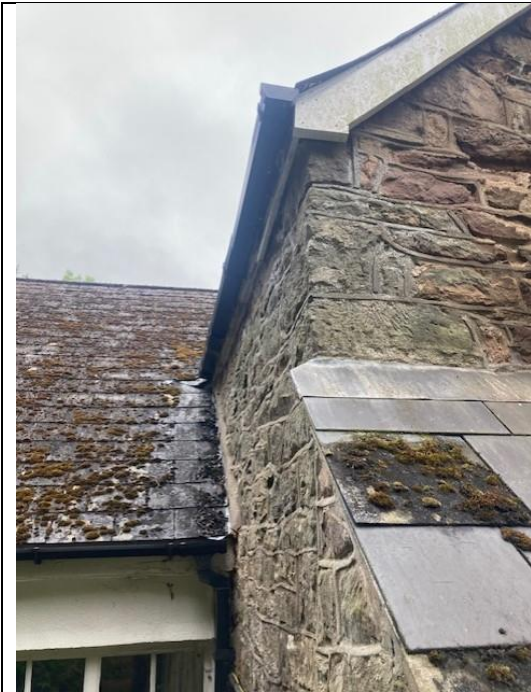
Plate 5 – fascia boards on northeast and north west elevations of cottage showing section of rot on northeast elevation

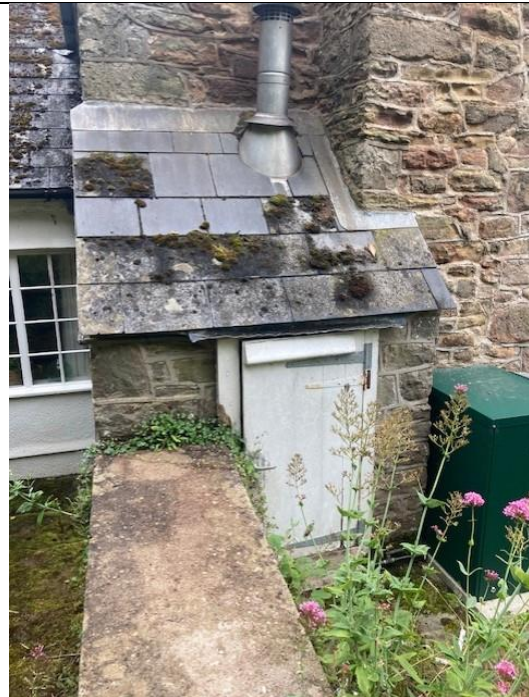
On the northwest side of the original cottage there is a small boiler room with an external door. At the time of the survey the door was ajar providing potential access into the space. The wooden door also showed signs of rot at the base which means it does not fit tight to the floor (plate 6).

Plate 6 – external boiler room on northwest elevation

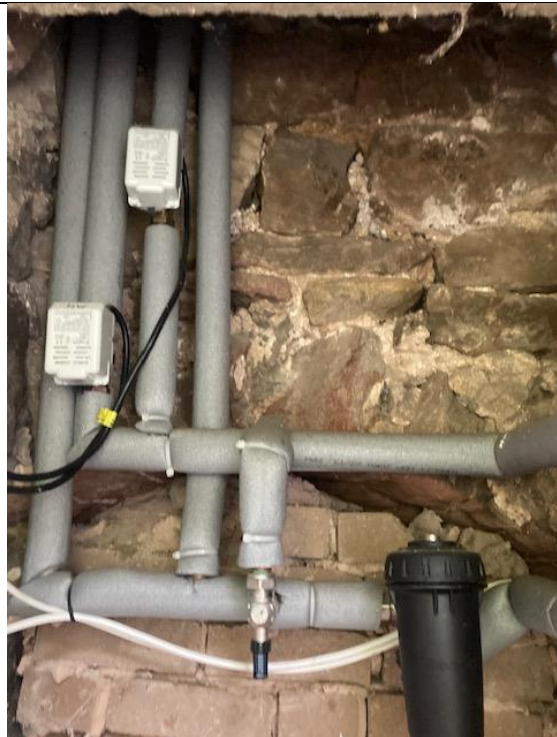
Internal inspection of the boiler room showed small numbers of bat droppings on the floor which are likely to be pipistrelle due to the size and shape (plate 8). These were mixed with mouse and rat droppings. The internal stonework is roughly mortared, and thus there may be gaps and cracks providing suitable roosting opportunities for crevice dwelling bats (plate 7).

Plate 7 – internal stonework in boiler room

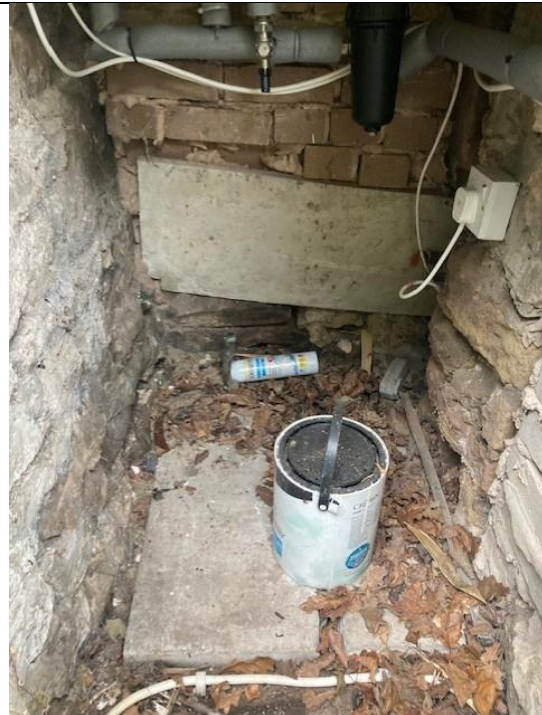
Plate 8 – location of pipistrelle sp, dropping on floor of boiler room

The presence of bat droppings on the floor of the boiler room confirms that bats have utilised the building for roosting. Bat activity surveys were subsequently undertaken to establish whether the building is still currently used by these species, and to characterise the nature of the roosts present.

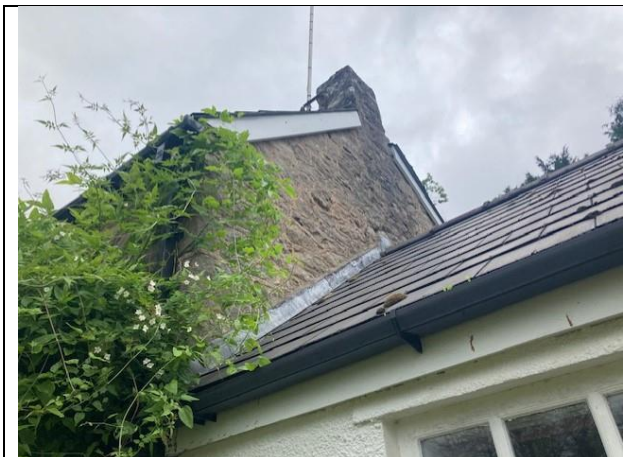
Plate 9 – Facias on southeast elevation of cottage

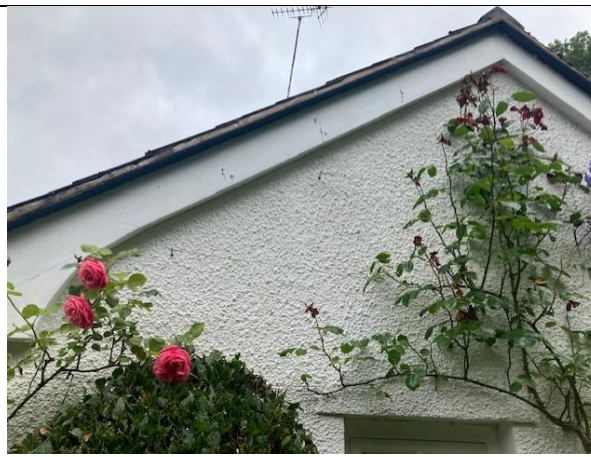
Plate 10 – facias on south east elevation of section 2

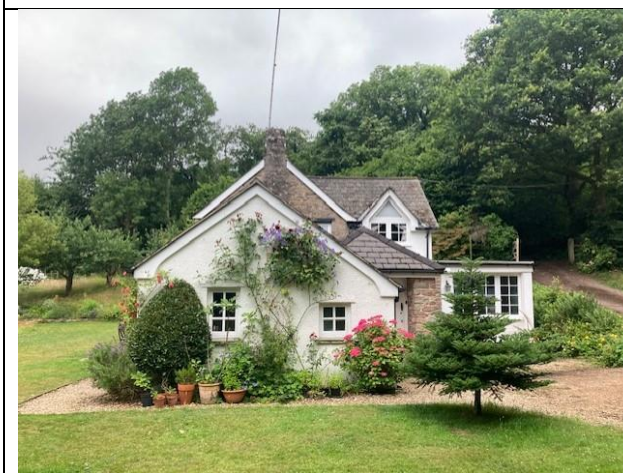
Plate 11 – View of site looking northwest

The cottage comprises four main parts (Figure 6; Plates 11 and 12): an original rectangular stone built cottage with a pitched roof (section 1), a block or stone-built and rendered extension with pitched roof on the southeast elevation (section 2), a block or stone-built and rendered extension with pitched roof on the northeast elevation (section 3), and a flat roofed block-built and rendered garage extension (section 4) currently used as an office on the northeast elevation. The stone walls of sections 1 are generally in good condition with intact pointing. The render on the walls of Sections 2, 3 and 4 is in good condition with no cracks or lifting noted. The main pitched roofs of the cottage (sections 1, 2 and 3) supports a slate roof and concrete ridge tiles. These are in good condition and well-sealed with no visible gaps for roosting bats, except for several small gaps noted under a few of the ridge tiles. There are several cracks along the tile verges of section 1. There are wooden soffits covering the eaves on section 1 with numerous gaps between the soffit and stone work that could offer bats access into the roof void of the original cottage (Plate 5 and 9). A bee's nest was also noted accessing the roof space of section 3 at the point where section 3 and section 1 join on the northern aspect (Plate 4). There is a significant area of rot on the wooden bargeboards on section 1 on the north east aspect (Plate 5). The garage extension (section 4) is flat roofed and is tightly sealed, offering very limited potential for roosting bats, except for occasional or opportunistic

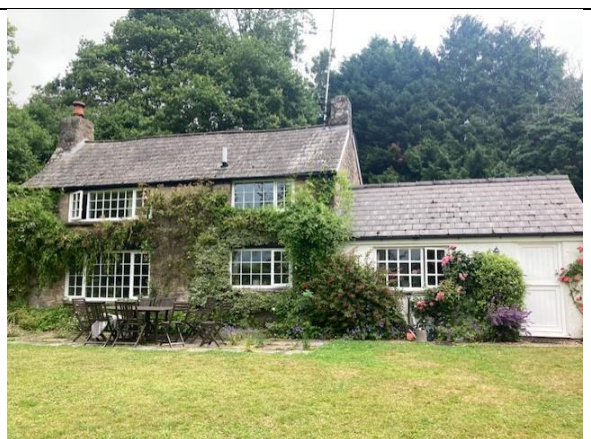
Plate 12 – view of site looking northeast

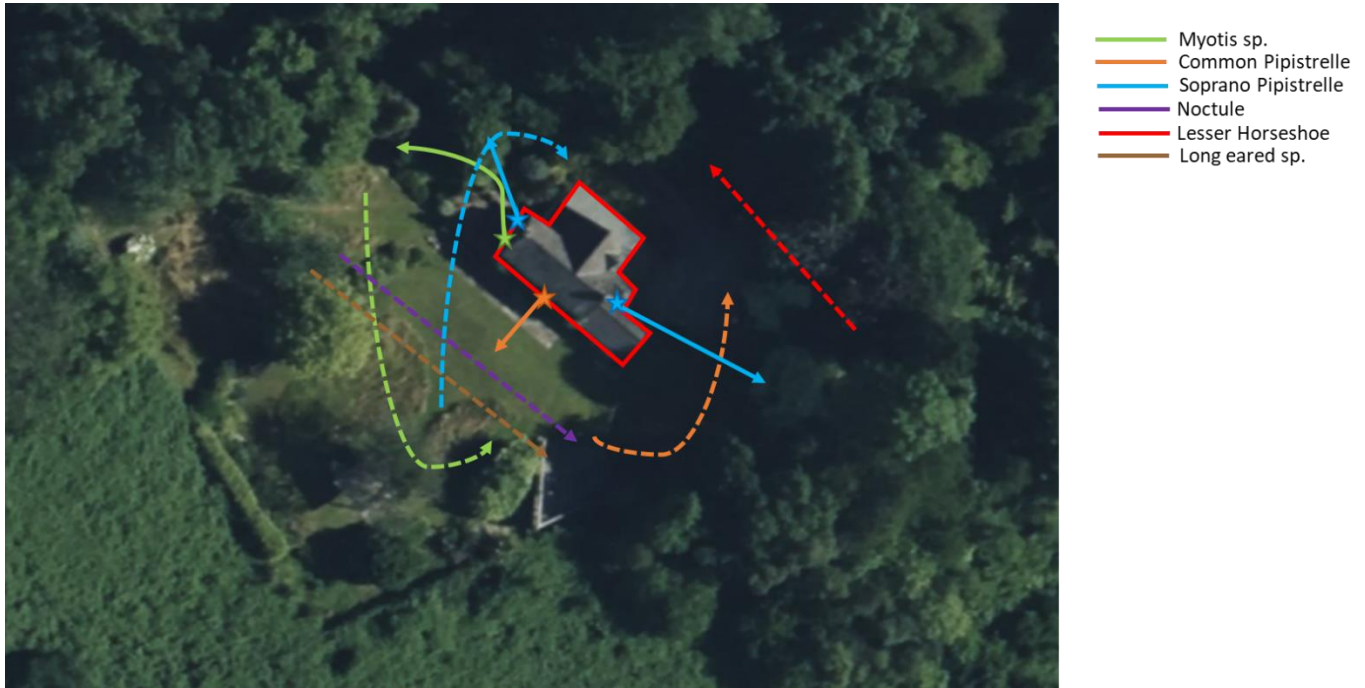
Figure 7: Survey 1 results

Time	Species	Location
20:38	<i>Myotis</i> sp.	NW apex
20:45	<i>Myotis</i> sp.	NW apex
20:46	<i>Myotis</i> sp.	NW apex
20:53	<i>Myotis</i> sp.	NW apex
20:57	<i>Myotis</i> sp.	NW apex
21:00	Soprano Pipistrelle	NW apex
21:00	Soprano Pipistrelle	Gap between section 2 and porch
21:01	Soprano Pipistrelle	SE apex
21:03	2x <i>Myotis</i> sp.	NW apex

21:09	Common pipistrelle	SE face of cottage
21:23	Myotis sp.	NW apex
21:26	Soprano Pipistrelle	Gap between section 2 and porch

In total 8 myotis sp. Bats, 4 soprano pipistrelles and 1 common pipistrelle emerged from the cottage.

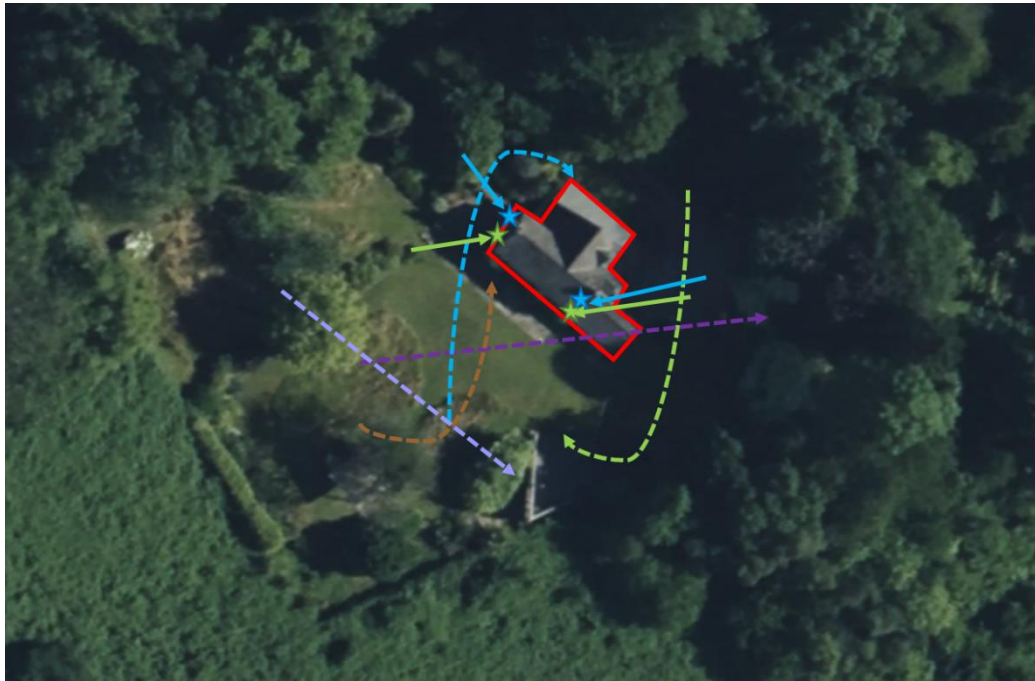
Figure 8: Survey 2 results

Time	Species	Location
05:47	2x soprano pipistrelles	NW apex
05:55	Myotis sp.	NW apex
06:00	Myotis sp.	NW apex

06:06	Soprano pipistrelle	SE apex
06:07	Soprano pipistrelle	SE apex
06:08	Soprano pipistrelle	SE apex
06:13	Myotis sp.	SE apex

- Myotis sp.
- Soprano Pipistrelle
- Noctule
- Leisler's
- Long eared sp.

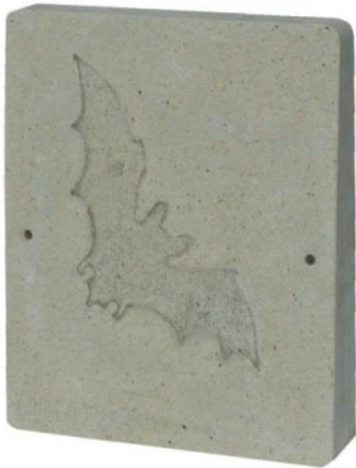
The 2FE shelter produced by Schwegler. This is designed to be attached to the external wall of a building and provides a shelter for crevice dwelling bats.

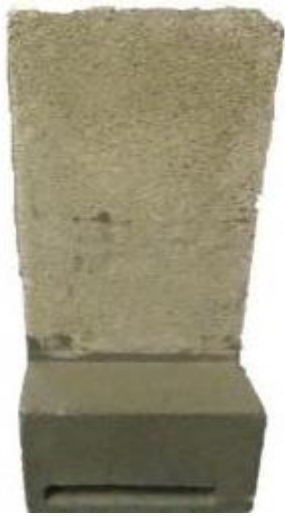
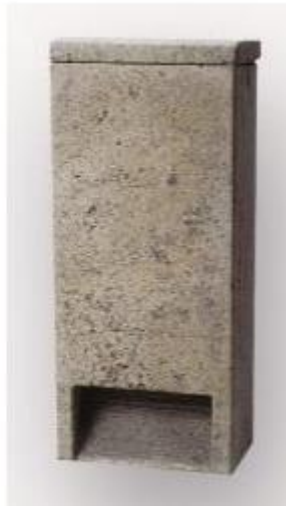
Suitable bat box products to be installed integral to the walling of the new sections include:

- Segovia Build-in Woodstone bat box
- Schwegler 2FR Bat Tube

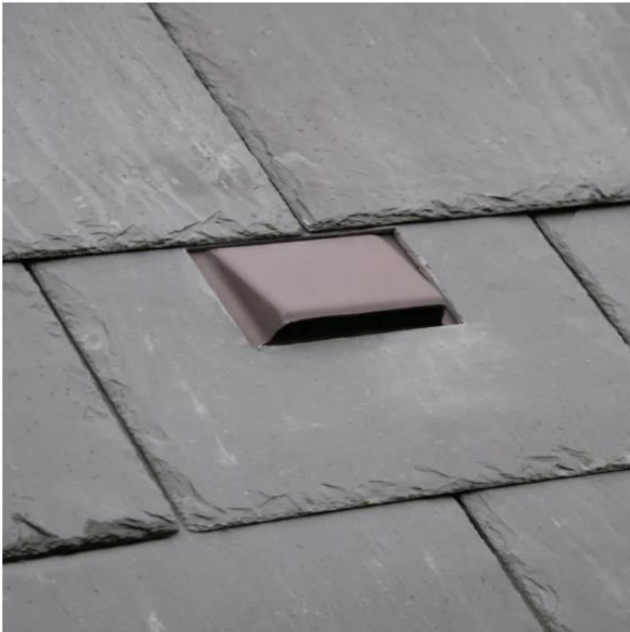
Bat tiles or slates to be installed to provide access into roof space – an example below

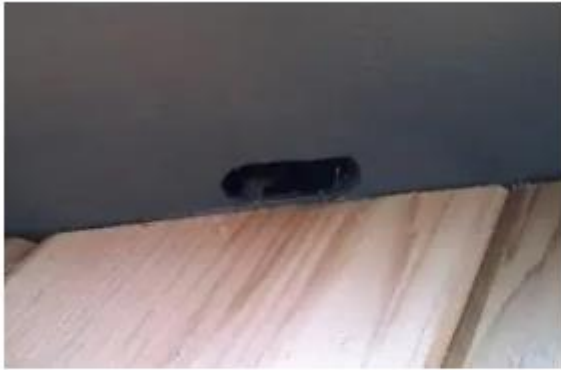
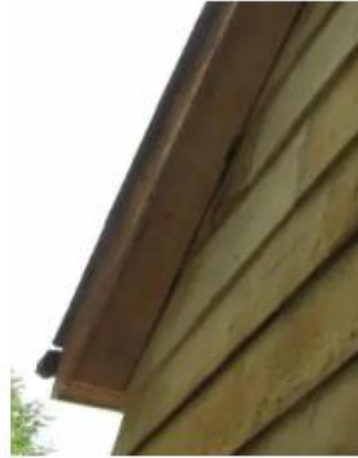
Crevice dwelling bat species often exploit gaps in or under fascias, soffits and bargeboards, to gain entry into buildings. If these features are being removed, replaced or made inaccessible to bats during the development work and bats are known to be using these features, then compensation within the new fascia, soffit or bargeboard should be implemented. This can be as simple as cutting holes in the new soffit box or bargeboard. The holes must be located next to the wall of the building as bats often require a surface (often a wall) to land on before crawling through the access. Examples of this are shown below:
