# Medhurst St Mary Bourne

## Bat Survey

A series of dusk emergence and dawn re-entry surveys on the dwelling at Medhurst, St Mary Bourne, prior to the proposed demolition and construction work.

Version 1 dated 22<sup>nd</sup> June 2023

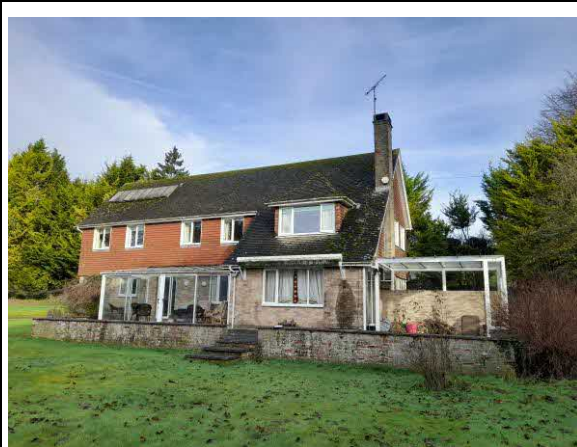
**Photograph 1.** General view of the southern elevation of the dwelling.

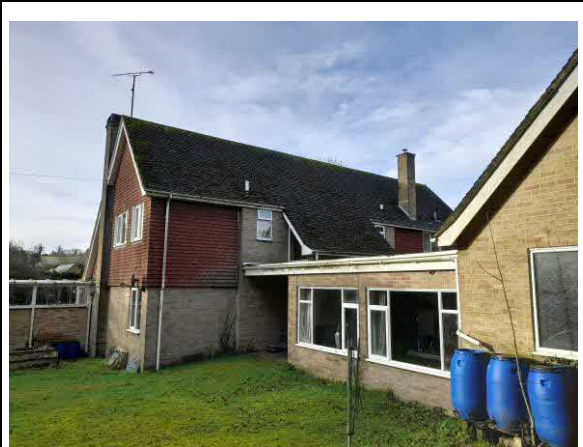
**Photograph 2.** Northern and eastern elevations of the dwelling, and eastern elevations of the extension adjoining to the garage.

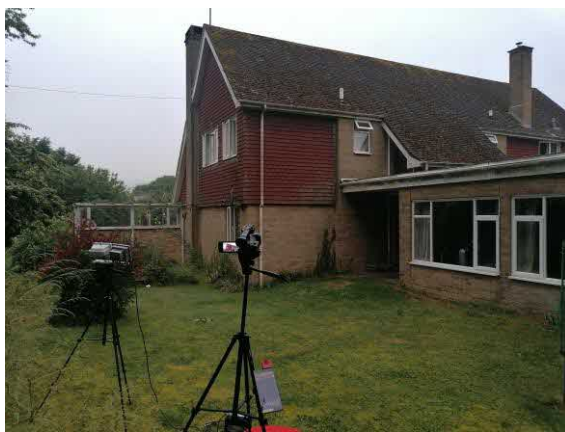
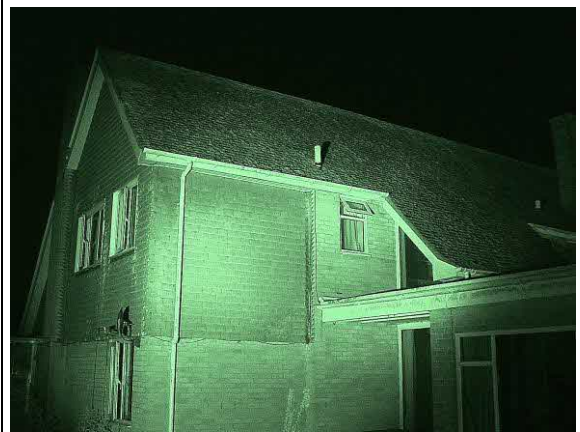
**Surveyor Position 1**

**Photographs 3 & 4.** Camera set up to support the visibility of the eastern elevation of the dwelling, and IR still image.

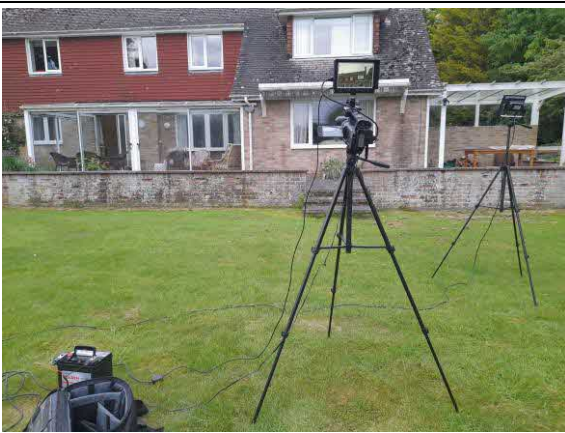
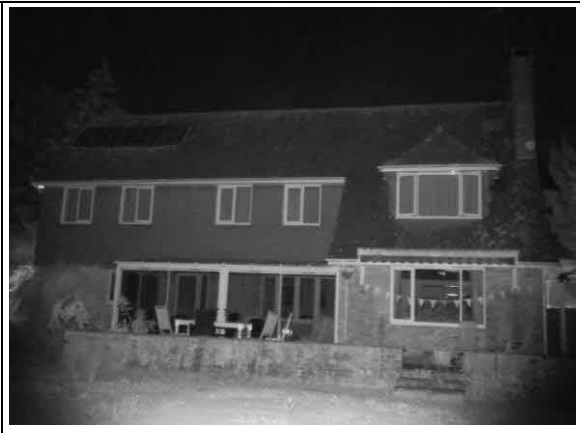
**Surveyor Position 2**

**Photographs 5 & 6.** Camera set up to support the visibility of the southern elevation, along with a still IR image.

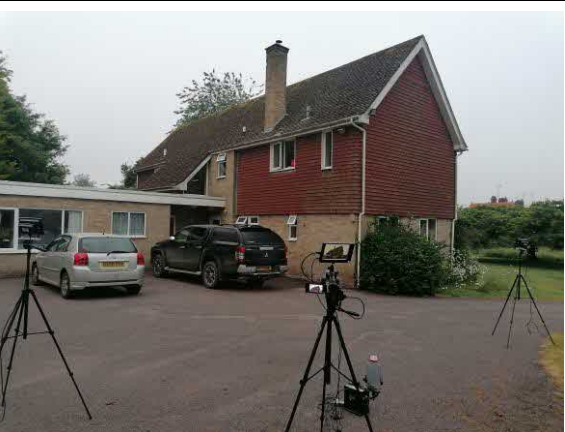
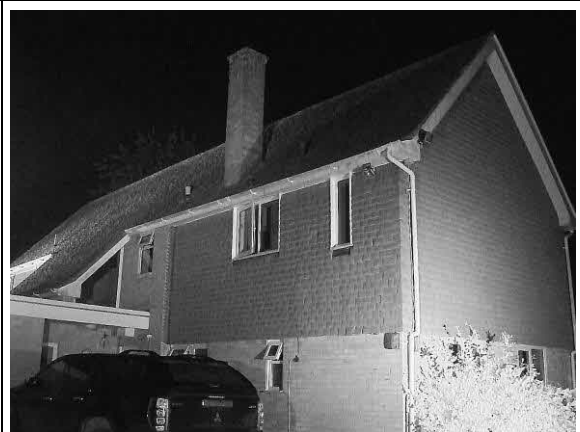
**Surveyor Position 3**

**Photographs 7 & 8.** The western and northern elevations and corresponding IR image.

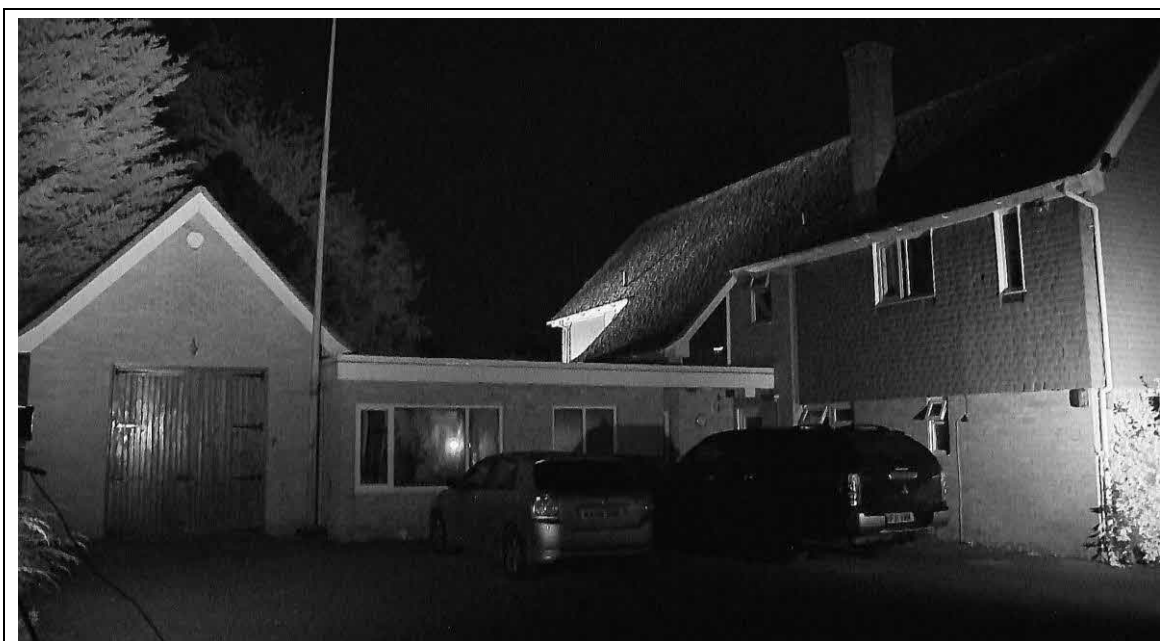
**Photograph 9:** Infrared image taken by surveyor 3 in the early part of the dawn survey.

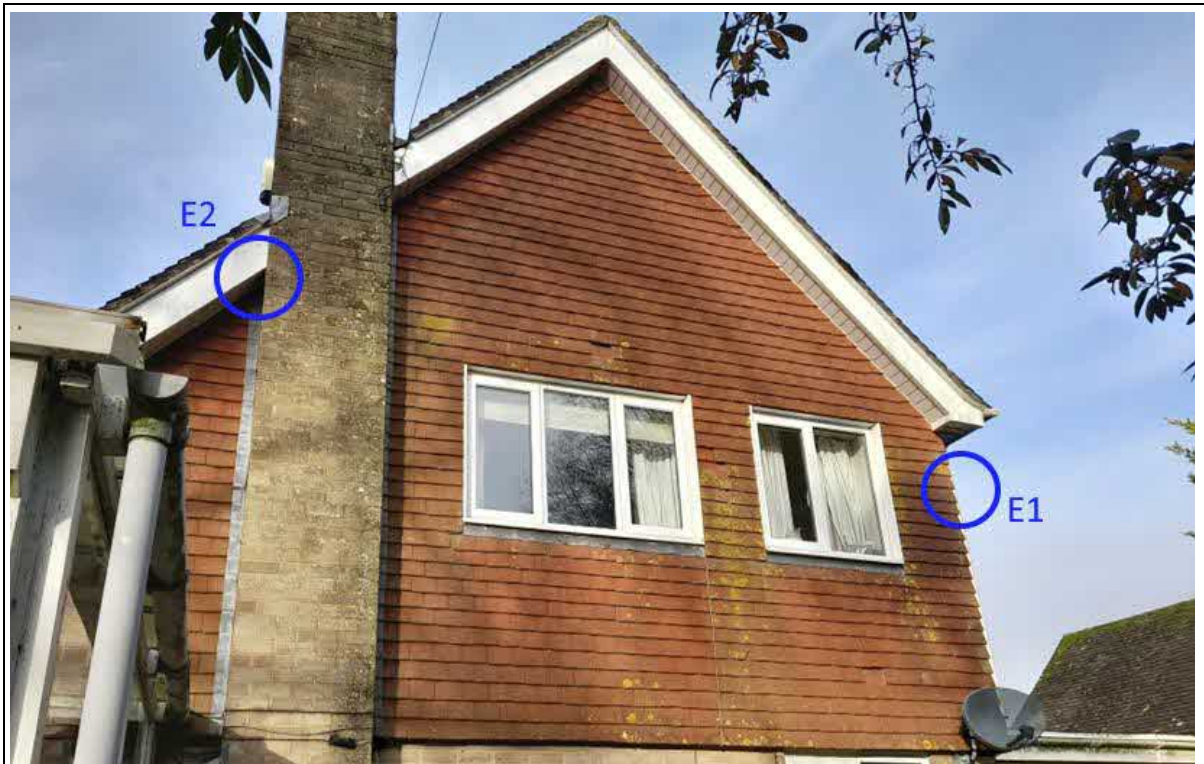
- 4.1.1. The surveys confirmed the presence of two soprano pipistrelle bat roosts under hanging tiles at both the northern corners of the main section of the dwelling (photographs 10, 11 and 12), and one common pipistrelle bat roost to the left of the easternmost chimney (photographs 13 and 14).
- 4.1.2. Roost E1 was used by a single soprano pipistrelle bat on two out of the four survey visits, roost E2 was used by a single common pipistrelle bat on one dusk survey, and roost R1 was used by two soprano pipistrelle bats on one occasion, the dawn survey.

**Photograph 10.** Two roost locations on the eastern elevation of the building.

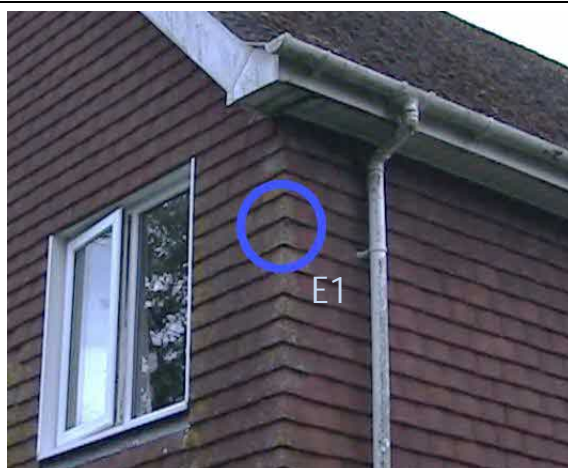
**Photograph 11.** Soprano pipistrelle recorded on the IR camera emerging from roost location E1, 21:03 18/05/23.

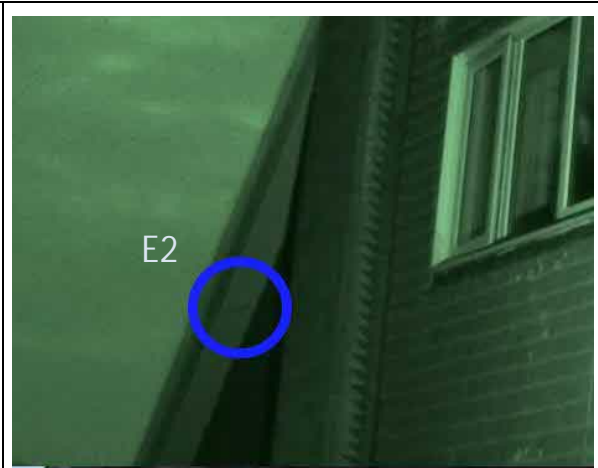
**Photograph 12.** Common pipistrelle recorded on the IR camera emerging from roost location E2, 21:27 18/05/23.

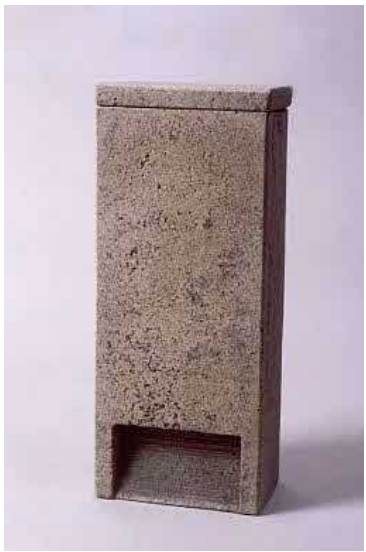
<p><b>Schwegler 1FR bat tube</b> Built in to the external wall.</p>	<p><b>Schwegler 1FR bat tube</b> built in and rendered over on the external building elevation.</p>	<p><b>Hollow Bat Box</b> External wall mounting</p>

- 5.6.2. In order to replace the roosts that will be lost, it will be necessary to provide four suitable permanent replacement roosts within the new building. Ideally, the roosts should be replaced on a like for like basis. Pipistrelle bats predominantly roost in crevices while long-eared bats predominantly roost in voids, hence replacement bat boxes suitable for both crevice and void dwelling species will be required. It is recommended that three single crevice bat tubes and one hollow box are installed (as below), available from WildCare and Greenwood's Ecohabitats respectively.

- 5.6.3. The tube is designed to be installed built into an external elevation and can be either bricked in or rendered over into the façade. While the hollow bat box can be fixed onto an external elevation. The replacement roosts must be stalled as high as possible (at least 3m).
