SWE Ref: SWE 682

**Ecology Report**

Welland Down Farm

SWE Limited was commissioned to undertake a protected species survey of three barns within the property of Welland Down Farm, Sandford, Devon, EX17 4EN (Ordnance Survey grid reference SS811063). The survey was required to assess the impacts of the proposed conversion of the barns to residential. The location of the barns is shown in Figure 1.

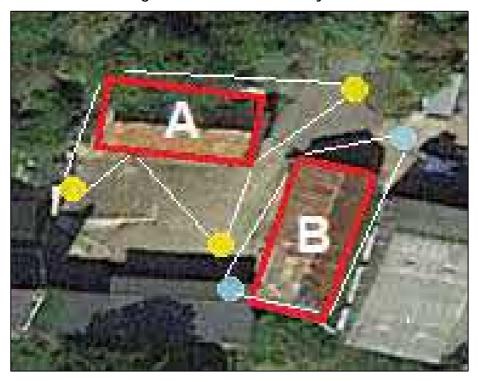
Figure 2. Location of surveyors.

Subsequent to the findings of the PRA and eDNA analysis, which concluded that Barns A and B had been used as a roost by brown long-eared bats, emergence surveys of the two barns were conducted as per the Bat Conservation Trust (2016) guidance. Two to three experienced surveyors using thermal / infra-red equipment observed the buildings from c. 15 minutes prior to sunset and for up to 1.5 hrs after sunset (Figure 2 shows surveyor locations). The surveyors used Echo Meter Touch 2 detectors attached to Samsung tablets, Pulsar Helion 2 XP50 Pro thermal cameras and Nightfox Corsac infra-red camera.
