ECOLOGICAL SURVEYS LTD

SUPPLEMENTARY DOCUMENT Update for: - Edelweiss	
Grid Reference:	SU 33003 43450
Address:	Edelweiss Abbotts Ann Andover Hampshire SP11 7BH
Client:	Mr & Mrs Marzano
Architect/Planning Consultant:	Bourne Valley Associates
Date of Surveys:	Initial Investigation: - 16/02/2021 DUSK Emergence 1: - 05/05/2021 DUSK Emergence 2: - 19/05/2021 DUSK Emergence 3: - 02/06/2021
Date of Report:	19/09/2023
Update Reference:	Addendum_Edelweiss_Marzano_September 2023
Associated Reports Reference:	PRNA_Edelweiss_Marzano_February_2021 BESR_EPSL_Edelweiss_Marzano_June_2021
Surveyor(s):	T. Woo-Glover NE Bat Class Licence 2 L. Honey, T. Honey, S. Woo-Glover
Author:	S. Woo-Glover BSc (Hons), MSc
Verified by:	Paul Diamond Cert (Hort), BSc (Hons), MSc, MCIEEM, MArborA; Associate Member of the Landscape Institute; Bat Class License Holder 1 and 2
Revision no:	01
Issue date:	September 2023
Ecological Surveys Ltd Registered Address: Tel:	14, Lower Clicker Road, Menheniot, Liskeard. Cornwall. PL14 3PJ (01503) 240846 / 07736 458609

1. INTRODUCTION

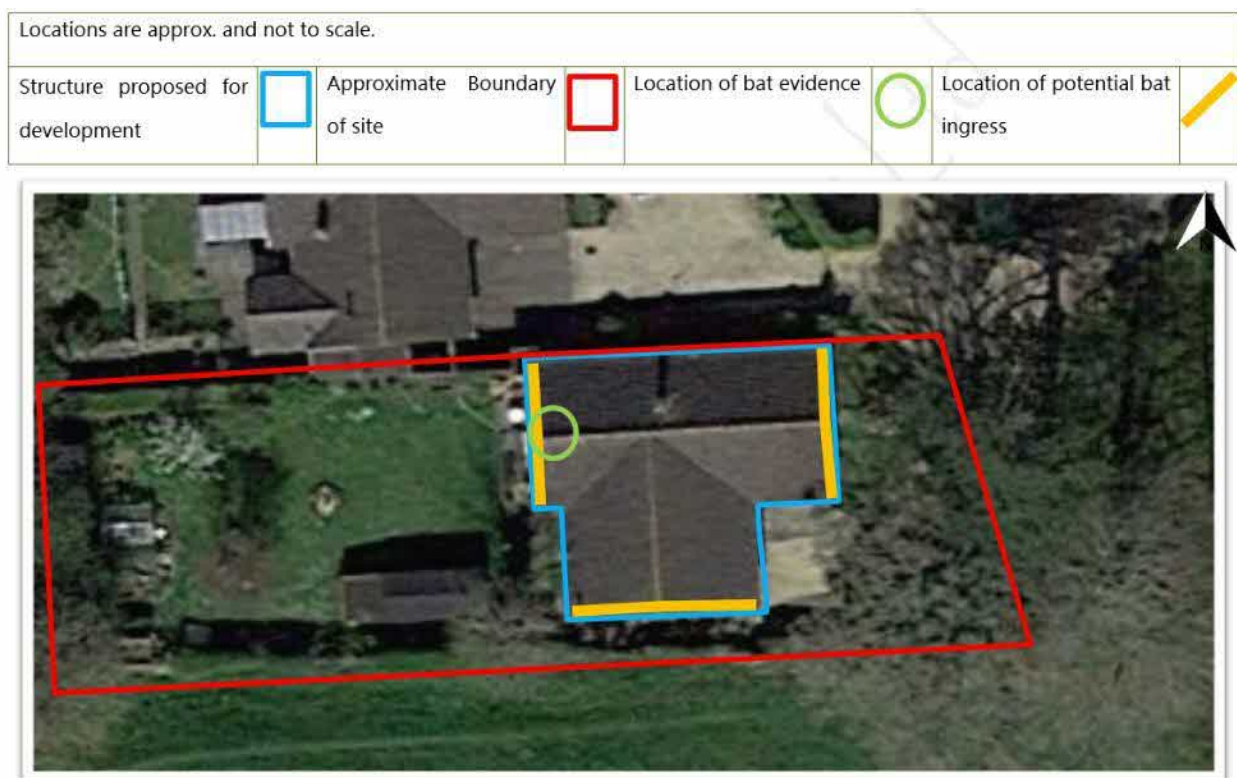
Emergence Points

Three Emergence Surveys were therefore undertaken in accordance with Bat Conservation Trust (BCT) guidelines (Collins, 2016) to glean sufficient evidence. A common pipistrelle emerged from the gap behind soffit during one of the three occasions and therefore the roost is assessed to be an Occasional Day Roost.

This Figure indicates the Emergence Points.

A ○

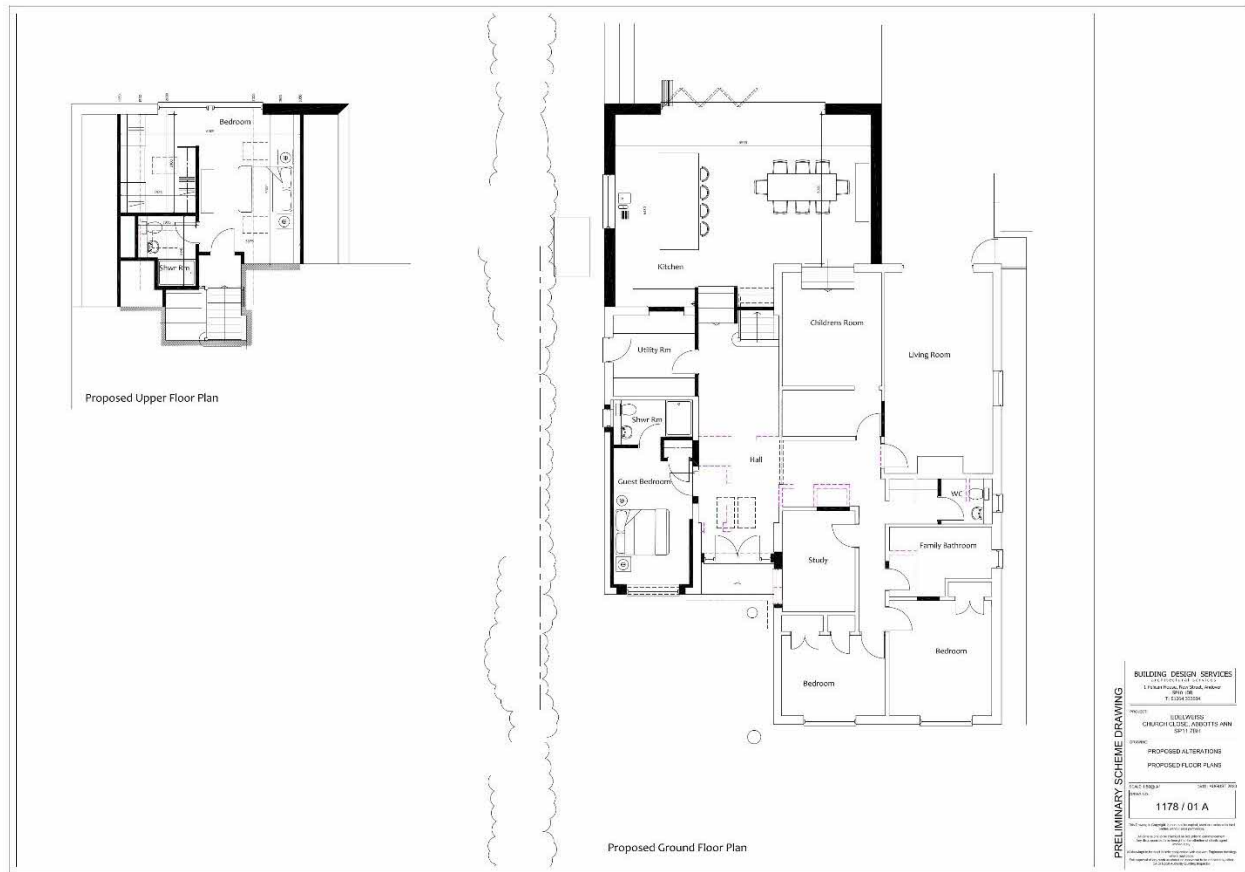
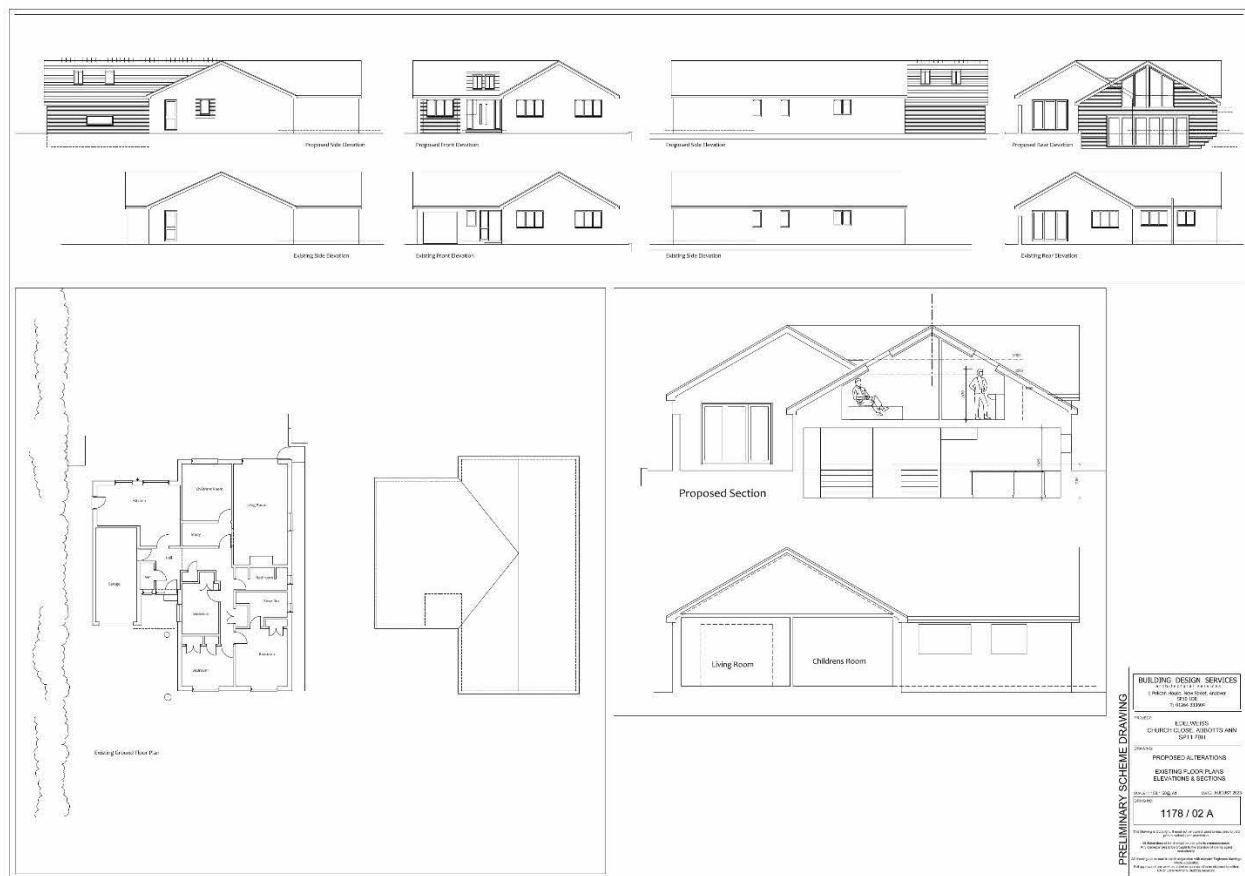
The client has now revised the proposal which will avoid impacting the Bat access point and Bat roost. The new proposal only seeks to construct an extension to the property, and will not impact on the soffit with recorded bat emergence or the wall top bat roosting habitat. An EPSL is therefore no longer considered a requirement, provided works are carried out carefully,

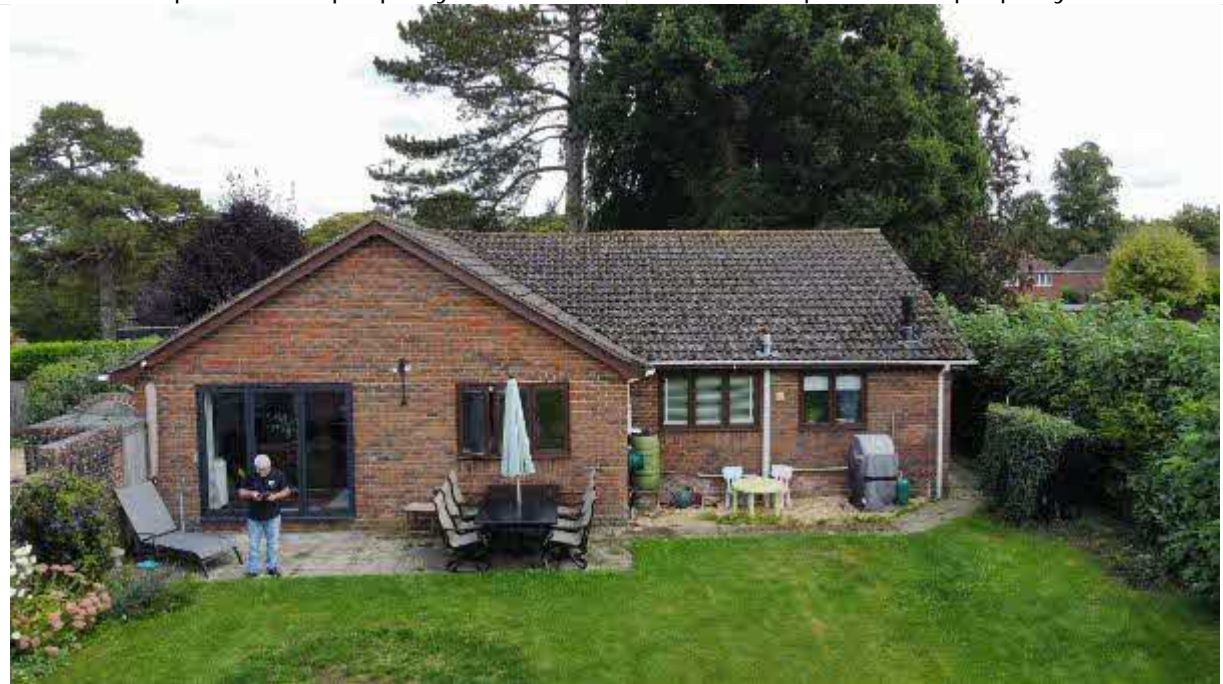
Western aspect of the property (Aspect with bat emergence)

The identified bat roost and access point will not be directly impacted by proposed works. Nonetheless, care should be taken at all stages of the project to ensure no criminal offence is committed with regards to bats. Although the identified bat roost is considered to be present predominantly on the wall top, a thorough investigation of the loft is required prior to any works either to ceilings, within the loft void, or where the extension connects into the loft.

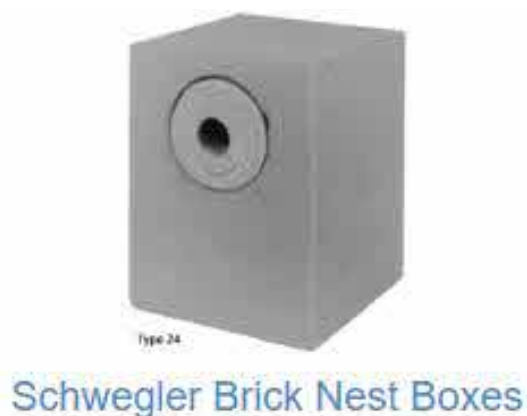
Bird box image below from <https://www.nhbs.com>

- 1 built-in bird brick is required to be built in on the northern or eastern aspect on the extension.
- Nesting boxes must be of durable and ideally permanent construction.
- Site nest boxes in locations that are accessible for maintenance, away from bird feeders, a discrete distance away from other nest boxes and so that they provide some protection from predators (no less than 3m high) and vandalism. Replace box over time where damaged/decaying.
