GROUND INVESTIGATION REPORT

**FOR
BROWNSIDE MILL,
BRUN TERRACE,
BURNLEY,
LANCASHIRE**

**PREPARED FOR
M. SMITHSON PROPERTIES
LTD**

**REPORT NO. 7416B
JUNE 2022**

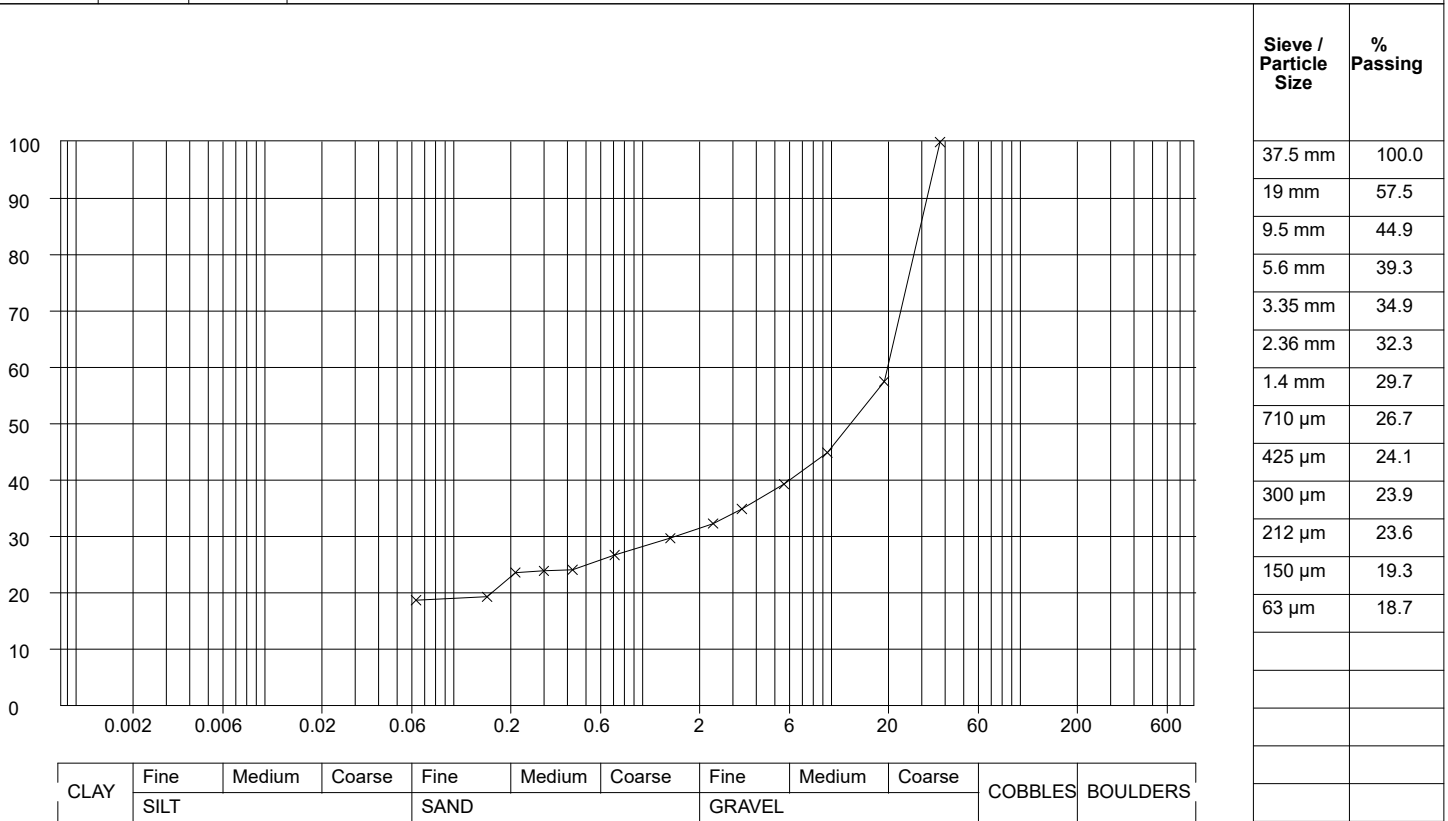
DETERMINATION OF PARTICLE SIZE DISTRIBUTION

Borehole / Trial Pit	Depth (m)	Sample	Laboratory Description
BH2	10.50 - 10.95	B	Dark brown silty sandy subangular to subrounded fine to coarse sandstone, siltstone and coal GRAVEL.

Grading Analysis	
D85	31.0 mm
D60	20.1 mm
D10	<63.0 µm
Uniformity Coefficient	-

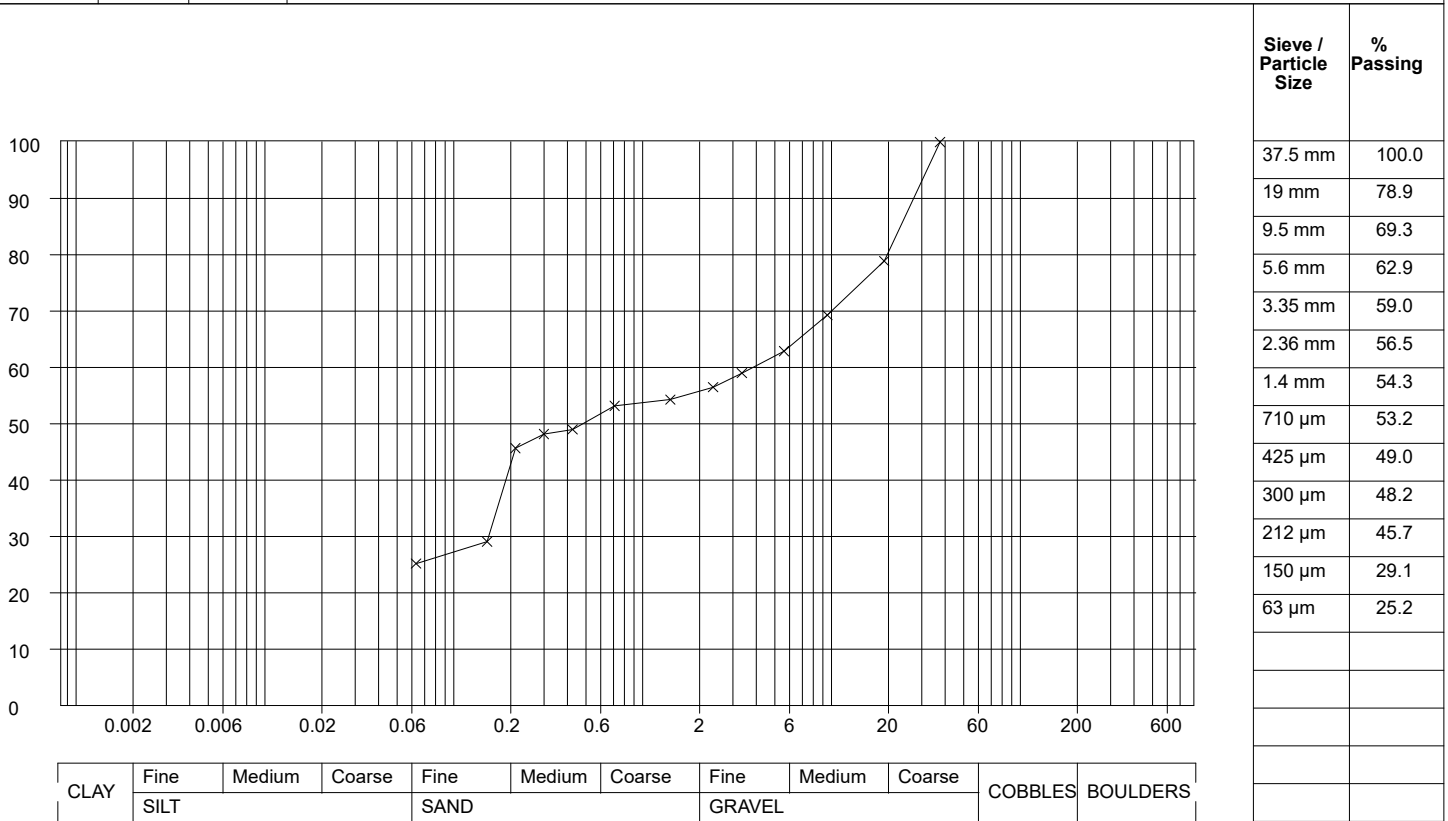
DETERMINATION OF PARTICLE SIZE DISTRIBUTION

Borehole / Trial Pit	Depth (m)	Sample	Laboratory Description
BH3	2.00 - 2.45	B	Probable MADE GROUND: dark greyish brown very clayey very sandy fine to coarse gravel sized fragments of stone.

Grading Analysis	
D85	24.3 mm
D60	3.9 mm
D10	<63.0 µm
Uniformity Coefficient	-

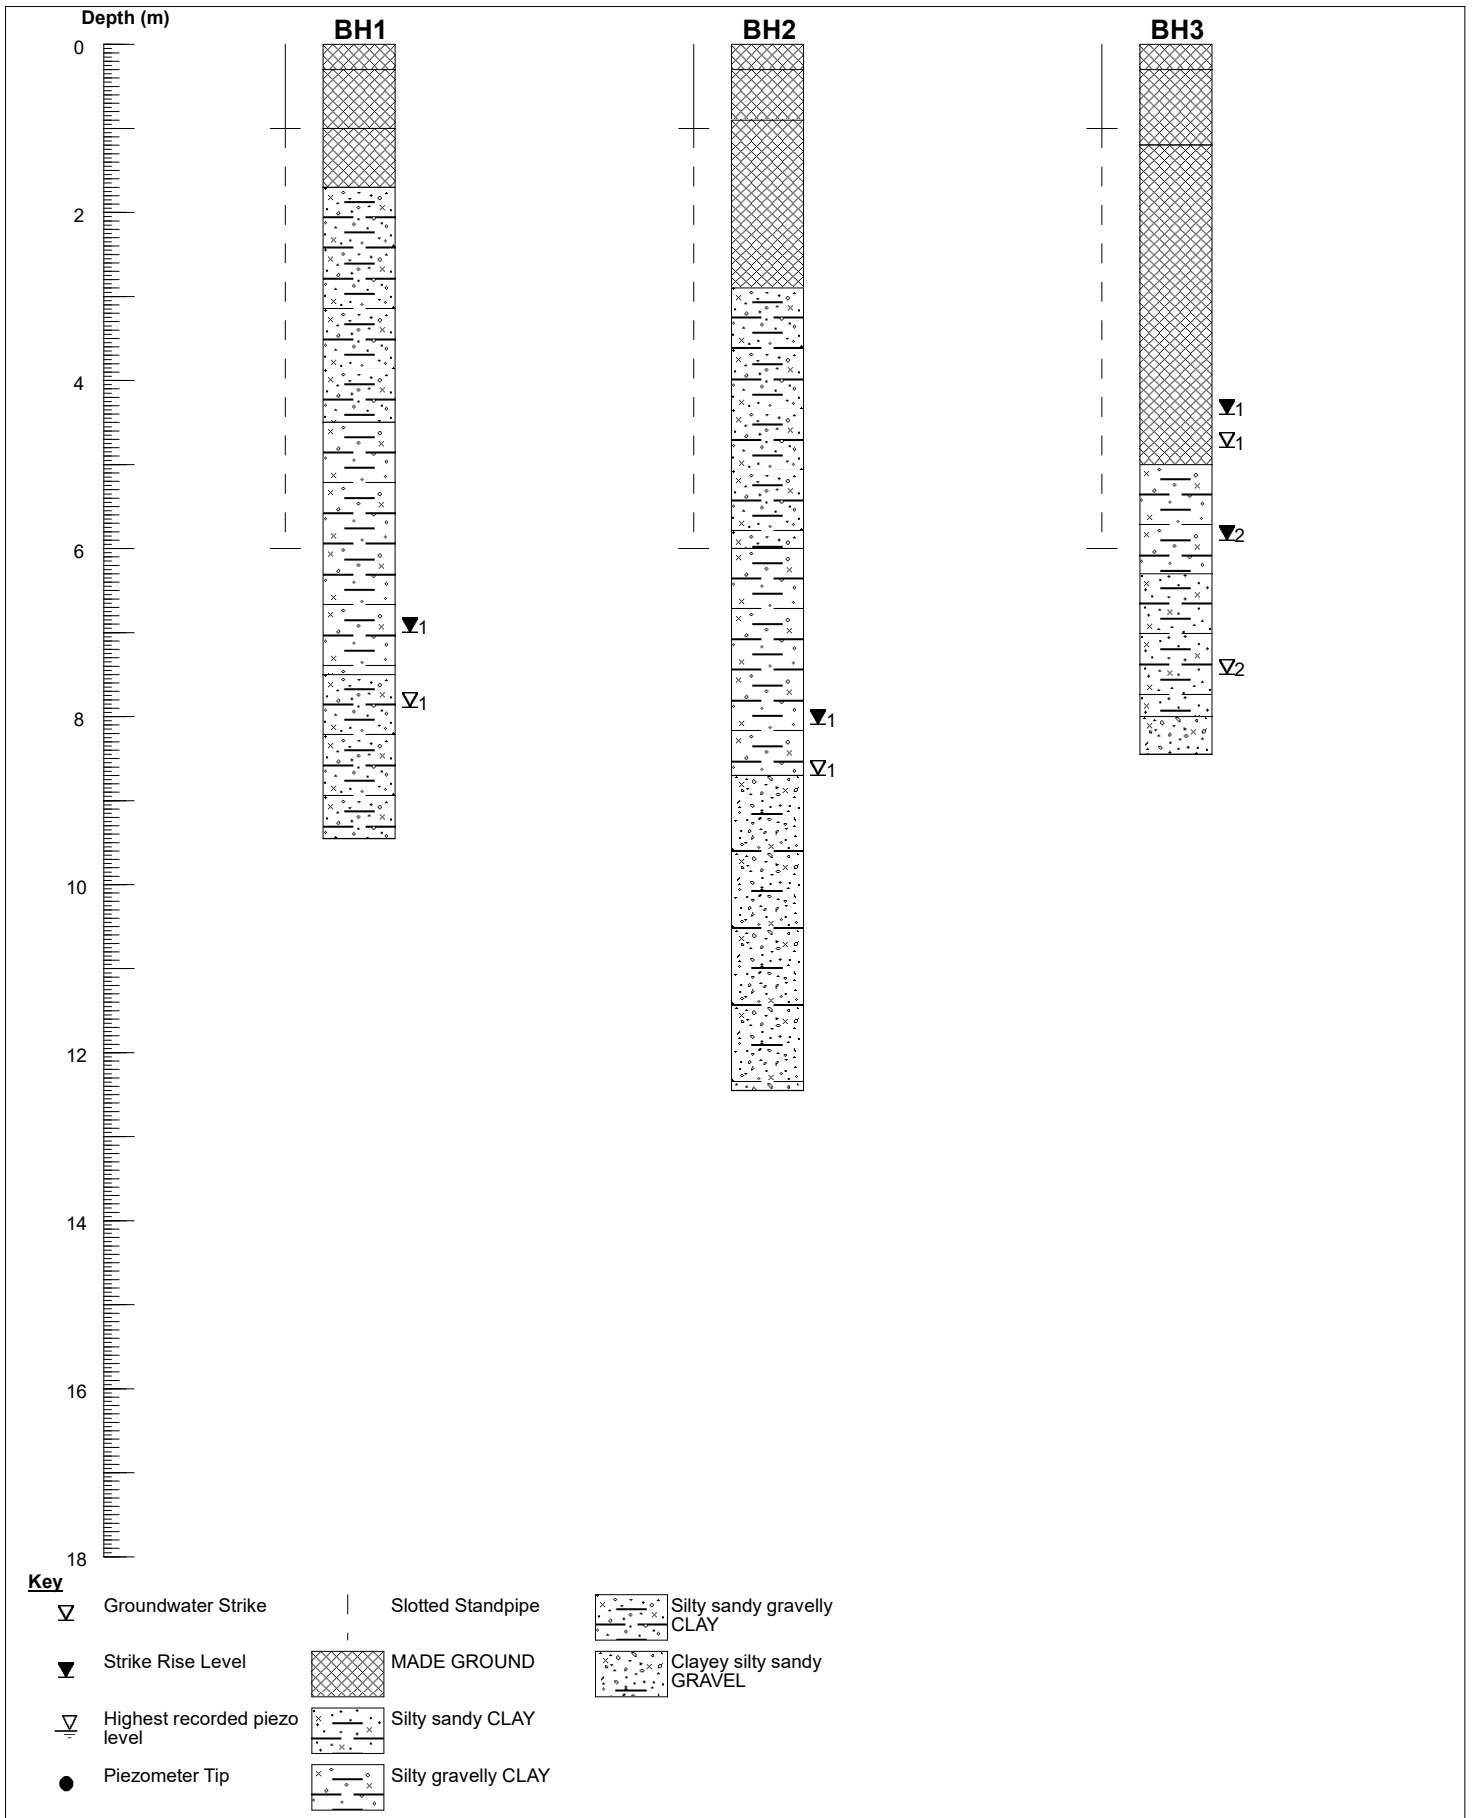
7.50-7.95	SPT N=48			10,11/11,12,12,13		(0.45)				
8.00-8.45	SPT N=49			9,10/11,12,13,13		8.45	Complete at 8.45m			
8.00-8.45	D									
				25/02/2022:6.20m

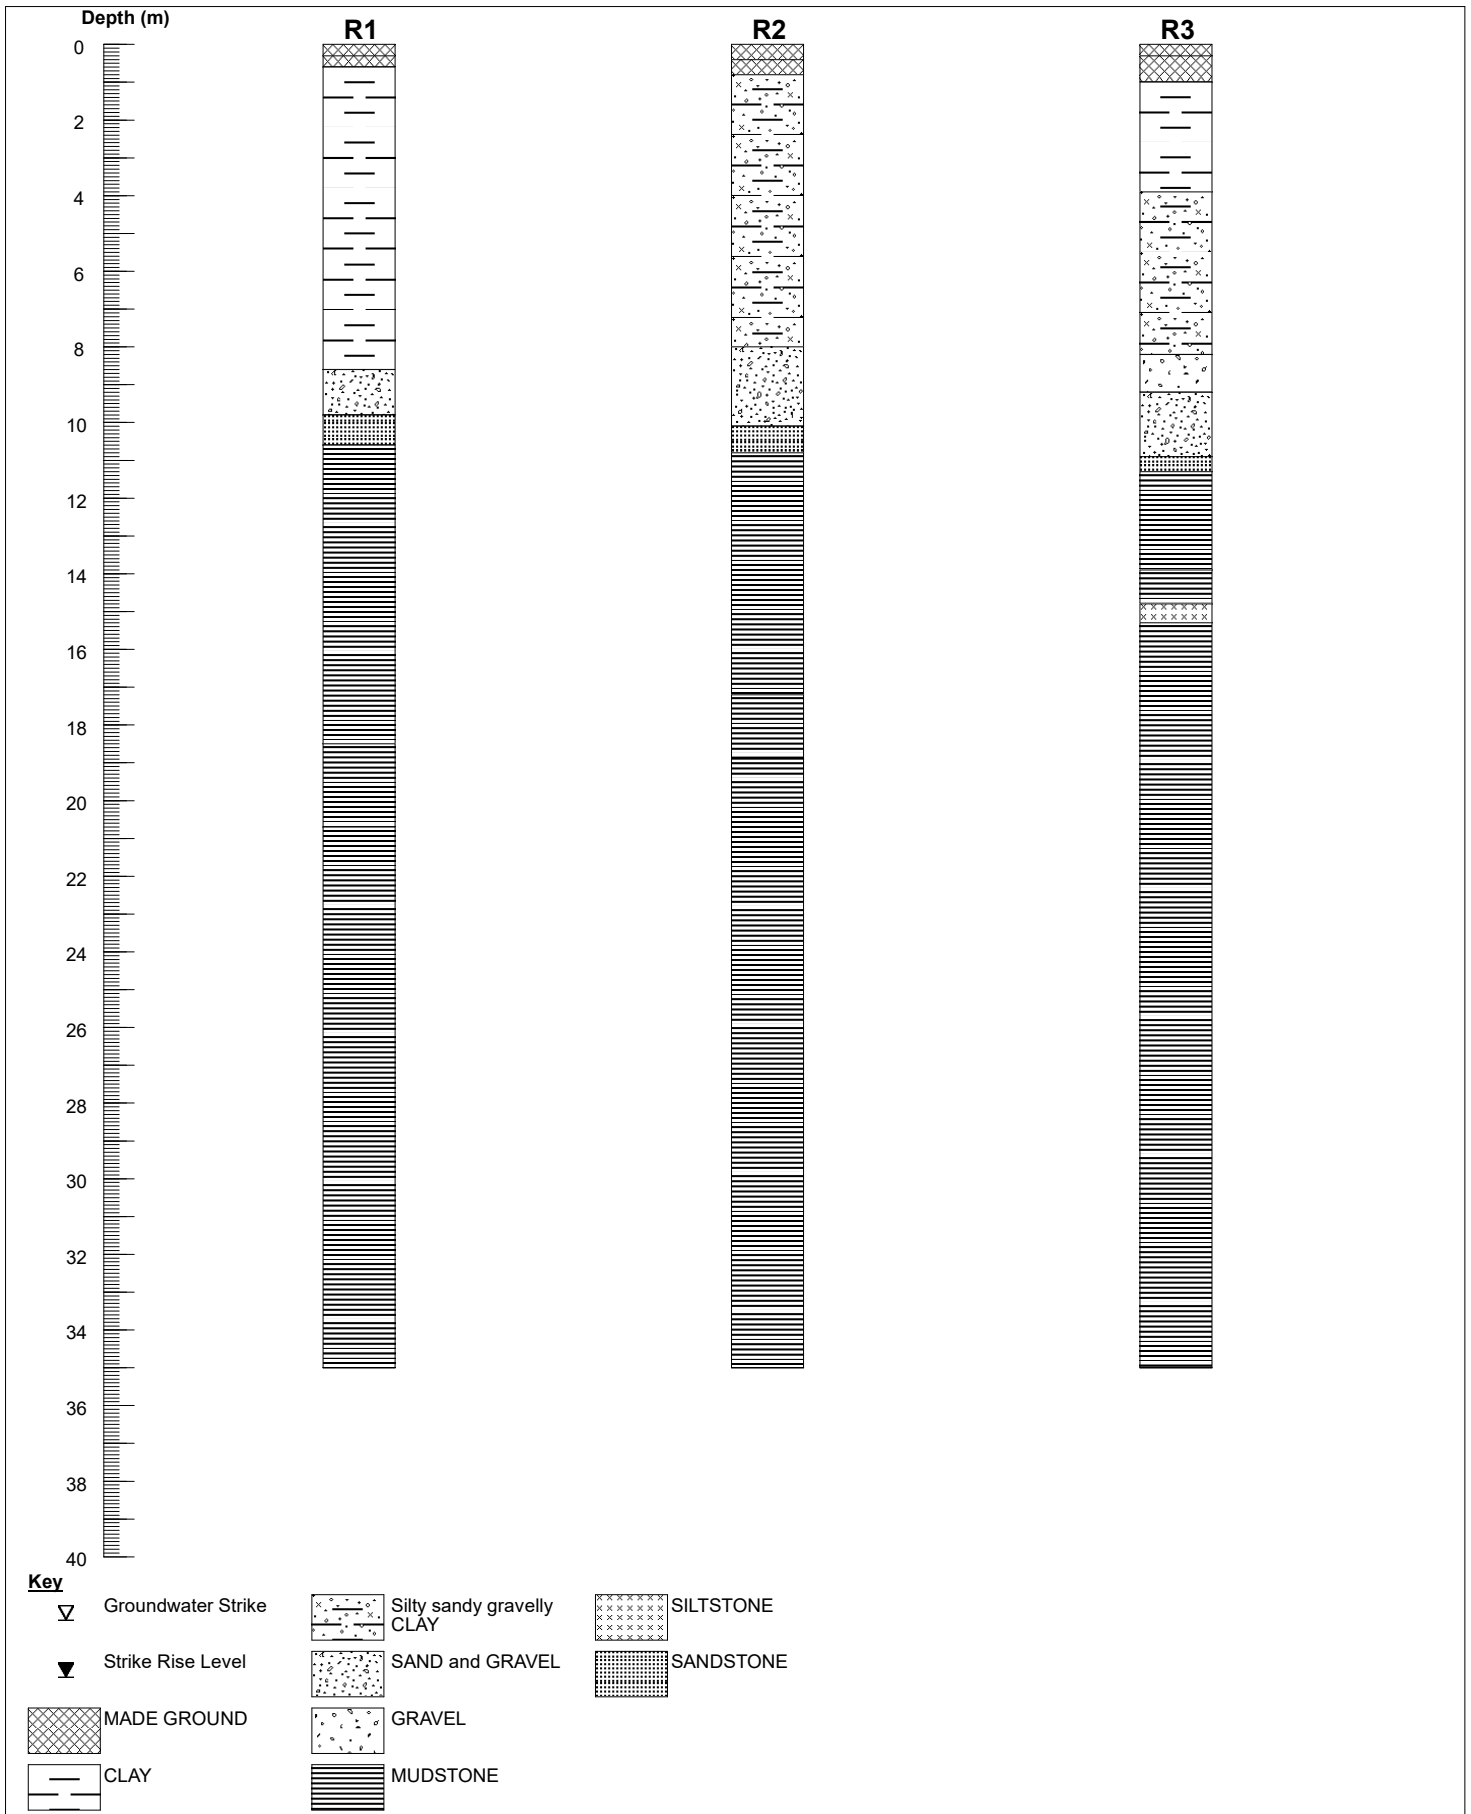
Remarks	Scale (approx) 1:50	Logged By VW
	Figure No. 7416C.R3

Depth (m)	TCR (%)	SCR (%)	RQD (%)	FI	Field Records	Level (mOD)	Depth (m) (Thickness)	Description	Legend	Water
								Strong grey MUDSTONE with occasional sandstone bands.		
					30/05/2022: DRY		35.00	Complete at 35.00m

The boreholes encountered no coal seams, and no voids, broken ground, loss of flush or groundwater inflows that might be indicative of mineworkings.

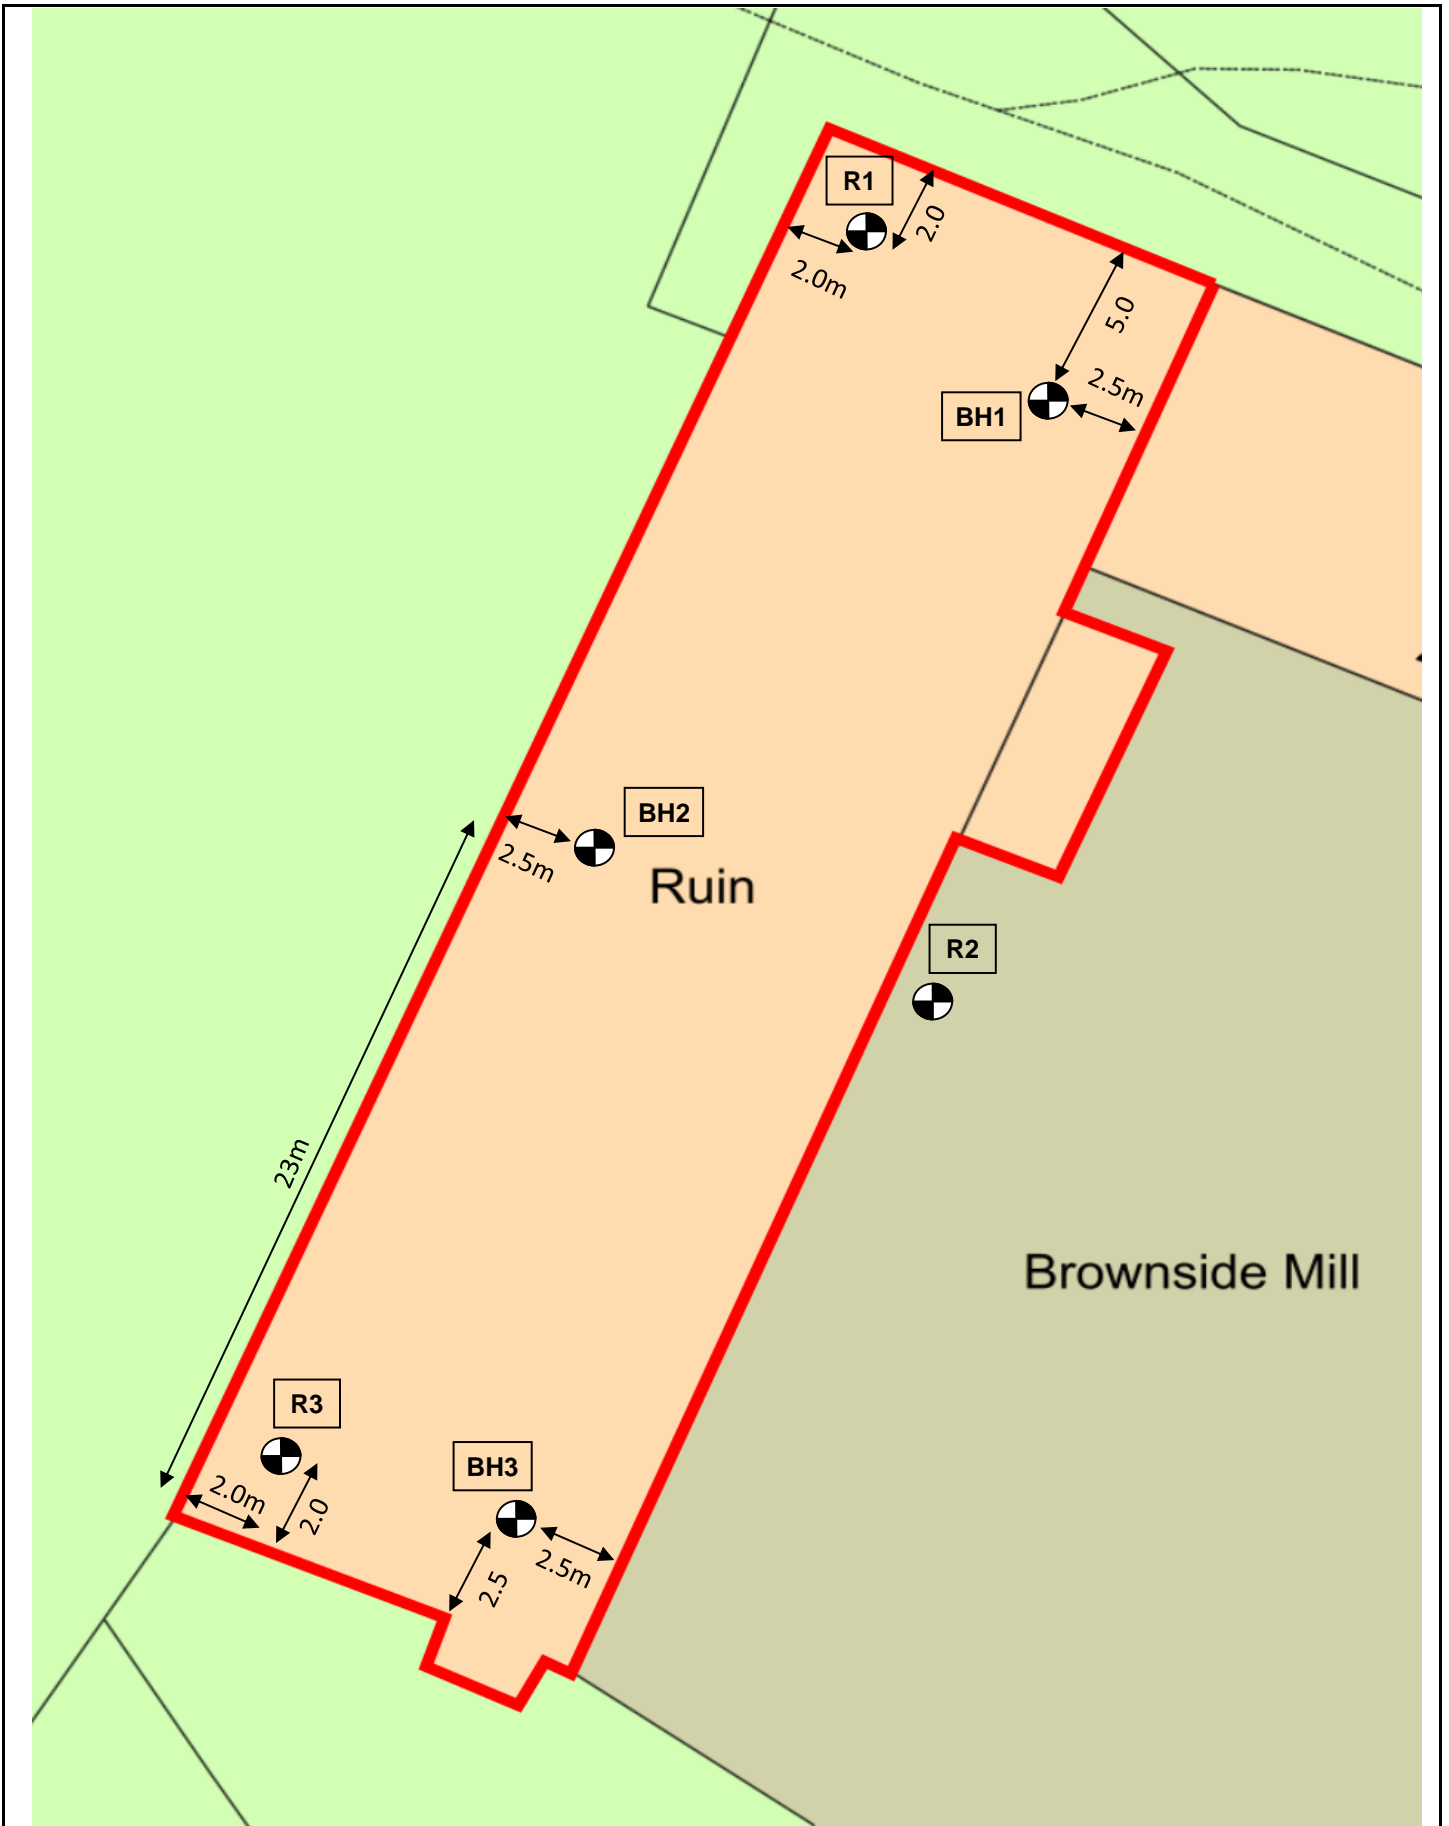
SUB SURFACE SITE INVESTIGATION AND SPECIALIST GEOTECHNICAL CONSULTANTS 3 Peel Street, Preston, PR2 2QS. Tel. (01772) 561135 Fax (01772) 204907	Borehole Location Plan			
	Date Drawn 16-Jun-22	Date Checked	Orientation

Details of the findings of the investigation are given on the appended Borehole Records and a summary of the ground conditions is given in Section 2.2.
