THE ARCHAEOLOGY CO.

Brownside Shed Mill
Level 1 Historic Building Survey

March 2022

A level 1 historic building survey was required prior to the demolition of the Brownside Shed Mill, Worsthorne-with-Hurstwood. Brownside Mill was erected in the mid 19th century as a cotton mill, with the subject building built in the late 19th / early 20th century.

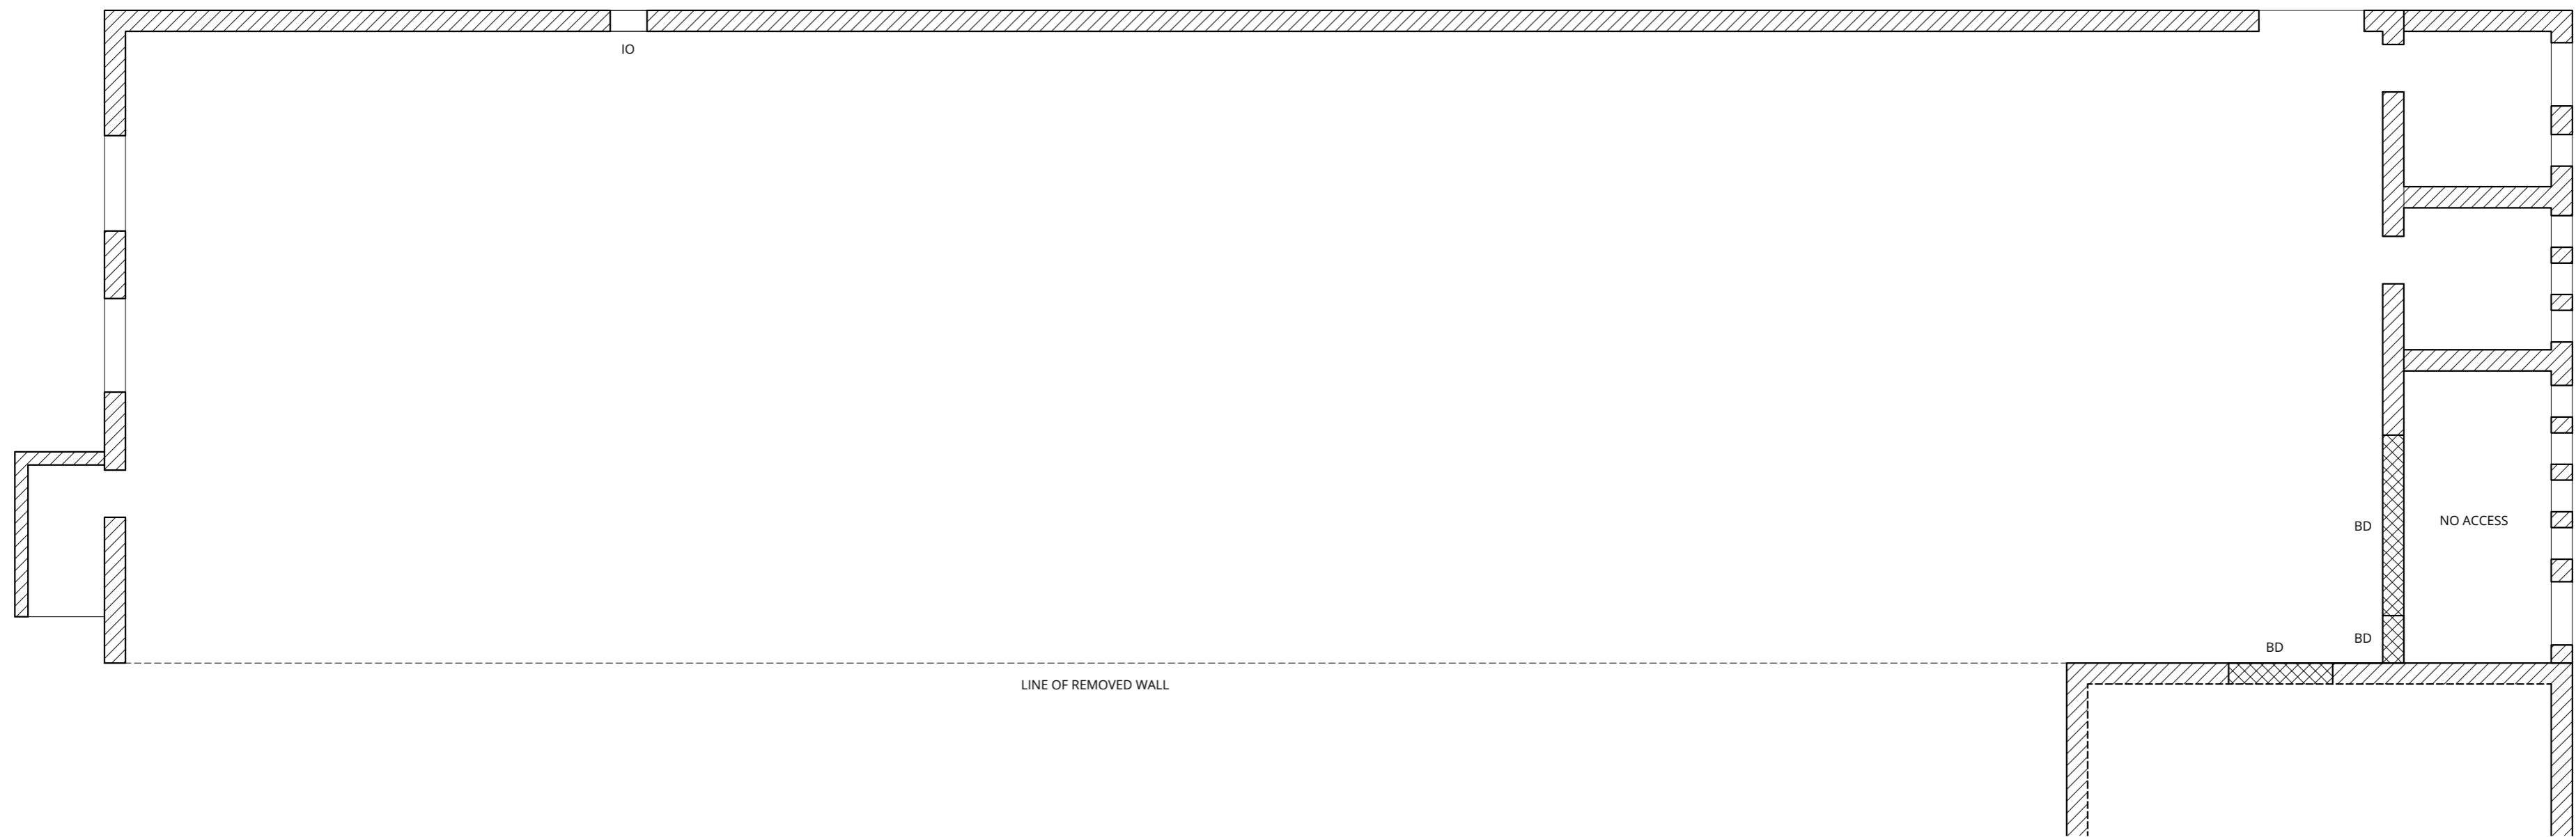
Figure 6: Ground floor plan

BD - Blocked Doorway
 IO - Inserted Opening

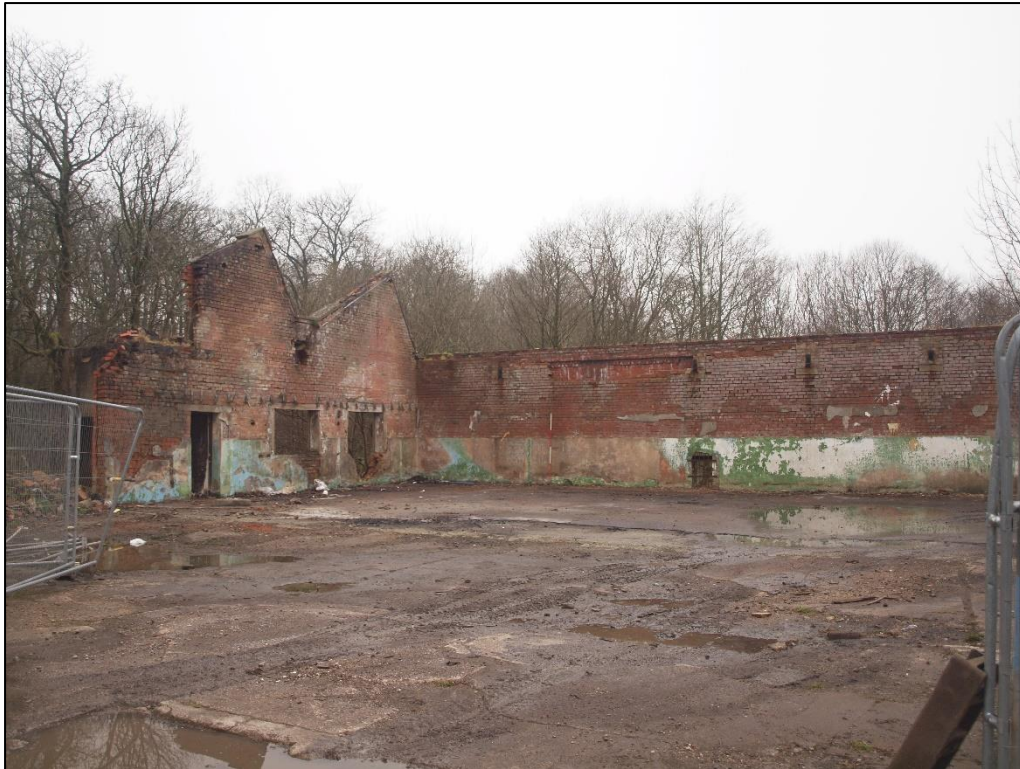
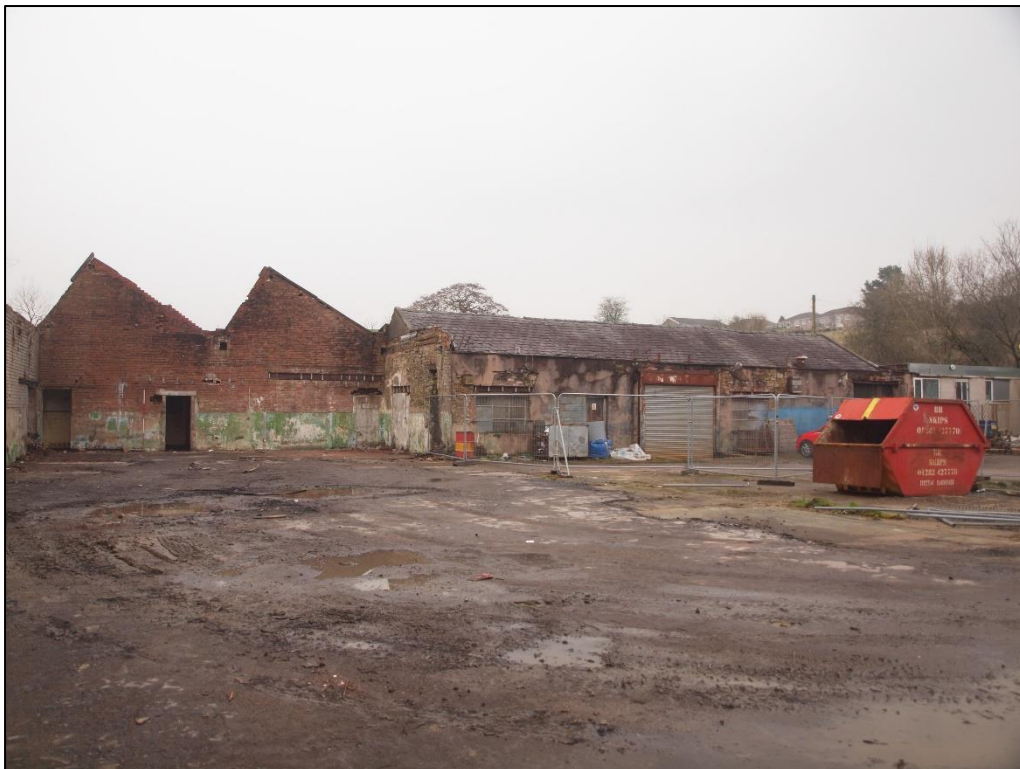
6.1 (Plates 1 - 4). The building comprises the former western end of the mill complex. It is a single story high and brick built in English Garden Wall bond (5:1). The eastern wall of the building had collapsed along with the room, leaving only the three remaining walls. Internally the floor is of concrete, although a patch of brick lies to the northern side.

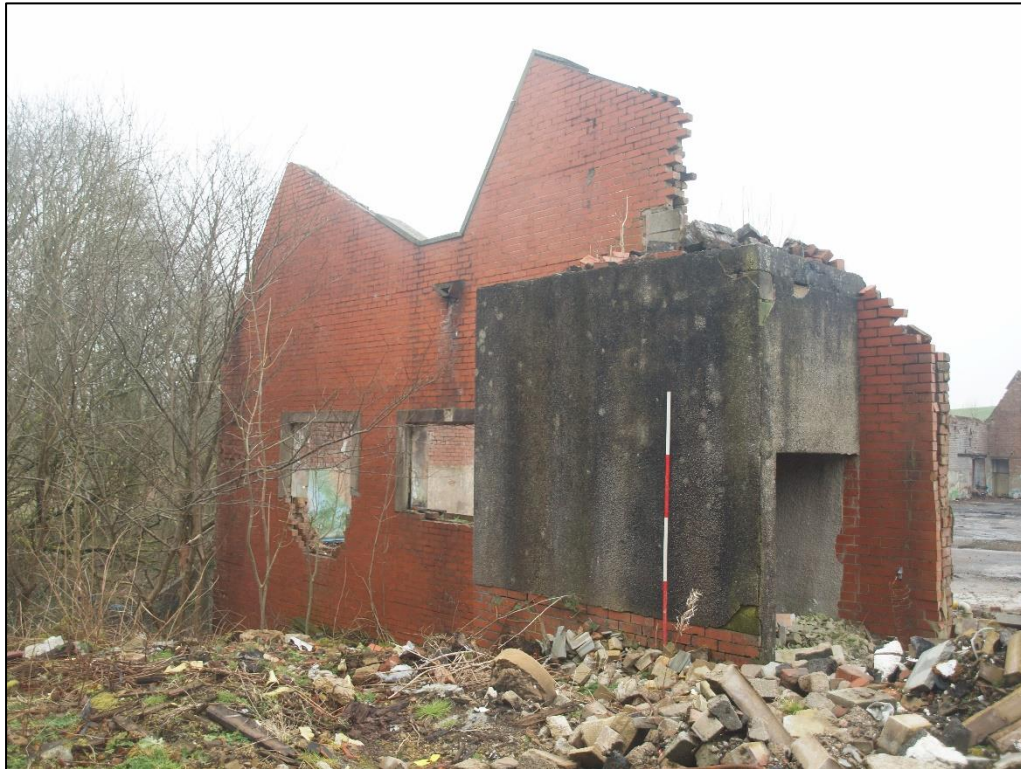
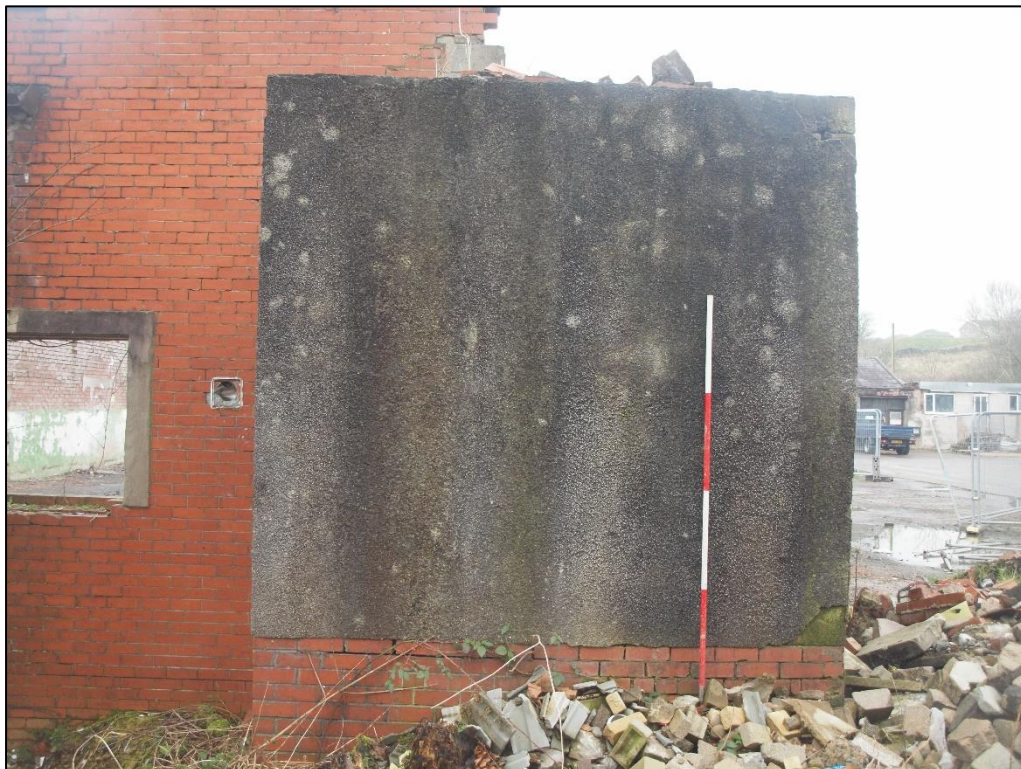
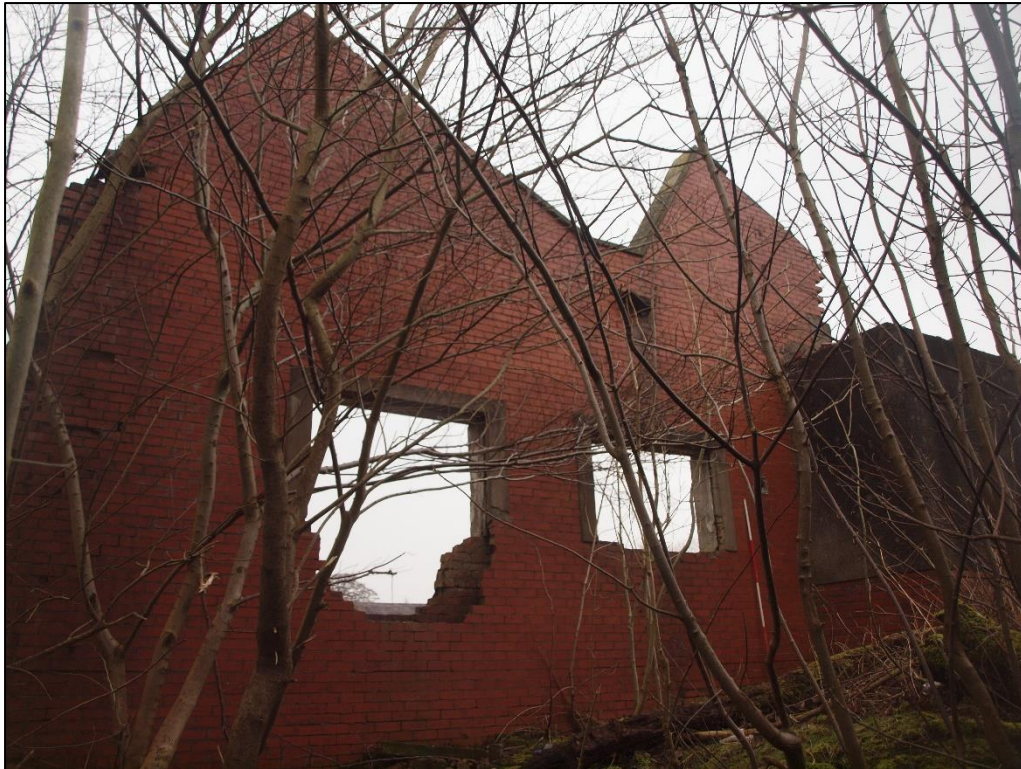
6.2 South elevation (plates 5 – 7). This elevation consists of a pair of saw tooth gables, although the eastern has partially collapsed. Sandstone coping is still present in places. To the East end a large landscape window is present, with cill and wall below having been partially demolished. A matching window lies to the east of this in the centre of the face. Both have a rendered surround over the brickwork. To the east side a small brick built extension has been constructed. This has been rendered over much of the face.

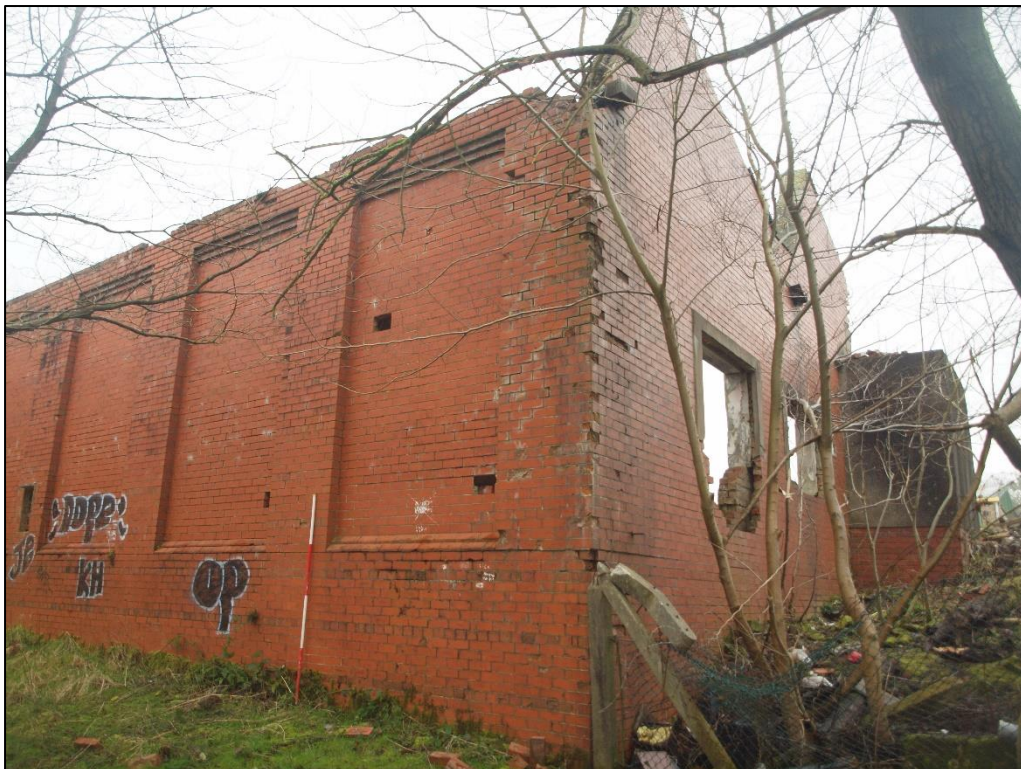
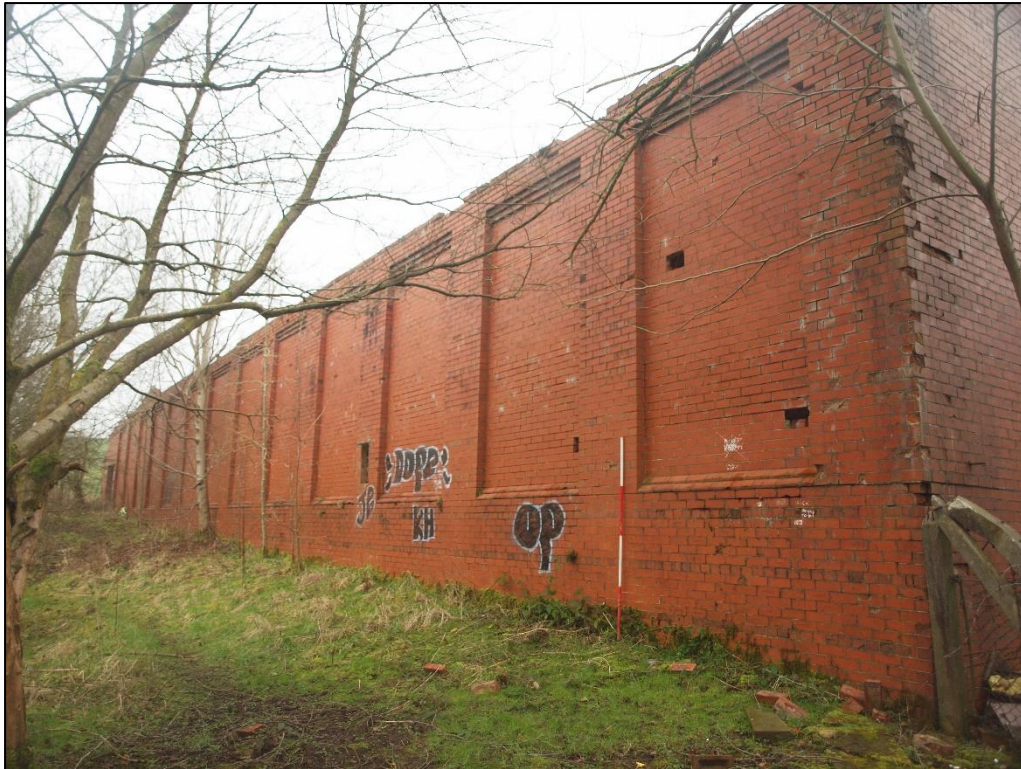
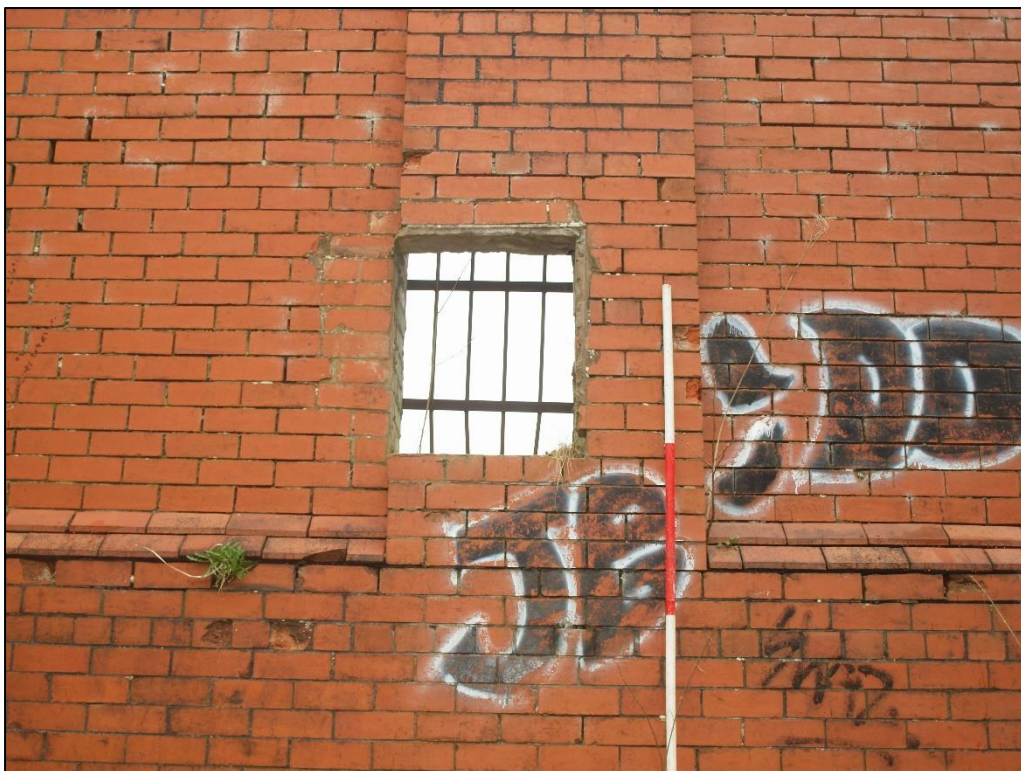
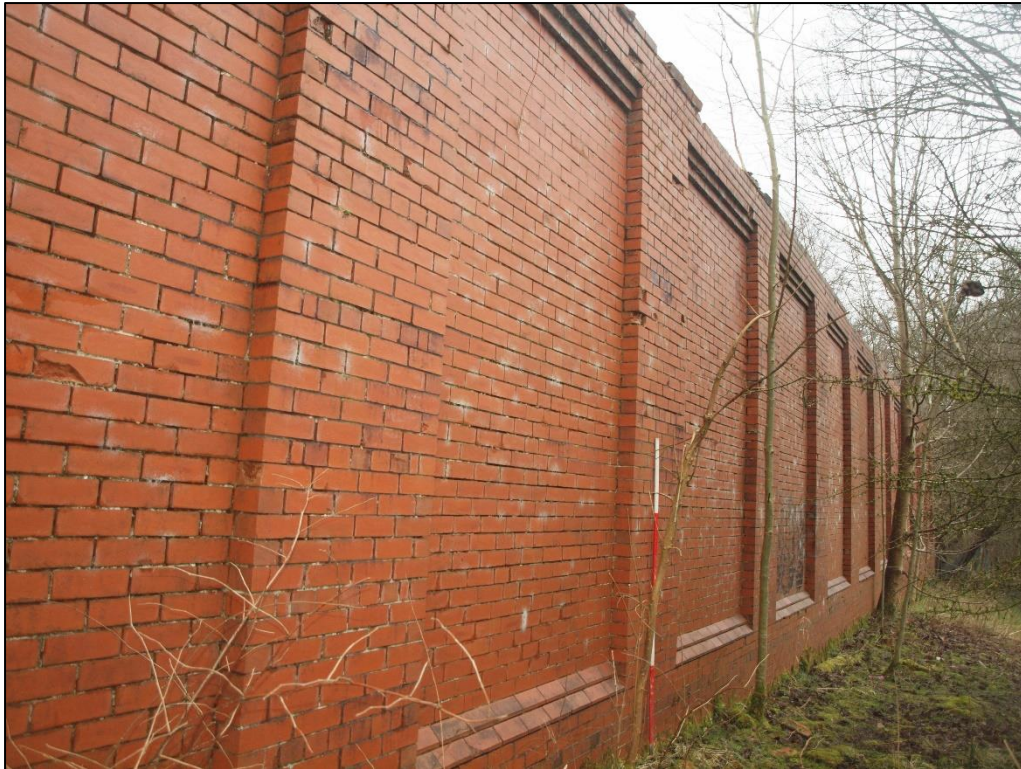
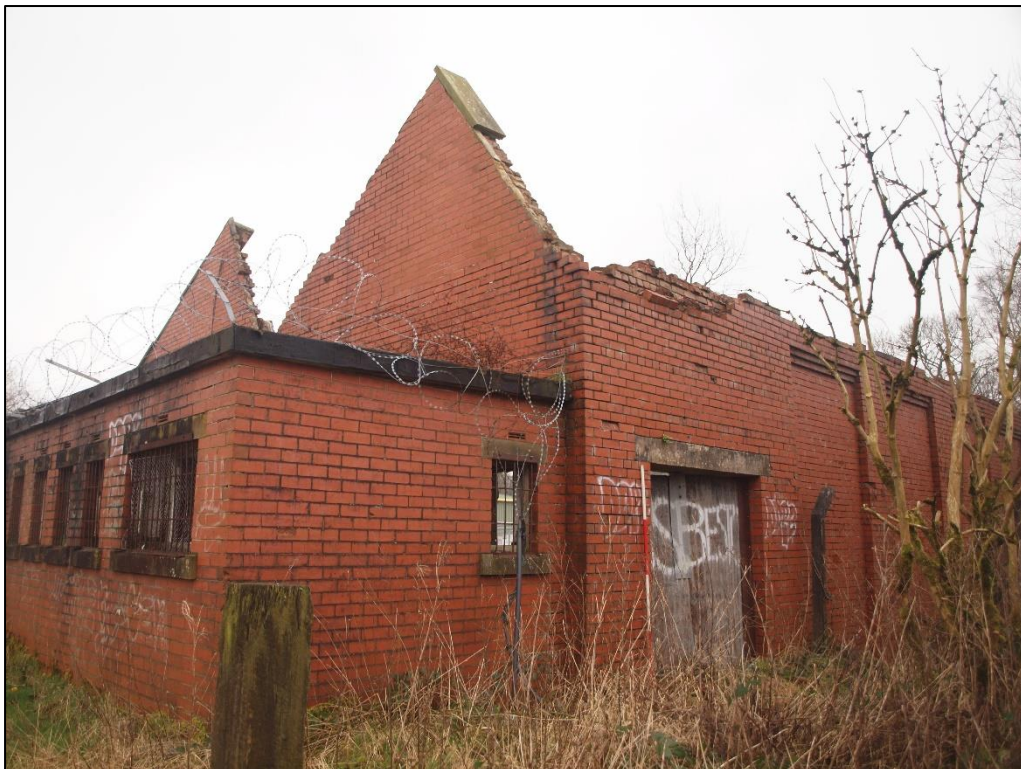
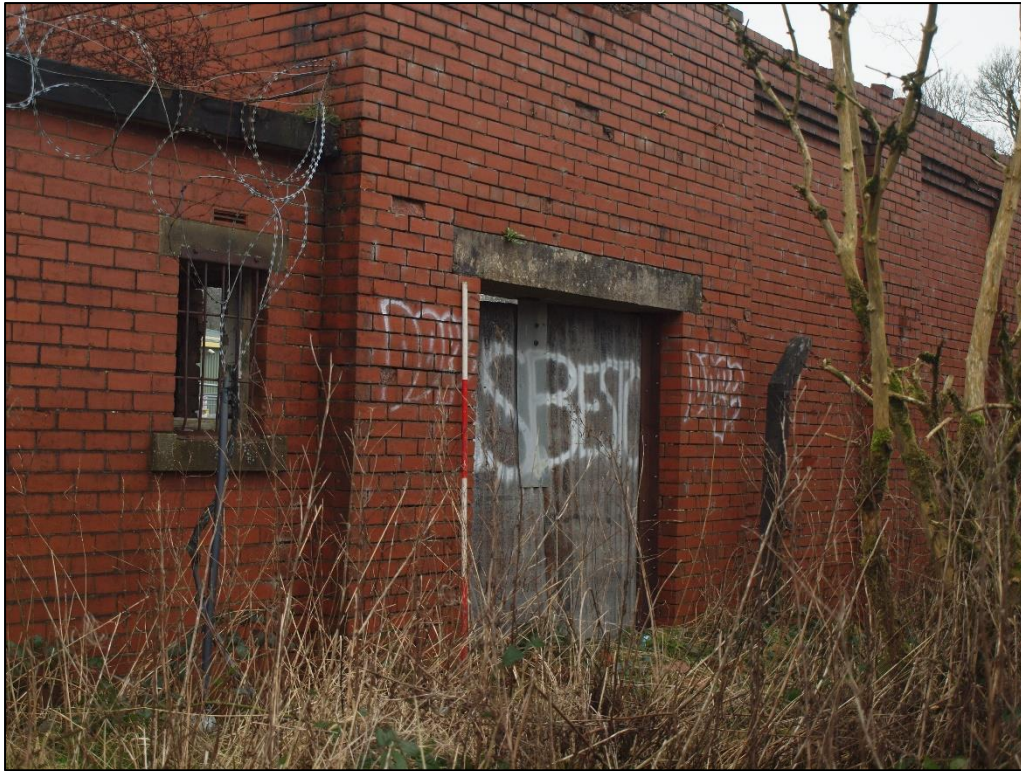
6.3 West elevation (plates 8 – 13). This forms the long external elevation. for the most part it is featureless, with 13 recessed brick panels lining the face. At the southern end, between panels 10 and 11 a small opening has been inserted, fitted with a metal grate internally. AT the northern end, to the north of the first recessed panel is a loading doorway with sandstone lintel. Beyond this, to the north, is a small brick built toilet extension, with small portrait window to the south side.

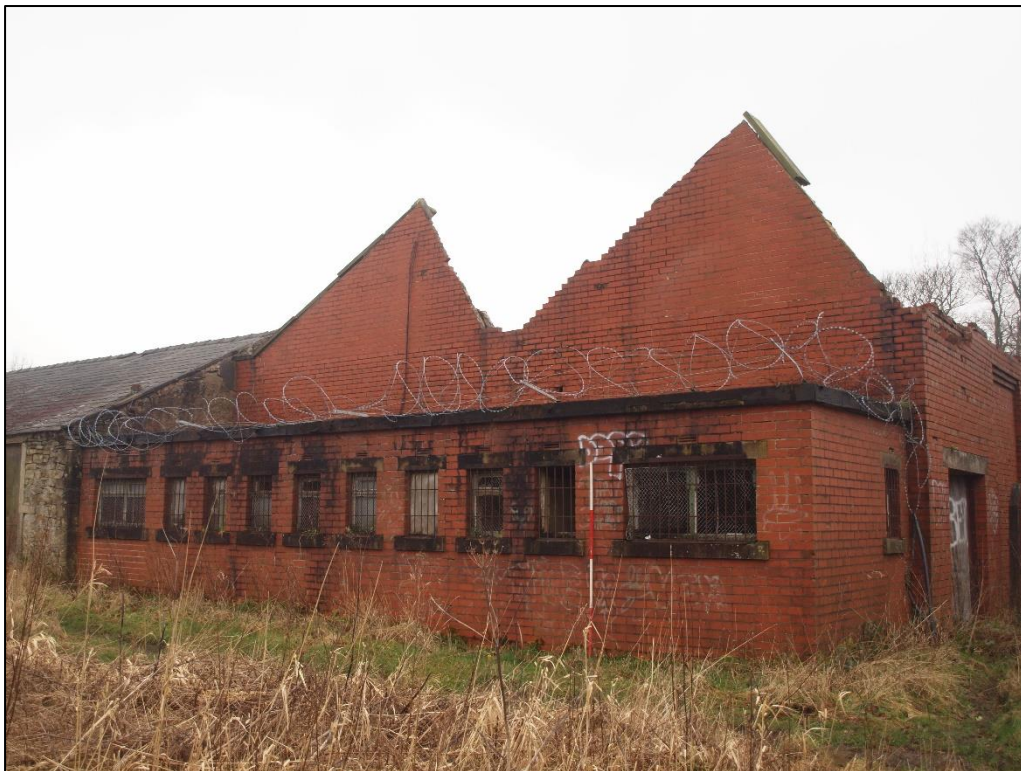
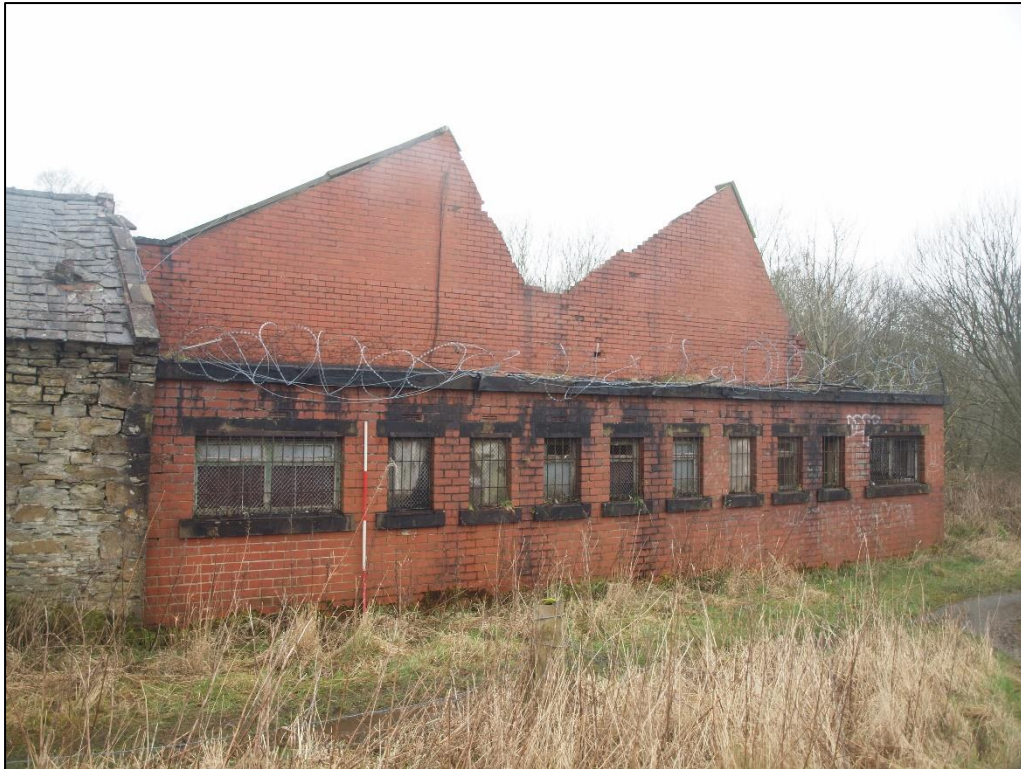
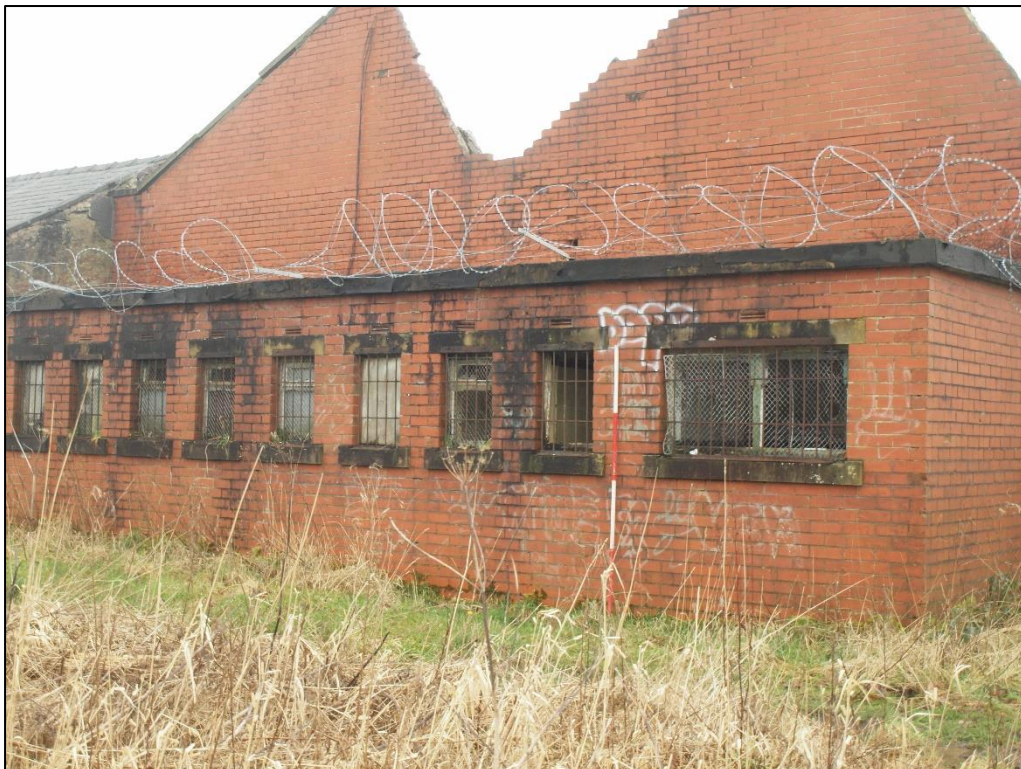
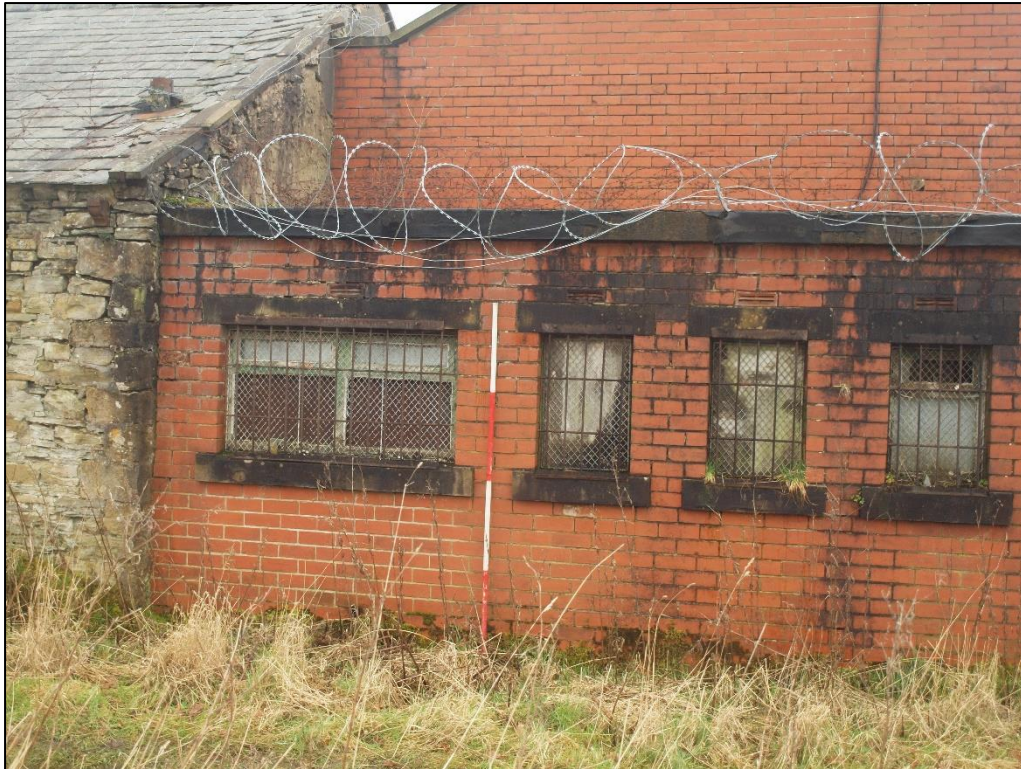
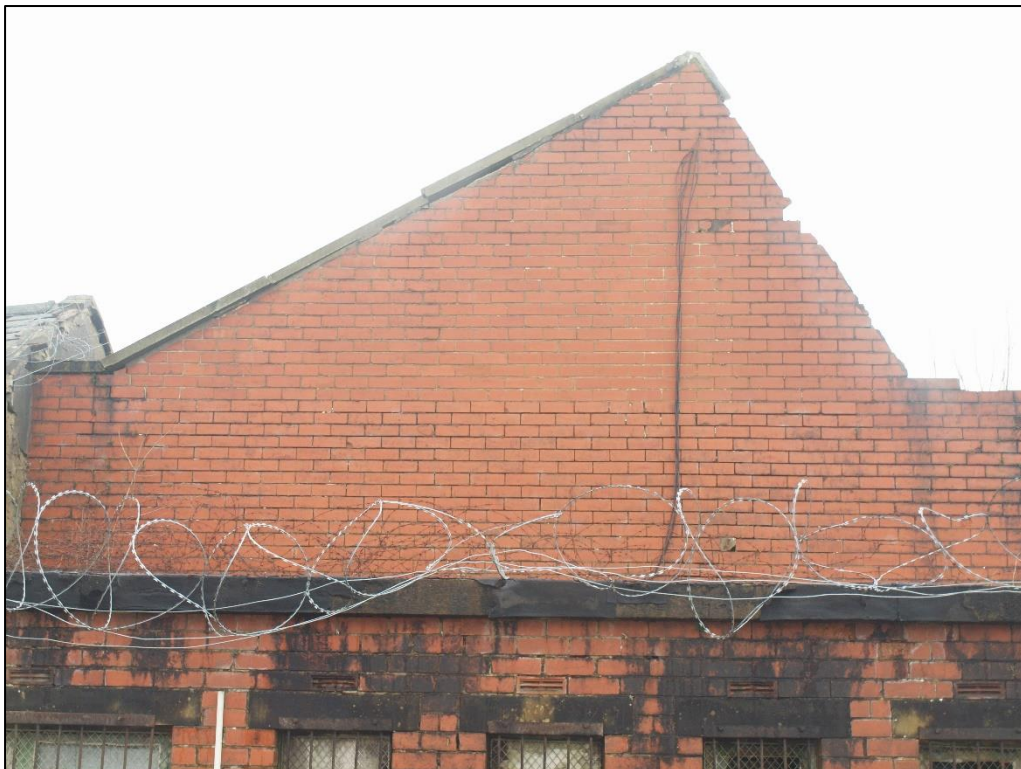
6.4 North elevation (plates 14 – 18). This forms the other saw tooth gable end. While both gables are in a better condition, the majority of the sandstone coping has been lost. The upper part is featureless and the lower part is obscured by the toilet extension. This contains 8 small portrait windows across the face with landscape windows flanking them to the east and west. All have sandstone cills and lintels.

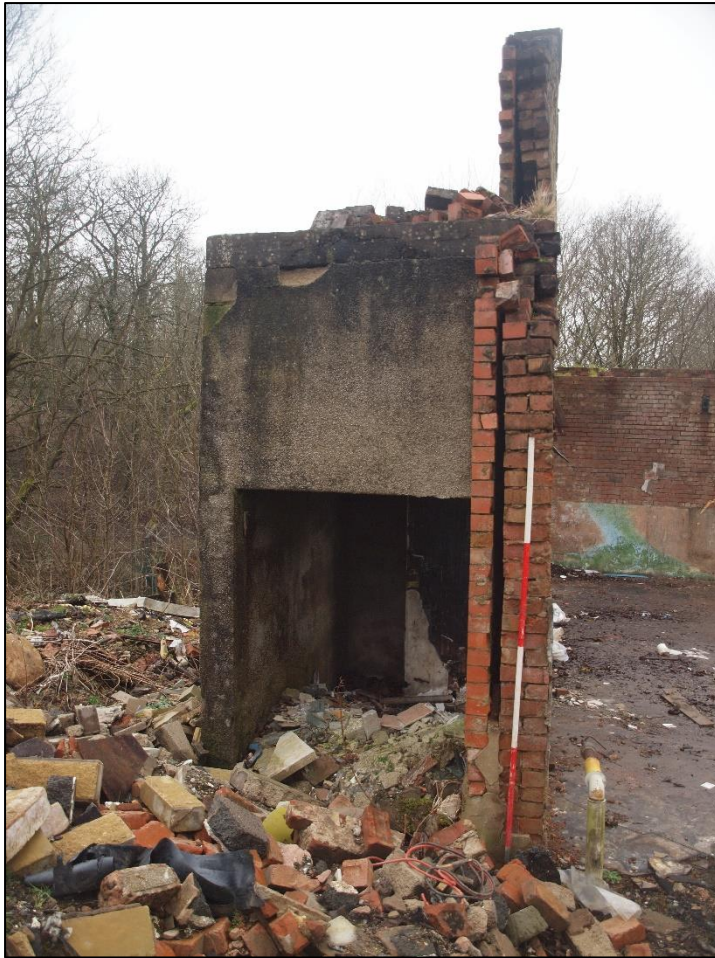
Plate 19: Remaining east elevation of southern extension

- 6.5 As noted, the east elevation is no longer present. However, the north elevation of the southern extension is still present. This is simple, with a wide, low opening in the face, the rest of which is rendered (plate 19).
