THE ARCHAEOLOGY CO.

Brownside Shed Mill
Level 1 Historic Building Survey

March 2022

A level 1 historic building survey was required prior to the demolition of the Brownside Shed Mill, Worsthorne-with-Hurstwood. Brownside Mill was erected in the mid 19th century as a cotton mill, with the subject building built in the late 19th / early 20th century.

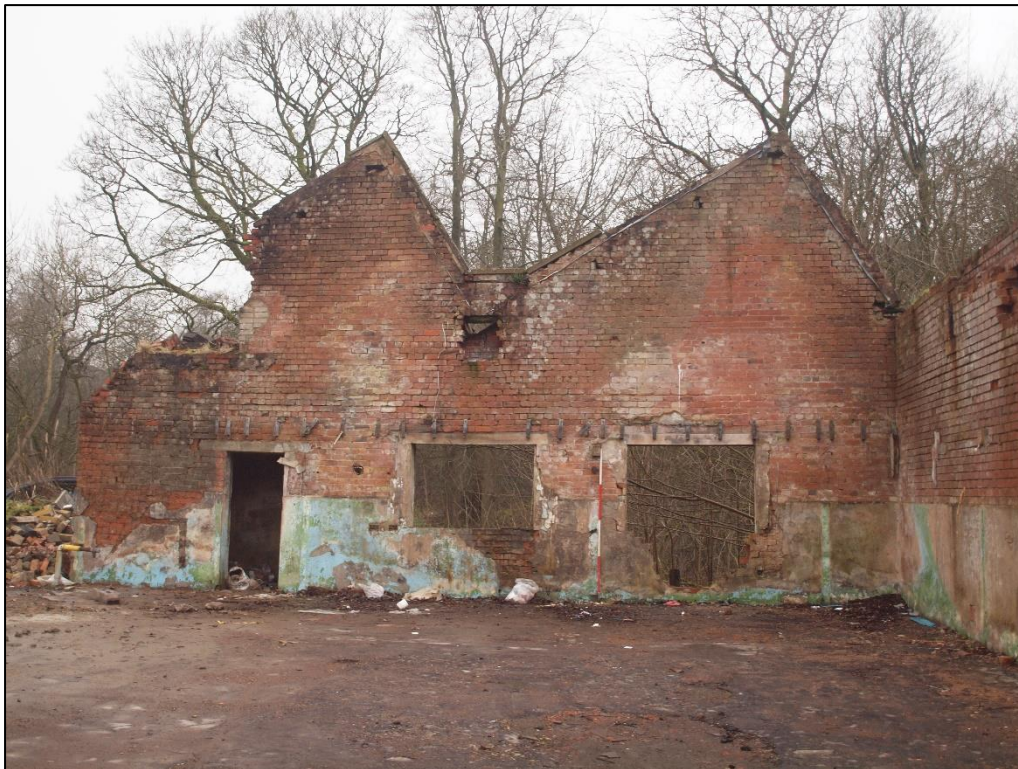
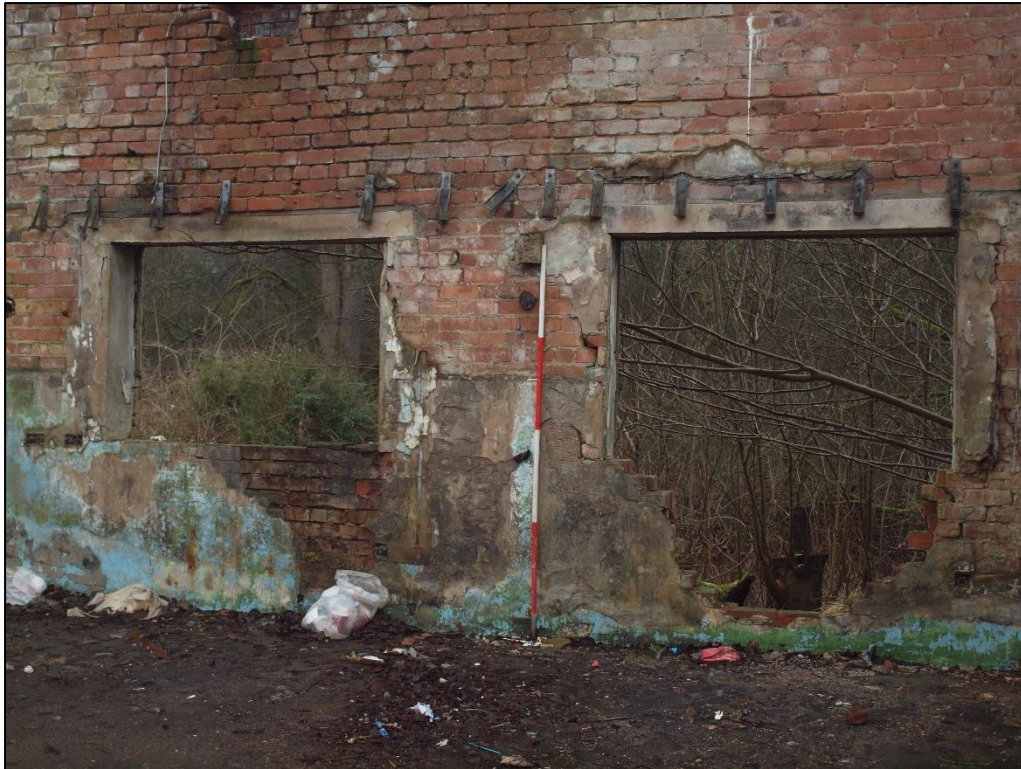
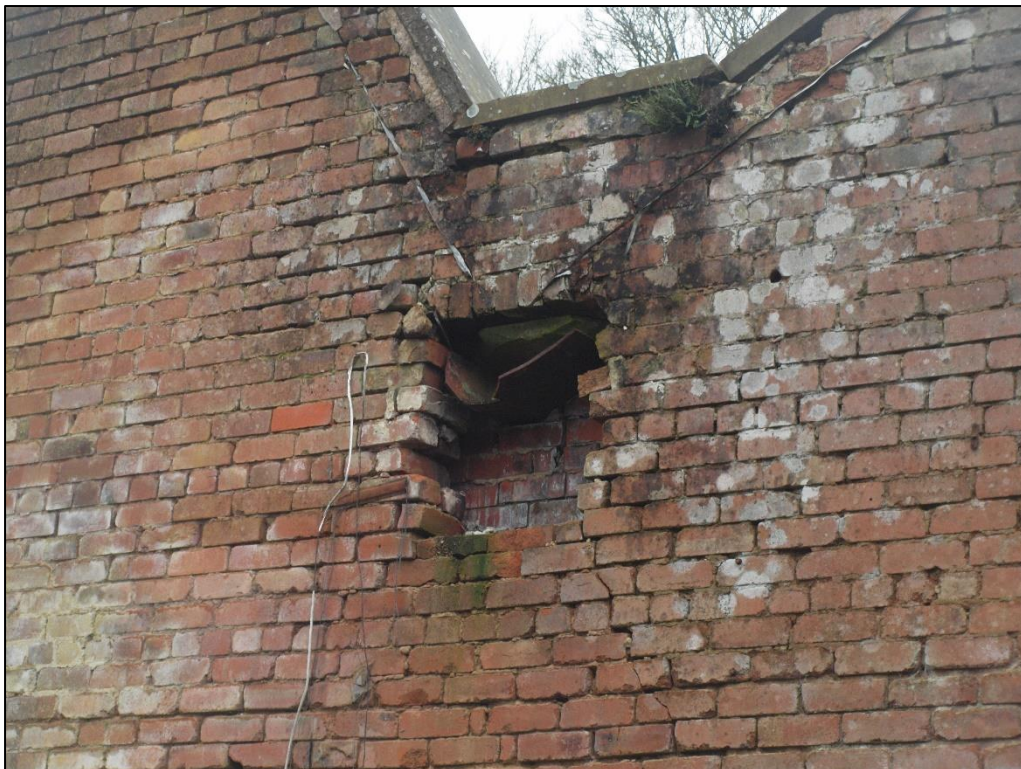
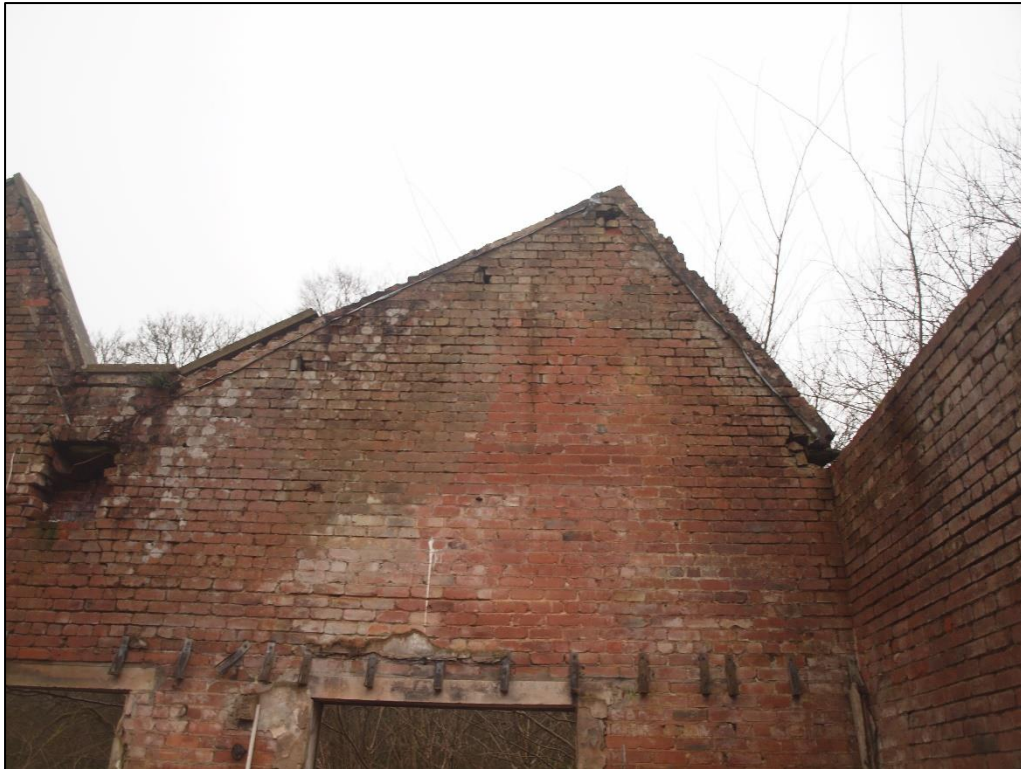
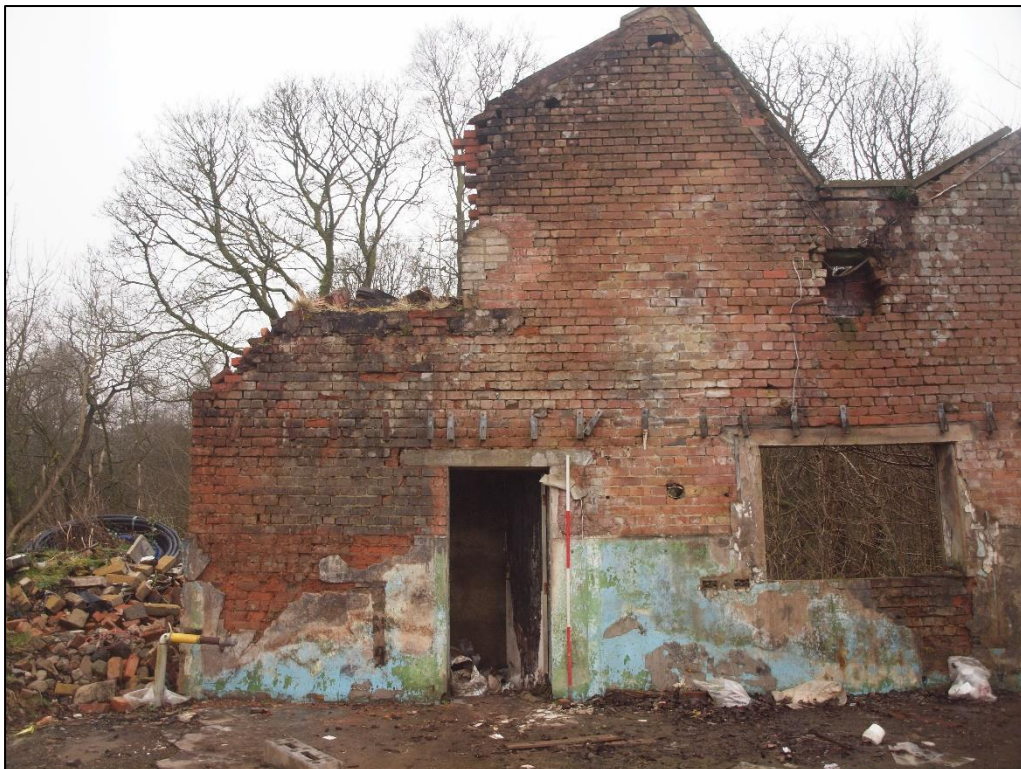
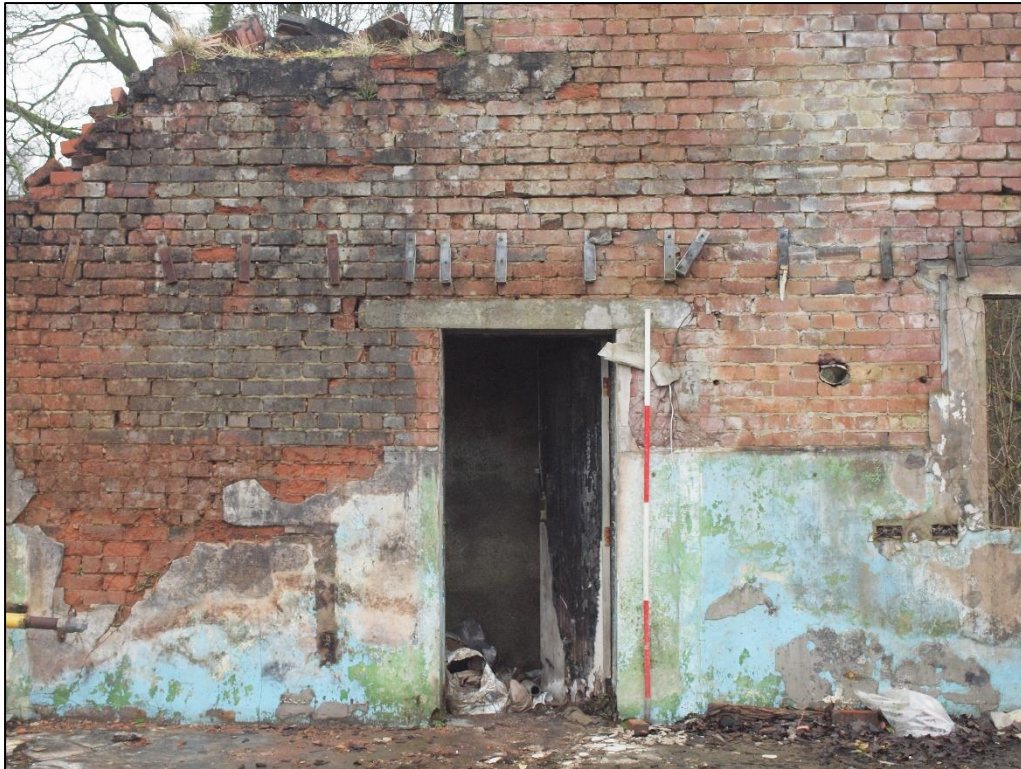
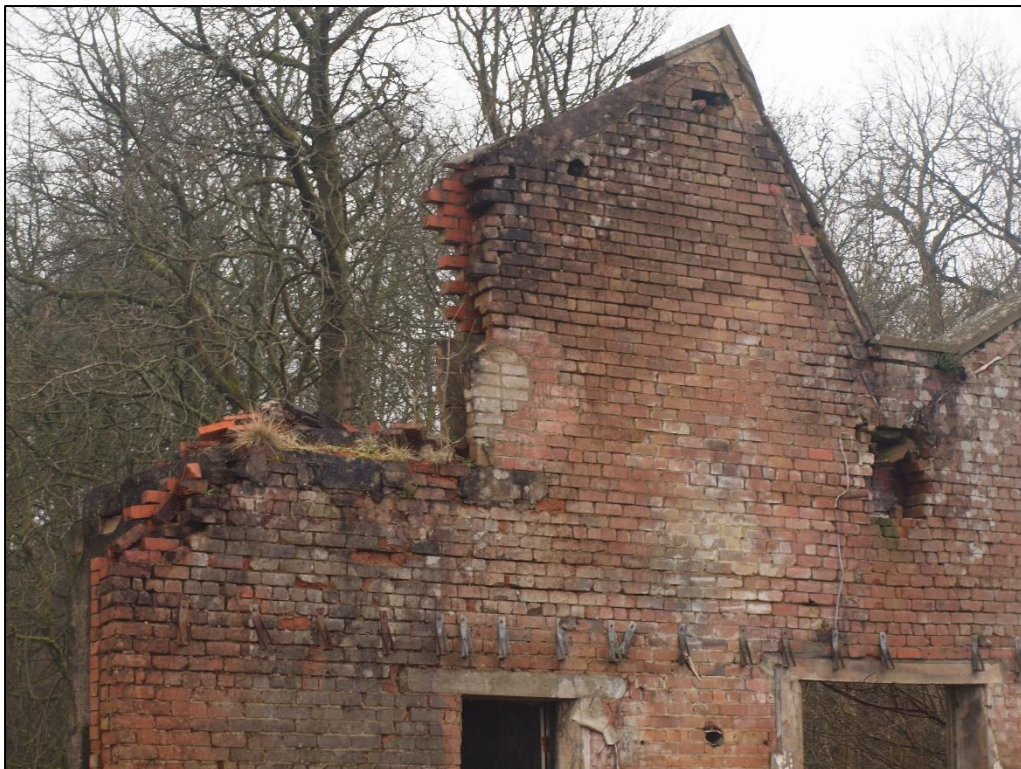
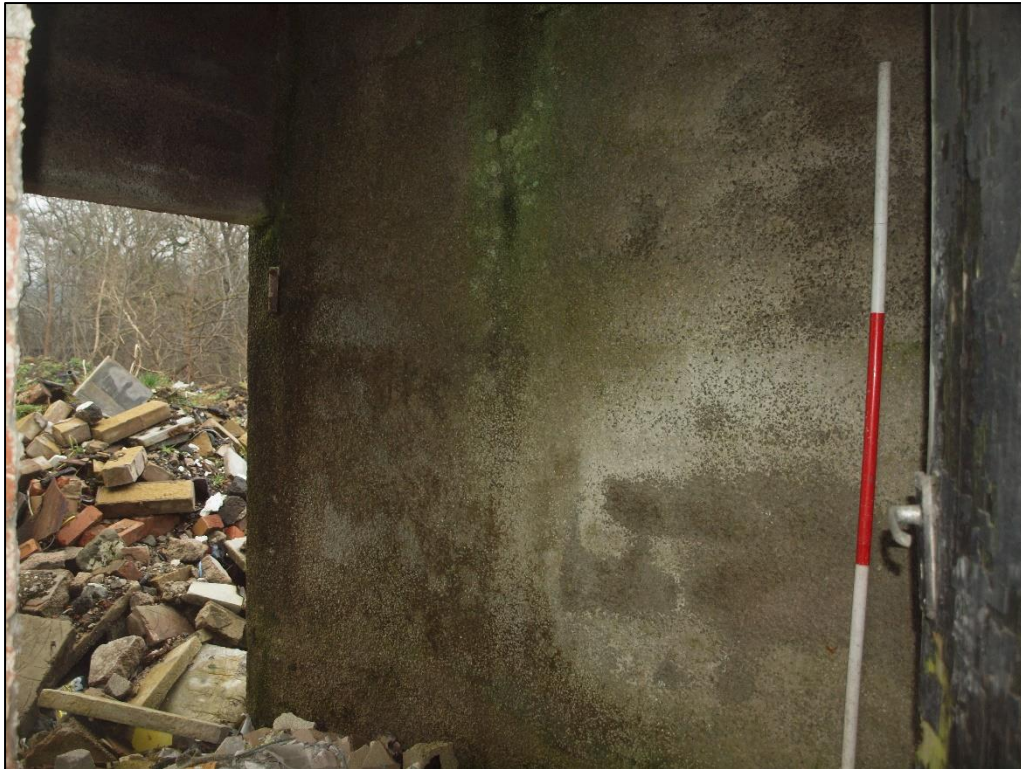
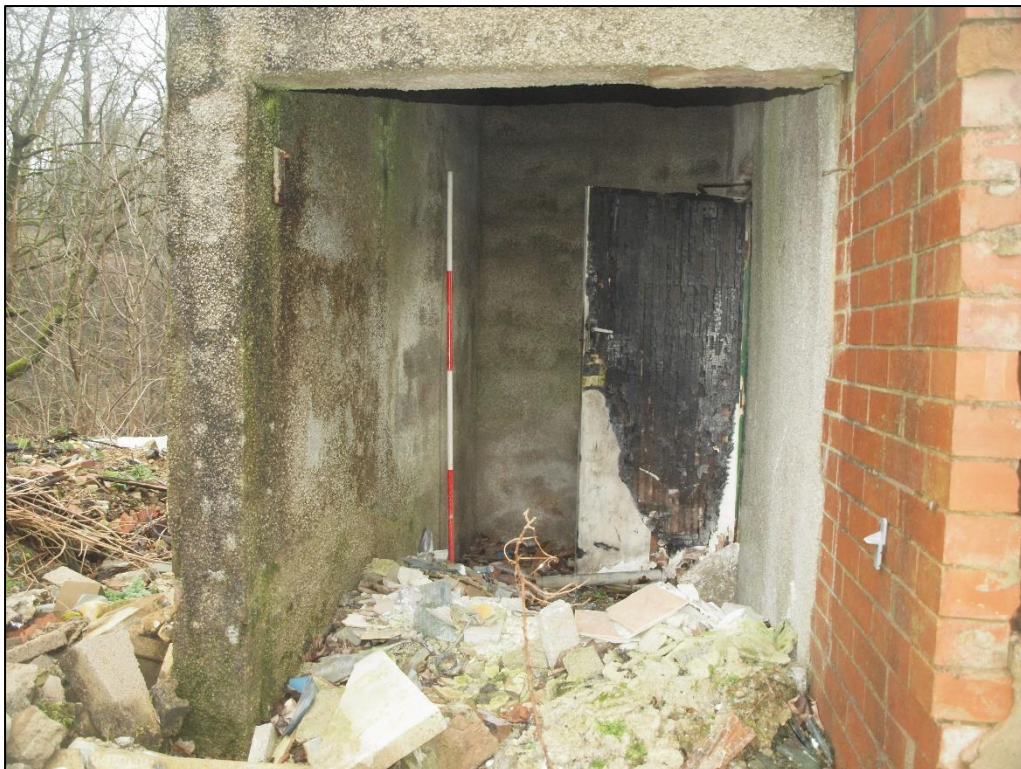
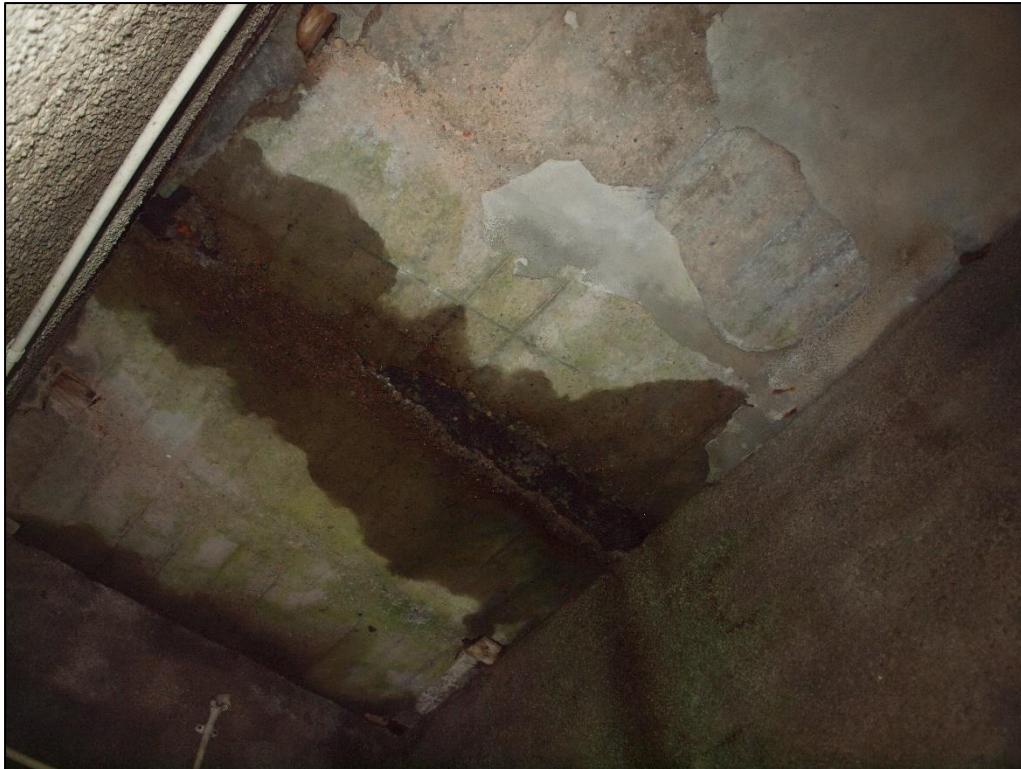
- 6.6 South elevation (plates 20 – 30). This forms the internal gable end of the building. In the valley between the gables a large opening is present, showing where the former gutter ran. To the east of this a partial blocked opening is visible, although partially destroyed by the collapsed gable. The large windows noted on the exterior visible, with a doorway to the east of them leading into the extension. This extension comprises a single room, with a wide low opening to the east and the space is rendered to match the exterior. The ceiling is concrete.

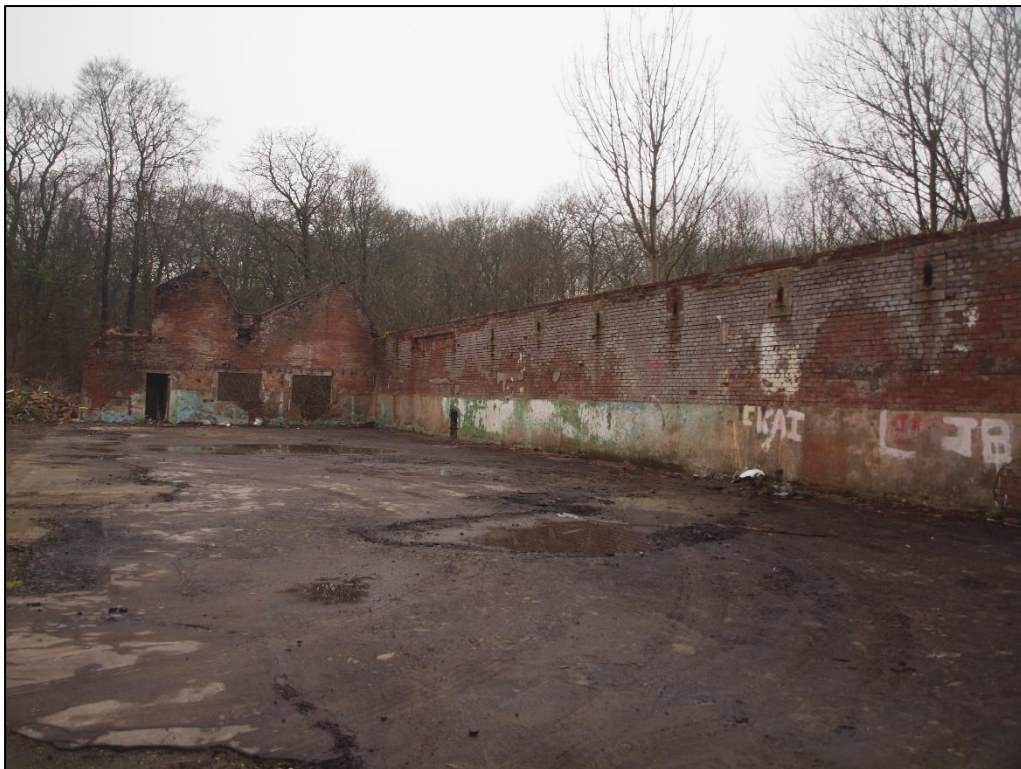
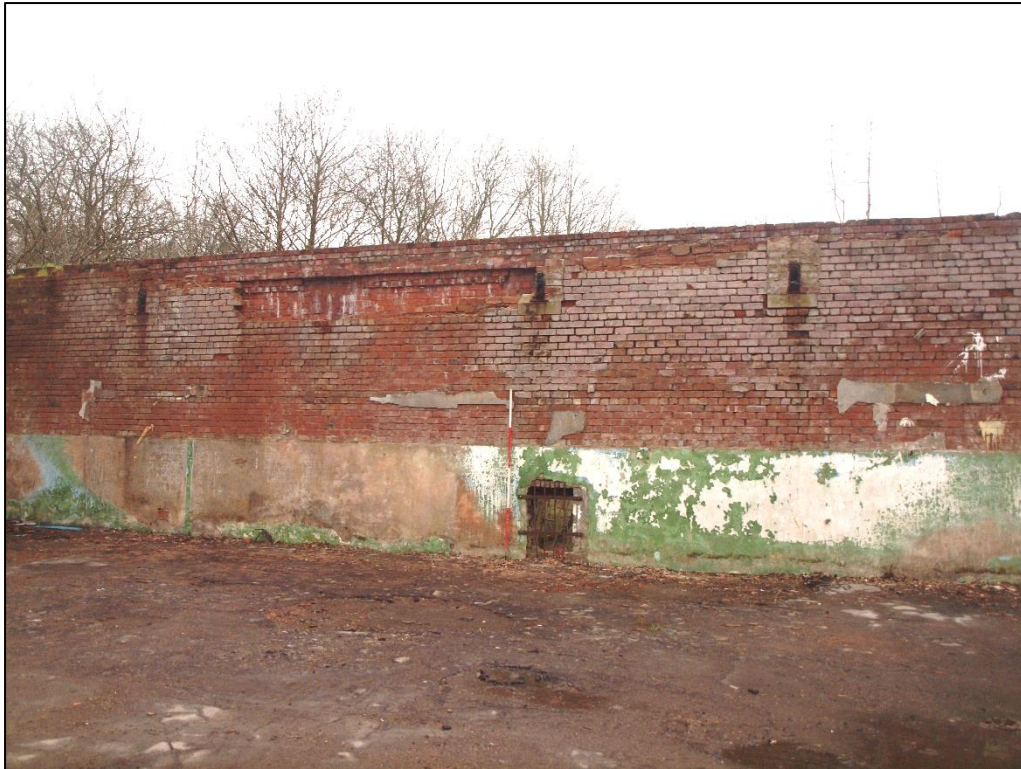
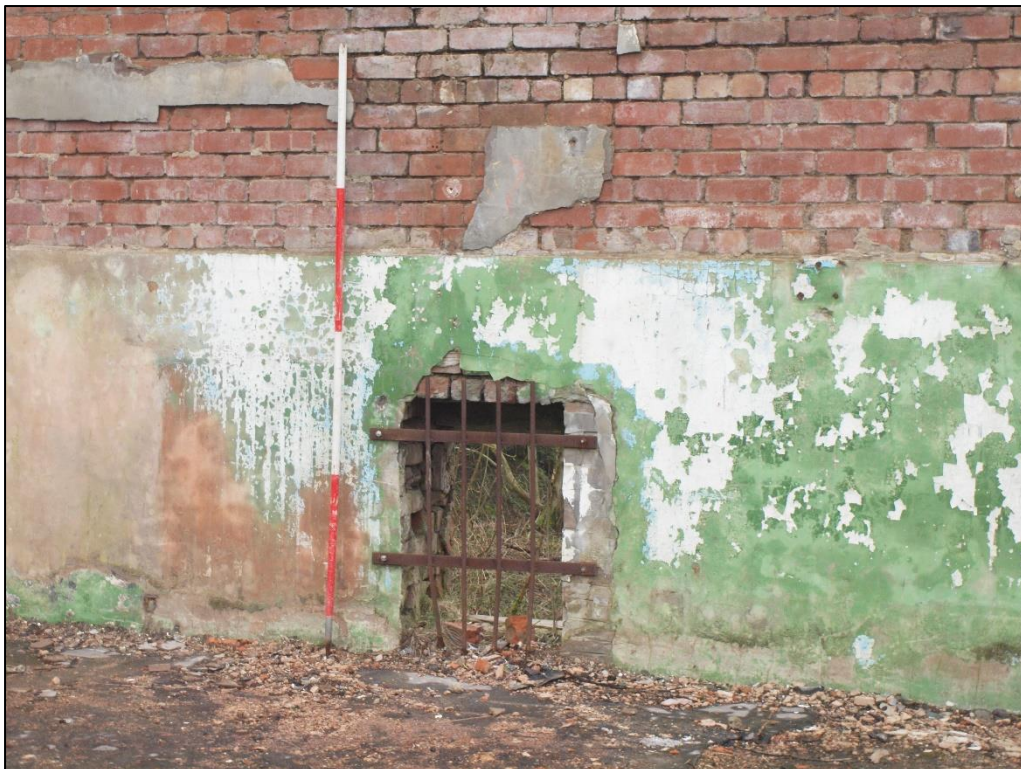
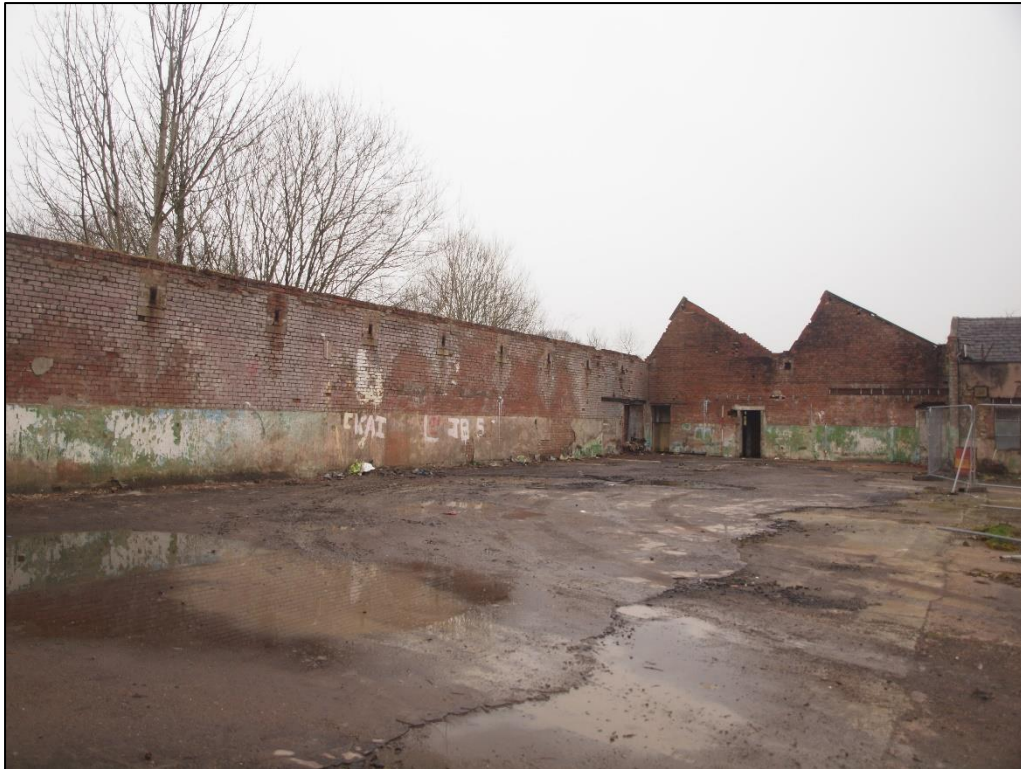
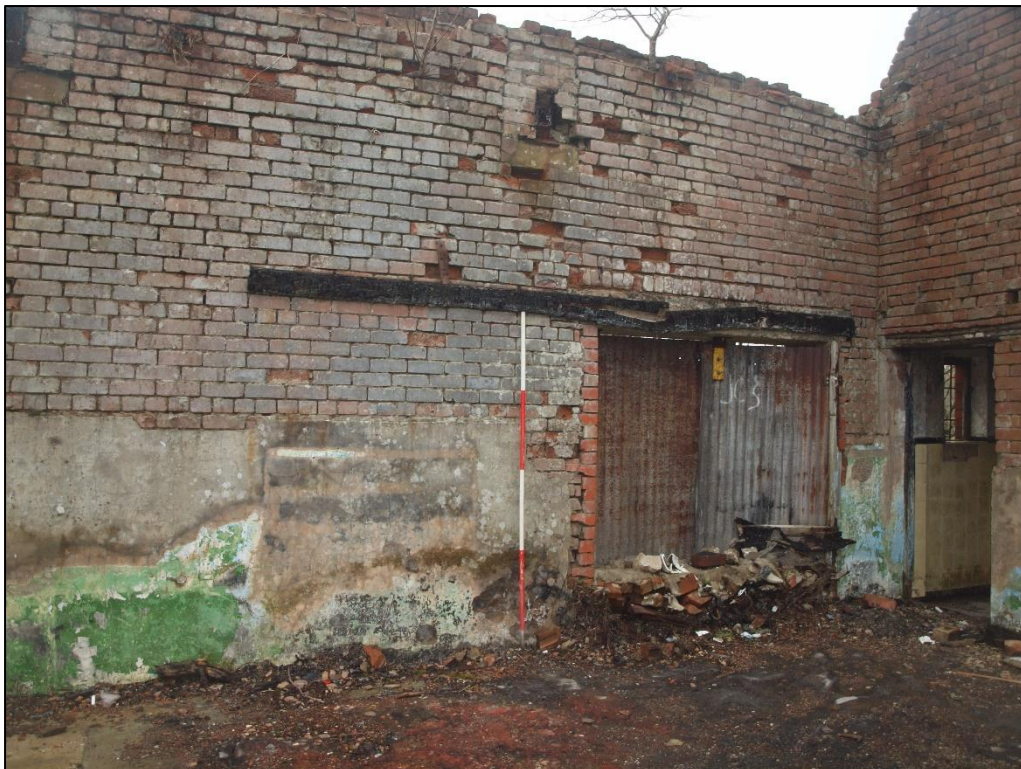
- 6.7 West elevation (plates 30 – 34). This forms the long elevation and is, for the most part, featureless. The panelled recessed seen externally are not present internally, and band of render, c.1m high, runs across the face. The inserted opening with metal grate is visible to the south side. Beam slots line the face along the upper part, showing the location of the trusses. At the northern end the loading doorway is present, with a long timber lintel visible over, suggesting a sliding door. The lintel is badly burnt.

Plate 34: North end of west wall showing loading doorway with burnt lintel

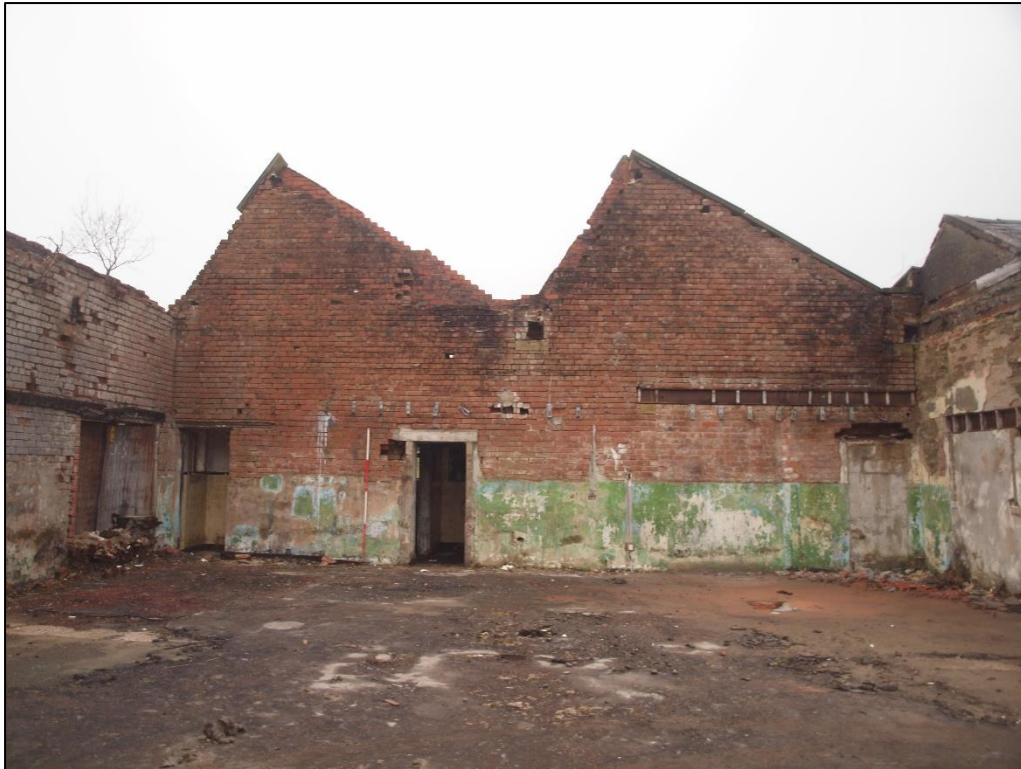
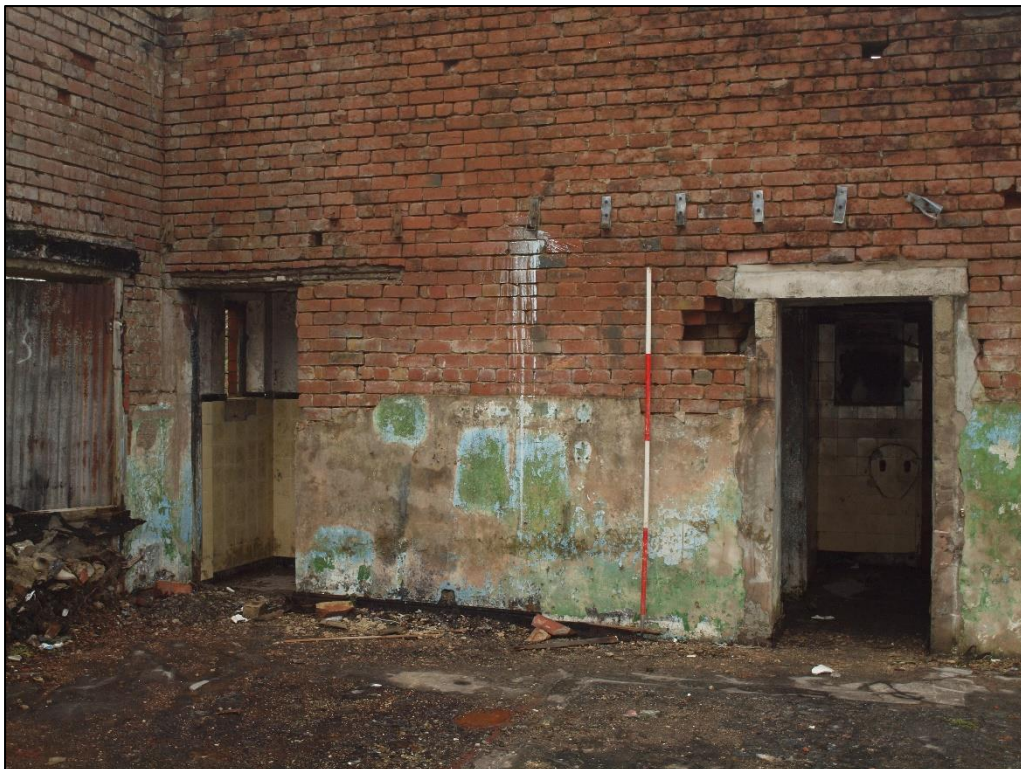
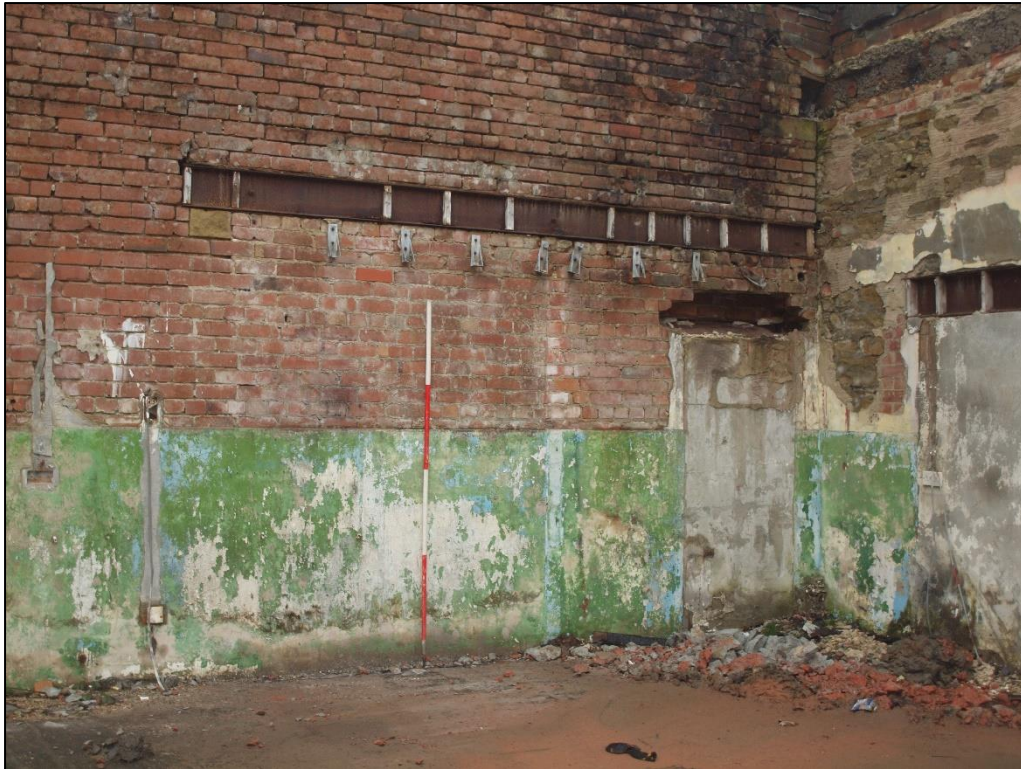
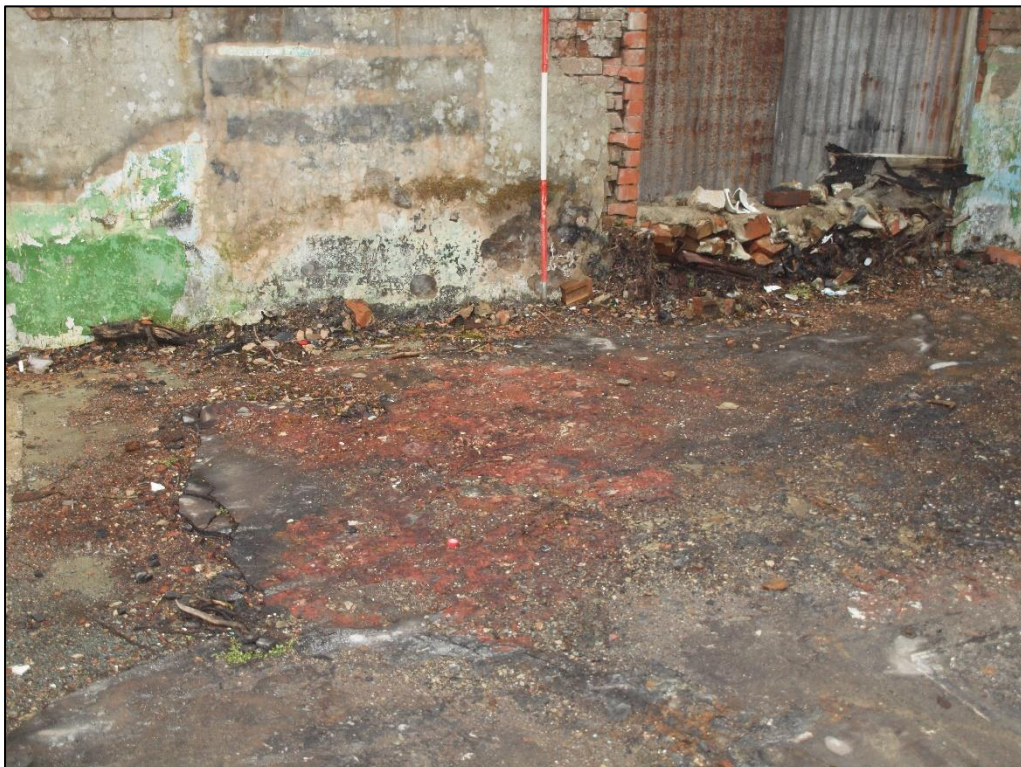
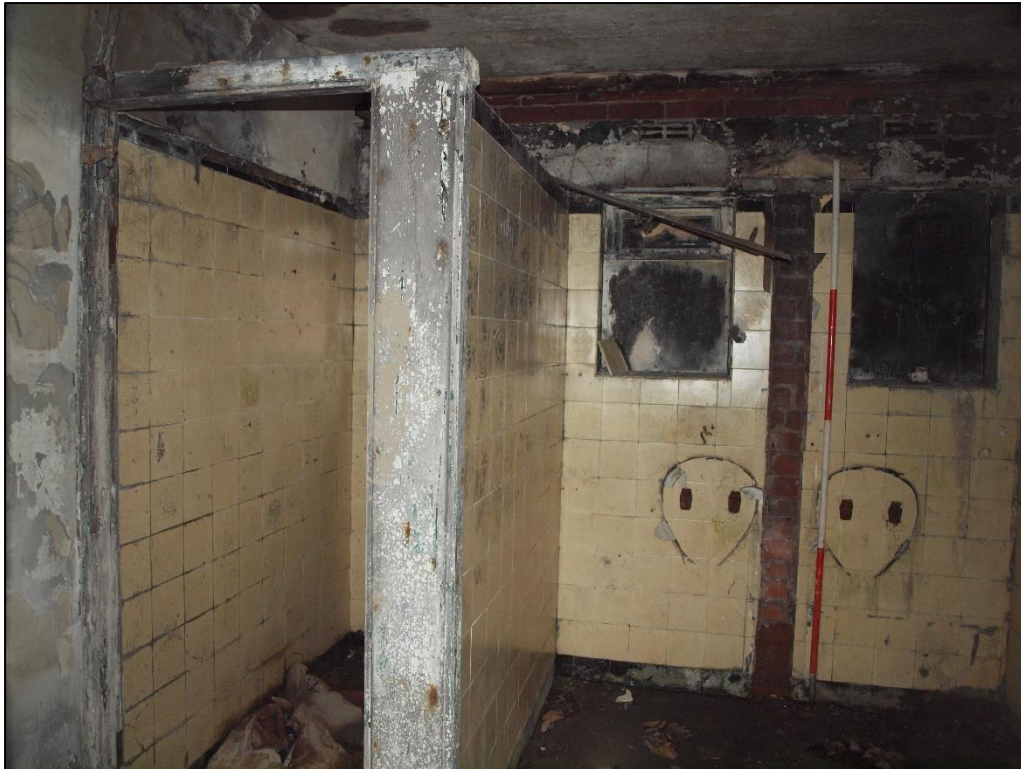
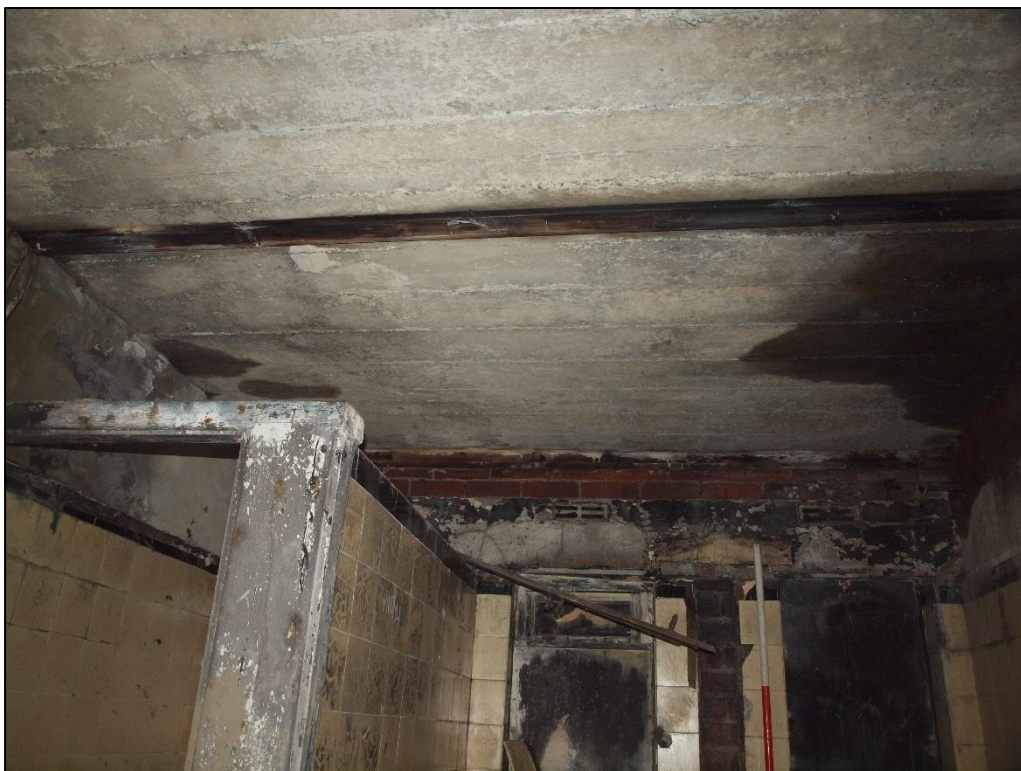
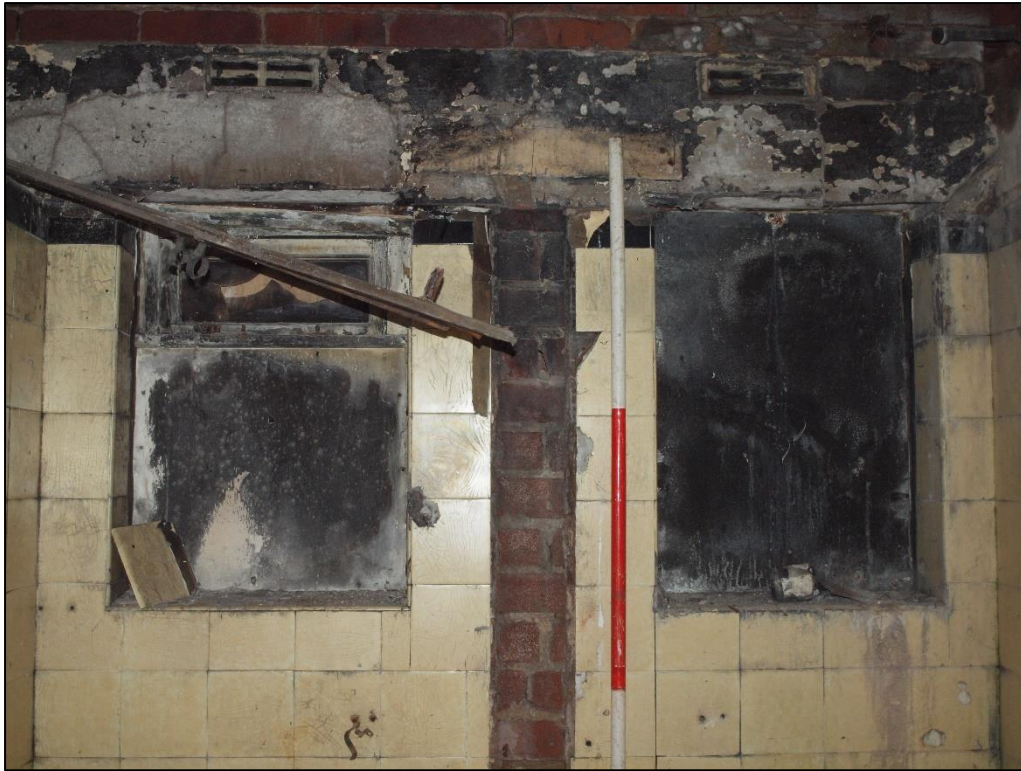
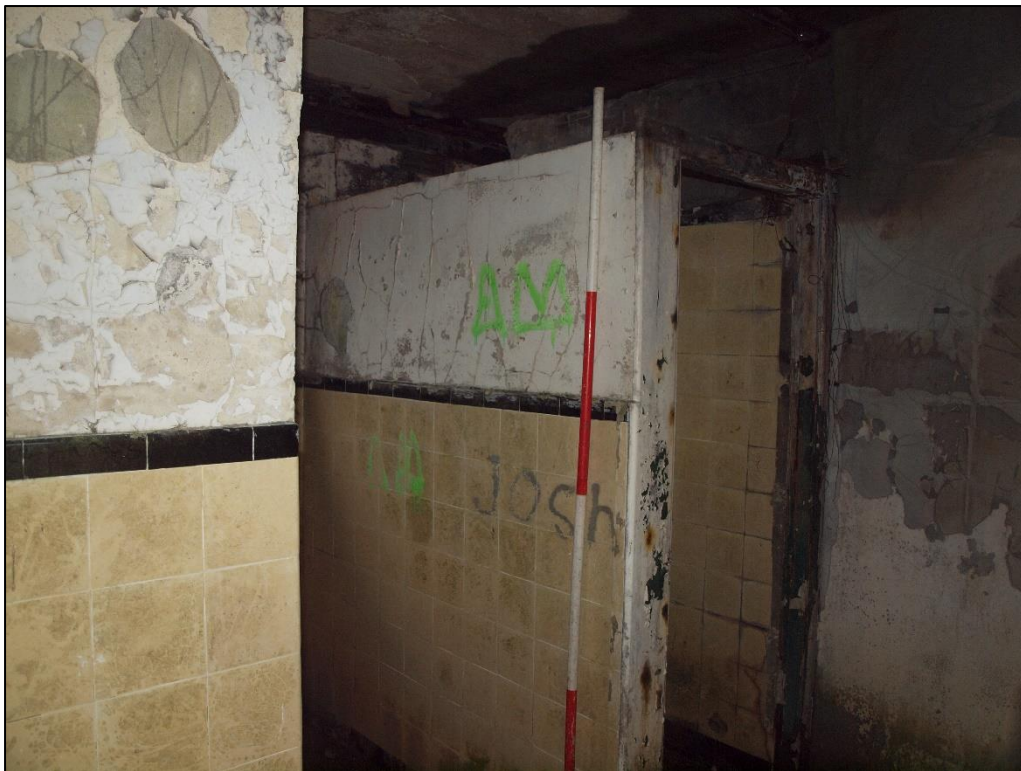
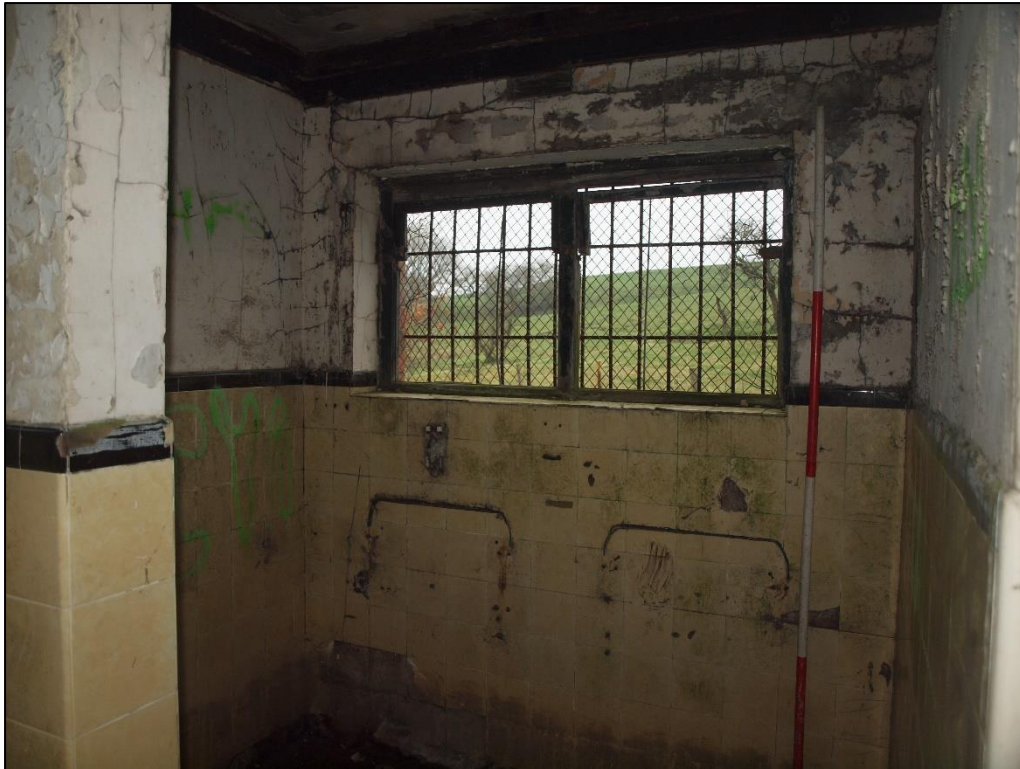
- 6.8 North elevation (plates 35 – 43). This face contains three inserted personnel doorway within it. That to the south leads into a small toilet block, as does a second doorway to the east of centre. The third doorway, lying at the western end of the face, has been blocked. Above this doorway, and spanning most of the eastern gable, is a large RSJ set in the wall and marking the location of a large blocked loading bay opening, within which the personnel doorway is located.

Plate 37: Blocked doorway to east side, with large lintel over showing location of former loading doorway

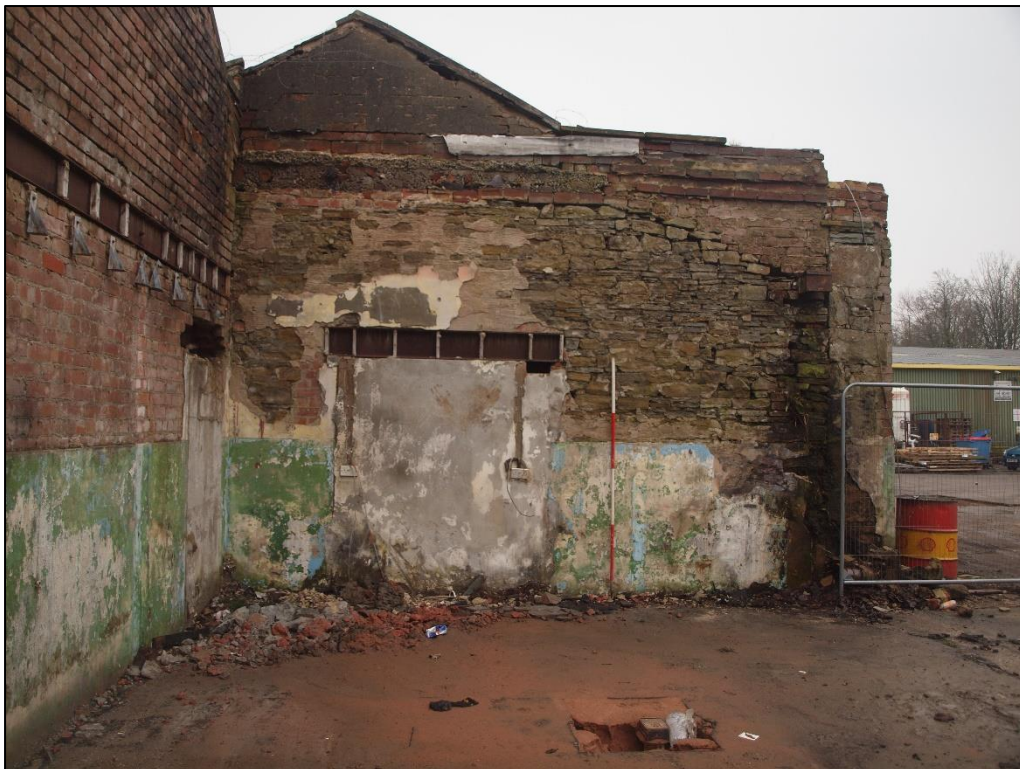
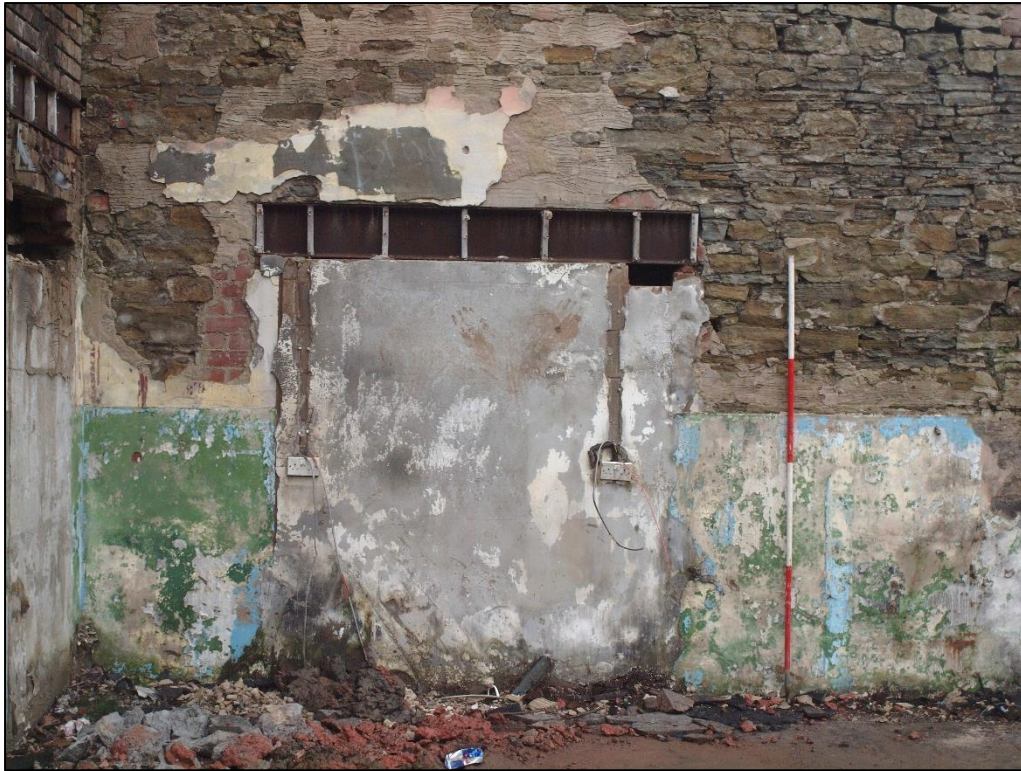
- 6.9 East elevation (plates 44 & 45). A partial east elevation lies at the northern end of the site, formed by the adjoining stone-built building. The stone construction is visible through the decayed render and a large blocked loading doorway lies to the north side of the face. At the top of the face the building has been repaired with brick.

Plate 44: Remaining internal east elevation showing stone construction of adjoining building
