Heritage Impact Assessment

Churton Hall, Pump Lane,
Churton

The Barnston Estate

July 2023

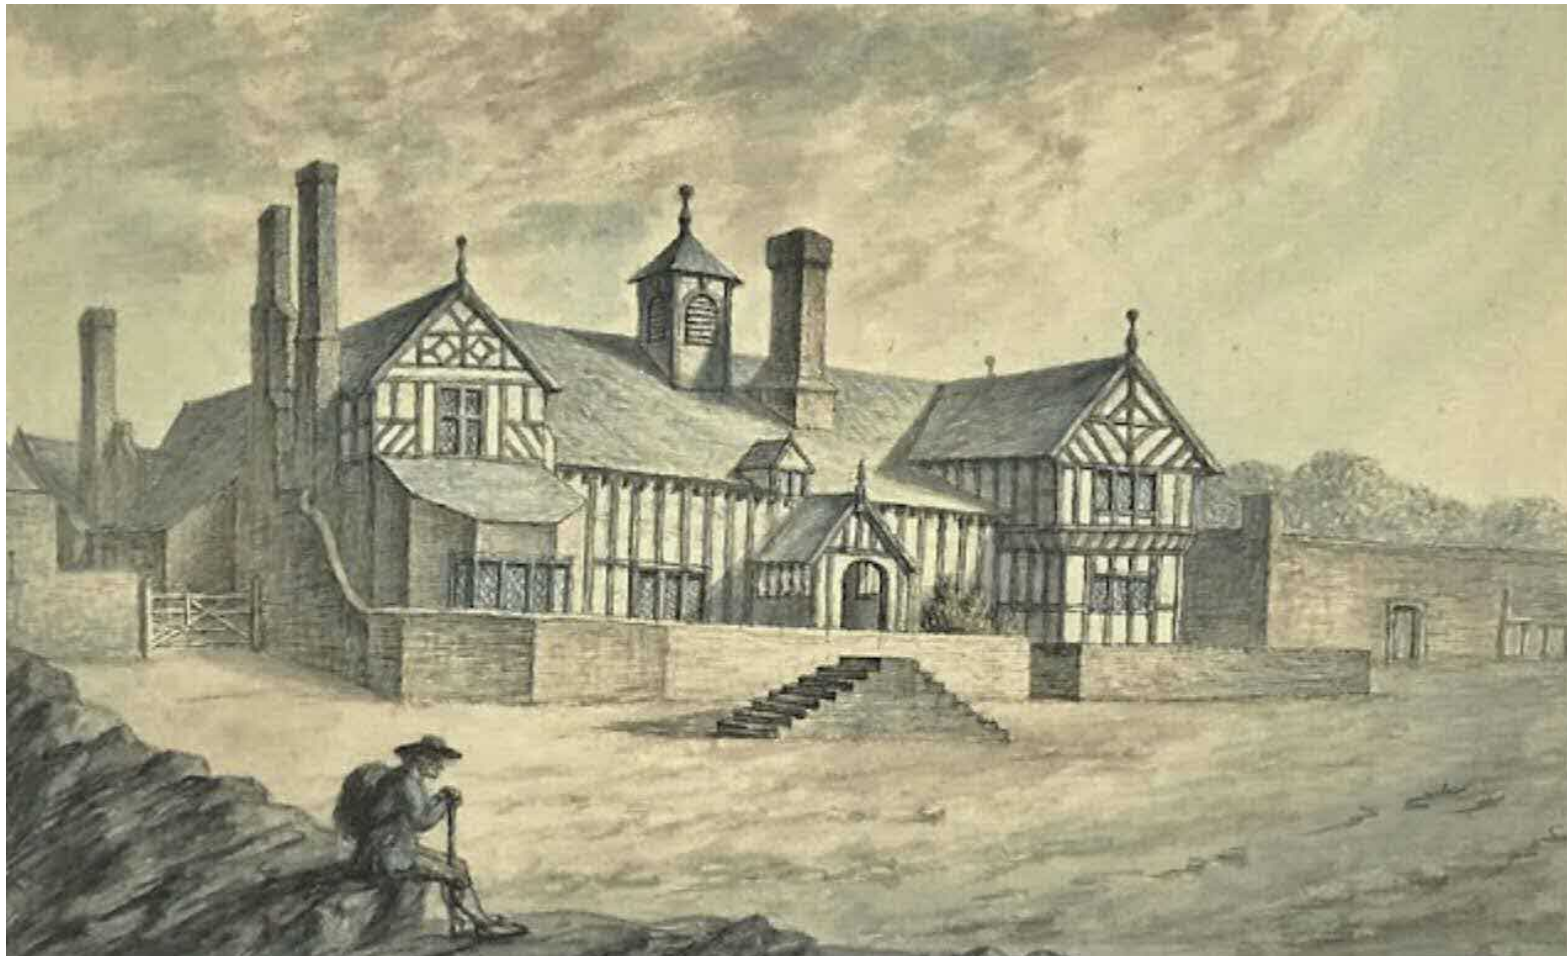
Fig 3. Churton Hall, 1793, drawn by J. Ingleby (Image: National Library of Wales). Note the wall next to the lateral chimney of which remnants remain; the outbuildings to the rear, which were rebuilt in the early 19th century. Also note the central chimney stack, the eaves line which is roughly parallel to the timber framing wall plate, the walled garden to the west and entrance. At this point the Georgian side door hasn't been built. There are mounting steps for a carriage to the front of the wall of the hall.

- 4.6 A drawing of Churton Hall dated 1793 by John Ingleby (1749-1808), a Welsh topographical artist from Halkyn, Flintshire, shows the building which in terms of form, looks very similar to as existing. It shows that the building was a E-plan, a central hall portion with two cross wings and a porch. There is a single storey projecting wing with a hexagonal lean-to roof to the north east. The drawing depicts mullioned windows to ground and first floor, and what appears to be a slate roof with finials to the projecting north gables. Externally the building, except for the single storey north projection, is expressed as a box frame construction. The drawing shows that there are three chimneys, one offset forward from the roof apex to the hall area, off centre from the porch, the other two are lateral to the east gable end. There is also a possible bell tower above the porch to the north roof slope of the roof apex. The boundary wall around the north front is brick, as is the much taller garden wall to the west. The low roof structures to the rear of the house are also evident, possibly a separate kitchen.

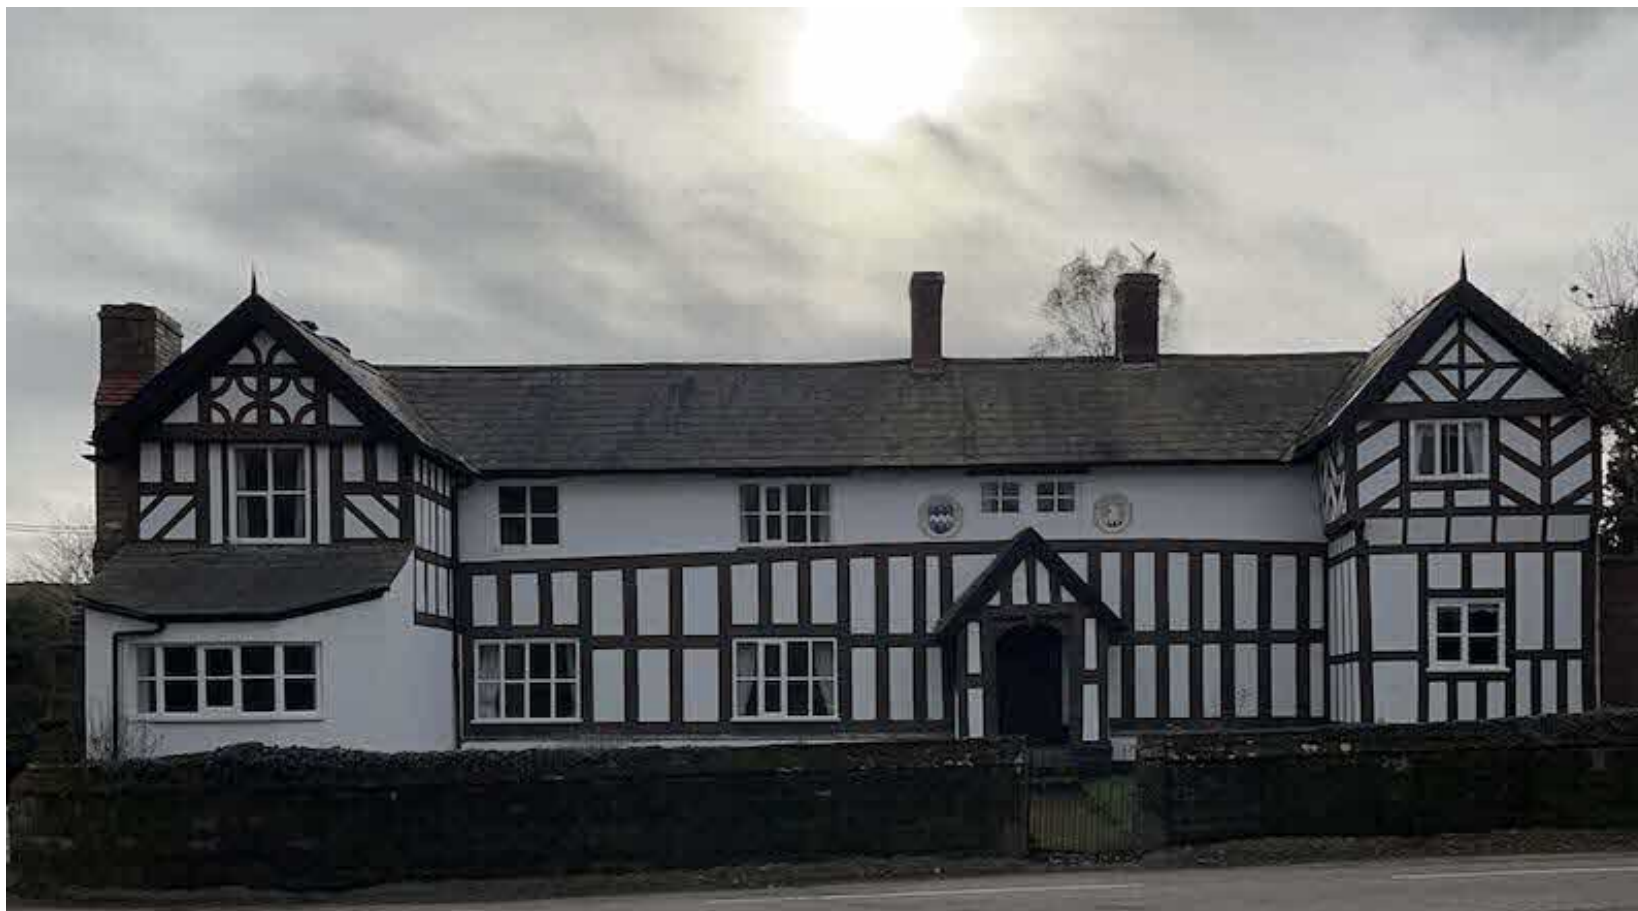
Fig 4. Churton Hall, 2023. Note the raising of the roof, probably undertaken in the 19th century, with 19th century casement windows; the smaller windows above the porch that replaced a dormer window; the off centre first floor window to the west wing; the central chimney stack is a late 19th or early 20th century addition the right chimney has been altered. The lateral chimney stack to the east gable has been truncated. The north west projecting gable perhaps retains some 19th century vernacular revival chevrons to the first floor.

- 5.10.8 In the 19th century there were extensive alterations including the raising of the eaves level above the timber framed wall plate to allow for increased head height. Staircases were added, including within the existing hall. The possible former kitchen area at right angles to the east of the building was demolished and the erection of a significant extension to the southeast of four bays was added. This has windows that look onto the farm courtyard. A secondary farmhouse entrance door was created from the farmyard. A modest staircase was inserted to the 19th century service wing, linking both the service wing and main house.

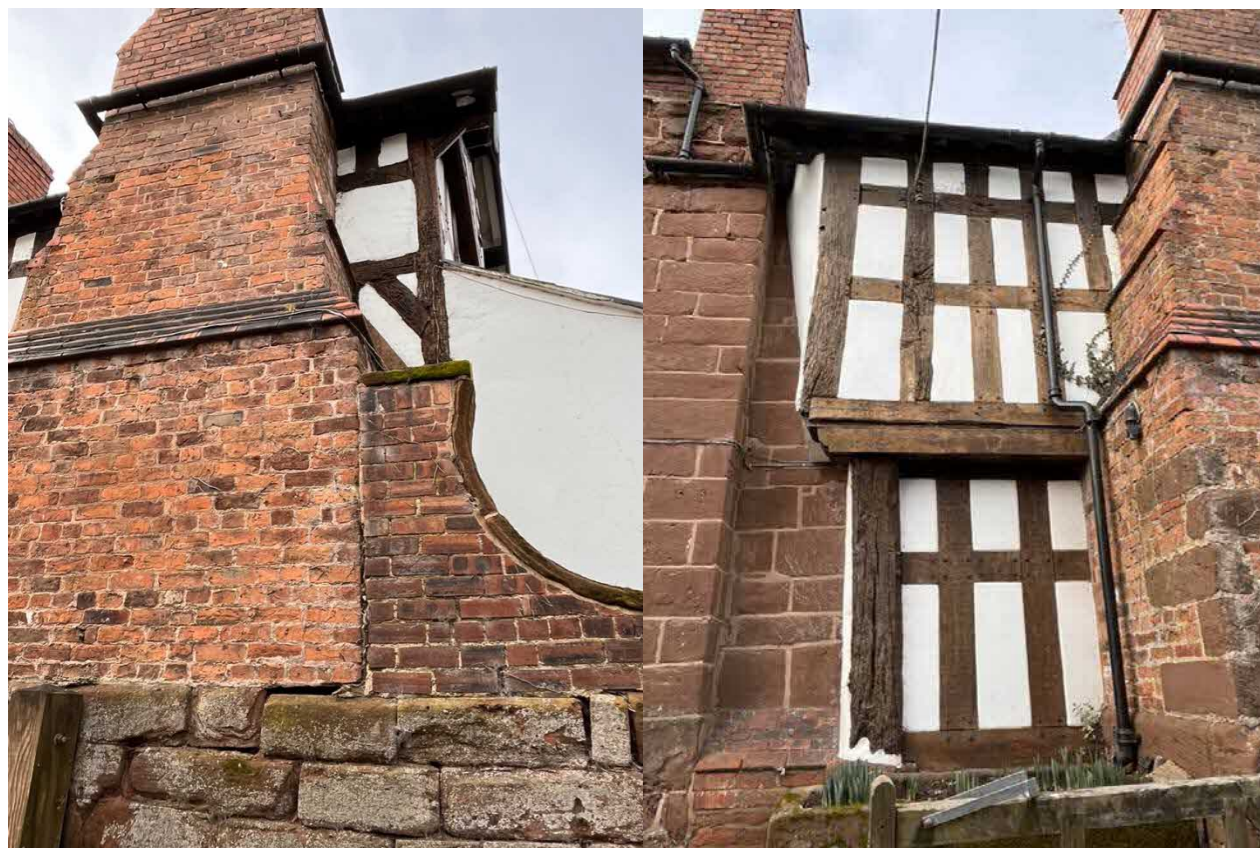
Fig 5. The east elevation of Churton Hall, 2023. Note the curved wall adjacent to the lateral chimney stack shown in the image of 1793. The second photograph shows the jettied first floor and close studded timber framing, truncated by a coursed sandstone wall, part of the second lateral chimney stack – the earlier one is of stone.

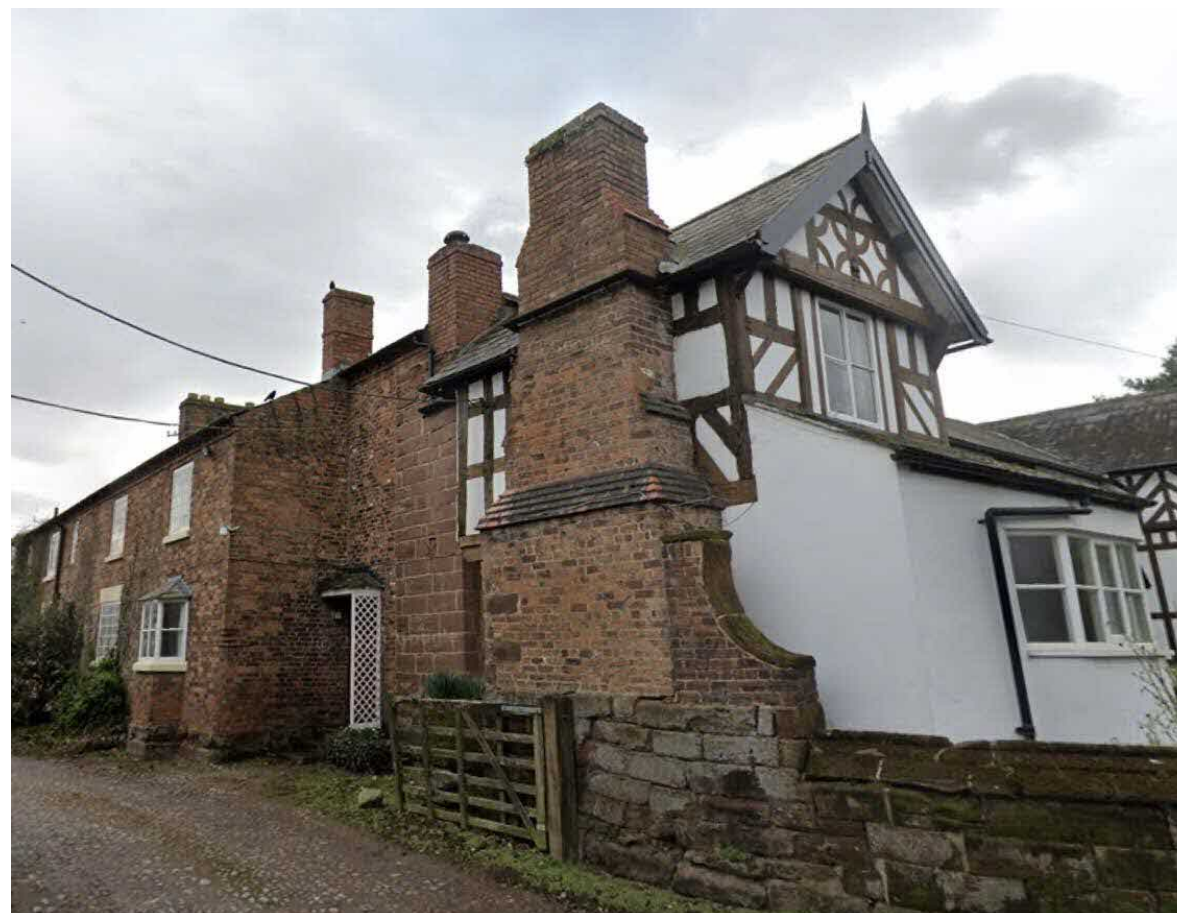
Fig 6. The east wing of the house, with a service wing to the rear. Note how this has changed since the 1793 drawing. There is a two storey wing, which appears to be one build and is early 19th century. This has metal small paned windows. There is a side entrance from the farmyard, which suggests that this became the primary entrance. It is a six panel raised and fielded Georgian front door, probably early 19th century. Internally there is a door of the same age leading to the early 19th century wing. The bay window to the left of the latticed entrance door is later 19th century, this room was the farm office.

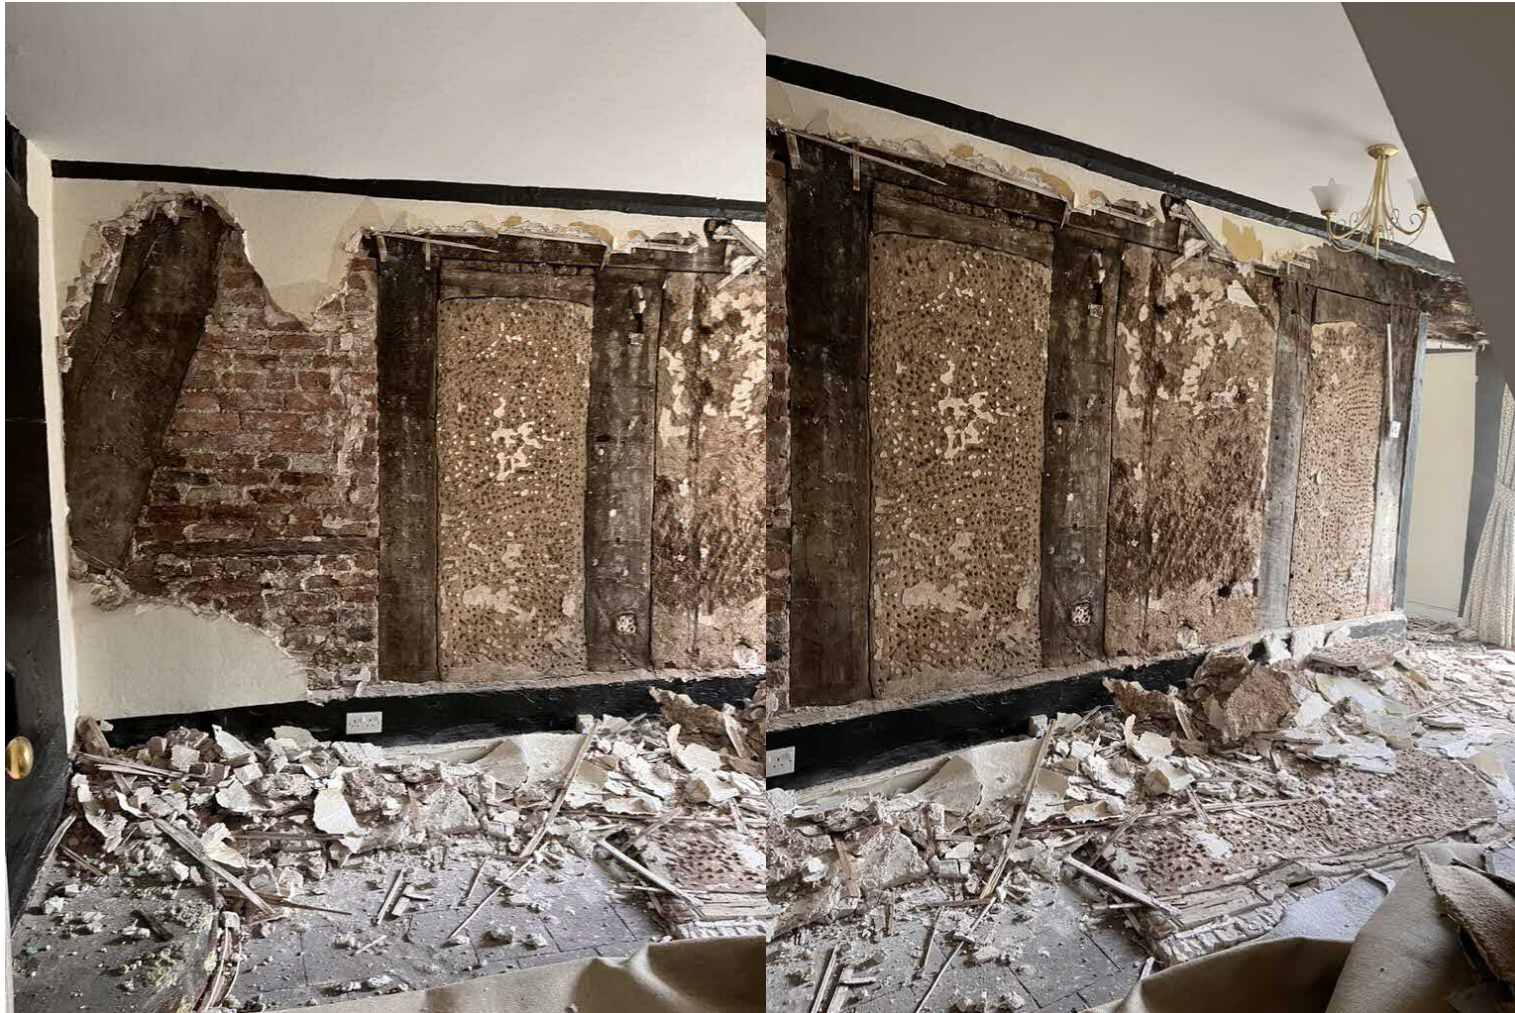
Fig 7. The assumed screens partition within the cross passage. Note the cruck to the left of the first photograph.

- 5.10.2 The hall appears to have been a three unit layout with a hall to the west, a cross passage in the location of the present hallway, a screens partition for access to the buttery and pantry to the east. This would make sense given that the ground floor inside the hall slopes from west to east, and natural drainage would therefore follow the topography and terrain. The cross passage had doors at both ends, which remains the case today if indeed the north front door and the Regency style French doors directly opposite were early openings.

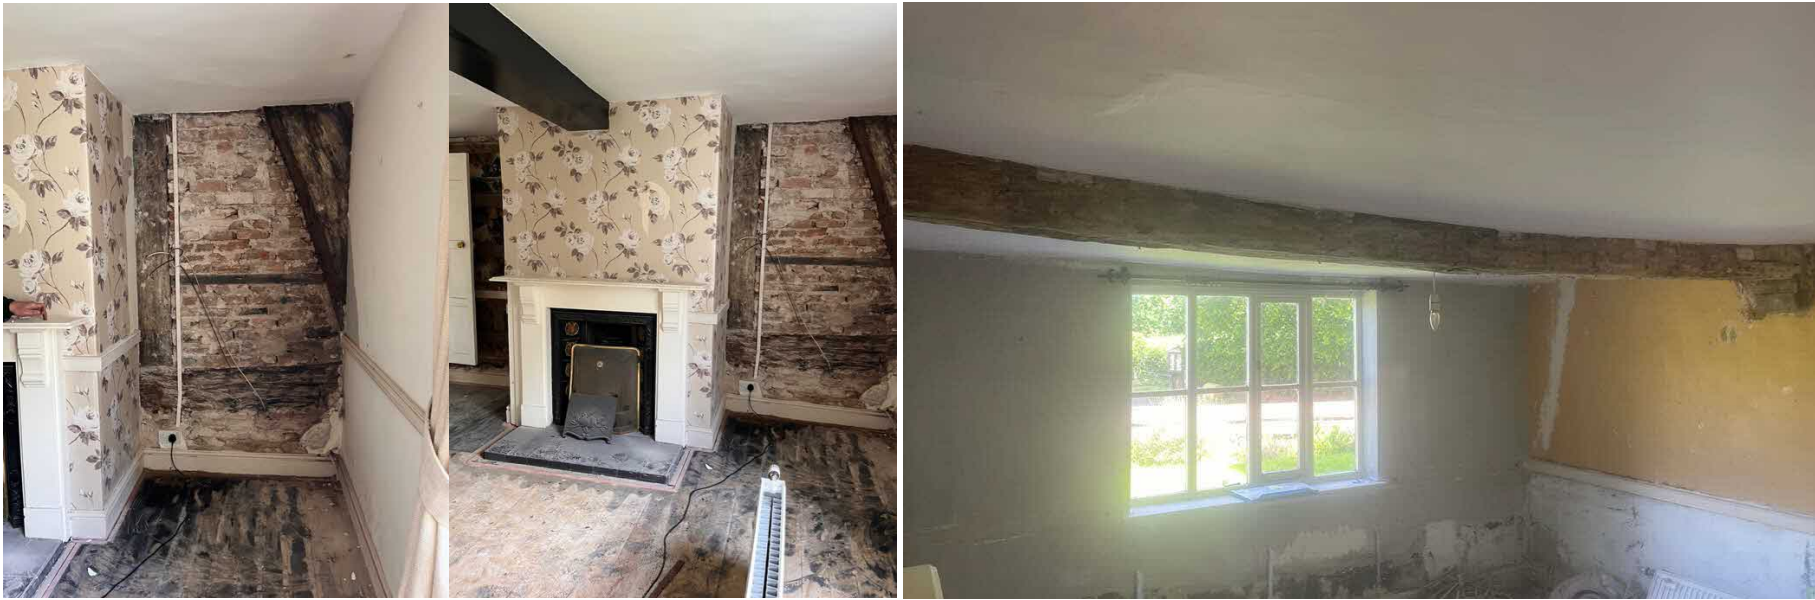
Fig 8. The other side of the screen passage inserted next to an early 20th century fireplace. The floorboards were probably installed at the same time, or later. The sandstone cellar is underneath this floor. A stop chamfered beam is encased in plaster and painted black gloss. This has now been uncovered. It has been raised and is resting on a corbel that may indicate the location of the division wall between pantry and buttery.

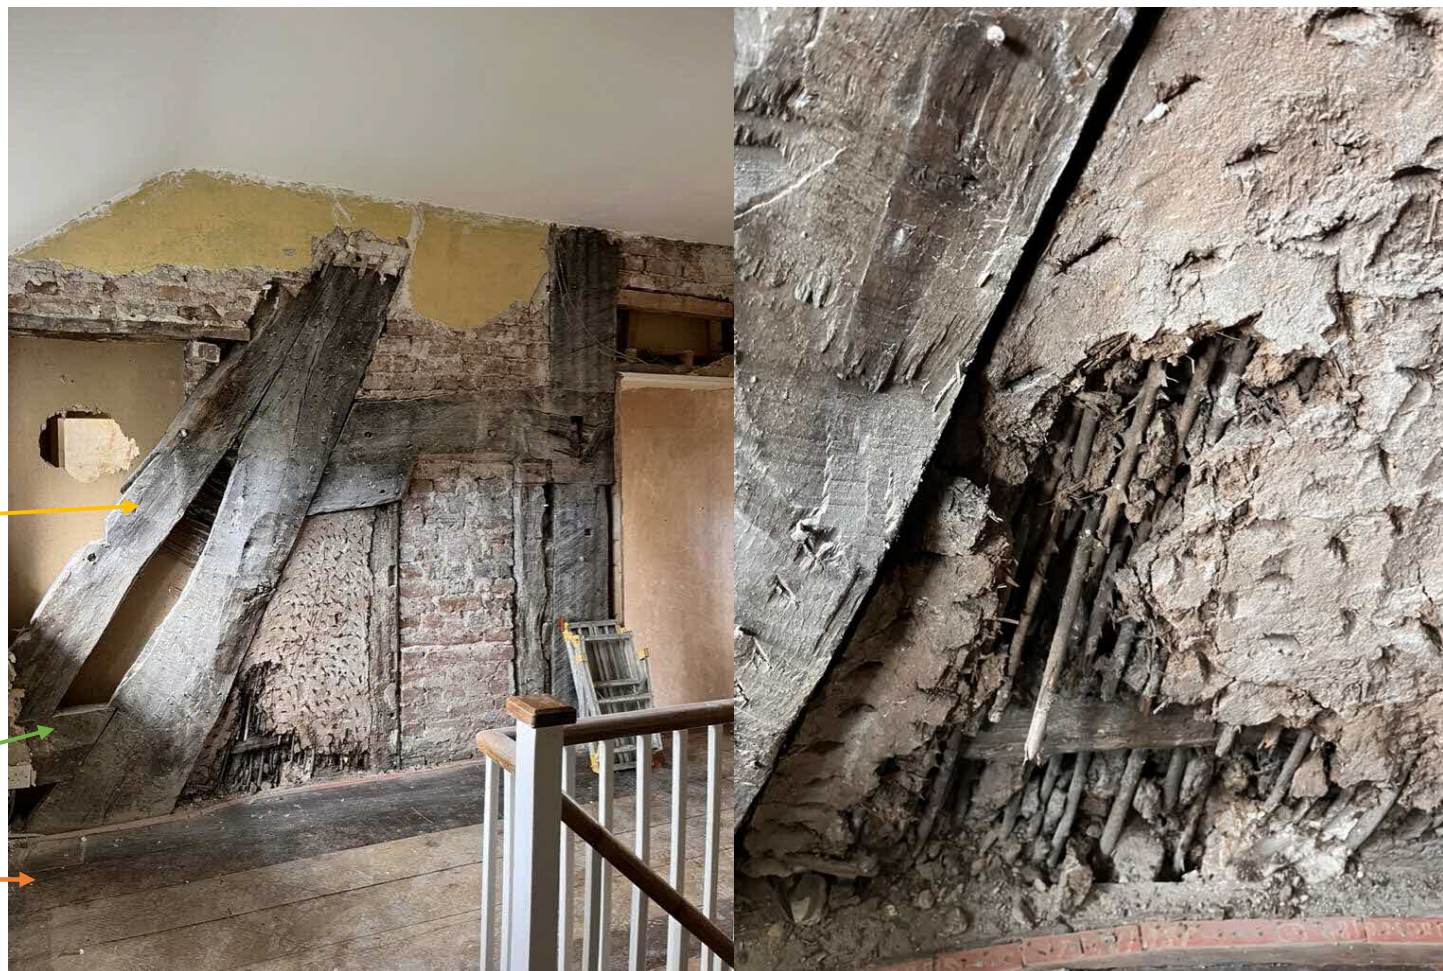
Fig 9. The cruck to first floor above the screens partition showing wattle and daub and later brick infill. Note the packing piece (arrowed yellow) and the spur (arrowed green). The tie beam (arrowed orange) at floorboard level appears original to the truss.

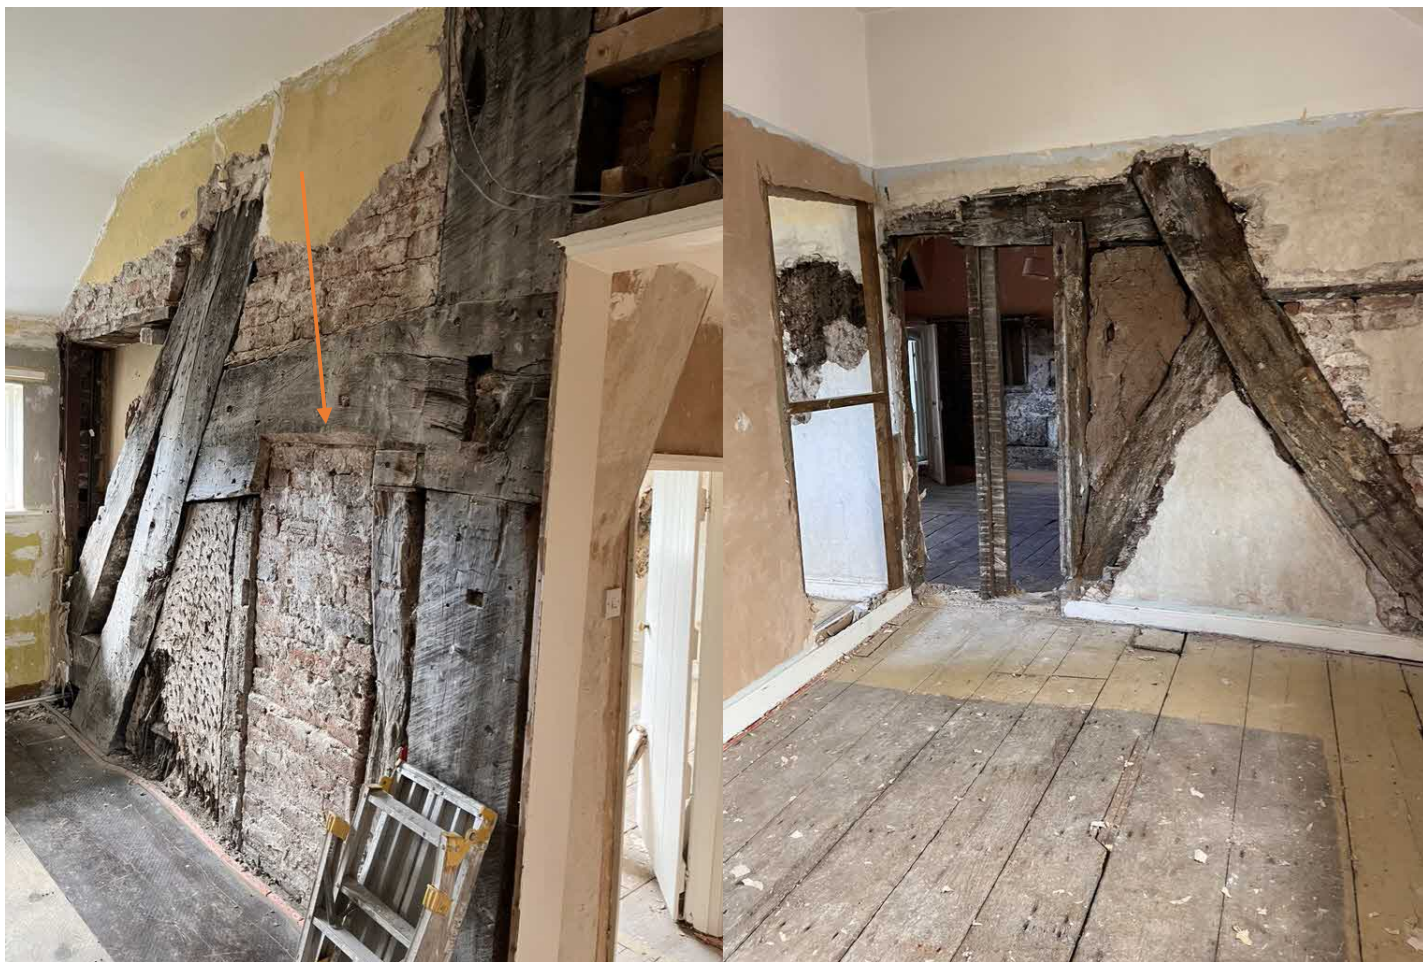
Fig 10 The crucks to first floor. To the left is the cruck above the screens partition. Note the inserted door (arrowed orange). To the right is between the 17th century chamber with lateral chimney and inner room. Note wide floorboards.

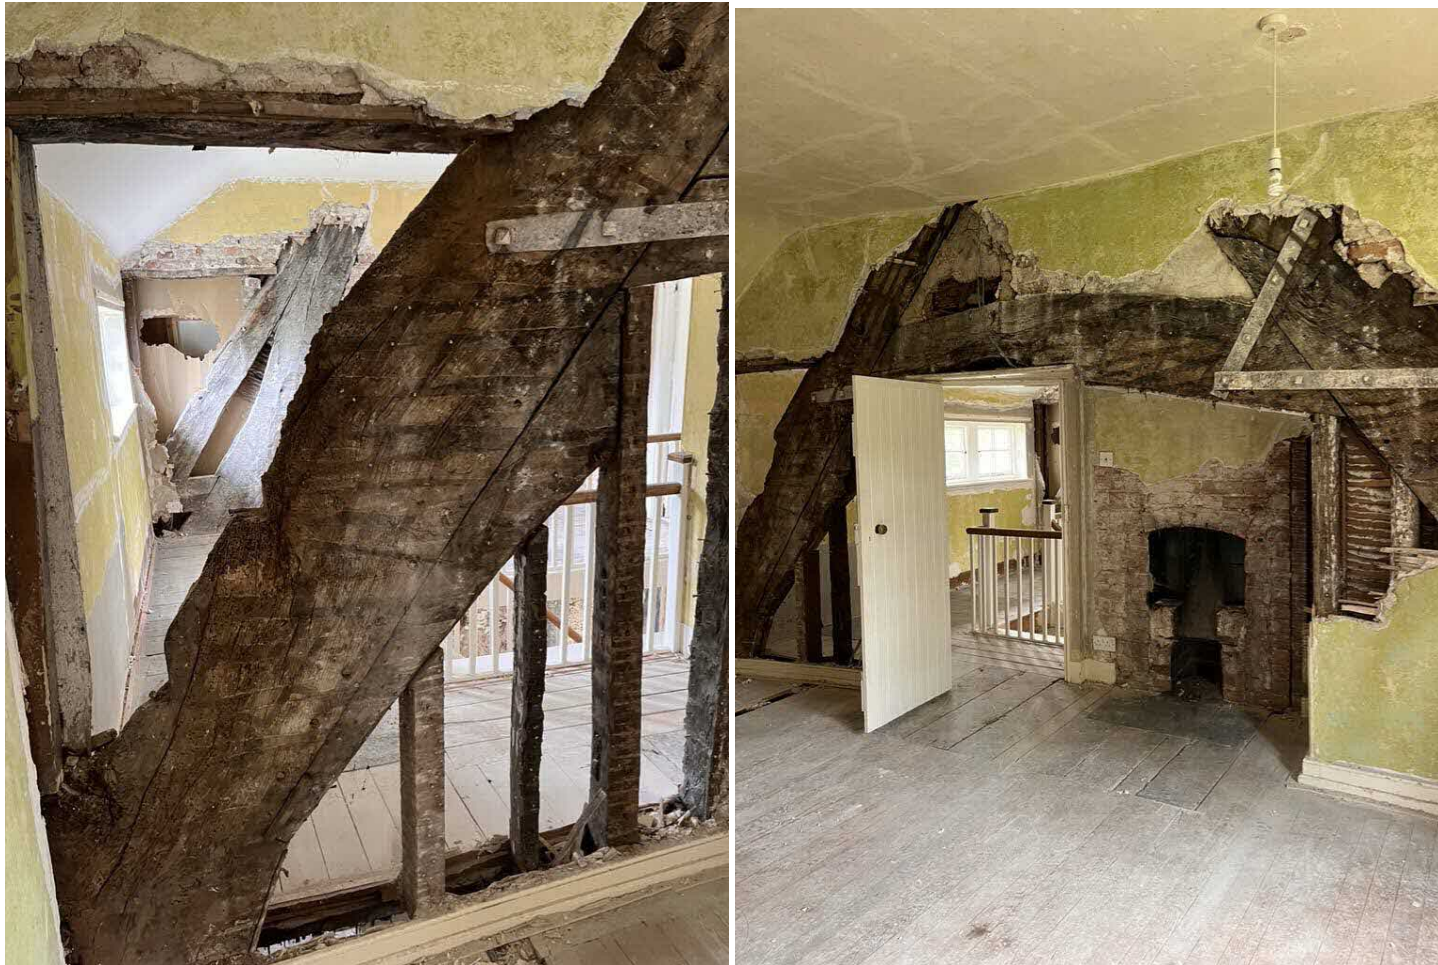
Fig 11. The raised cruck to the west of the existing hallway. The 'upper' face of the truss faces west, into the bedroom, suggesting that this faced the most important end of the house.

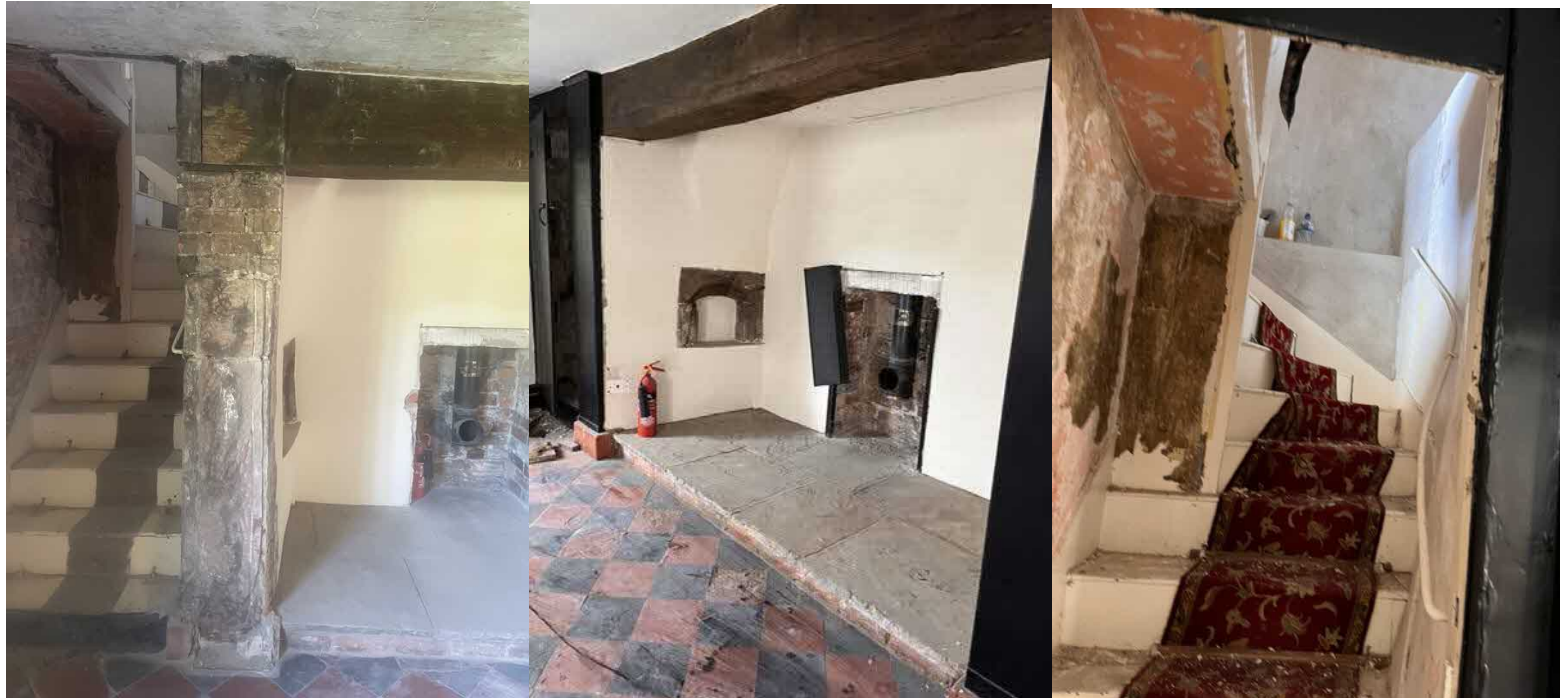
Fig 13. The altered inglenook on the east wall; the bread oven; stairs to the side of the fireplace leading up to two bedrooms. The tiles were probably added in the 19th century on an earth floor.

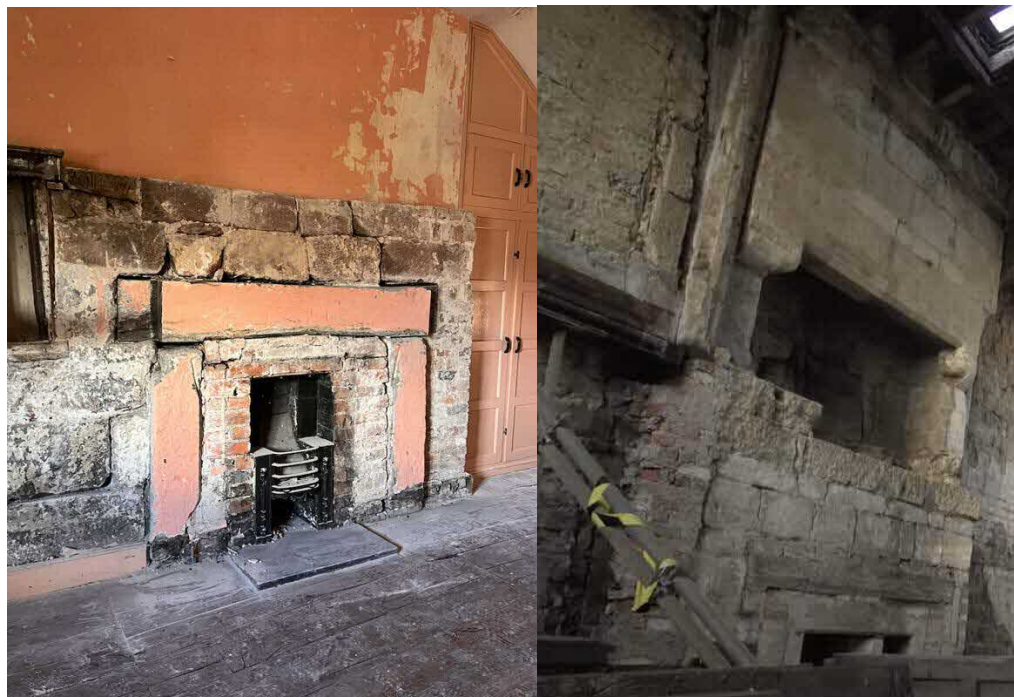
Fig 14. The fireplace to the solar, or chamber above the east room with inglenook. Note the various changes to the fireplace as flues became slimmer. The sandstone blocks are substantial. The Georgian grate was probably inserted in the early 19th century with other improvements undertaken at the time. The image to the right is that of Llwyn Celyn, a late medieval hall house of 1420. Note the similarities of the ground floor fireplace to that at Churton.

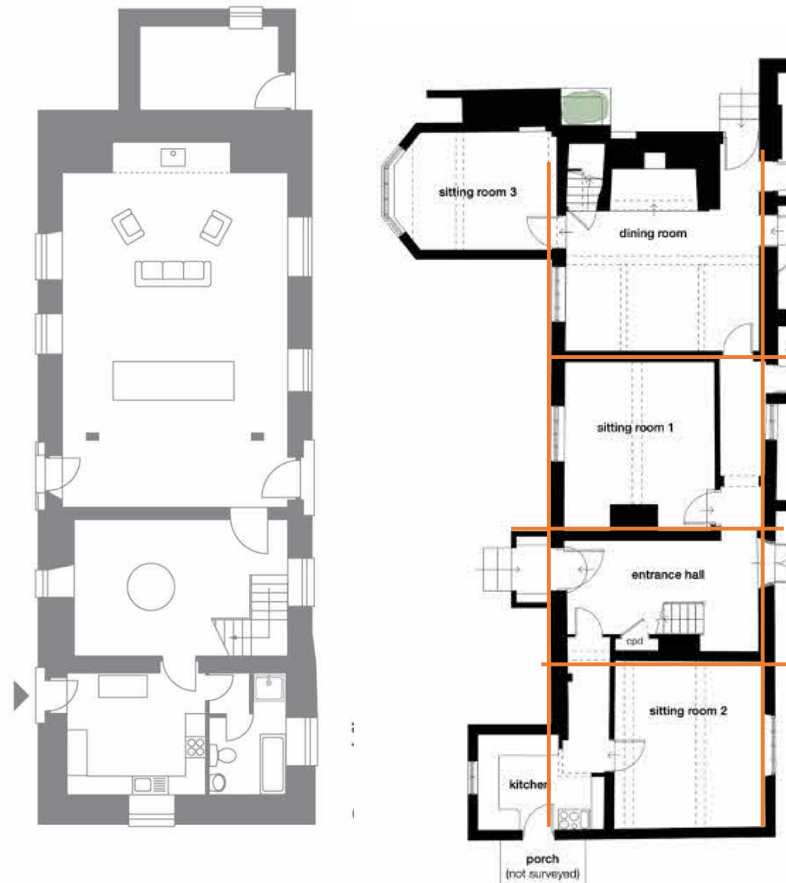
Fig 15. Left: The plan for of Plas Uchaf, near Corwen, Denbighshire, a hall house of c1400; and the ground floor plan of Churton Hall. These are at different scales but the outline in orange of Churton Hall shows the possible layout of the cruck framed hall. Sitting rooms 2 and 3 were added in the 17th century with a lateral chimney to the east elevation. At this time floors and the stairs would have been inserted.

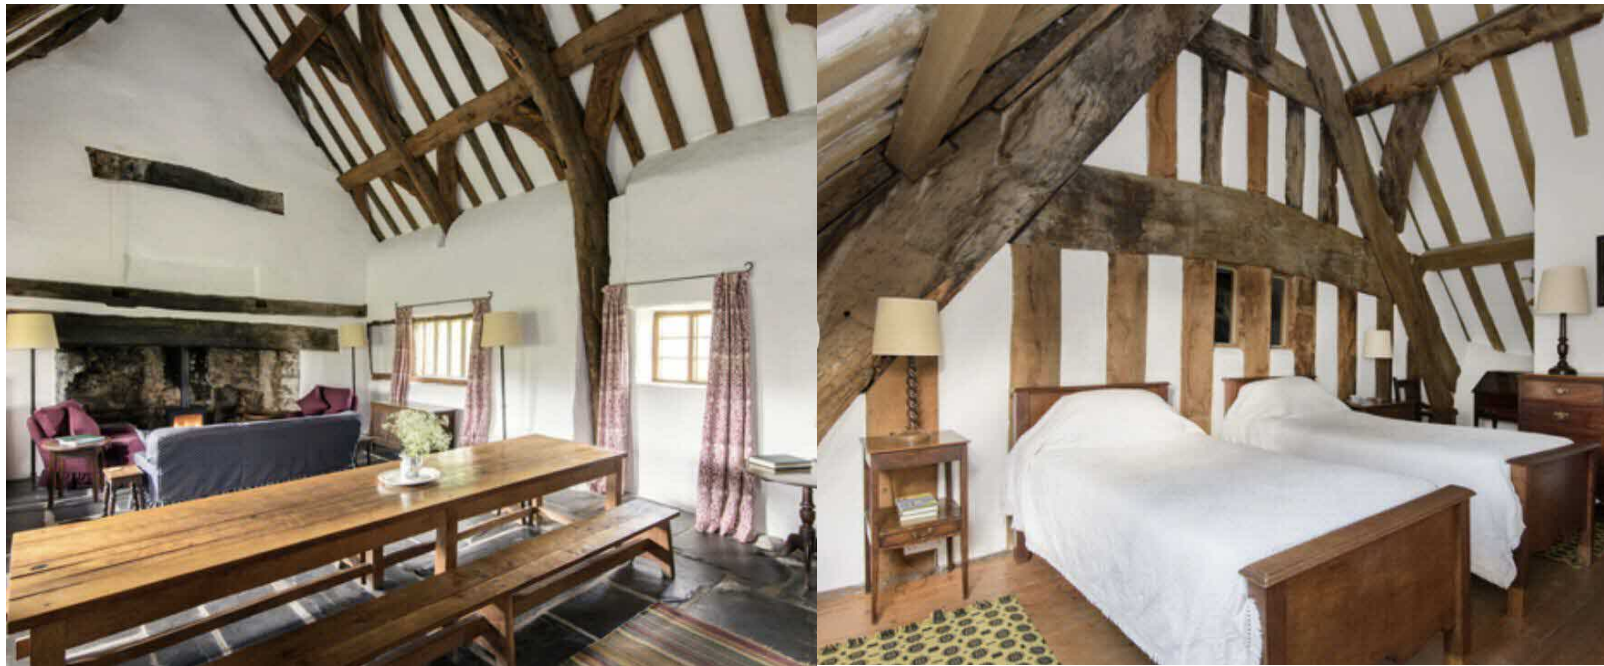
Fig 16. Left: Plas Uchaf, near Corwen, Denbighshire, a hall house of c1400. (Grade I)

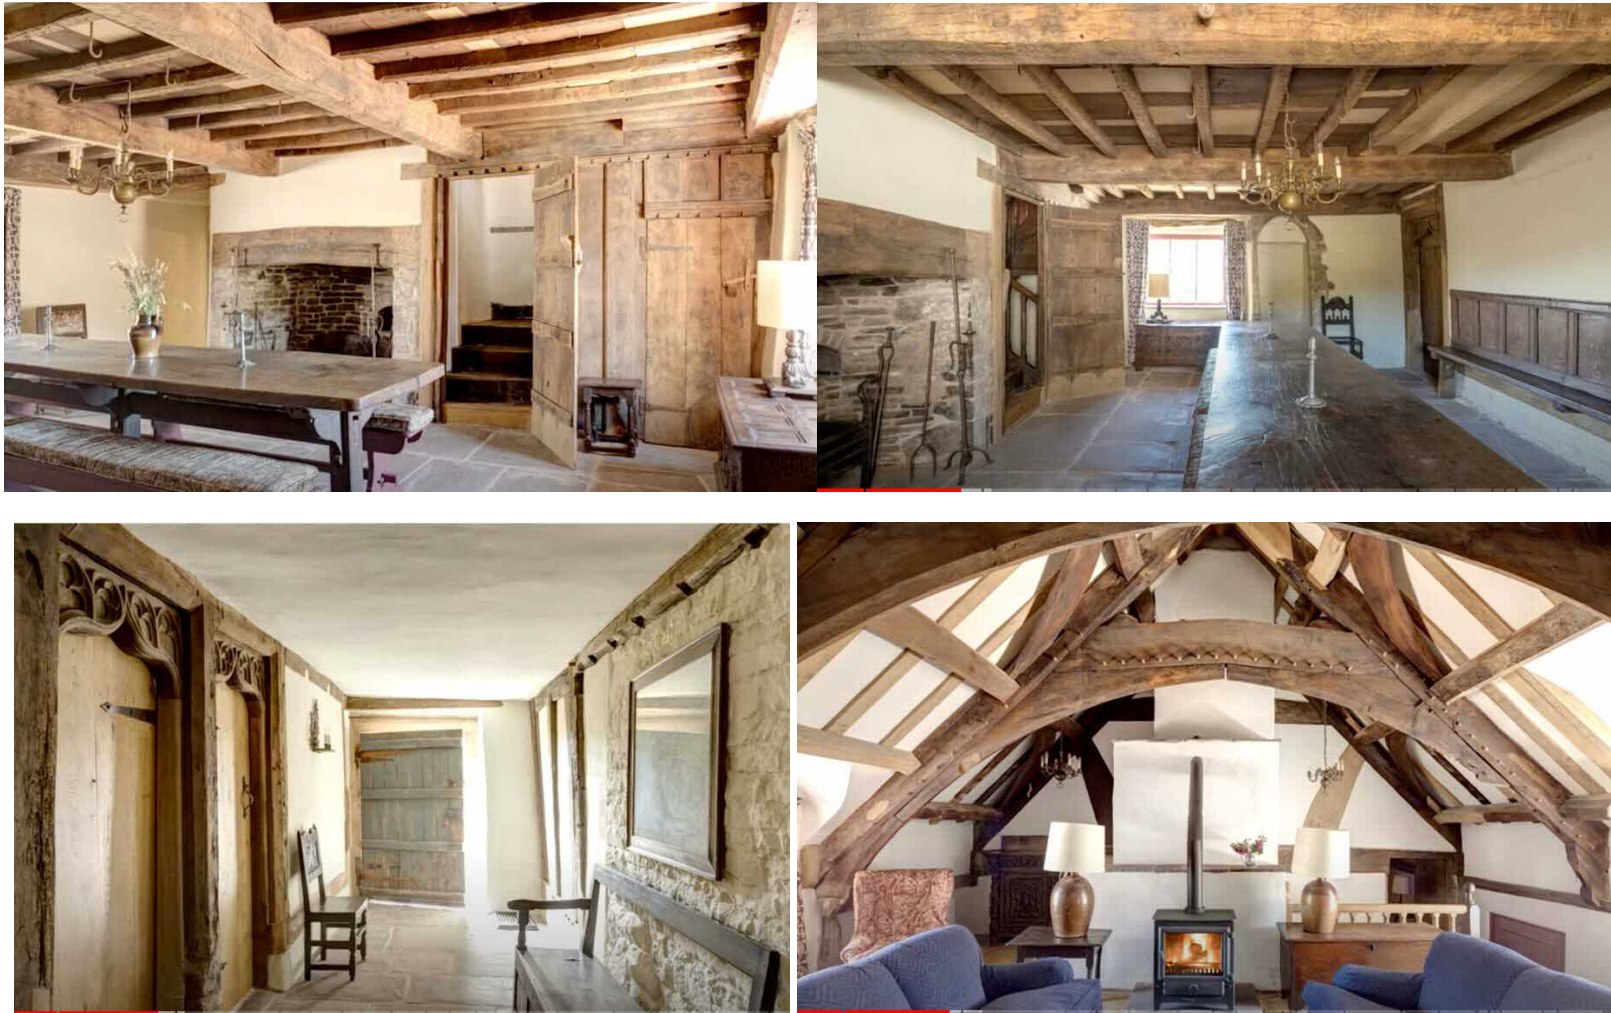
Fig 16: Llyn Celyn, Monmouthshire (Grade I) restored by the Landmark Trust. Note the 17th century fireplace and stairs, and restored timber finishes (top photos); the cross passage (bottom left); the cruck frame with arched brace (bottom right)

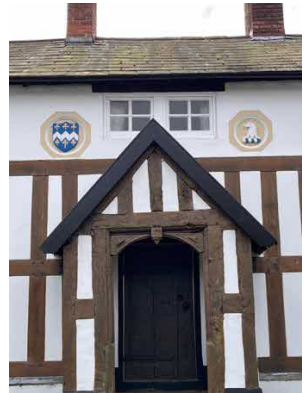
Evidential Value - High	<p>The site has a history of use associated with the Barnston's since the 15th century. Dendrochronology dates the cruck frame from this period. The cruck frame is in remarkable condition. There are also clear stages of development from the 16th, 17th, 19th, and 20th centuries. The site is medieval.</p>	<p>Overall significance High</p>

Historical Value – Outstanding <i>(Special Historic Interest)</i>	<p>The building appears to be a remarkable survival of a cruck framed hall house, uncovered during a soft strip of the building. There is evidence of the upper end being to the west, with the lower service end to the east, including evidence of a screens passage and doors to a buttery and pantry. There are clear sequencing and phasing, including a lateral chimney stack of the 17th century. Internally there are stop chamfered timber beams, and an inglenook fireplace to the east, a possible replaced spiral stair adjacent to the inglenook and various fireplaces dating from the 17th, 18th, and 19th centuries. The survival of the cruck frame and the wattle and daub panels suggest that it is a rare surviving example of its type.</p>

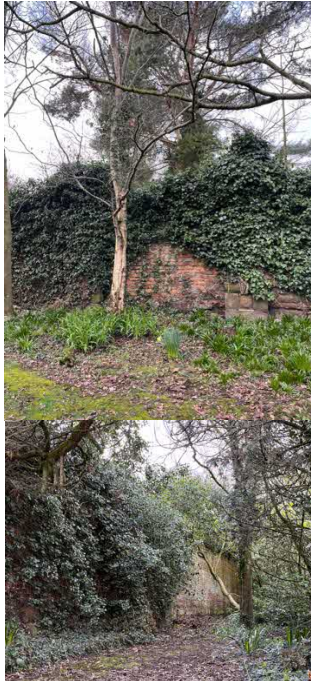
<p>Evidential Value - High</p>	<p>An almost complete if dilapidated wall around a former garden associated with Churton Hall.</p>	<p>Overall significance Medium</p>

<p>Historical Value – High <i>(Special Historic Interest)</i></p>	<p>A structure recorded in an inventory of the 1700’s, at a time when the walled garden and its use, was of key importance to the hall</p>	
<p>Aesthetic Value medium <i>(Special Architectural Interest)</i></p>	<p>The wall is dilapidated and requires recording, repair, and restoration. Features of interest include hidden stone gatepost denoting a more formal entrance, and a dovecot, largely hidden.</p>	
<p>Communal Value - low</p>	<p>The site is in private use associated with Churton Hall.</p>

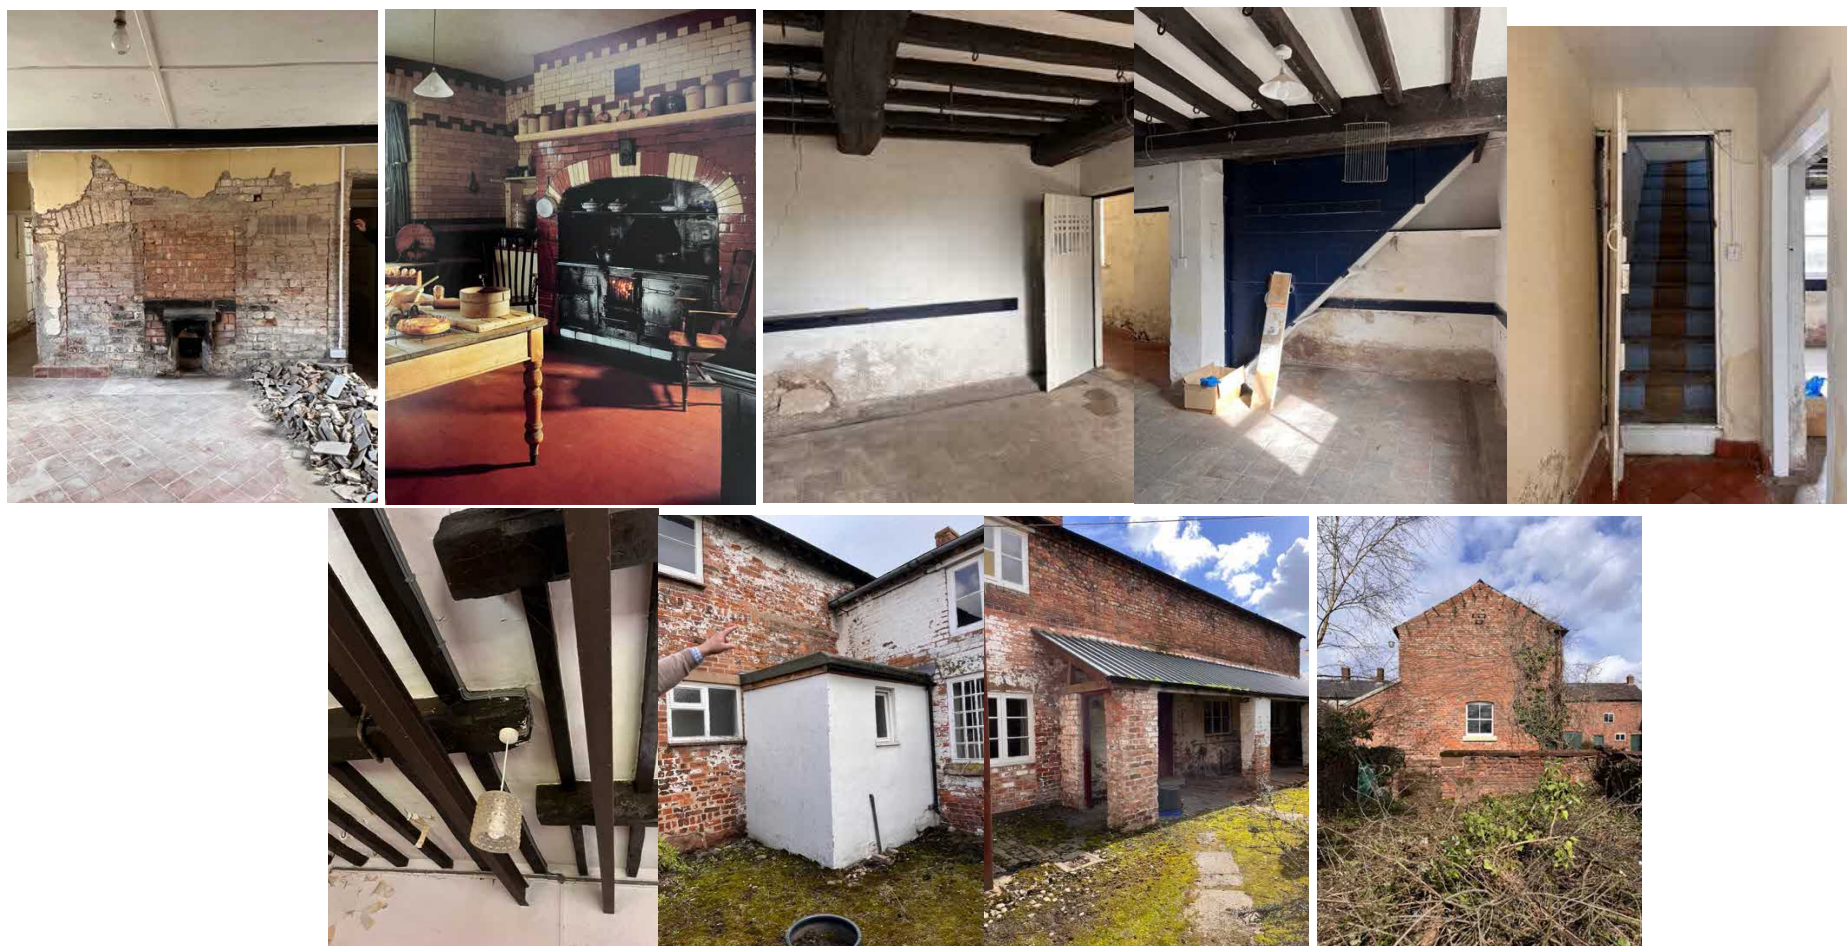
Fig 22. Features of the Victorian wing including from top left to right: the former kitchen range area – the second image is from ‘The Victorian Society Book of the Victorian House’, image 3 and 4 show the meat room and the later staircase to be removed, which will reinstate the room proportions. Bottom left to right; evidence of a missing wall to be reinstated, the flat roofed modern WC behind main house; the functional veranda to be removed – former dairy area; and the south facing gable.
