Ecological Impact Assessment and Bat Survey

SILVER HILL HOUSE, DALTON, NORTHUMBERLAND

SUMMER 2023

Ruth Hadden, BSc. MCIEEM
Ryal Soil and Ecology
Ryal
Northumberland

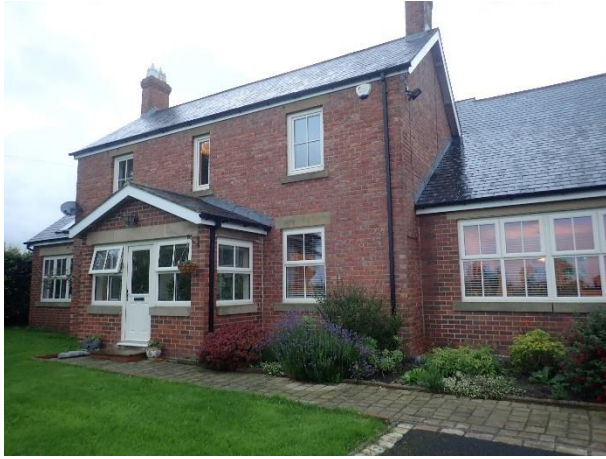
Showing the east gables from the southeast

Silver Hill House from the southeast

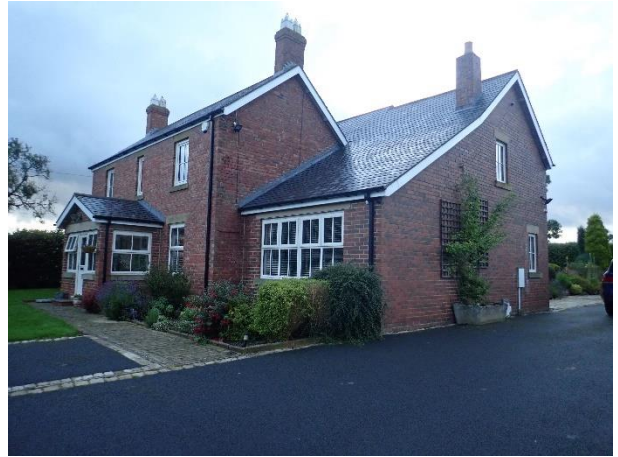
The north aspect from the northeast

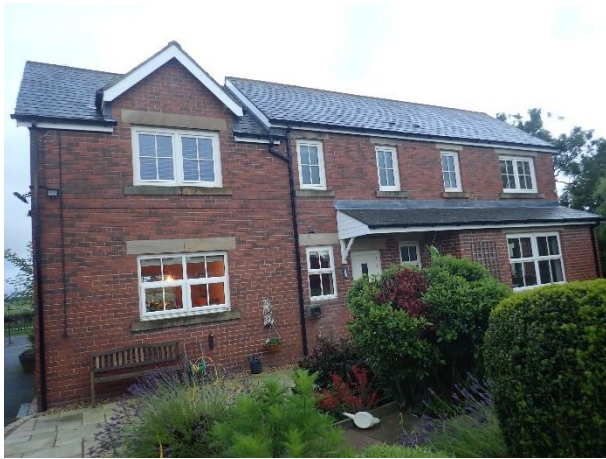
Porch from the southwest

The proposals are to extend the building to create an ensuite bedroom. The eastern extension will be demolished and rebuilt in oak timber. The porch will be demolished and a smaller matching open porch constructed.

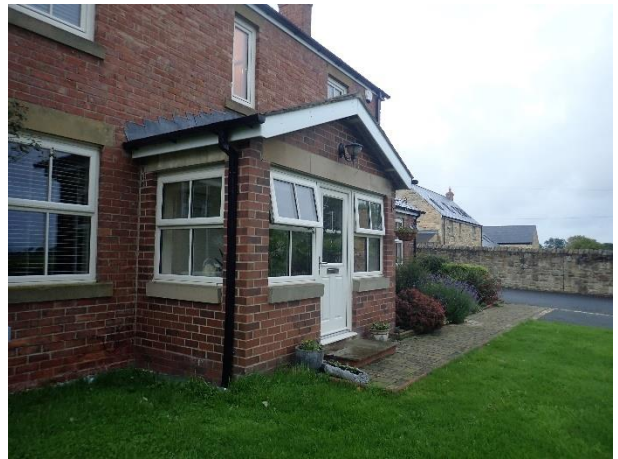
Mortar fillet missing in places

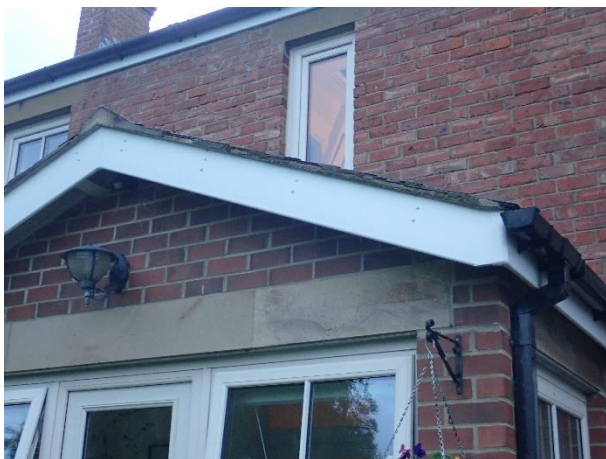
Evidence of nesting birds was seen on site, with a starling nest reported on the east gable wall top and a house martin nest on the east gable apex of the extension. A Tawny Owl and swallows were seen or heard during the surveys.

East gable showing bird lime from reported starling nest

One Starling nest box to be located in a tree to the southwest of the house at a height of 2-3m. Please see references and plan below for location.

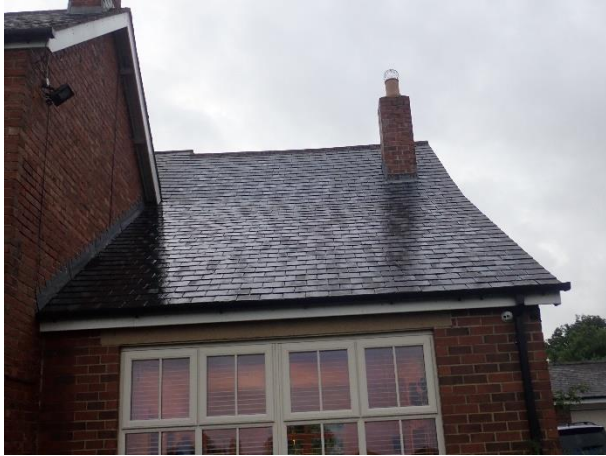
The catslide roof from the south, well-sealed and sound.

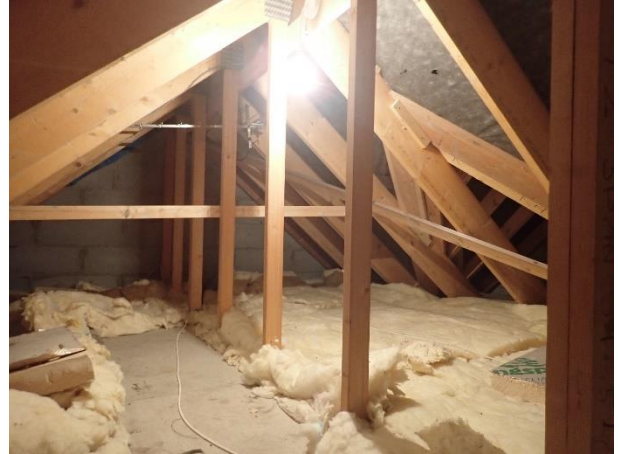
Lofts space of the extension

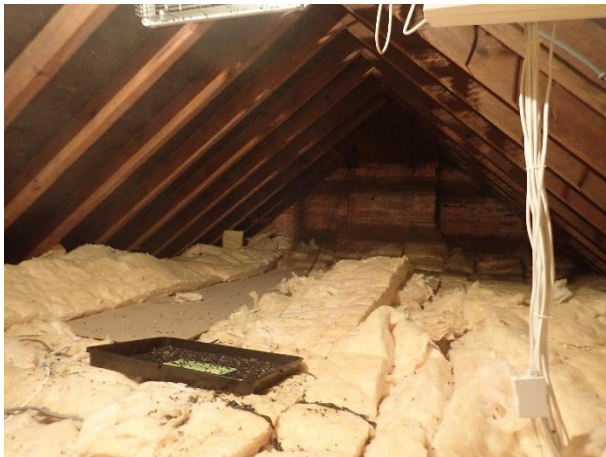
Main house loft space, evidence of cluster flies and occasional mouse dropping

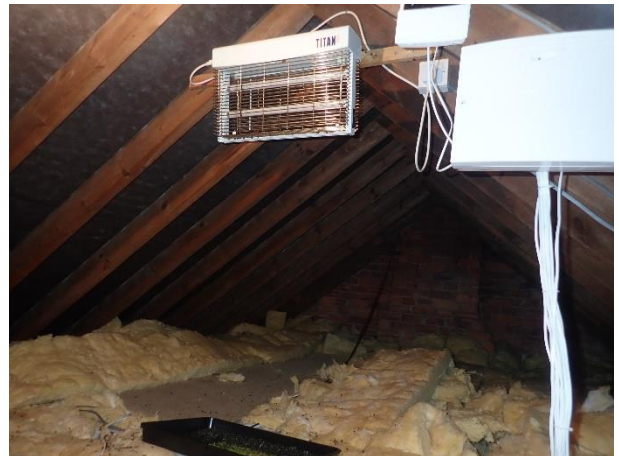
Electronic fly killer within the loft

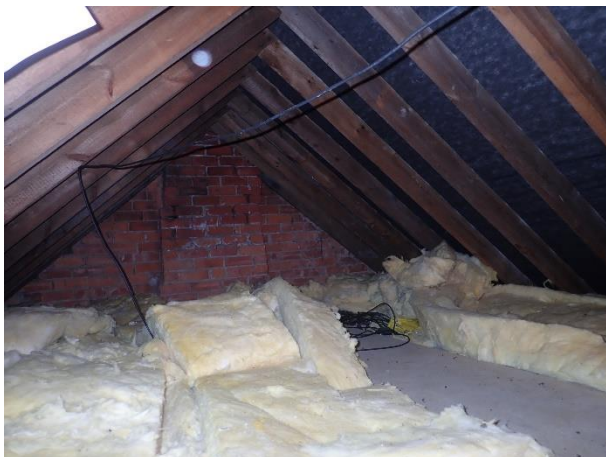
Inspection results of the exterior of the building affected by the proposals, identified no traces or evidence of bats. The building had a pitched slate roof with breathable membrane in both lofts. No evidence of bats was noted. Please see photographs for details. Due to the potential of crevices at the wall tops of the gable wall and below the slates on the porch the site was considered low risk of bat roost potential and one dusk survey were carried out.

Insulation otherwise clean with no evidence of bats

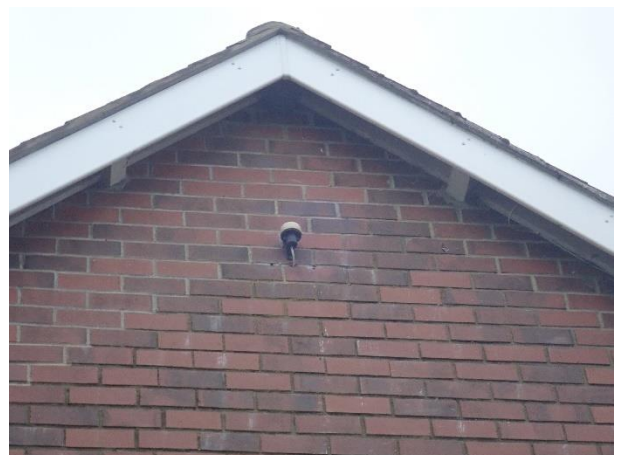
House martin nest at the apex

- A bat and bird Method Statement to be followed during the works on the building.
- Two sparrow terraces to be located at eaves height on the east gable of the garage.
- One Starling nest box to be located in a tree.
- Any external lighting will be on a relatively short timer, directed away from bat roost access points and flight paths and motion-sensitive only to large objects.
- Any nesting bird species that may be present will be allowed access to the nest until the young have fledged between April and October.

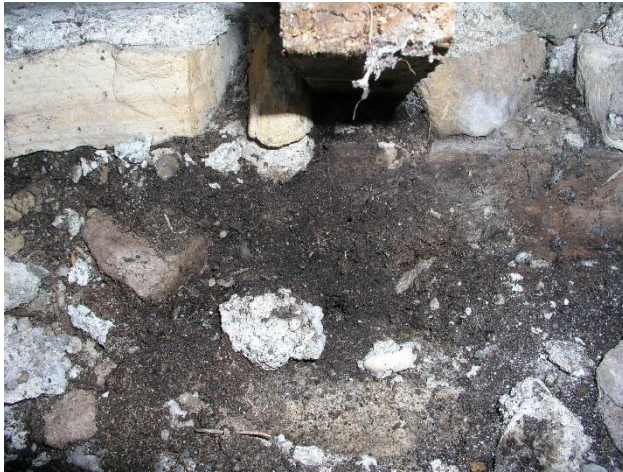
Other traces that can indicate a past presence of bats are their droppings. These resemble mouse droppings but unlike mouse droppings can be crumbled to dust between finger and thumb. Droppings may be found on wall tops and beneath slates and tiles on top of any sarking.

Photo showing disintegrated bat droppings beneath coping stones. If examined carefully, in the black dust exoskeletons of insects can be seen shining.
