GEO-ENVIRONMENTAL AUDIT

PHASE 2 Site Investigation & Risk Assessment

Proposed Residential Development

Former Albert Mill

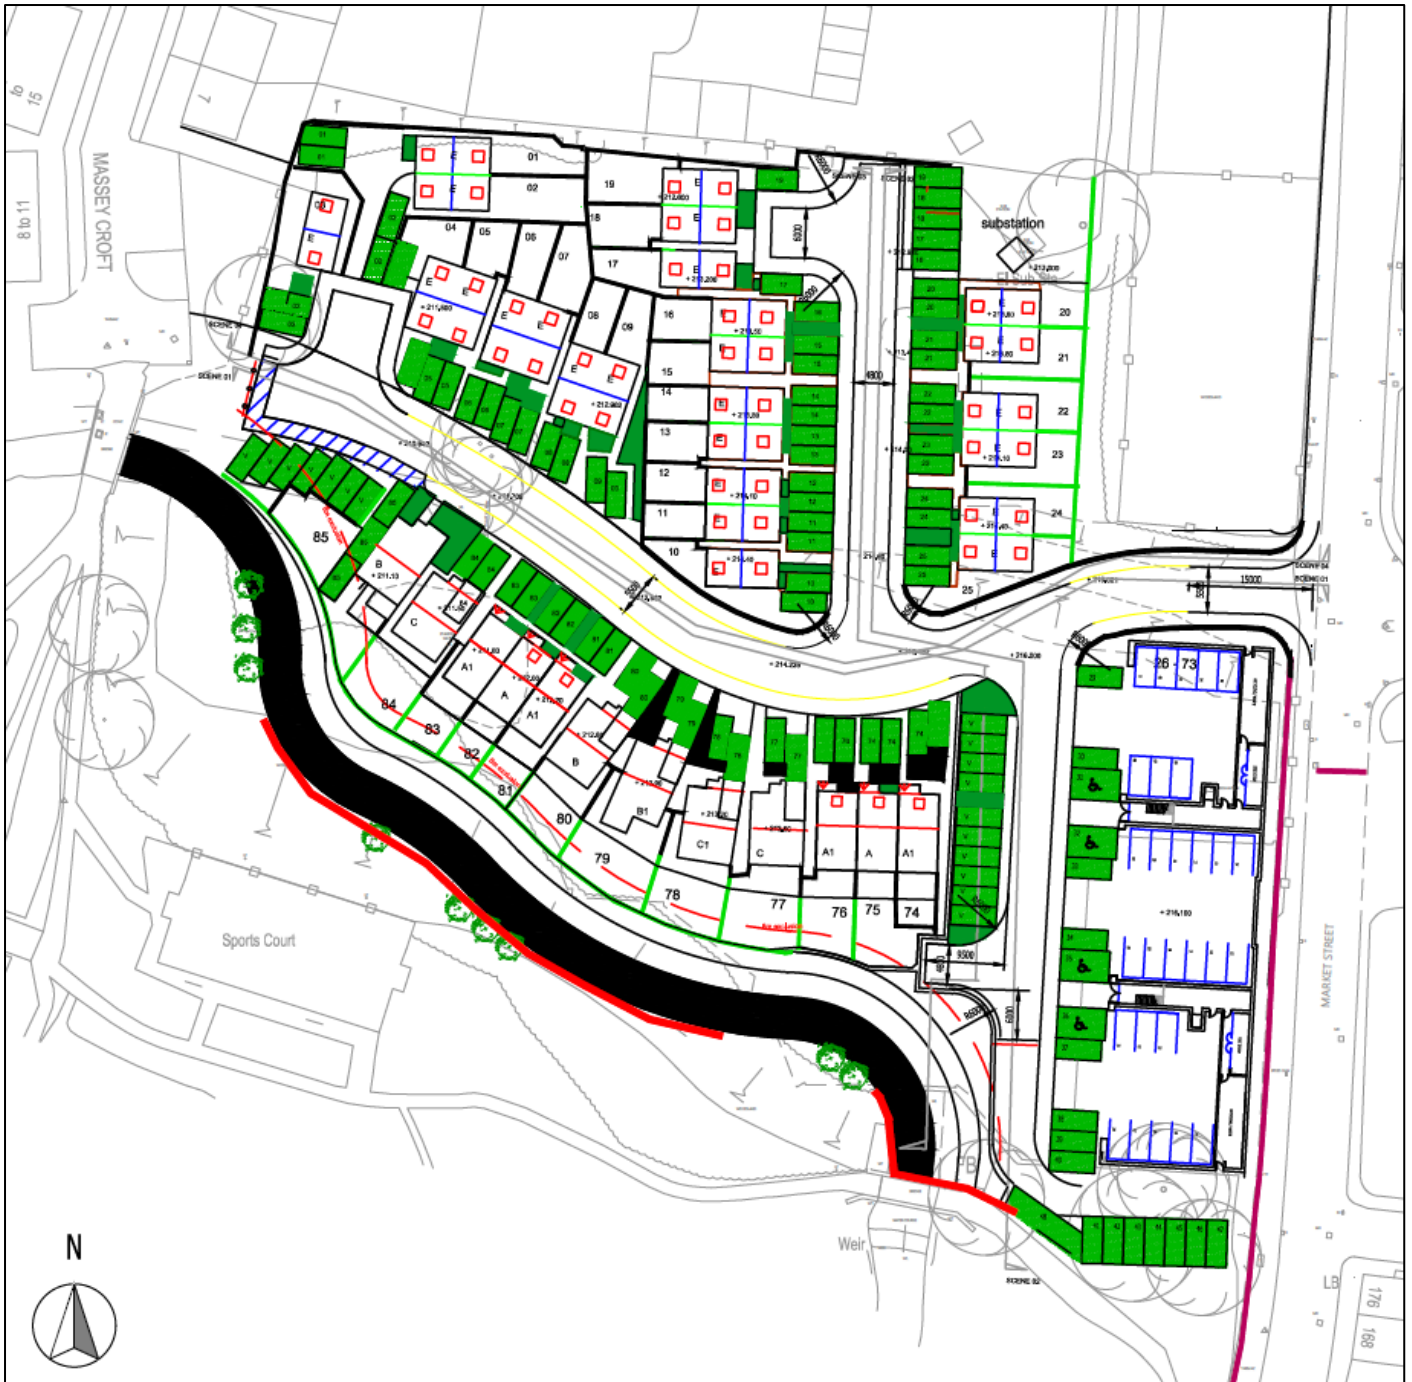
4.2. Proposed Development.

The proposed development is for the erection of 37No. dwellings and 48No. apartments. The dwellings are to have driveways and rear garden areas. The proposed apartments are proposed to have an undercroft/garage parking areas.

The Site is located at the bottom of the Market Street highway retaining wall and thus a new access road will be created into the Site which bridges the difference in level of approximately 9m.

As part of the proposal, Site levels are to be increased by 2-3m (under appropriate licences to be obtained from the Environment Agency), to bring the Site in level with the surrounding land to the north & west sides, and lessening the level difference to the east side highway retaining wall.

The partially culverted river channel will also be rerouted through the Site, providing a wildlife corridor to the south side with new green slope embankments down to the river bed.

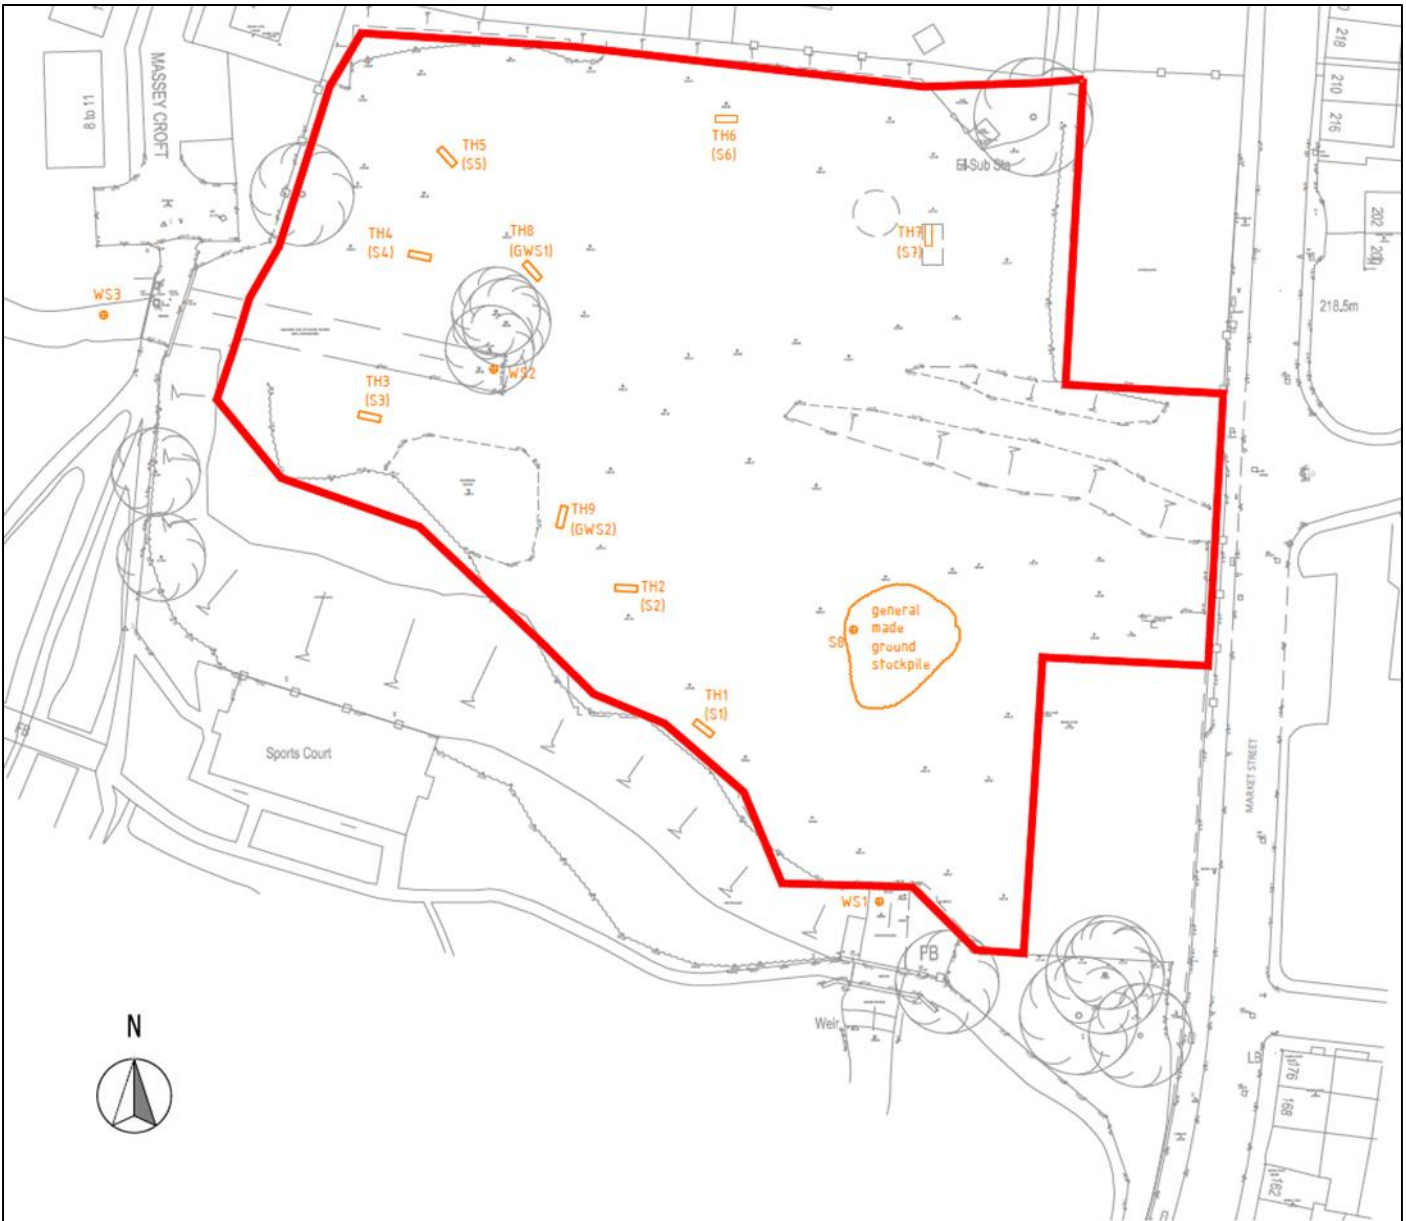
4.3. Site Investigation Plan.

THs1-7	trial holes	TJBA	17.04.2023
S1-8	soil samples	TJBA	17.04.2023
THs8-9	trial holes	TJBA	20.07.2023
WS1-3	water samples (river)	TJBA	20.07.2023
GWS1-2	water samples (ground)	TJBA	20.07.2023

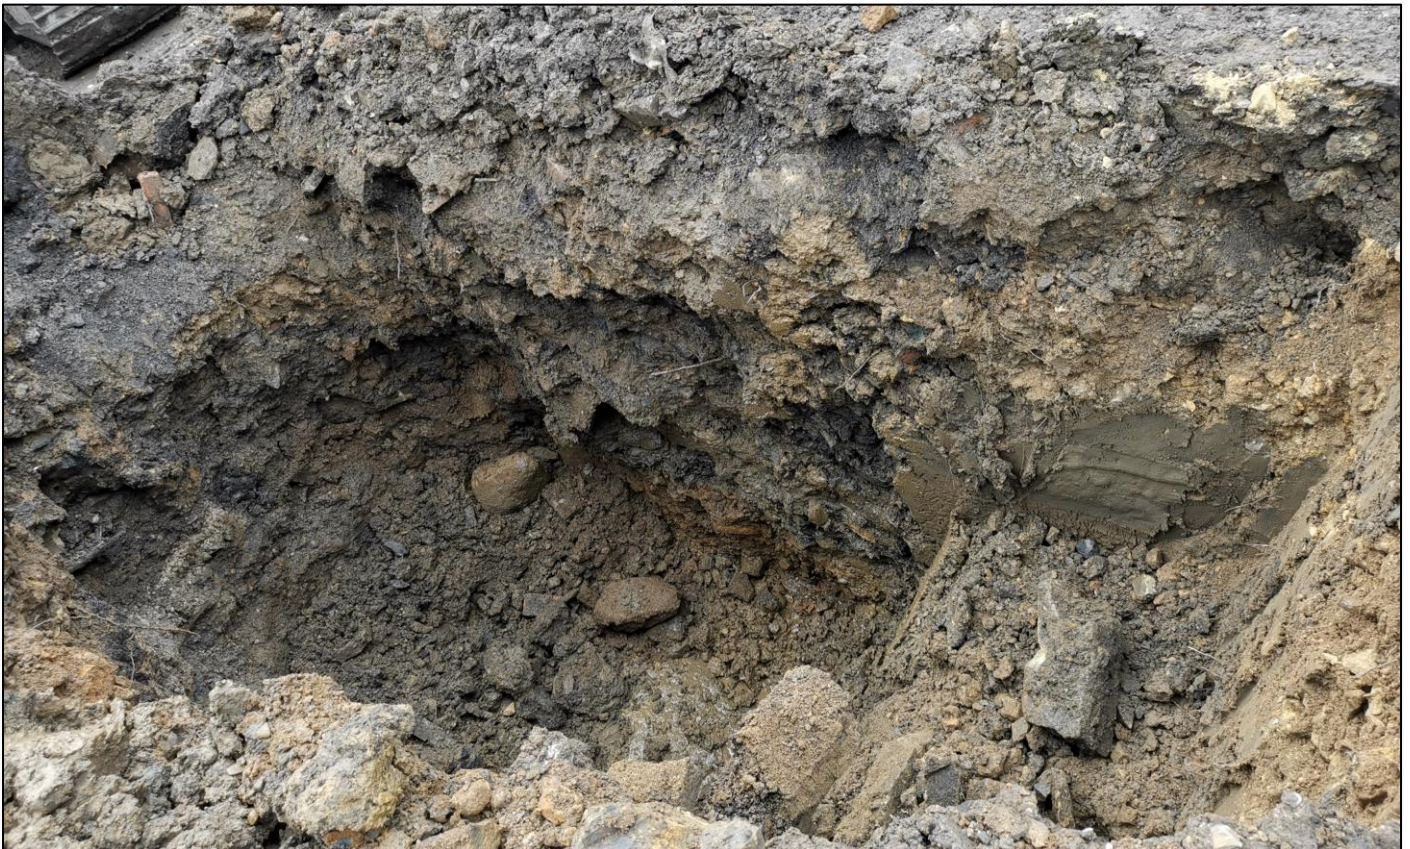
Trial Hole 2.

- THs2 & 3 were undertaken in general areas adjacent & beneath some of the former mill buildings (TH2) & around the former mill pond (TH3). The trial holes revealed between 900-2000mm silty sand & gravel made ground which appeared to be moved/replaced alluvial material possibly placed in situ due to historic groundworks associated with the pond. Virgin alluvial sand & gravels were noted below to bottom of hole. Groundwater noted at 1800mm (TH2) and 3000mm (TH3).

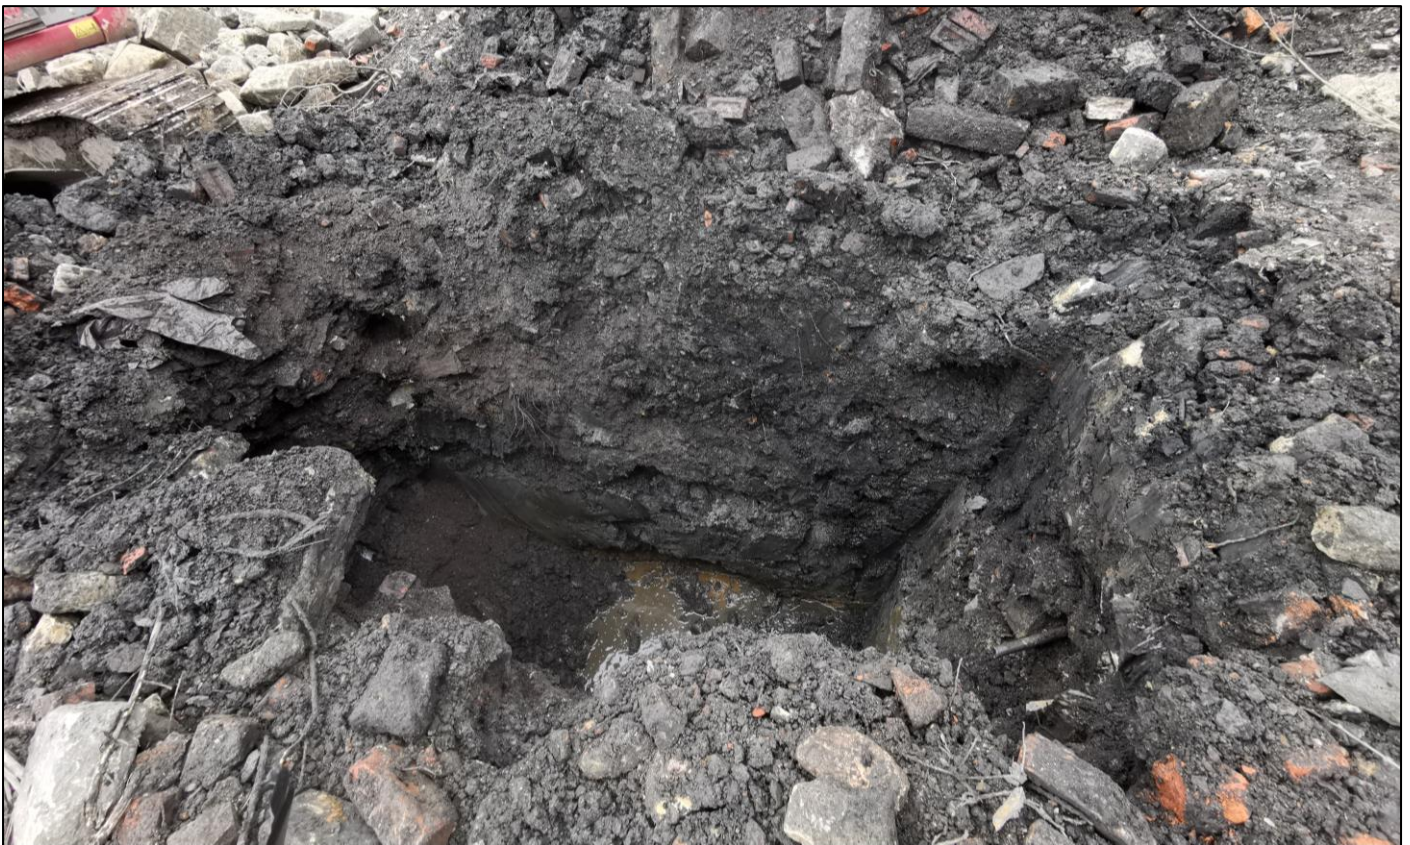
Trial Hole 4.

- TH4 & 5 situated around the former 1960s tanks to the west side of the former mill buildings. The trial hole revealed between a 1800-2200mm made ground of clayey demolition fill with abundant cobble & boulders of brick, stone, slate with rare glass, pottery, plastic etc. A slight organic/hydrocarbon odour was noted in these THs. The made ground was underlain by virgin boulder clays with groundwater perched on top of the clay in both THs at respective depth (1800-2200mm).

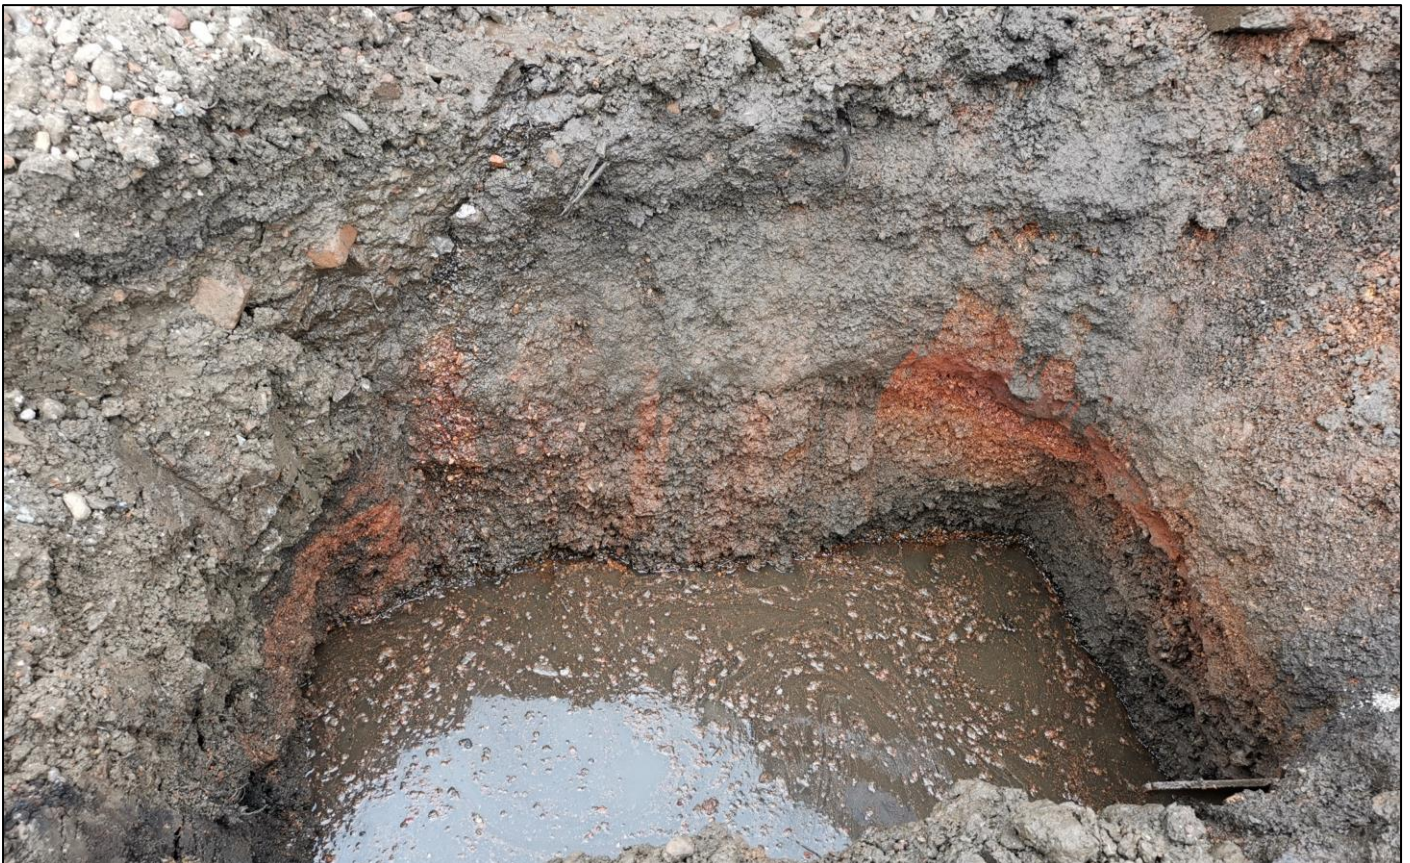
Trial Hole 6.

- THs6, & 7 were located around the north boundary to target the 'refuse tip' and infill in this area, and TH7 also positioned local to the former tanks to the northeast of the Site. In both trial holes ash fill was found to 1900mm depth in TH6 & to 3000mm in TH7 (due to GL changes). In both holes firm boulder clay was noted beneath the ash fill. There was no visual or olfactory evidence of hydrocarbon contamination in either of the trial holes. Abundant groundwater was noted which quickly inundated the holes due to the porous nature of the ash fill and was noted at approximately 1500 to 2500mm depth bGL again perched on top of the clay.

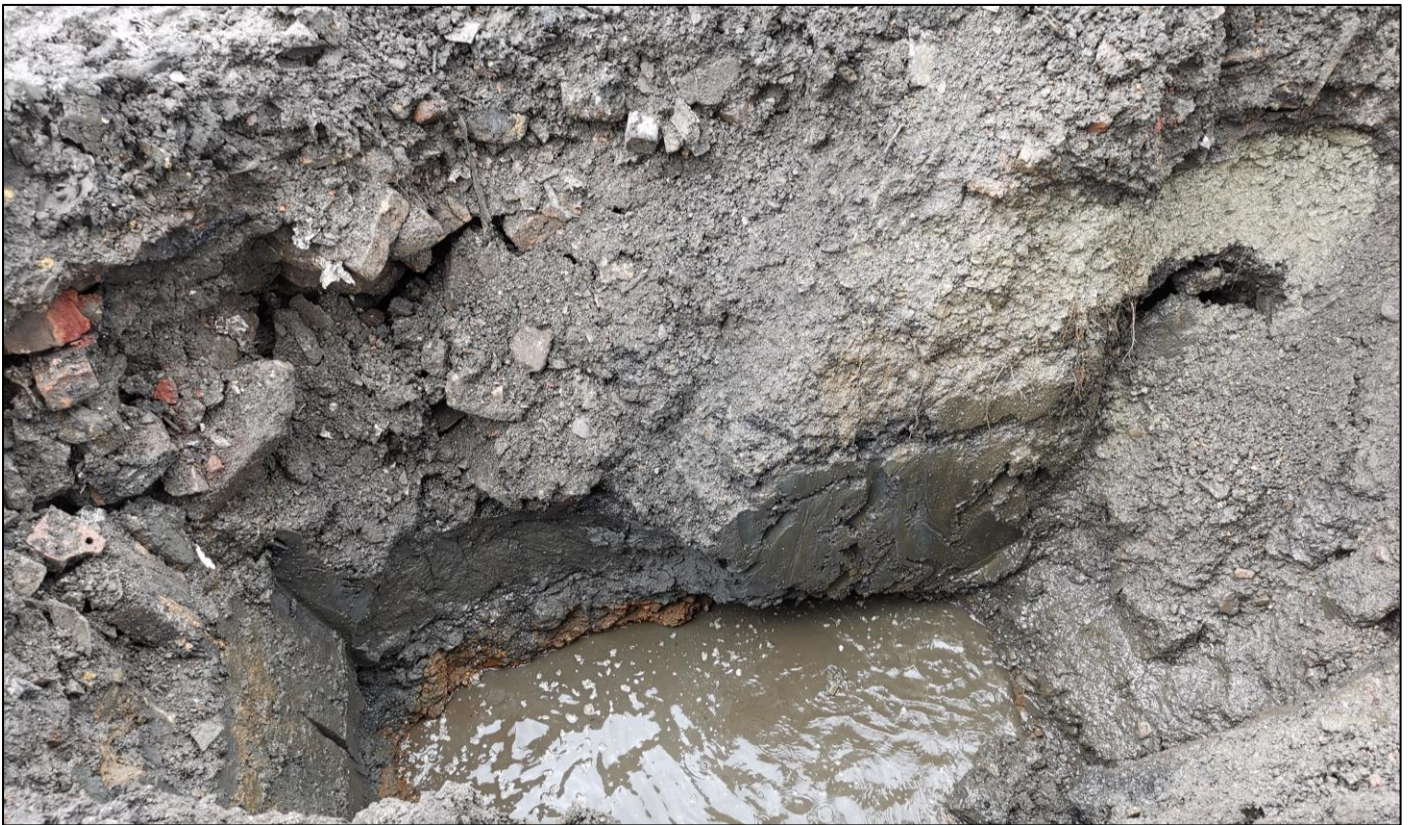
Trial Hole 8.

- TH8 was positioned in the location of THs4 & 5 to the north side of the River Spodden (the location of hydrocarbon odours in the earlier investigation). The trial hole revealed 1500mm of made ground comprising a clayey sand & gravel demolition fill with abundant cobble & boulders of brick, stone, slate with occasional plastic etc. The made ground was underlain by virgin clays with groundwater noted at 2400mm depth.
- TH9 was located to the south bank located between the old mill pond and the former mill buildings. The trial hole revealed a relatively thin made ground (400mm) of clayey demolition fill over alluvial gravelly clay over alluvial clays. Groundwater was noted at approx 2600mm depth.
