Bat Survey Report

The Hermitage

**Batchmere Road
Almodington
West Sussex
PO20 7LD**

23-078
September 2023

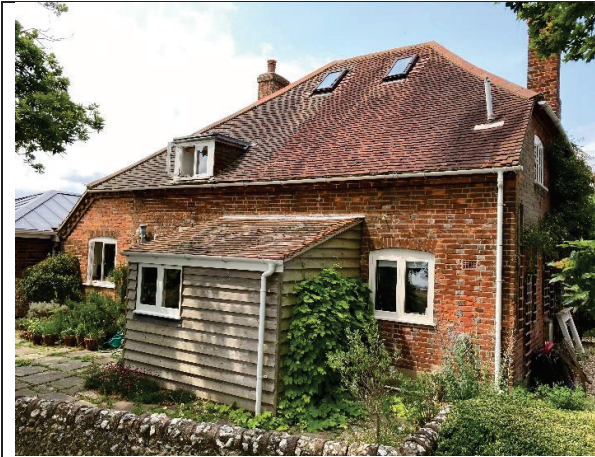
- 4.1 The building is a two-storey, brick-built dwelling with a half-hipped roof supporting a mixture of hand and factory-made clay roof tiles. The southern hip extends to a catslide roof, with a more recent single-storey extension to the southern elevation supporting a pitched metal roof. Attached to the eastern side of the building is a single-storey lean-to clad with wooden weather boarding and a pitched roof of factory-made clay tiles.

Photograph 1: *The eastern elevation of the house*

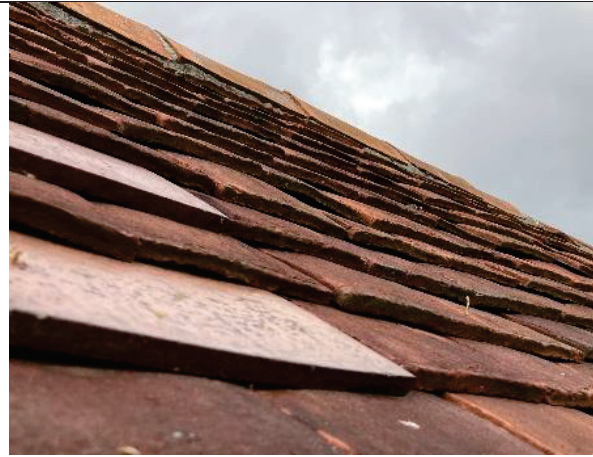
- 4.2 Externally, there are numerous gaps suitable for access by bats on all elevations of the house beneath lifted roof tiles, mortar gaps in the brickwork and beneath the lead flashing on the east-facing dormer.

Photograph 2: *Hand-made roof tiles on the eastern elevation as seen out of the pitched roof windows*

- 5.2 The daytime assessment identified high potential within the building for use by crevice-dwelling bats due to the presence of numerous external gaps beneath lifted roof tiles and loose lead flashing providing access into the batten spaces, as well as mortar gaps in the brickwork.

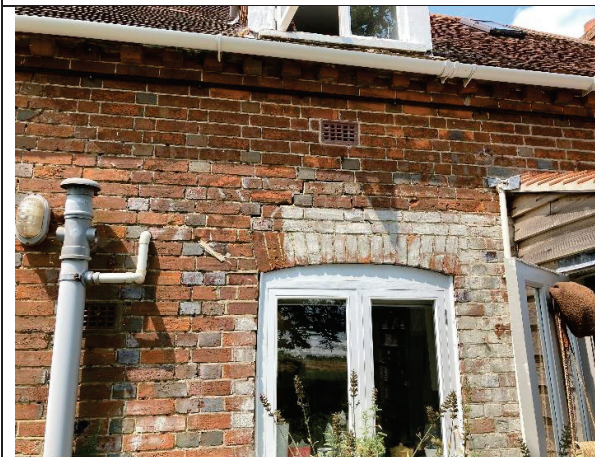
Photograph 3: *Mortar gaps in the ground floor brickwork*

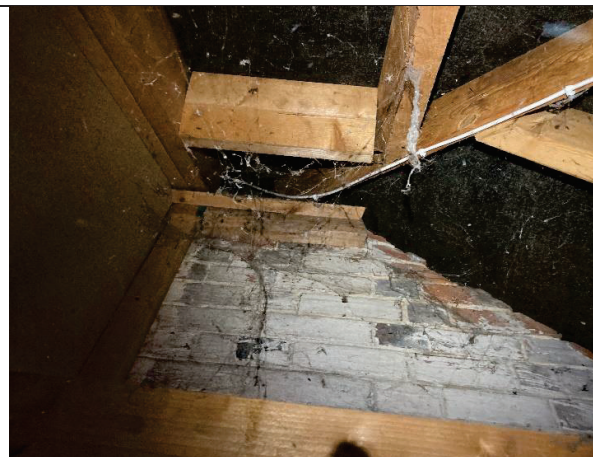
- 4.3 The house has two roof voids, the first is located on the south-eastern corner of the building and accessed from the ground floor. This void is no more than 2m³ in size and heavily cobwebbed. The roof is lined with bituminous felt and light ingress was noted along the eastern side of the void. No droppings typical of bats were found within this void and the large amount of cobwebbing present suggests this void has not been used by bats recently, if ever.

Photograph 4: *The first roof void showing heavy cobwebbing*

- 5.3 The conversion of the central roof void has resulted in bright internal conditions and a complete lack of suitable roosting provision, this void is therefore considered to hold negligible potential for void-dwelling bat species. The very small size of the other roof significantly reduces its suitability for bats, and it is considered unlikely to have been used by void-dwelling species due to the very high level of cobwebbing.

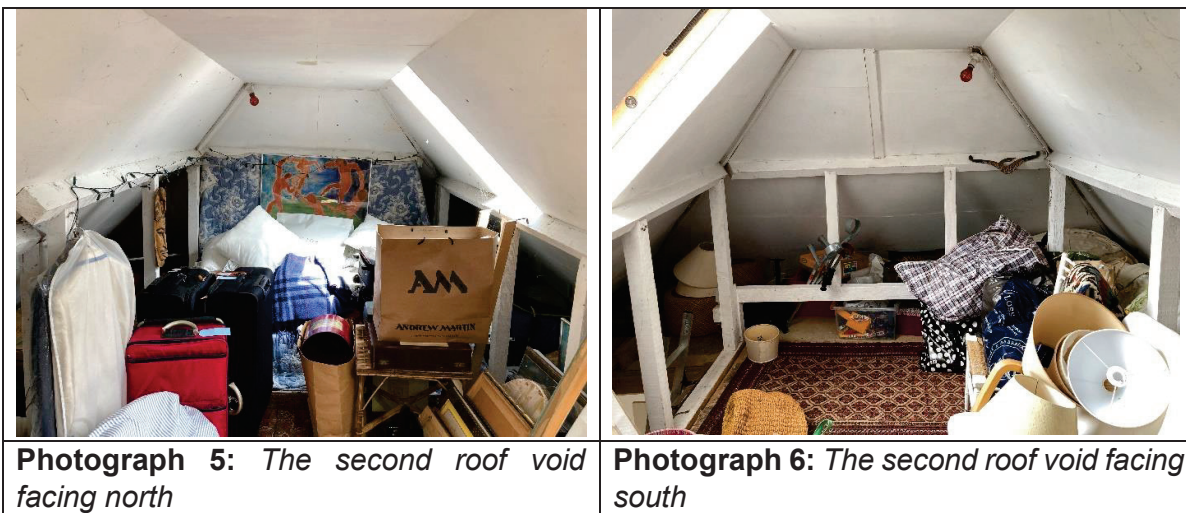
4.4 The second void is located centrally over the first floor, it has been converted into ancillary living space with two roof light windows located along the eastern side of the void and is in current use as a storage space. The void is boarded internally, small gaps in the boarding revealed the roof to be lined with bituminous felt, with fibreglass insulation observed between the felt and the boarding in some places. No evidence of bats was found within this void.

Photograph 5: The second roof void facing north

Photograph 6: The second roof void facing south

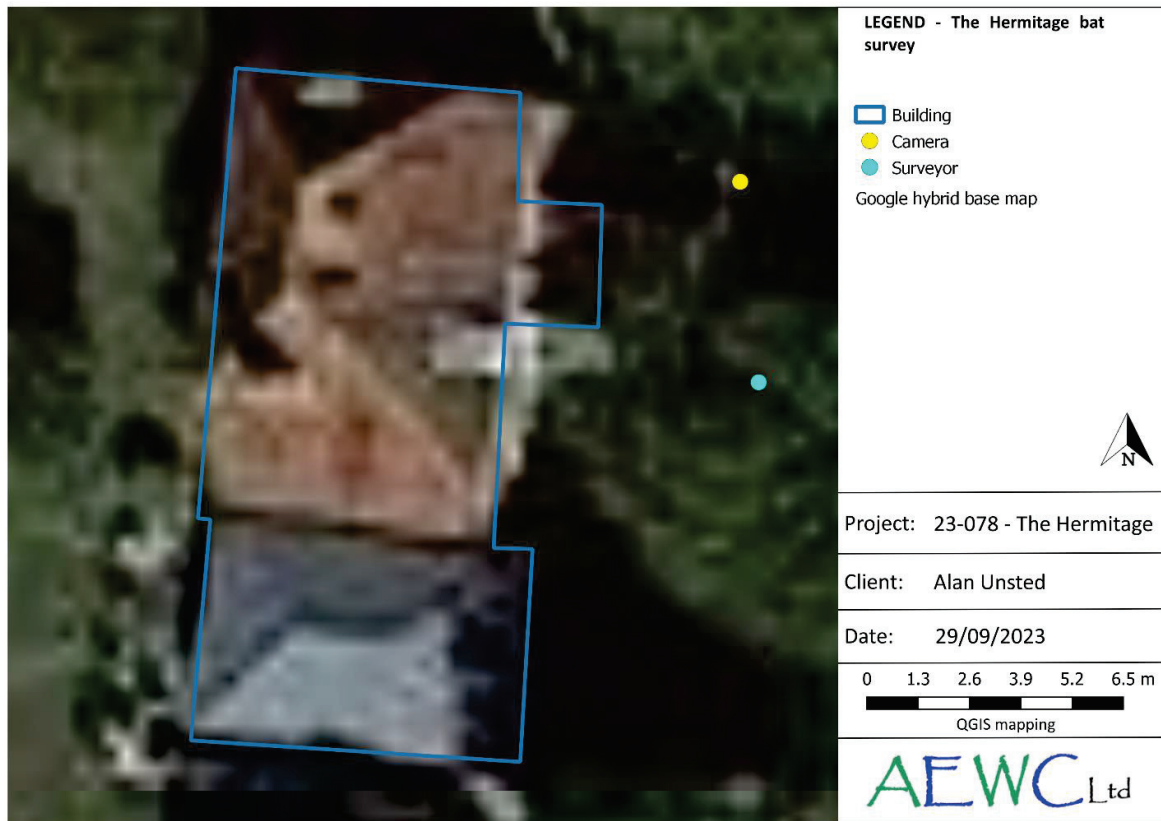
FIGURE 4: SHOWING POSITIONS OF THE SURVEYOR AND NIGHT VISION CAMERA DURING THE THREE EMERGENCY SURVEYS.

- 2.11 Three emergence surveys were undertaken at The Hermitage. Each survey was undertaken by a single surveyor and single night vision camera watching the eastern elevation of the building, the only area to be affected by the development proposals. The surveyor and camera were positioned to get a good all round view of the impact areas.

- 4.9 A diagram showing the locations of the surveyor and night vision camera during the evening surveys can be seen in Figure 4 below.
