-The drawings show a proposal for the replacement of the existing chimney stack. The intention is to take it down to the ridge line, rebuild it using salvaged stone, replace perished ashlar stone, and renew the chimney capping.

Proposed Chimney - West Elevation 1:20 scale

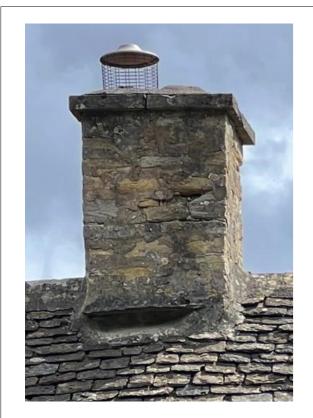
-The chimney capping and ashlar stones show signs of deterioration and require a restoration to prevent any harm caused by falling parts and bring back the original appearance of the chimney.

- The chimney is shared with the adjoining property, No 16; therefore a Party Structure Notice will be served.
