**Ecological survey:
Protected species and habitats.**

**Corner Farm,
Hoxne,
Suffolk.**

Final report: 30th June 2019.

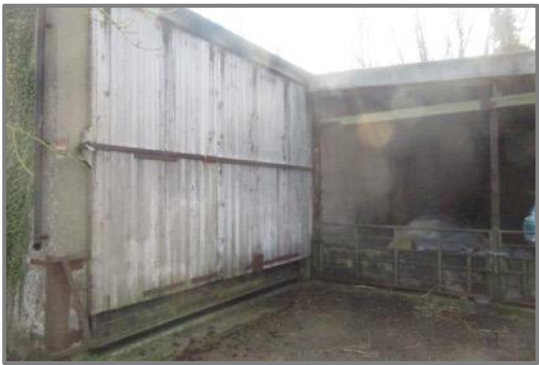
Image showing building A, showing construction around steel portal frame with large doors and open canopy.
Photo 2

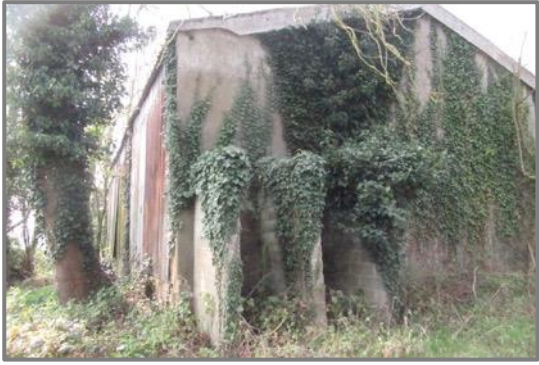
Image of the exterior of building A showing block gable end wall and metal sidewalls. Also showing ivy on gable end wall.
Photo 3

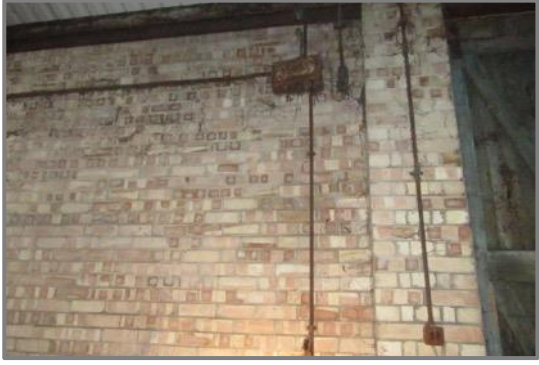
Internal image of building 1 showing solid brick walls.

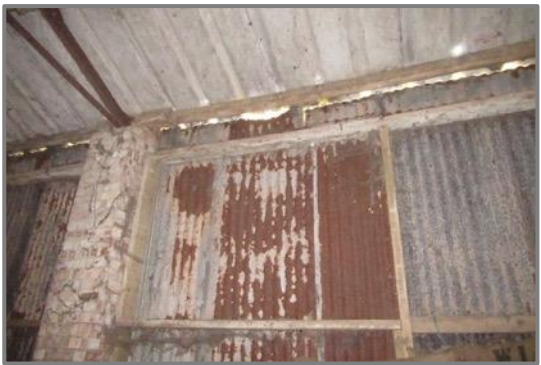
Internal image of building A showing corrugated metal side walls and cement fibre roof supported on simple metal roof trusses.

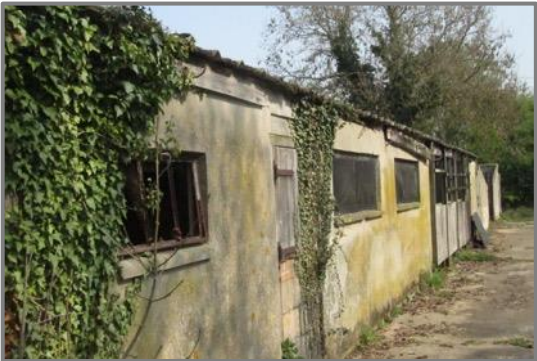
External image of building B1, a block wall construction with cement fibre roof.
Photo 6.

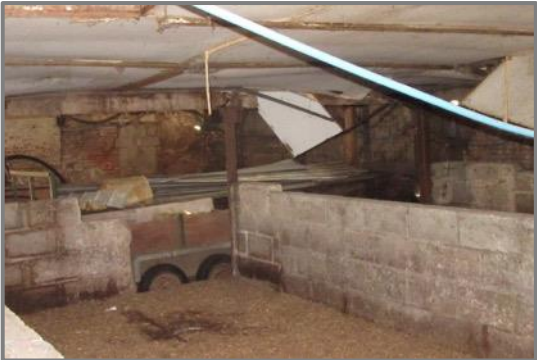
Interior of building B1 showing roof lining and metal frame.
Photo 7.

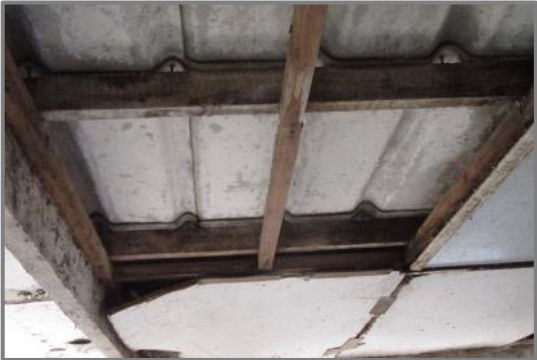
Image showing the cavity within building B1 with a cement fibre roof supported on a timber frame and clad with fibreboard.
Building B2		
Photo 8.

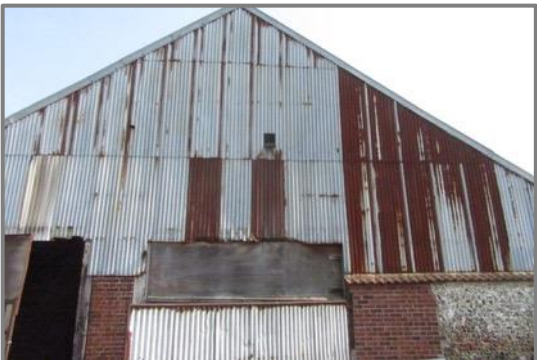
Exterior of building B2 showing the gable end wall constructed with corrugated metal sheet over brick and block walls.

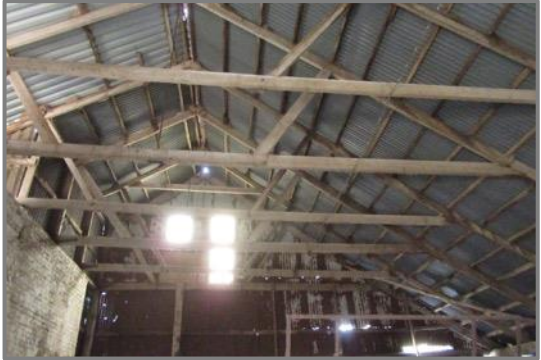
Image to show the interior of building B2 showing roof construction with simple timber trusses supporting a metal profile sheet roof cladding.

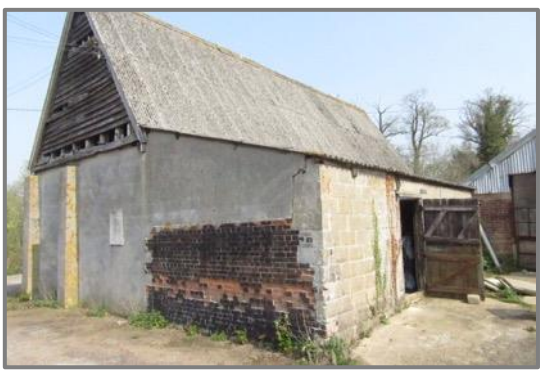
Image to show the exterior of building C showing roof cladding with cement fibre sheeting, and wall construction from solid concrete blocks with sections of timber cladding to the gables.

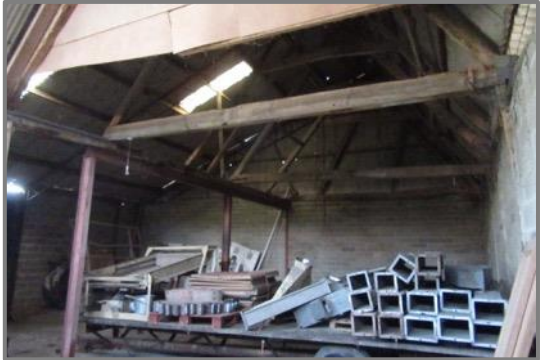
Image of the interior of the barn, showing the combination of traditional timber frame and recent steel supporting frames.
Photo 12

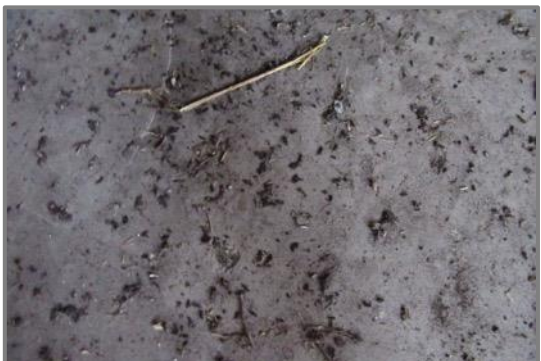
- Evidence of bats was found within the buildings in the form of feeding remains and bat droppings.
- The building includes features favourable for roosting bats such as an open joints in the timber frame.

Illustration of bat droppings below open joint in the timber frame.
Photo 13

- Evidence of bats was found on the site within buildings C.
 - A Natural England European Protected Species Mitigation (EPSM) Licence will be required prior to works starting on site, the EPSM licence is applied for after planning has been granted and prior to works starting on site.

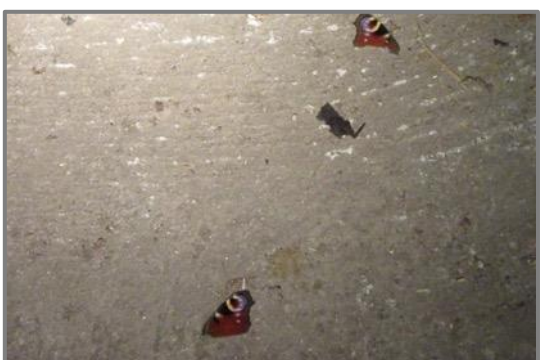
Illustration of feeding remains found generally scattered throughout the interior of the building.
Photo 14

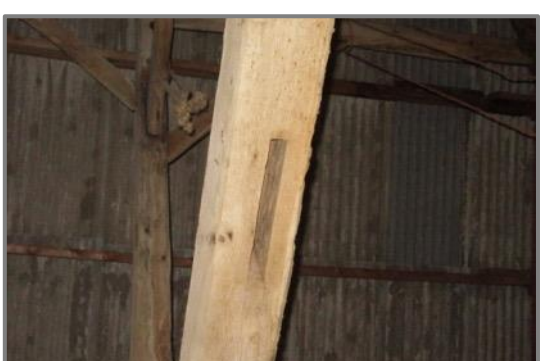
Illustration of open joint in the timber frame, clean and polished within suggesting that it has been used by roosting bats.

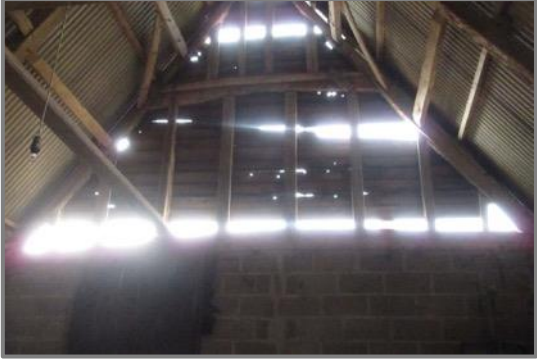
Illustration of timber clad gable end wall which offers easy access into the internal spaces of the barn for roosting bats.

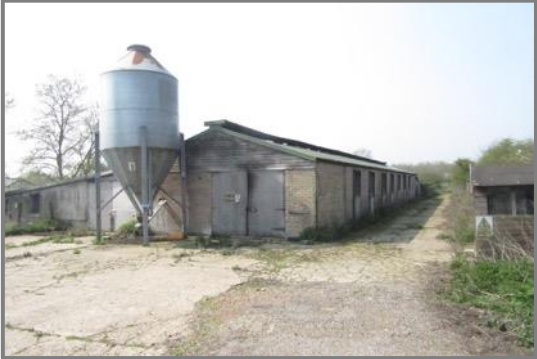
Illustration showing the general construction of building D&E, showing brick and cement fibre walls and metal profile sheet cladding to the roof.

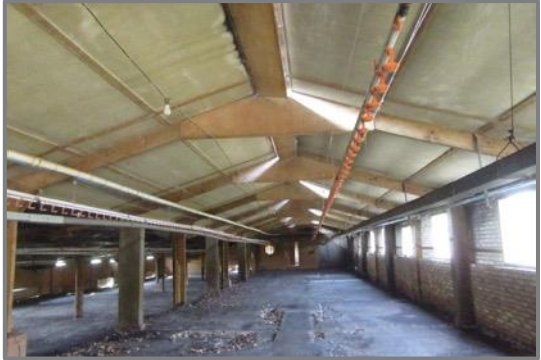
Illustrating the interior of the building and showing the roof lining and the internal space well illuminated by windows along the walls..
Photo 18

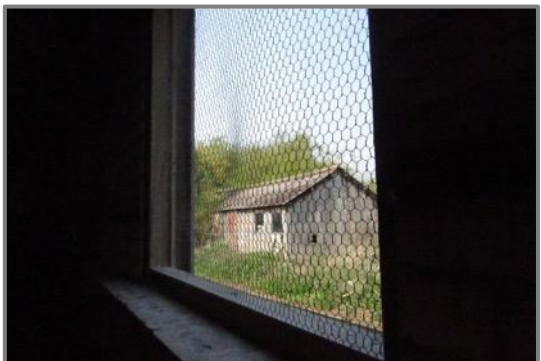
Illustration of the windows clad with mesh to prevent bats and birds entering the building.
Photo 19

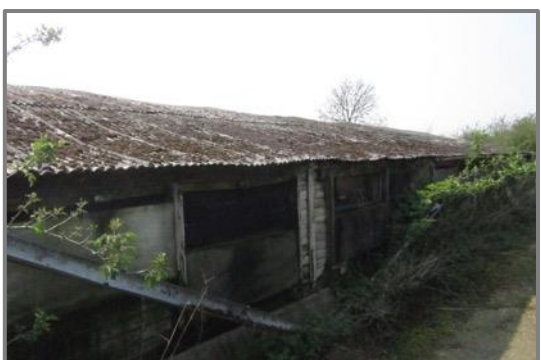
Illustration of building F, showing exterior with timber cladding and cement fibre roof.
Photo 20

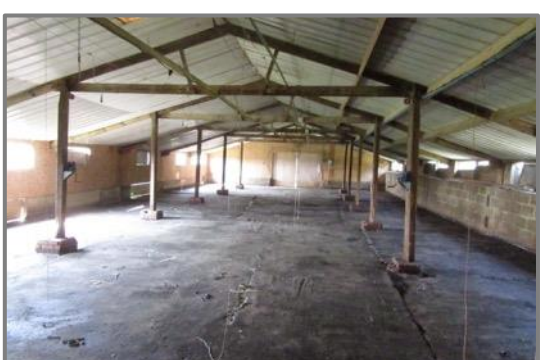
Showing internal space well illuminated by open windows (as photo 18 above), also showing lining to the roof and timber lining to the walls.

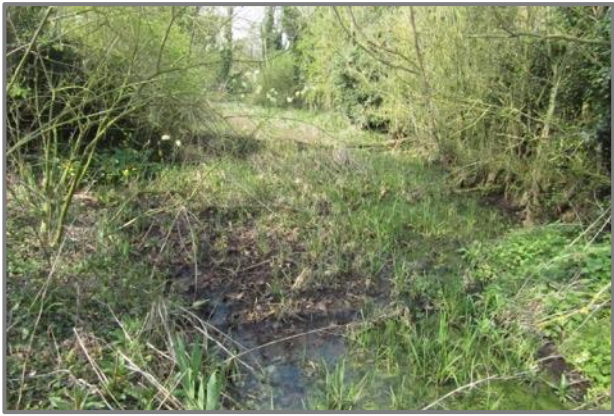
Table 7. Great Crested Newt Habitat Suitability Index (HSI)									
Background Information									
Pond Number	1		Survey date	8 th April 2019					
			Location	Corner Farm OS Grid ref: TM19097734					
Access	Good all round		Dist. from development	Within the development site					
			Surveyor	J Parden. NE licence: 2016-20270-CLS-CLS					
General description. A garden pond set within the grounds and managed garden of the domestic residence on the site. The pond is shaded by surrounding planting including tall trees and low shrubs and hedgerows with lower branches spreading over the surface. Beyond the shrubs the pond is surrounded by mown lawn and the adjacent public highway. The pond appeared to be a permanent feature, is choked with vegetation and is heavily silted.			Photo 22. Showing pond 1

Permanence	SI3	Dries annually.				0.1			
Water quality	SI4	Poor – assumed. Too shallow and dries to frequently to support a diversity of invertebrates.				0.33			
Shading	SI5	90%				0.3			
Waterfowl	SI6	Assumed none – too shallow.				1			
Fish	SI7	Assumed none – dries annually				1			
Pond Density	SI8	13 ponds = score of 4				1			
Terrestrial Habitat	SI9	poor >25% surrounding habitat favourable for terrestrial amphibians. The majority of the site is mown lawn / domestic garden.				0.33			
Macrophytes	SI10	100% Mostly marginal reeds.				0.8			
						Total	0.43 Poor		
Great Crested Newt Absence / Presence survey									
Date	Water temp <5°C*	Ph <6**	Torch		Net	Bottle trap	Egg search	Other species	Comment
			M	F					
Conclusions.		See discussion below. Screen out – pond scored 'poor' suitability for Great Crested Newts.

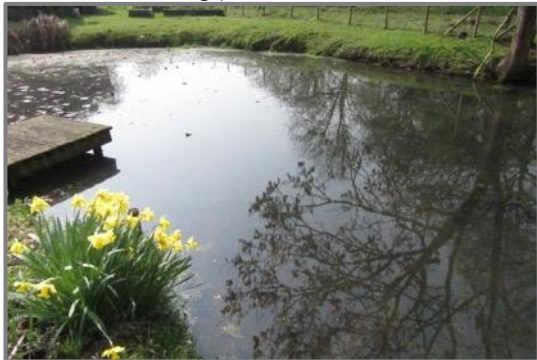
Table 8. Great Crested Newt Habitat Suitability Index (HSI)			
Background Information			
Pond Number	2	Survey date	8 th April 2019
		Location	Corner Farm, OS grid ref: TM19067733
Access	Good all round	Dist. from development	Within the development site
		Surveyor	J Parden. NE licence: 2016-20270-CLS-CLS
<p>General description. A pond located within a combination of garden and woodland setting. The pond was is a permanent water infrequently.</p> <p>The pond was 100% shaded within the woodland section and unshaded in the garden section.</p> <p>Evidence of wildfowl in the form of grazing and feathers was observed.</p>		<p>Photo 23. Showing pond 2.</p>

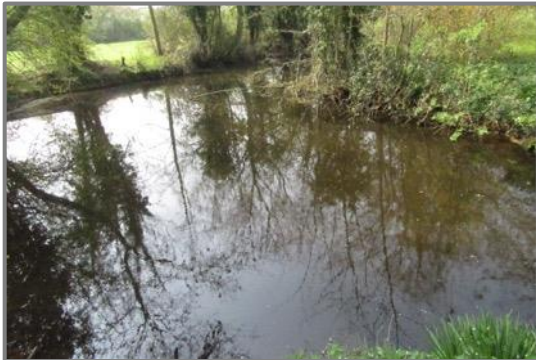
Table 9. Great Crested Newt Habitat Suitability Index (HSI)									
Background Information									
Pond Number	2		Survey date	8 th April 2019					
			Location	OS grid ref: TM19177735					
Access	Good all round		Dist. from development	Within 70m of the development site separated by significant barrier, B1118					
			Surveyor	J Parden. NE licence: 2016-20270-CLS-CLS					
General description. A pond located within a wooded domestic garden setting. A former moat with fish and wildfowl present The pond was 90% shaded and frequent permanent. The pond had an absence of aquatic vegetation either as a consequence of grazing by wildfowl or the effects of shading.			Photo 25. Showing pond 3.

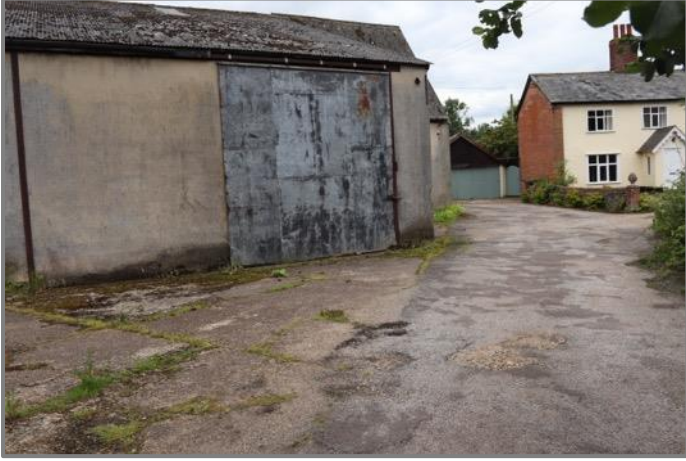
Showing typical concrete and hardcore former farmyard surfaces throughout the site.
Photo 28

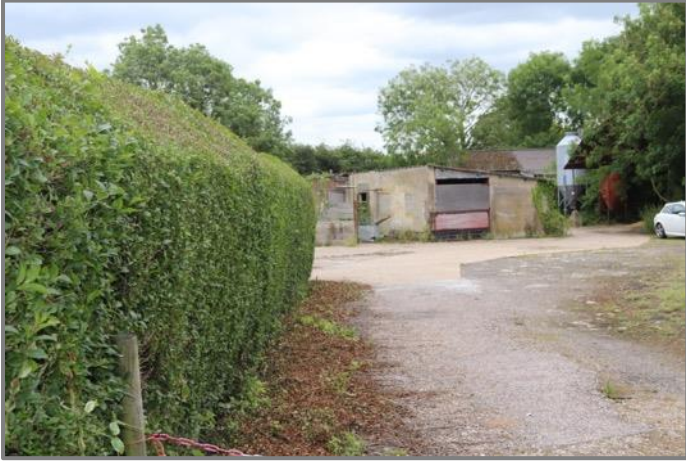
Showing typical concrete and hardcore former farmyard surfaces throughout the site.
Photo 29

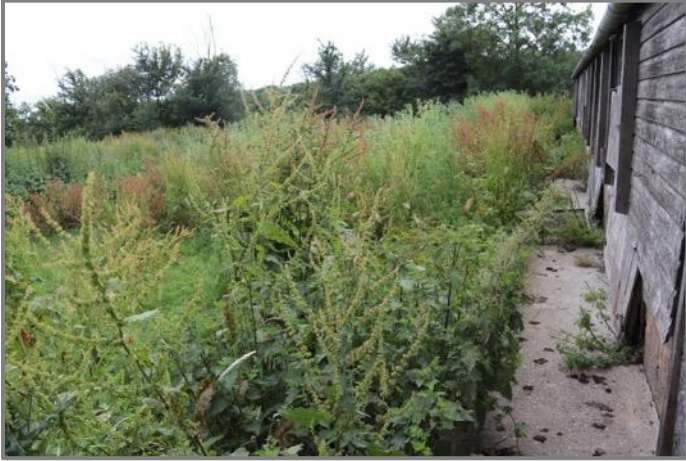
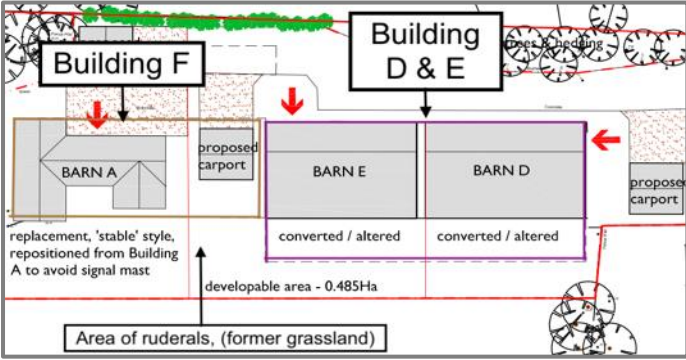
<p>Showing the area of ruderals to the south of buildings D,E & F. This is currently part of grassland currently being lightly grazed by cattle. The grassland appears to be former improved grassland that has recently become managed by light grazing only and become locally dominated by thistle, nettle and docks.</p> <p>Also attached is a plan to locate the area on the site.</p>

- Areas of ruderals and brambles should be cleared during the winter and once cleared should be maintained as bared ground or short mown vegetation.
- **Construction phase.**
