Reference 20347.02HS

Heritage Statement reference 23 Old End, Padbury, Buckinghamshire MK18 2BE

Introduction

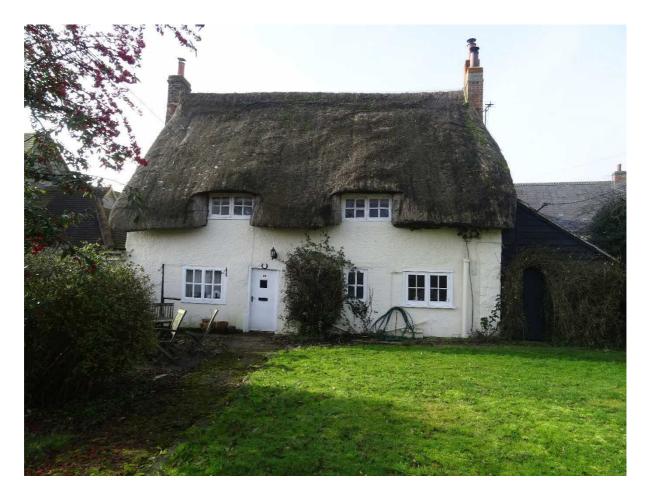
23 Old End, Padbury, Buckinghamshire is a detached Grade 2 thatched cottage consisting of part colour washed rubble stone and part colour washed brickwork.

The building is 2 storeys with the 1st floor being within the roof having eyebrow thatching above the 1st floor windows.

A timber lean-to shed with modern overlap boarding to the external walls to the right hand side of the property.

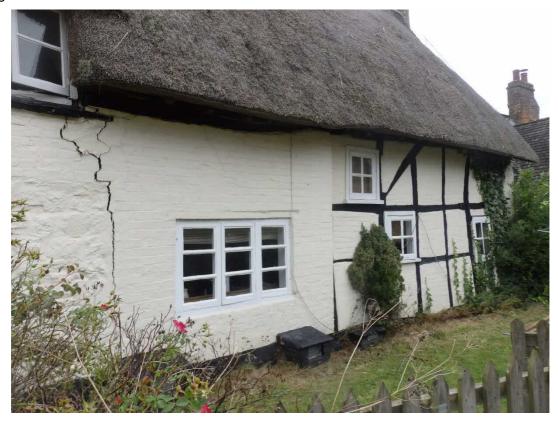
The rear elevation of the building consists of 1/2 of the wall having timber framing with colour washed brickwork between, with the remaining section of the rear elevation up to the rear right hand corner having just colour washed brickwork and colour washed rubble stone having the appearance of originally being two separate cottages with a repair having been carried our in the distant past to the rear right hand side..

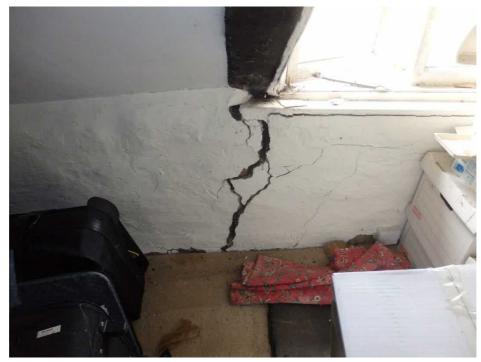
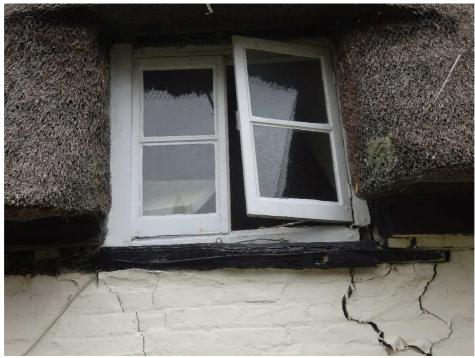
Serious structural damage has occurred to the right hand side of the building where cracking has occurred and appears to be progressing both internally and externally.

Other cracks are also present within both front and rear elevations of a tapering nature indicting that the right hand gable wall is sinking and pulling away from the main body of the property.

I has been conclude that the movement has occurred to the right hand side of the building is due to insufficient bearing capacity of the subsoils to support the structure.

Internal and external repair works will be necessary to restore the integrity of the building with the only visual change of appearance being a pattress plate to both front and rear elevations to restrain the bowing of the walls.

Minor crack repairs will be carried out using the various Helifix techniques so as not to be seen.

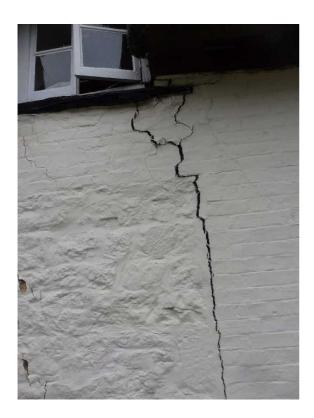
September 2023

Damage is progressing evidenced by photographs taken 6 months apart.

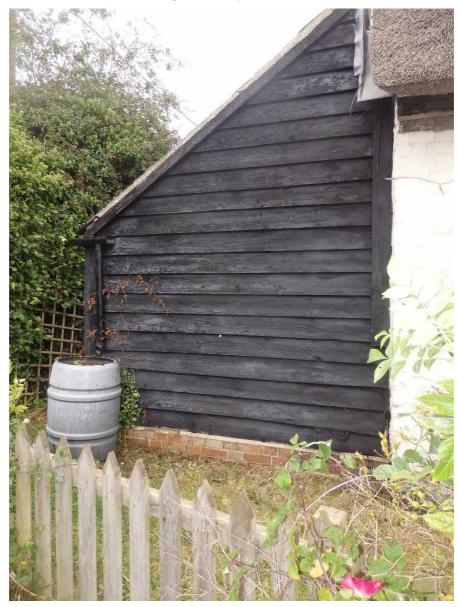
This will mean removing the timber shed that is attached to the left hand gabled wall.

The shed has a modern overlap boarding externally.

To carry out the underpinning works the gable wall will need to be made safe and to this extent we will have to erect a shoring system to prevent its collapse whilst works are being carried out.

We propose to remove the boarding leaving the frame standing so that we can photograph and number the timbers in order to erect back in its original format.

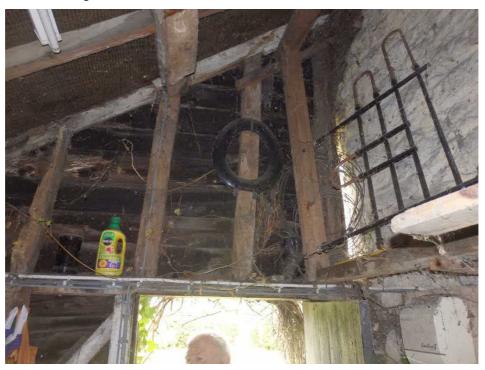
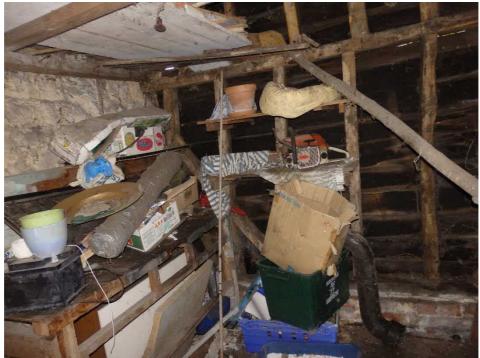
Inside there are some original and some new timbers.

There area some new timbers and we also noted worm and rot to some timbers and we aim to take specialist timber advise on these timbers for reuse.
