# **Bat Activity Surveys**

# Tall Trees

- Prepared for: Challinor Hitchcock-Yoo Ltd
- Issue date: 09/10/2023

Reference: AE0020/1/1

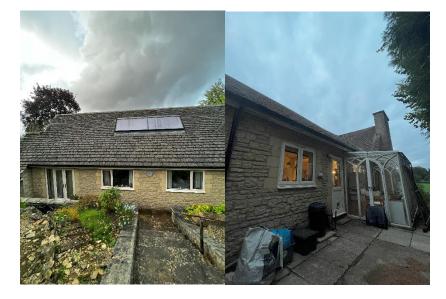
Figure 3. External overview of the property (left - southwestern aspect, right - eastern aspect)

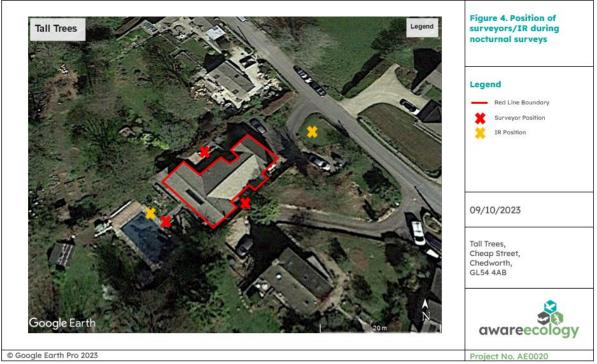
The surveyors were positioned at vantage points around the property to observe all potential bat access/egress points, as marked on the site plan below. Each surveyor was equipped with a hand-held bat full spectrum recording bat detector and an infra-red camera was positioned on the northeast and southwest aspects of the building to further aid visual detection of bat emergence and foraging behaviour. The night vision aids (NVAs) allow any emerging bats from 45mins after sunset to be detected and provide a more detailed coverage of the site than just human surveyors could provide.

#### Figure 4. Position of surveyors/IR during nocturnal surveys

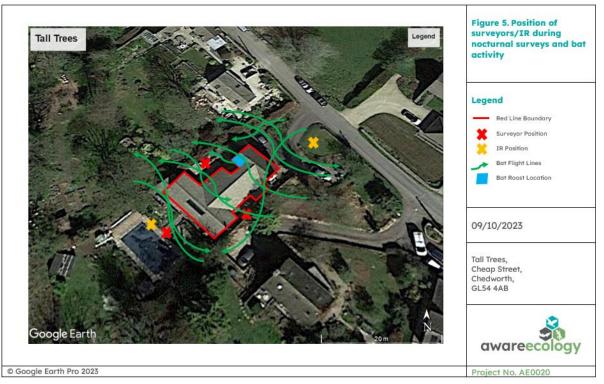
Survey Date	Survey Time	Bat Activity Recorded	
		Du	ısk
25/08/2023	19:56 - 21:41	Emergence	x2 common pipistrelles seen emerging from beneath tiles on northwest aspect.
		Foraging and Commuting	High levels of foraging activity of common pipistrelles were recorded around the property and the neighbouring gardens. There was also low foraging/commuting activity of noctule, natterers and brown long-eared bats around the site.
		Du	ısk
14/09/2023	19:10 - 20:55	Emergence	No bats were seen emerging.
		Foraging and Commuting	Moderate levels of foraging/commuting activity of common pipistrelles were recorded around the property and the neighbouring garden. There was also low foraging/commuting activity of noctule around the site, plus the occasional pass of lesser horseshoe and brown long-eared bats.

Figure 5. Position of surveyors/IR during nocturnal surveys and bat activity directions

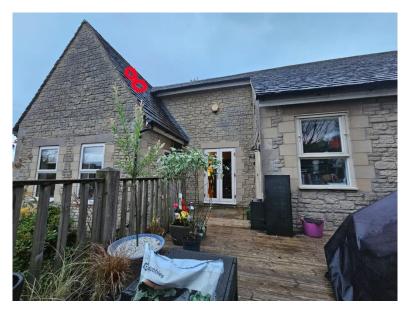
There was a maximum of 2 bats recorded emerging from under the tiles during the first dusk survey. Therefore, it is confirmed that the property is by roosting bats (common pipistrelle), as such a precautionary working method statement (PWMS) will be required prior to the works commencing.

Picture 1. Bat roost locations (red outline)

• The bat ecologist will provide a watching brief while key areas (within near proximity of the known roost) of the roof tiles are stripped by hand.

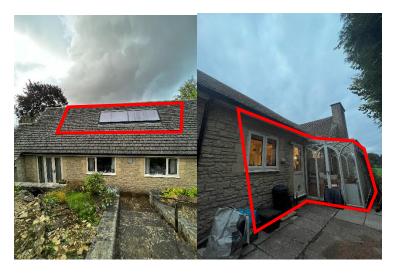
Picture 2. Sections of property where works are proposed (left - replacement solar panels, right - side extension)
