**Deerbolt Cottage
Blacksmith's Green
Wetheringsett
Stowmarket
IP14 5PZ
(TM 14177 65734)**

HERITAGE ASSET ASSESSMENT

Jane Blanchflower

August 2023

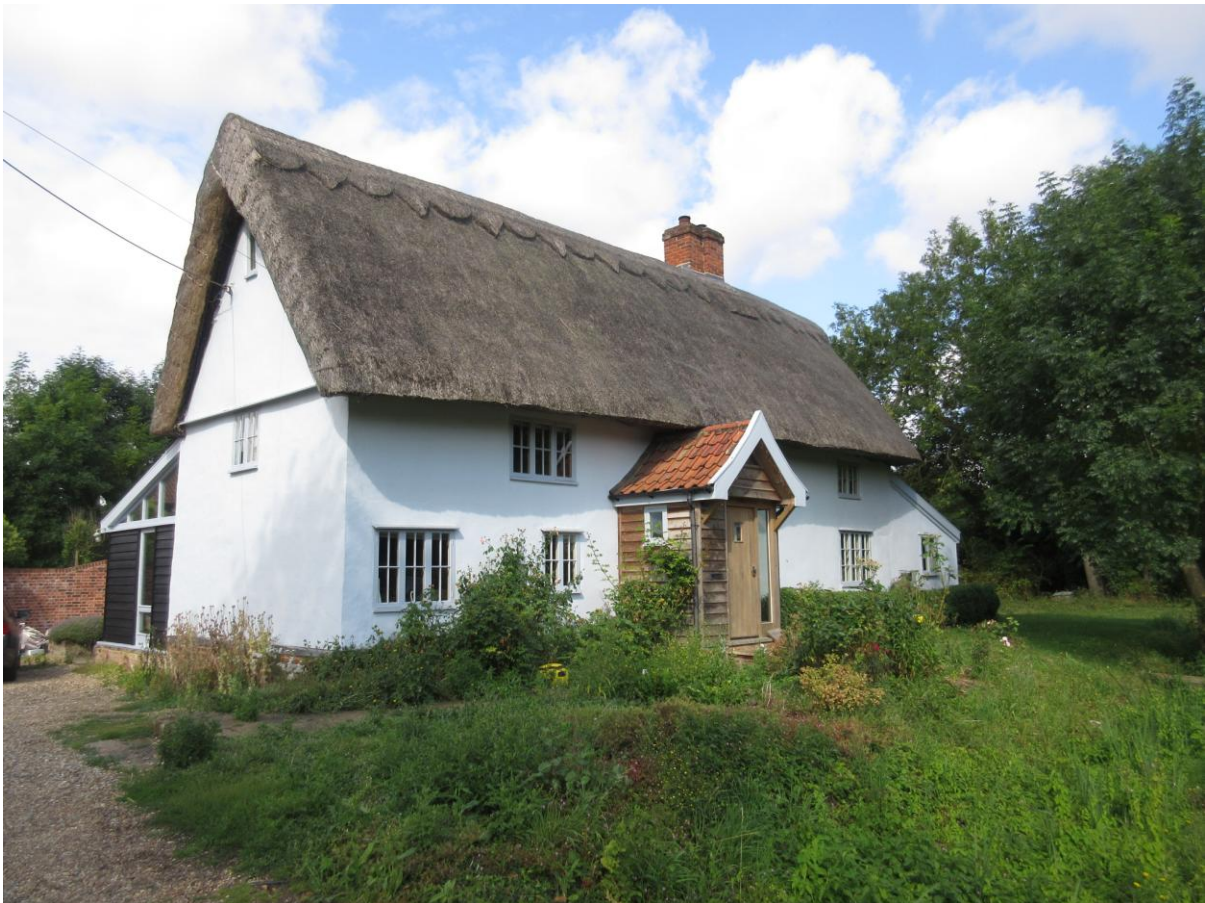
Deerbolt Cottage : SE & NE elevations

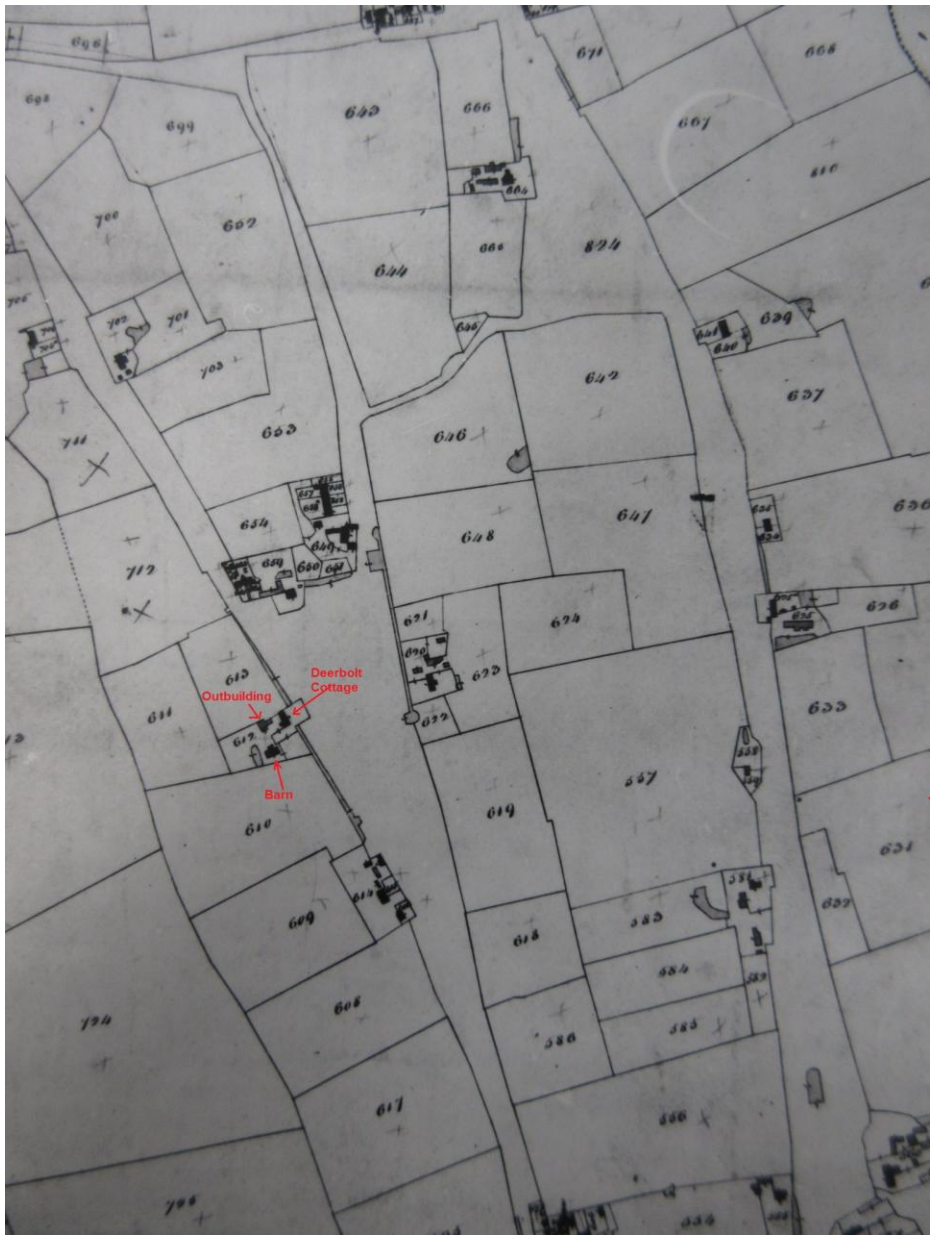
1841 Tithe Map for Wetheringsett cum Brockford (SROI P461/283) larger extract showing extent of Blacksmith's Green

The 1841 Tithe map for Wetheringsett cum Brockford was too fragile to view but a photocopy was available. The larger extract shows Blacksmith's Green as an extended strip of open land, broader at the N end, the wide 'green ditches' defining the perimeter are clearly visible to the E of Deerbolt Cottage and to the W of Orchard Farm on the opposite side of the green. Deerbolt Cottage is situated on enclosure 612.

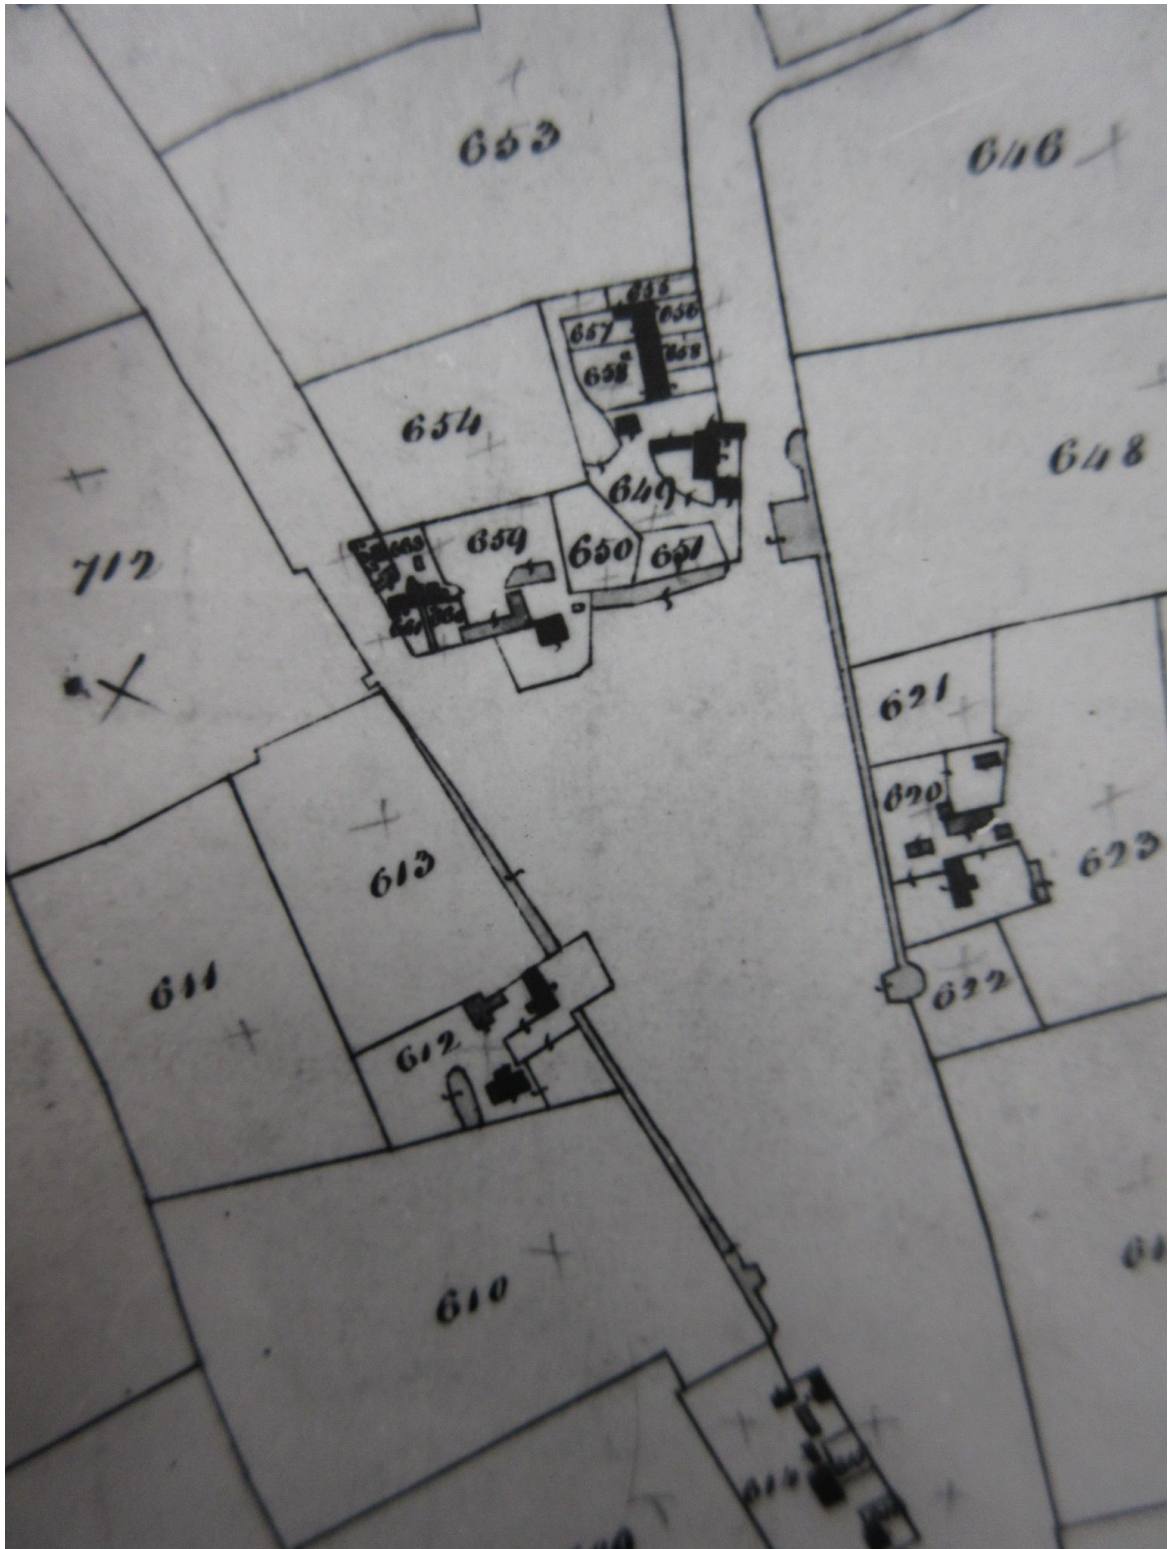
1841 Tithe Map for Wetheringsett cum Brockford (SROI P461/283) detailed extract showing Deerbolt Cottage immediately W of the Green with the barn and pond to the SW and outbuildings to the W, at the rear of the cottage

The 1841 Tithe Apportionment (SROI FDA283/A1/1a) lists the enclosures, their owners and occupiers, the state of cultivation and size in acres, rods and perches (abbreviated as 'a' 'r' and 'p') and the rectorial tithe payable in pounds, shillings and pence. Deerbolt Cottage, described as '*House, Barn, Yards etc*' was owned by John Kerry and occupied by James Hammond, a holding of approximately 19 acres. John Kerry also owned the '*House, Blacksmith's Shop etc*', occupied by Thomas Tye and situated on the W side of the green to the S of Deerbolt Cottage. These two properties represented John Kerry's total acreage in Wetheringsett cum Brockford, a small freehold farm with three and a half grazing rights on the Green.

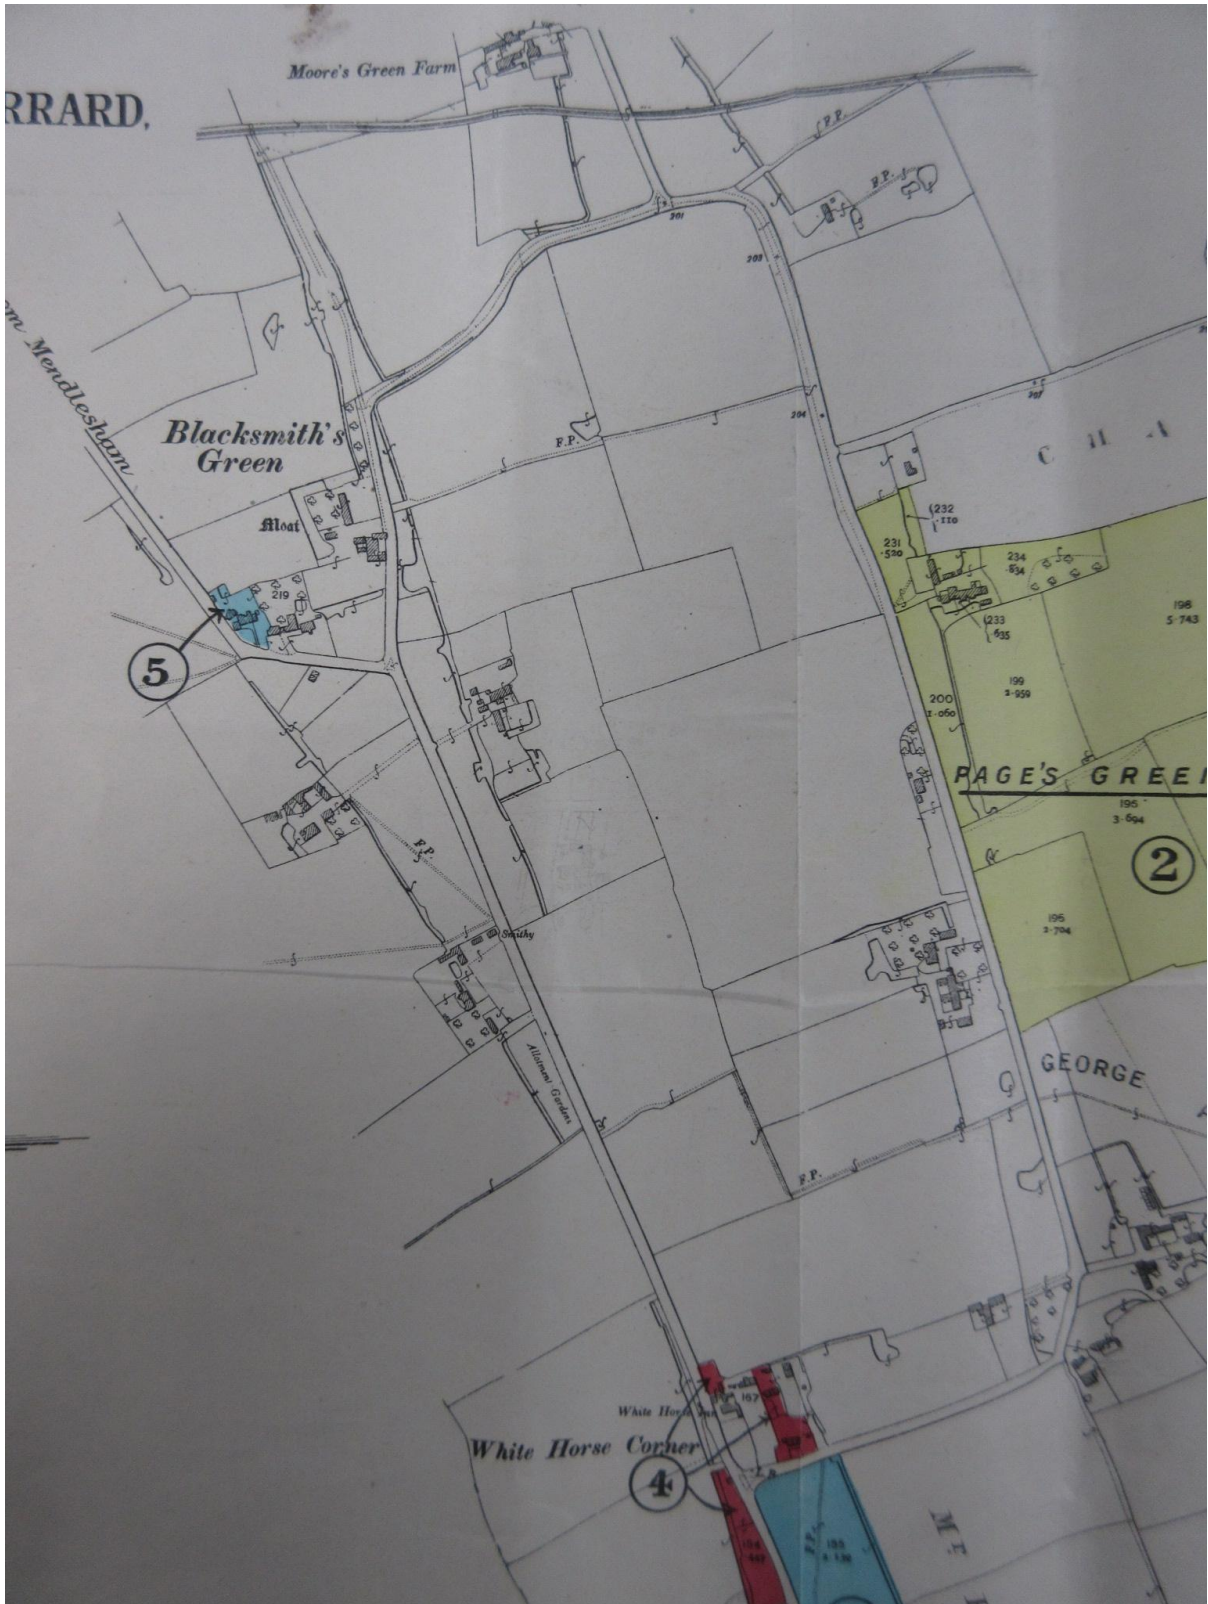
1919 Sale Plan No. 1 (from OS map) of the Thorndon Estate, scale 5 chains : 1 in (SROI H402/1/1919/75) larger extract

In 1919, the Thorndon Estate was offered for sale by auction by Messrs. Daniel Smith, Oakely and Garrard, Land agents, Surveyors and Auctioneers of St James's Square, London SW. Deerbolt Cottage was not part of the Thorndon Estate but it is shown on sale plan no. 1. The sale plan is based on the 1904 OS map therefore no further changes are shown.

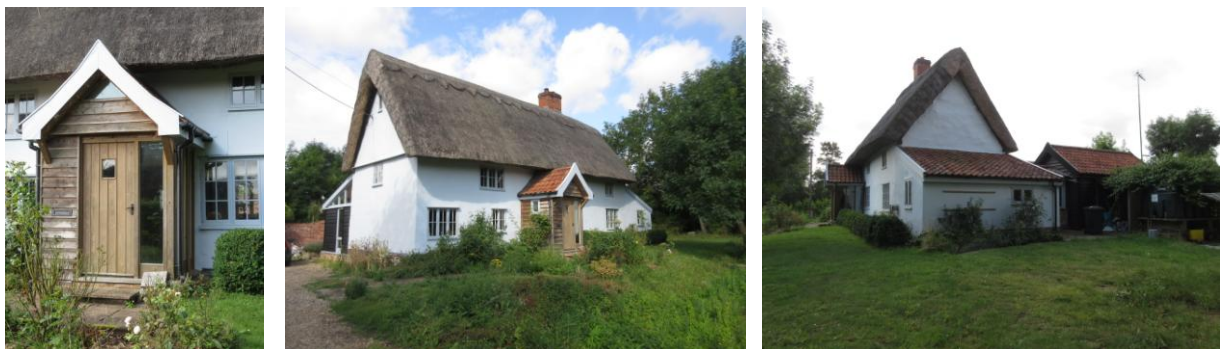
Left: detail of porch looking SW; Centre: looking NW; Right: NW elevation showing lean to extension and linked 21st century single storey study/bedroom (right) with pantile roof

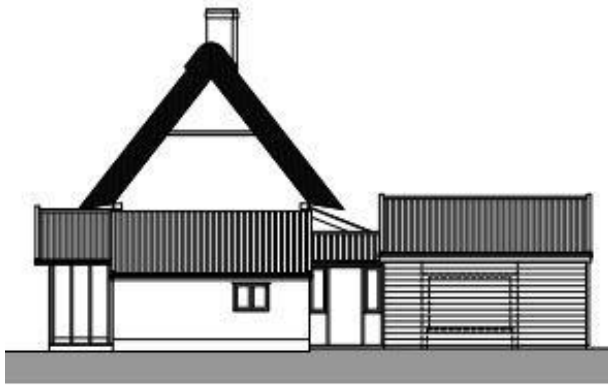
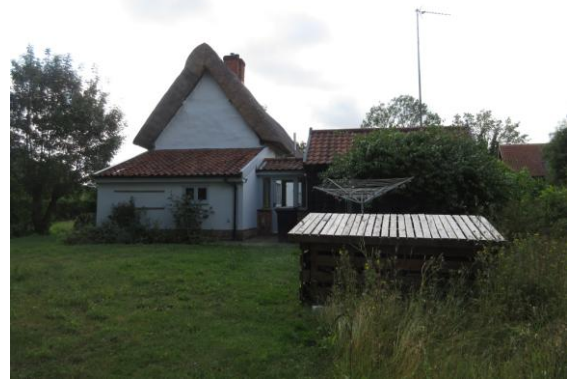
Left: NW elevation, scale 1 : 100 @ A1 (Nick Barber Architects drawing 1801 10); Right: NW elevation, study/bedroom obscured by lean to and foliage covering oil tank, log store in foreground

The NW elevation of the lean to has a small 2 pane, painted timber casement and a shallow pitched roof which meets the cottage at eaves level. The lean to is of brick construction, rendered and colour washed to match the exterior of the cottage. The study/bedroom extension (added by the previous owner in the early 2000s) is of brick construction, clad externally in black horizontal boards with a red clay pantile pitched roof. It was built partly on the site of a previous outbuilding shown on the map regression. Attached to the NW elevation of the extension is a 21st century, small open fronted timber shed of no architectural or historical significance. Adjacent to the NW is an oil tank and a paved area (possibly the site of a small swimming pool). The link between the study/bedroom extension and the lean to attached to the cottage has half-glazed doors in the NW and SE elevations with side lights set on low, fletton brick walls. The roof is of red clay pantiles with a very shallow pitch and lower ridge height than the extension.

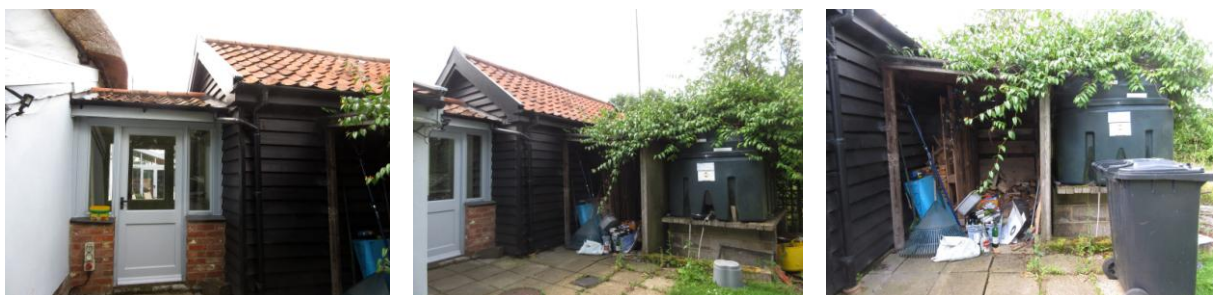
Left: detail of link between lean to and study/bedroom extension; Centre: looking SW showing open fronted timber lean to attached to study and oil tank; Right: looking W

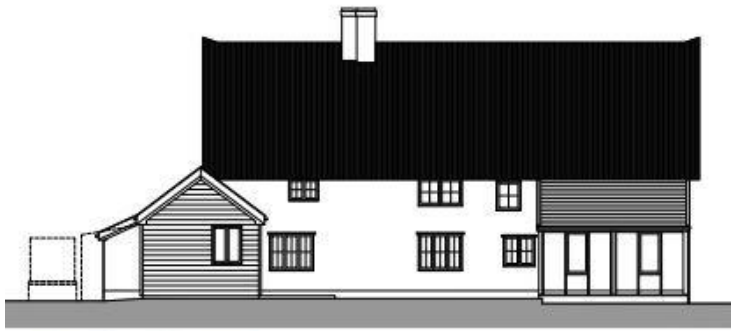
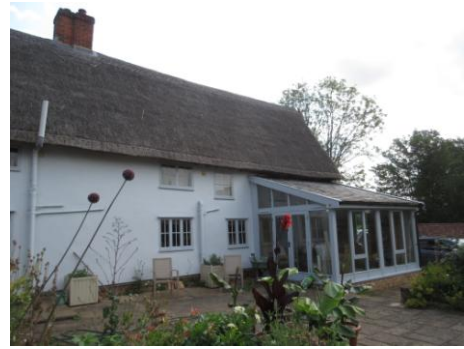
Left: SW elevation, scale 1 : 100 @ A1 (Nick Barber Architects drawing 1801 10); Right: SW elevation (part) looking SE showing 21st century glazed garden room

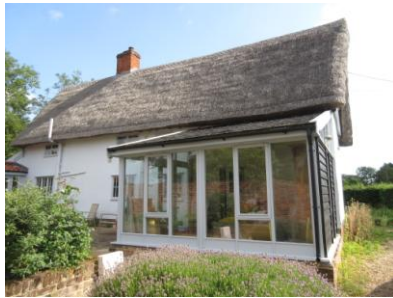
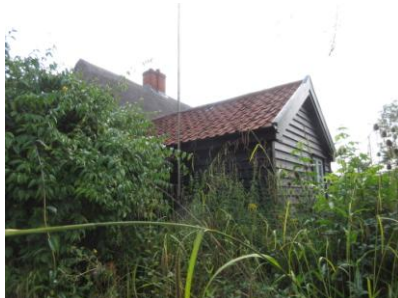
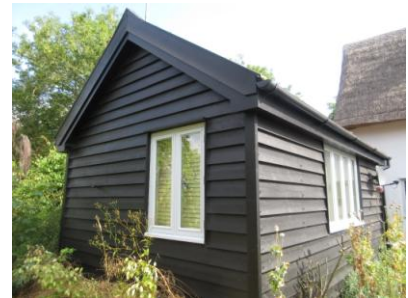
Left: looking NW showing detail of garden room; Centre: looking SE showing NW and SW elevations of study/bedroom; Right: looking NE showing the extension

Around 2007, the previous owner added a lean to garden room at the SE end of the rear SW elevation. This is timber framed with a natural slate roof, set on a reclaimed brick plinth, fully glazed on the NW and SW elevations with a door in the NW elevation leading to a paved courtyard. The SW elevation of the main building has 6 painted wood casements of the same design as those in the NE elevation.

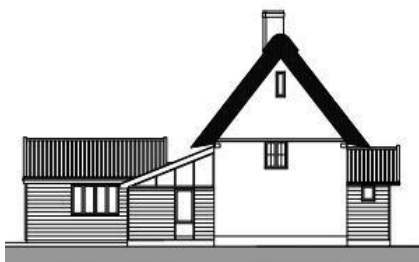
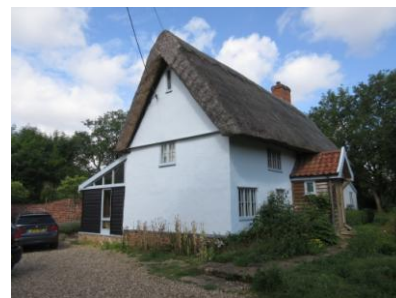
Left: SE elevation, scale 1 : 100 @ A1 (Nick Barber Architects drawing 1801 10); Right: SE elevation looking NW

Deerbolt Cottage has a painted wood casement at first floor level and a narrow slot window lighting the attic. There is a painted timber drip board at eaves level and timber barge boards to the gable. The garden room extension has a single, almost full length, vertical window with glazing above in the SE elevation. The study/bedroom has a large painted timber casement with 4 vertical panes and no horizontal glazing bars.

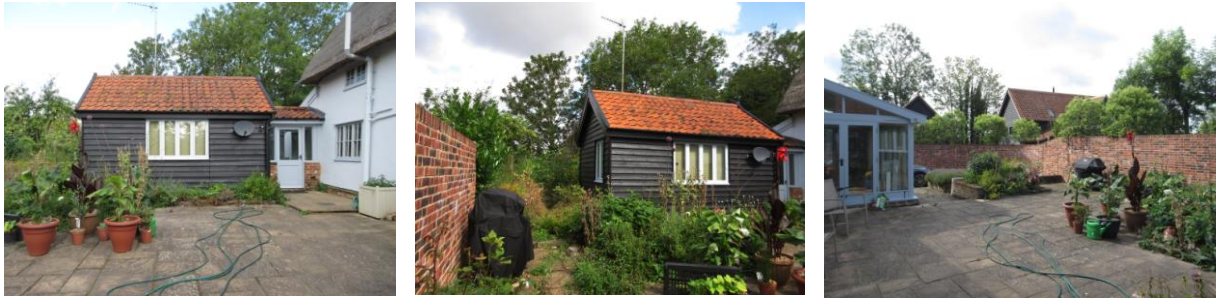
Left: looking NW showing SE elevation of study/bedroom; Centre: looking NE showing brick boundary wall constructed when the barn was separated from Deerbolt Cottage; Right: looking S showing rear boundary wall and Hart barn beyond

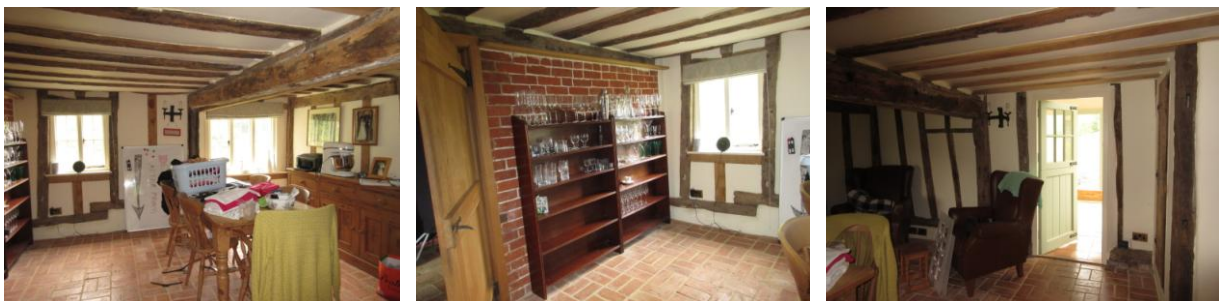
Left: looking NE showing stepped sole plate beneath window opening with diamond mullion mortices (see photograph below); Centre: NW wall re-built in brick (next to staircase); Right: looking SW showing inserted doorway to garden room and former doorway on SE side of cross axial beam

The dining room has a cross axial beam with empty diamond mullion mortices and a shutter groove in the underside. The cross axial beam in bedrooms 3 and 4 immediately above also has mullion and stud mortices suggesting that this was originally the end wall of the cottage and it was extended at a later date. The ceiling joists are smaller, the beam is off centre and the stepped sole plate are further indications of an alteration. The SE face of the beam has been reinforced with the addition of a new chamfered oak timber as shown in the photograph above. The window to the NW of the axial beam has 3 empty diamond mullion mortices in its underside but the wall plate is not fully exposed and no shutter groove was visible. The NW partition wall between the dining and living rooms has been re-built in red brick; originally this would have been a stud and plaster or muntin and plank division with two side by side doors to the service rooms. There is a modern planked oak door leading to the living room.

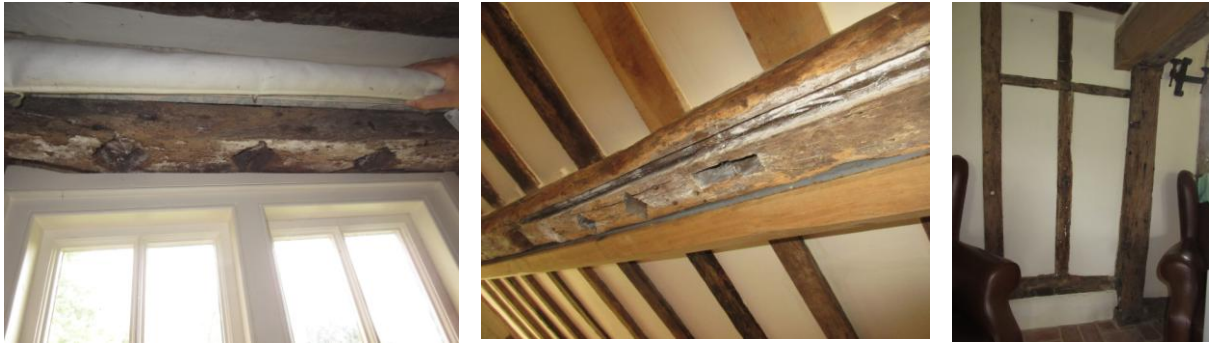
Left: diamond mullion mortices in underside of window lintel in NE wall; Centre: underside of re-used cross axial beam with mullion mortices, shutter groove and rectangular mortice for stud, reinforced with modern oak beam on SE face; Right: former doorway in SW wall

There are two 21st century small pane, painted timber casements with moulded glazing bars; these are present throughout the building. The NE and SW sole plates are stepped (see photographs) where the brick plinth has been raised in height at the SE end of the building. The plinth is cement rendered internally and the floor has been levelled and re-laid with reclaimed brick. The ceiling joists are unchamfered and there are 4 oak replacements. They are smaller in cross section to the SE of the cross axial beam. The wall plates are not visible in the NE and SW walls. A doorway has been created in the SW wall to access the garden room. Immediately SE of the axial beam, there is a former doorway in the SW wall.

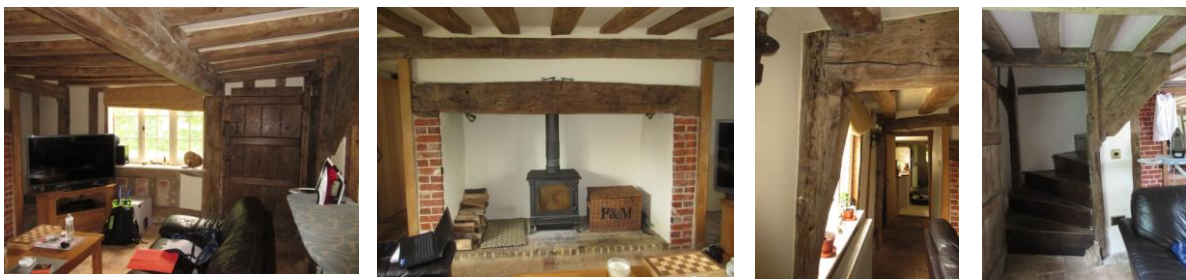
Left to Right: looking NE showing plank and batten front door; fireplace looking NW; jowelled main post in SW wall; looking SE showing staircase in SE corner of living room

The living room has a substantial cross axial beam with broad chamfers and stepped stops, supported on jowelled main posts. The ceiling joists are all original and unchamfered. The front door to the porch (in the NE wall next to the inserted staircase) is a good example of a 19th century plank and battened door. The staircase has a plank door and the underside of the staircase is exposed but would have been plastered originally. Beneath the staircase is a cupboard with a plank door with replacement strap hinges. The floor is of reclaimed brick.

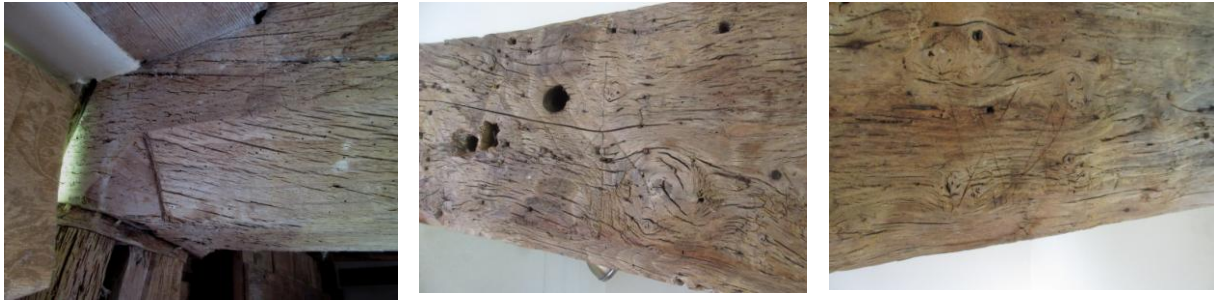
Left: stepped stop at end of broad chamfer on cross axial beam; Centre & Right: supersticious apotropaic or witch marks on bressumer face

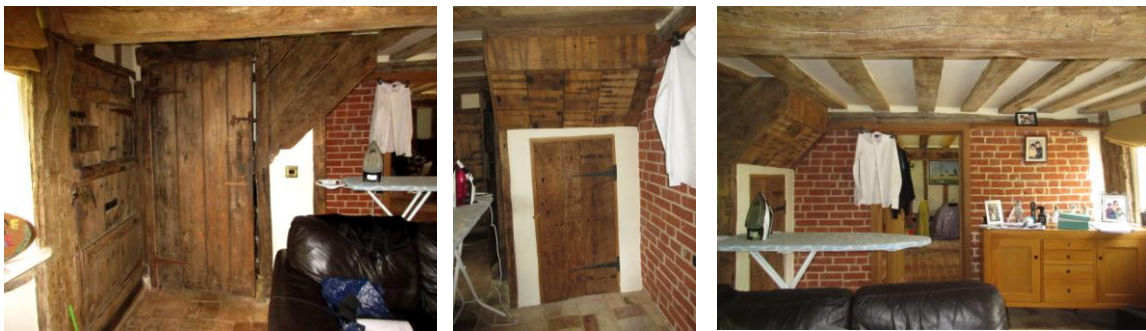
Left: looking SE showing door to stairs, front door on left; Centre: looking NE, showing door to understair cupboard; Right: looking SE showing brick partition wall & door to dining room

Beneath the NE window cill there is modern brick infill between the studs. The NE sole plate is original apart from a new section let into the NE wall next to the stack. The SW sole plate is a modern oak replacement and there are two new studs in this wall. The brick stack is a Tudor brick insertion, probably in the early 17th century. The fireplace has been rebuilt with modern brickwork supporting the original bressumer, a replacement white brick hearth and the fireplace walls are cement rendered. The bressumer has apotropaic marks incised on the face to deter witches/evil spirits from entering via the stack and there are scorch marks from rush lights. These would have been rushes dipped in tallow and supported in holders above the fireplace. A modern oak door set in a modern frame on the SW side of the stack leads to the kitchen.

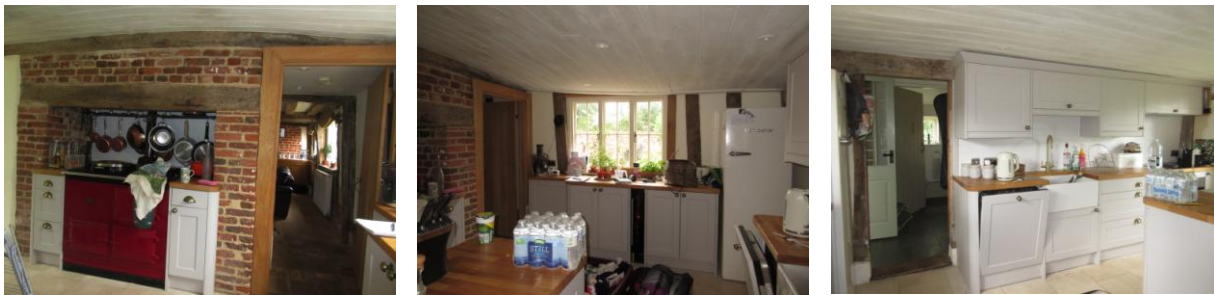
This has a back-to-back fireplace with the living room and the stack has two shafts, as shown on the roof plan. An AGA cooker has been inserted in the fireplace (smaller than the living room fireplace); this may have replaced a late 18th/early 19th century kitchen range. The bressumer is chamfered with flat stops. The ceiling is lined with whitewashed match boarding (c.19th century). The SW sole plate and studs are intact inside the modern kitchen cupboards. The NW wall is tiled above fitted cupboards but the framing was said to be complete (information from present owner). The wall plate is chamfered and there is an empty mortice where a stud has been removed to create a doorway into the lean to which is a later addition to the NW elevation.

Left: fireplace in SE wall and door to living room; Centre: looking SW showing boarded ceiling and 20th century casement inserted into SW wall; Right: looking NW showing door to utility room (in lean to extension) with exposed section of wall plate above

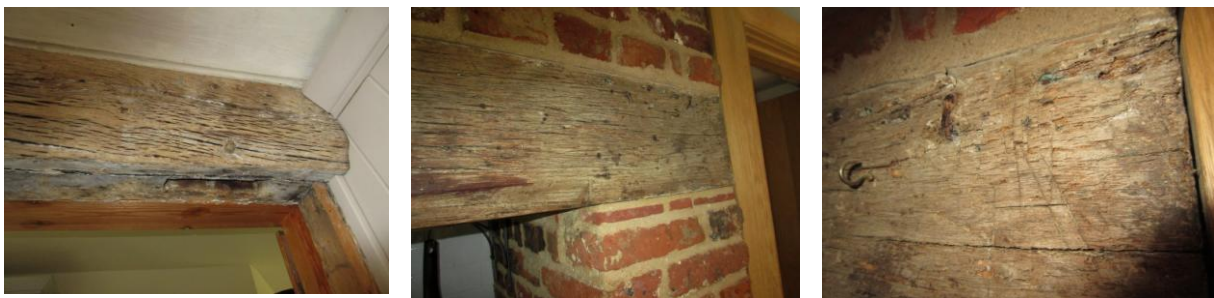
Left: empty mortice in underside of NW wall plate, removed to form doorway in former external wall; Centre: detail of bressumer showing chamfer with flat stop; Right: apotropaic marks incised on face of bressumer

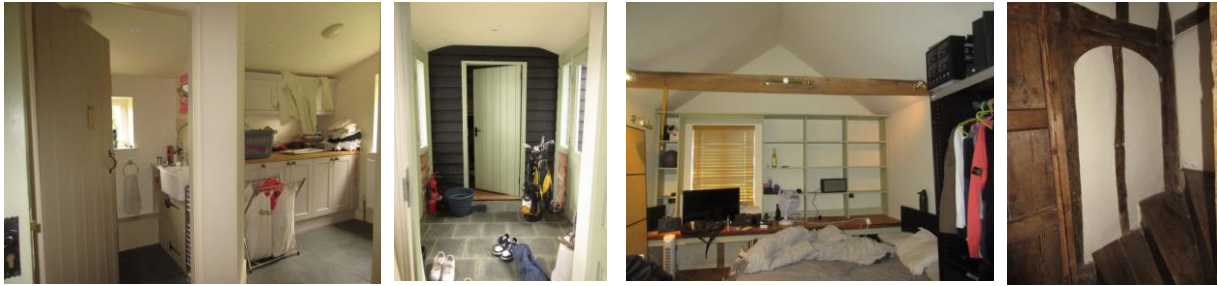
This is a rebuild c.2005 of an earlier structure in brick with plastered walls (ref. planning permission 1312/05). It consists of a utility room with separate WC in the W corner and there are no significant architectural features. There are two pane small casements in the NE and NW walls. In the SW wall a door leads into a glazed link between the cottage and a single storey, pitched roof, study/bedroom extension aligned at right angles to the cottage. This was added c.2005 (ref. 1312/05) on the site of a former outbuilding shown on the map regression.

Left to Right: utility room looking NW; glazed link looking SW; interior of study bedroom looking SW; 3-centred arch of former cross passage in NE wall at foot of inserted staircase

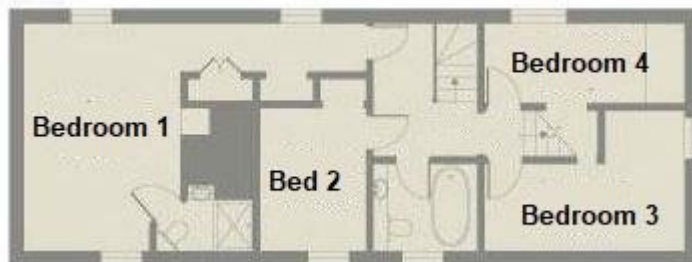
Annotated Agent's First Floor Plan with bedrooms numbered as in text (not to scale)

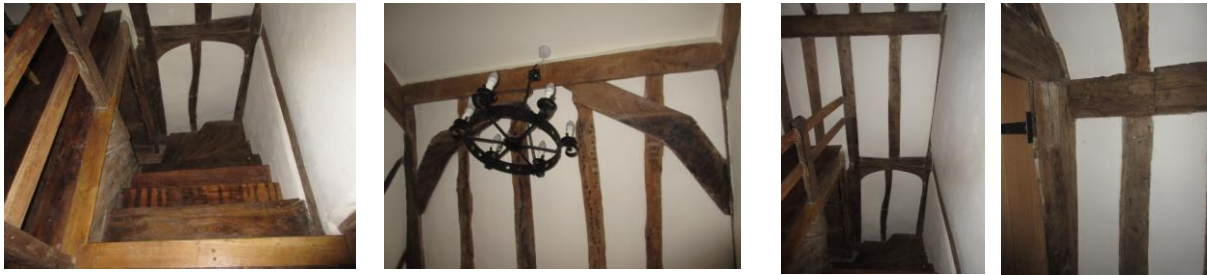
A framed dog leg staircase has been inserted in the former cross passage on the SE side of the living room. The upper part of the staircase (after the turn) has treads made from reused boards as shown in the underside visible in the living room. The banister rails on the landing are recent insertions and the floorboards are reclaimed. The landing was originally a single chamber but has been recently partitioned to form a bathroom on the SW side. The partition wall has a modern high level 5 pane light in an oak frame and the wall plate in the bathroom is chamfered with a simple stop and has an empty mortice where a stud was removed to insert the casement. The SW and NE roof slopes in this bay both have pairs of cranked wind braces; these are exposed on the first floor in each bay on both roof slopes.

Left to Right: looking down the staircase, new banister rails to left; NE roof slope viewed from landing, showing cranked windbraces; looking NE from landing showing slender studs at first floor level; jewelled mainpost on NE side of landing and edge halved scarf in wall plate

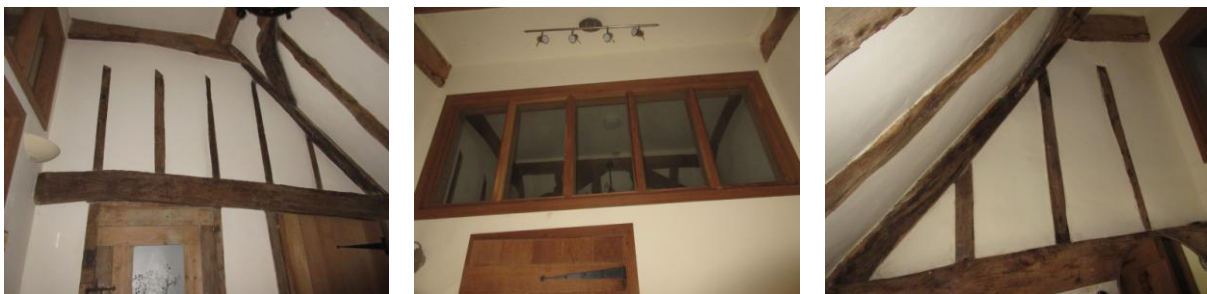
Left: looking NW on landing, showing cambered tiebeam with exposed slender studs and modern oak doors to bedroom 2 and passage to bedroom 1; Centre: looking NE from bathroom showing high level light in inserted partition wall; Right: looking NW showing SW part of cambered tie beam in bathroom

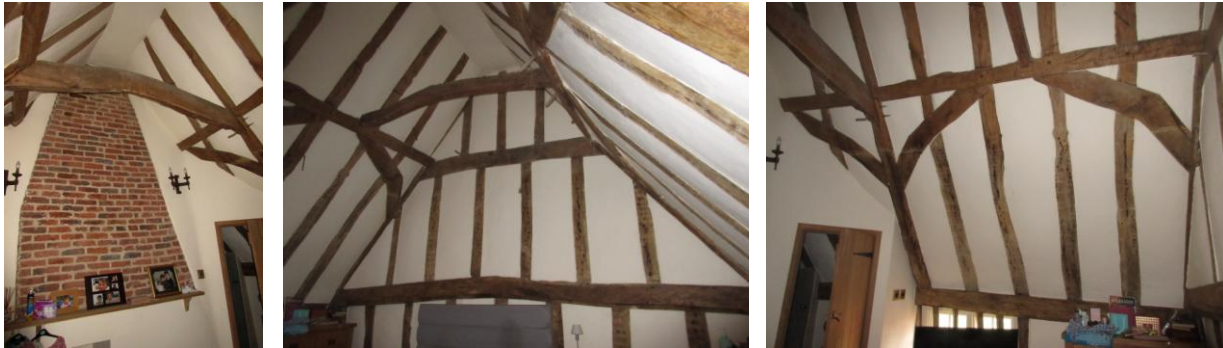
rafter roof structure with cambered collars and pairs of cranked windbraces is exposed. The timber members are pegged and are relatively slender as would be expected in a lower status farmhouse. A mullion window with shutter groove survives in the SW wall and there is a shutter groove and mullion mortices above the NE window. The tie beam in the NW wall is chamfered with a simple stop. An en suite shower room has been inserted to the SW of the stack.

Left: looking SE showing exposed brickwork of stack and cambered collar of clasped purlin roof; Centre: looking NW showing exposed studs, tiebeam, common rafters, collar and cranked windbrace; Right: SW roof slope showing pairs of cranked windbraces and top of mullion window, door leads to shower room beside stack

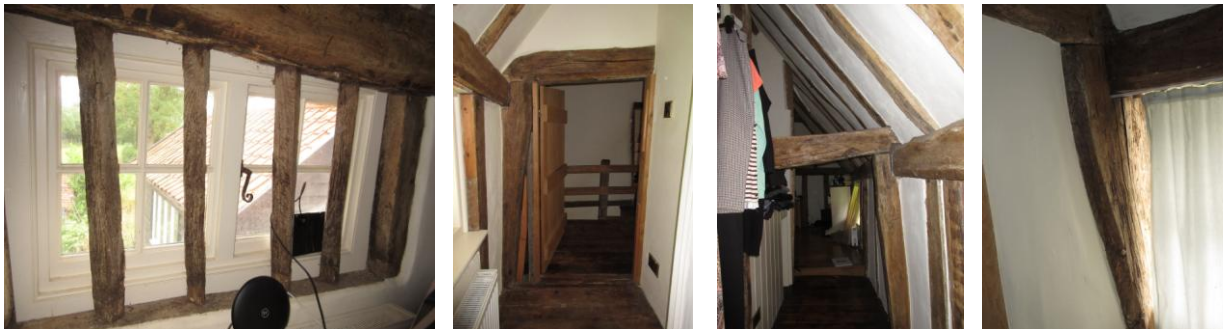
Left to Right: detail of diamond mullion window with shutter groove; Looking SE showing jowelled main post between passage and landing; Looking NW down passage to bedroom 1 showing tie beam on SE side of stack; jowelled main post in SW corner of bedroom 2

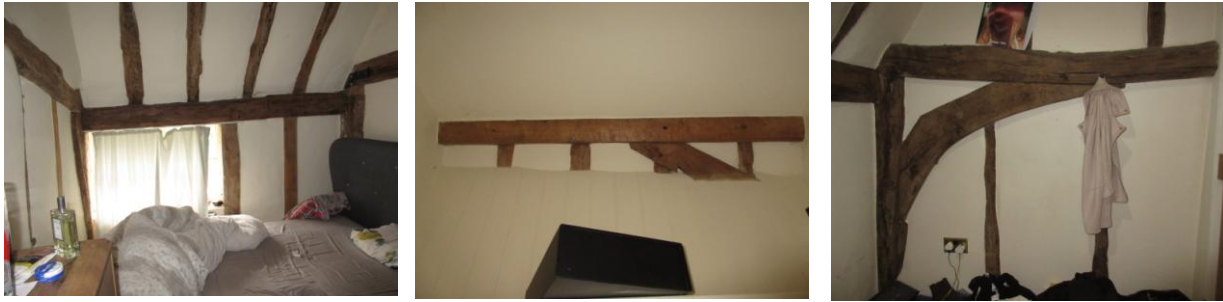
Partition walls have been inserted to form the NE wall of the bedroom. The floor plan (page 27) shows that the partition wall intrudes into the bedroom space in order to create a clothes cupboard on the SW side of the landing next to the stack. The SW roof slope has a cranked tie beam and the tie beam between this bedroom and the bathroom is chamfered with a simple stop. The floor is of reclaimed pine boards and the door is modern with a patterned obscured glass panel. The SE partition between bedroom 2 and the bathroom is original and may contain original infill.

Left: Bedroom 2 looking SW; Centre: Bedroom 2 looking NE showing purlin and top of cranked wind brace above partition wall; Right: Bedroom 3 looking NW showing cranked arch brace beneath tie beam

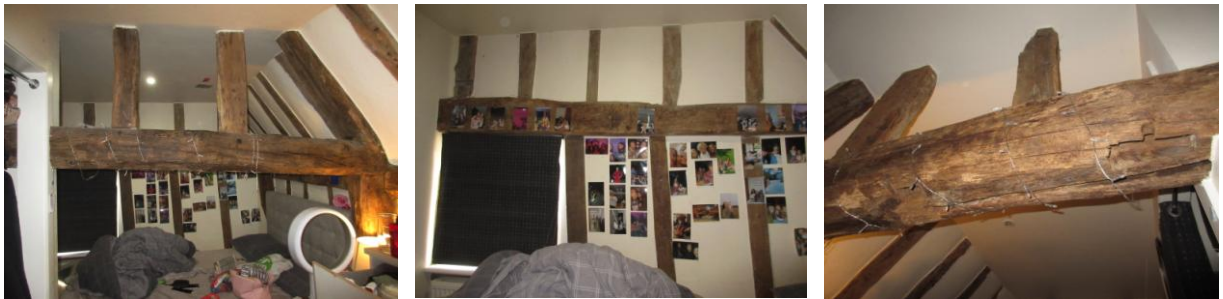
Bedroom 3: Left: looking SE showing open studs above tie beam; Centre: SE end wall with window beyond tie beam; Right: shutter groove and mullion mortices in underside of tie beam

Both bedrooms share a tiebeam with open studs (no infill) on either side of the modern partition wall. The underside of the tiebeam has a shutter groove and mortices for mullions in bedroom 3 and stud mortices (empty) in bedroom 4 on the NE side of the partition. This tiebeam mirrors the one in the dining room below and is further evidence that it was formerly the SE end wall of the cottage. The tiebeam is chamfered only on the NW face and the main posts are jowelled. There is an edge halved scarf in the NE wall plate in bedroom 4 and diamond mullion mortices above the casement in the NE wall. Both bedrooms have modern oak doors.

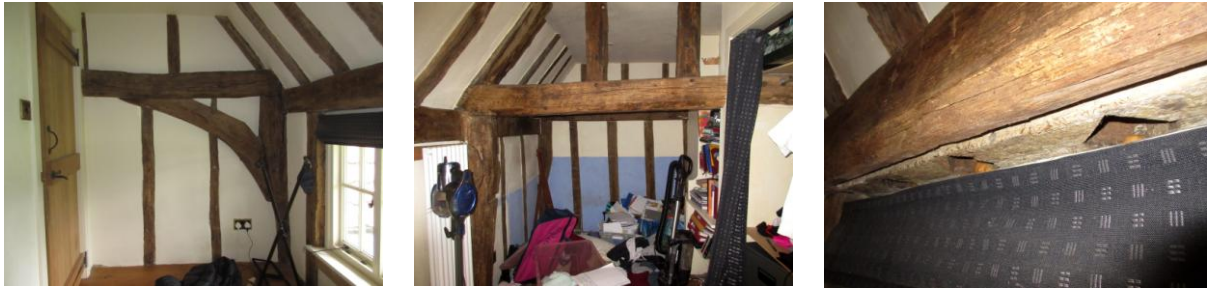
Bedroom 4: cranked arch brace at NE end of tie beam looking NW; Centre: looking SE showing open studs above tie beam with jowelled main post; Right: diamond mullion mortices above NE window

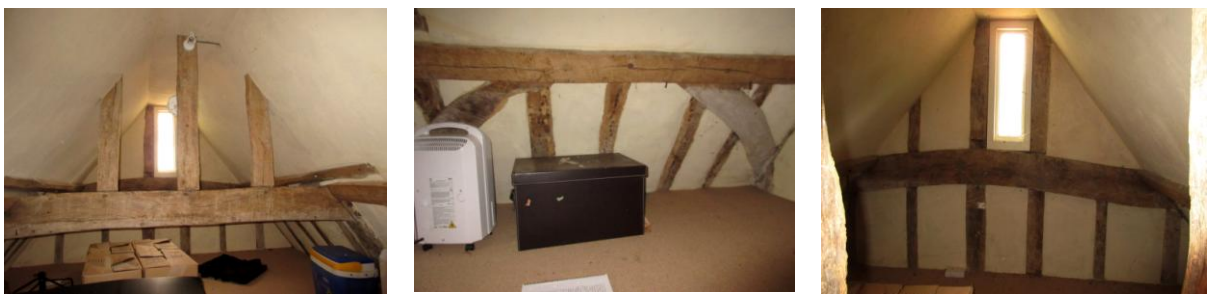
Left: looking SE showing open studs above collar; Centre: arched windbraces in NE roof slope; Right: window inserted between studs in SE gable

The attic is accessed by a modern ladder-type stair. The middle section of the attic between the floored SE cell and the galleried roof of bedroom 1 contains the water tanks and the roof slopes are lined.
