Ecological Impact Assessment and Bat Survey

**THE APPLE STORE SANDHOE, HEXHAM,
NORTHUMBERLAND**

June 2023

Ecological Impact Assessment for The Apple Store Sandhoe, Hexham, Northumberland

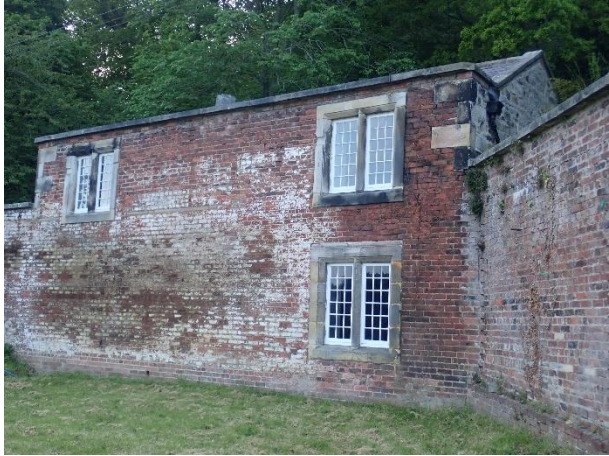
Viewed from the northwest.

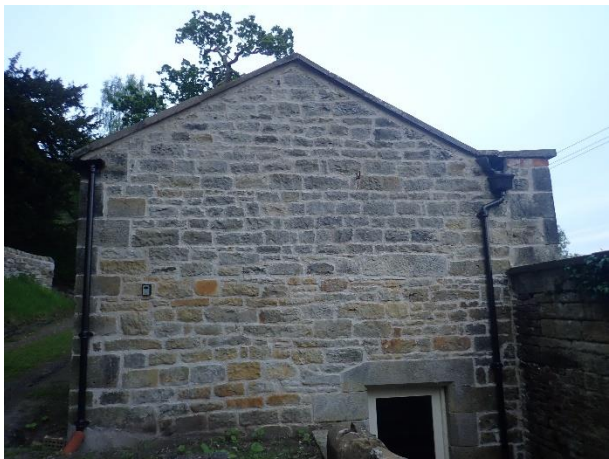
West gable, all stone work well pointed.

An external crevice will be created on the west gable walltop to provide a roosting site for crevice-loving bats. This will be in the form of an access gap measuring 20mm by at least 20mm created between the slates and the gable wall top through the mortar fillet into a larger crevice on the wall top below the watertable, resembling a 'flattened bottle' measuring c.100 x c.200 x 20mm. This provides a small space that acts as a suitable bat roost for the occasional bat. Please see Appendix 3 for detail.

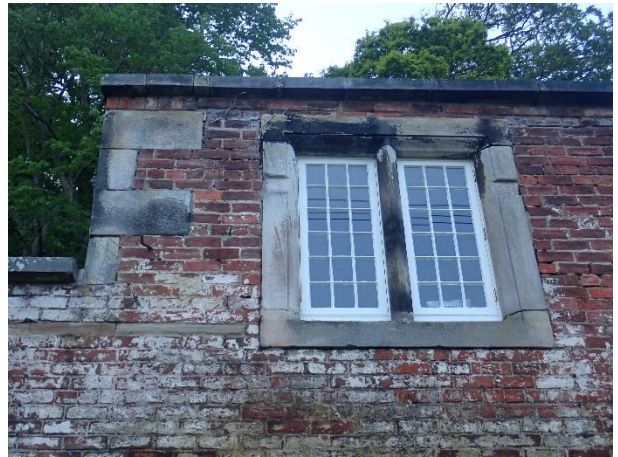
Crevices present in the brick work

Crevices in the brick work will be retained as at present.

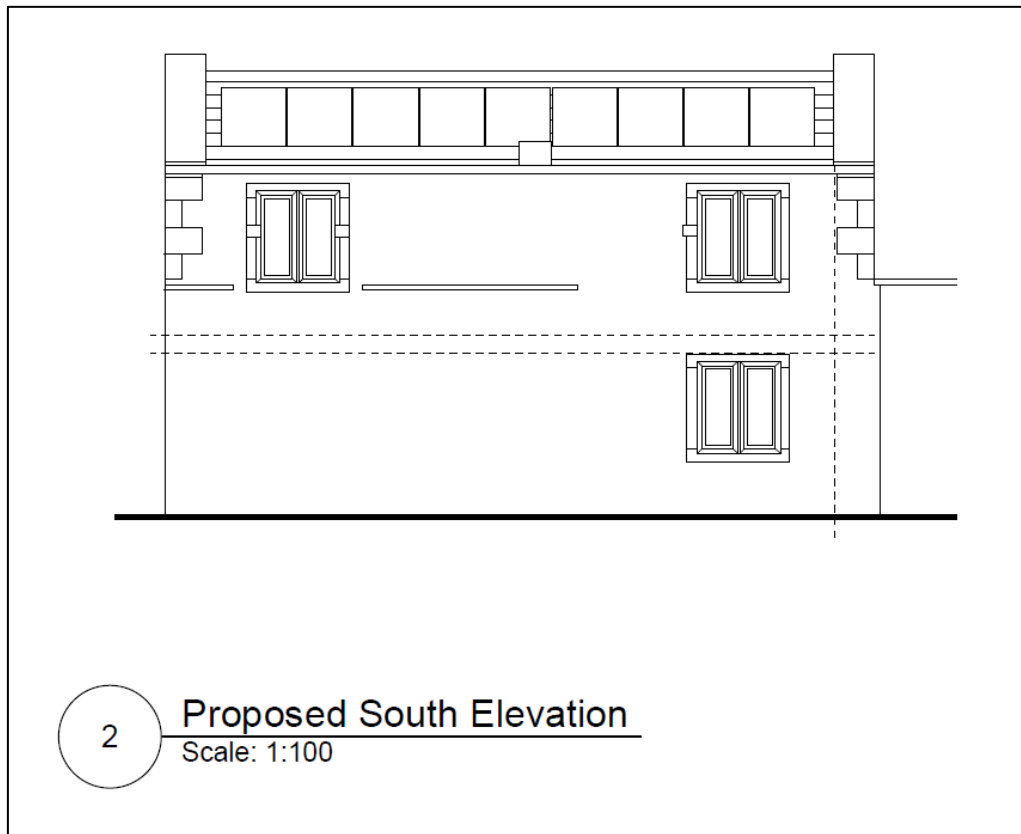
Figure 6. Proposed Works

The proposals are to add solar panels to the south facing roof aspect of the apple store. Slates will be removed to allow fixing points on the rafters.
