Site Investigation Report

126495.1.3.RSI

Job Summary

Auger were commissioned by Sedgwick to undertake a site investigation within the area of concern at the property.

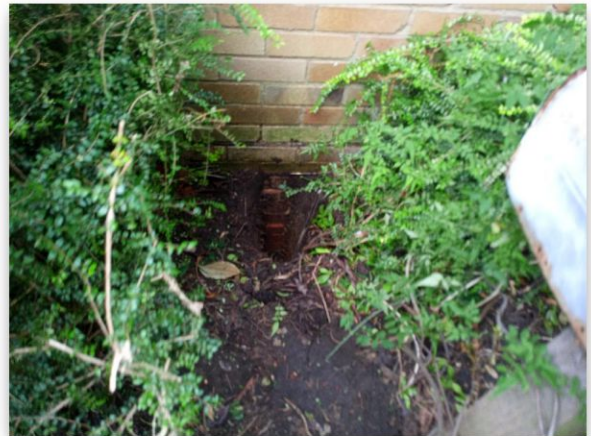
Fig 1.2: Trial Hole 1 Location

On our first visit Auger excavated to a depth of 1.2m, during this excavation we did not expose the underside of the footing. We then proceeded to Auger down to collect root samples to a depth of 3m.
