Ground Investigation

Investigation to determine the existing foundations and ground conditions. The investigation included two hand excavated trial pits, two 6m boreholes, a deep datum installation and soils and root testing.

Date	19th February 2022
Client	Sedgwick
Policy Holder & Address	[REDACTED] Redlands, St Marys Road, Worcester Park KT4 7JL
Reference number	[REDACTED]
Shire Reference	[REDACTED]

Drawing Title
LOCATION PLAN No.1

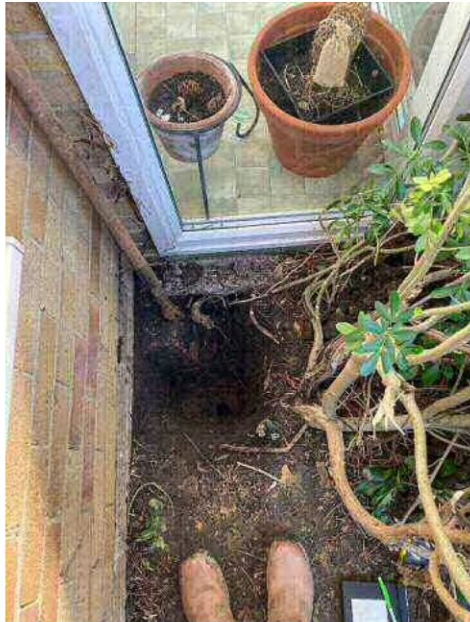
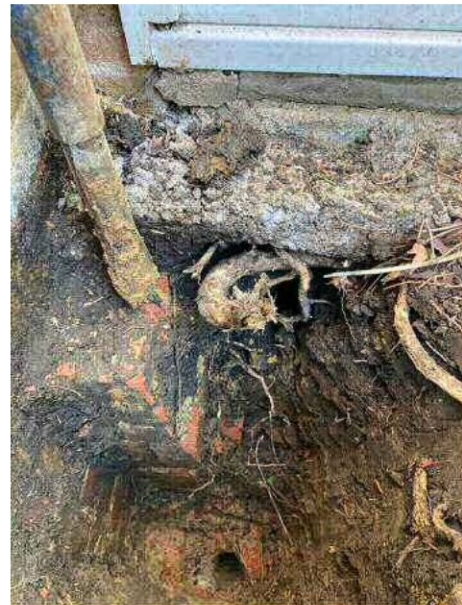
MACKINTOSH PROBE RESULTS - FREEFALL							SHEAR VANE kN/m ²	SOIL		DESCRIPTION						
DEPTH (m)	READING BLOWS/ 100mm	M VALUE BLOWS/ 300mm	VERY LOOSE	LOOSE	MEDIUM DENSE			DEPTH (m)	SOIL REF							
			25	50	75	100	125	150	175	200	225					
													1.0	A	MADE GROUND: Brown CLAY with brick fragments	
							70						1.3	B	Firm to stiff brown CLAY with roots up to 2mmØ	
													2.0		Concrete Fdn: Top 0.9m Depth 1.1m, Pjn 0.17m	
													3.0		NOTE: Porch is built of a concrete slab supported on brick wall shown in trial pit

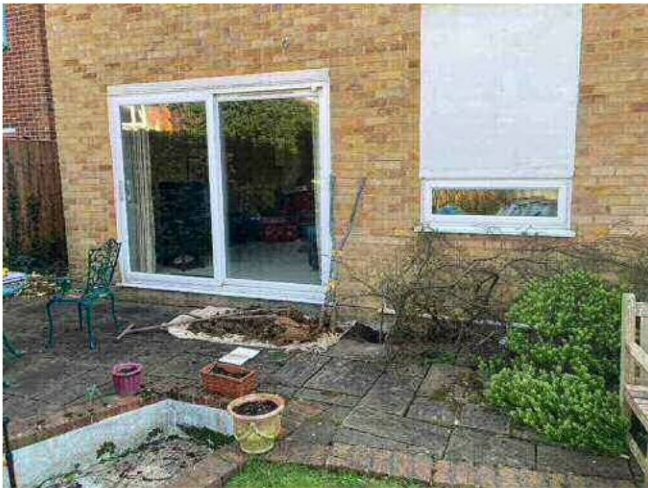
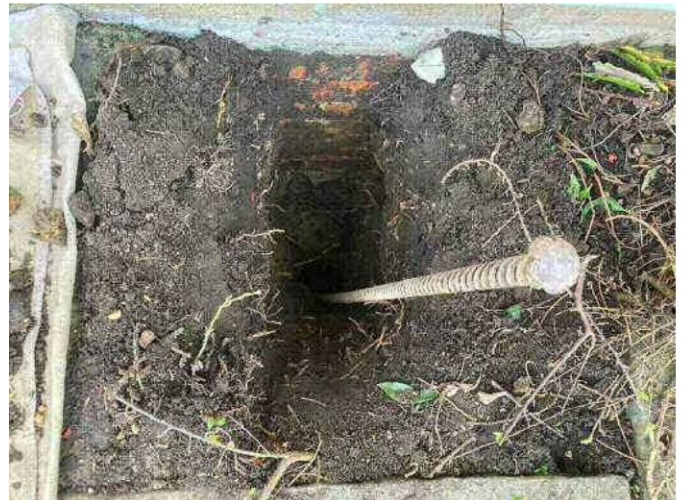
Drawing Title
TRIAL PIT No.2

MACKINTOSH PROBE RESULTS - FREEFALL								SOIL		DESCRIPTION
DEPTH (m)	READING BLOWS/ 100mm	M VALUE BLOWS/ 300mm	VERY LOOSE	LOOSE			SHEAR VANE kN/m ²	DEPTH (m)	SOIL REF	
				25	50	75				
								1.0	A	MADE GROUND: Brown CLAY with brick fragments
							70	1.3	B	Firm to stiff brown CLAY with roots up to 2mmØ
								2.0		Concrete Fdn: Top 0.9m Depth 1.1m, Pjn 0.17m
								3.0

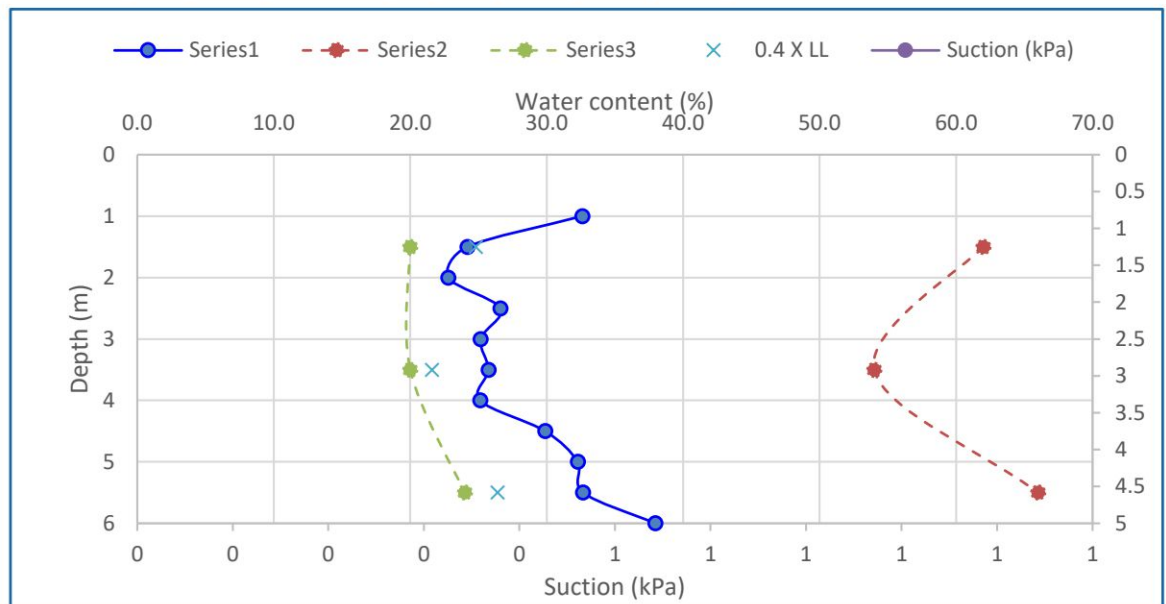
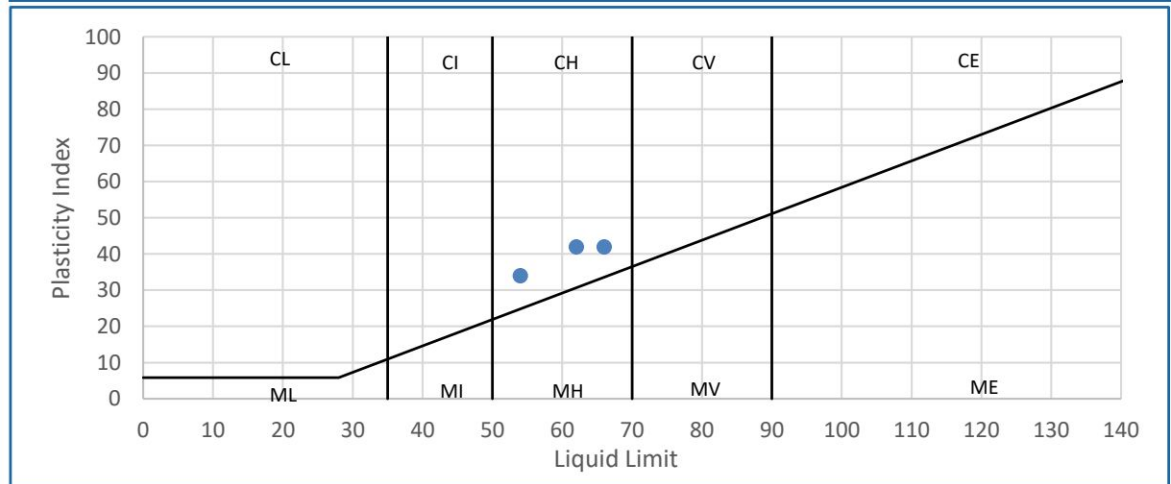
Plasticity Chart for Casagrande Classification

Samples from BH1

Lab Ref	Depth (m)	WC (%)	LL (%)	PL (%)	PI (%)	.425 mm(%)	mod. PI (%)	Av. Suc. (kPa)	Description
1	1	32.6							Soft to firm brown/dark brown banded CLAY with rare gravel and sand/topsoil. Gravel is fine
2	1.5	24.2	62	20	42	100	42		Firm brown/orange-brown/light grey veined CLAY with rare gravel and sand. Gravel is fine
3	2	22.8							Firm brown/orange-brown banded CLAY with rare gravel and sand. Gravel is fine
4	2.5	26.6							Firm brown/orange-brown/light grey veined CLAY with rare gravel and sand. Gravel is fine
5	3	25.2							Soft brown/orange-brown/light grey veined CLAY with rare gravel and sand. Gravel is fine
6	3.5	25.7	54	20	34	100	34		Soft to firm brown CLAY with rare gravel and sand. Gravel is fine
7	4	25.1							Soft brown CLAY with rare gravel and sand. Gravel is fine
8	4.5	29.9							Soft brown CLAY with rare gravel and sand. Gravel is fine
9	5	32.3							Firm brown CLAY with rare gravel and sand. Gravel is fine

10	5.5	32.7	66	24	42	100	42		Firm brown CLAY with rare gravel and sand. Gravel is fine
11	6	38.0							Soft brown CLAY with rare gravel and sand. Gravel is fine

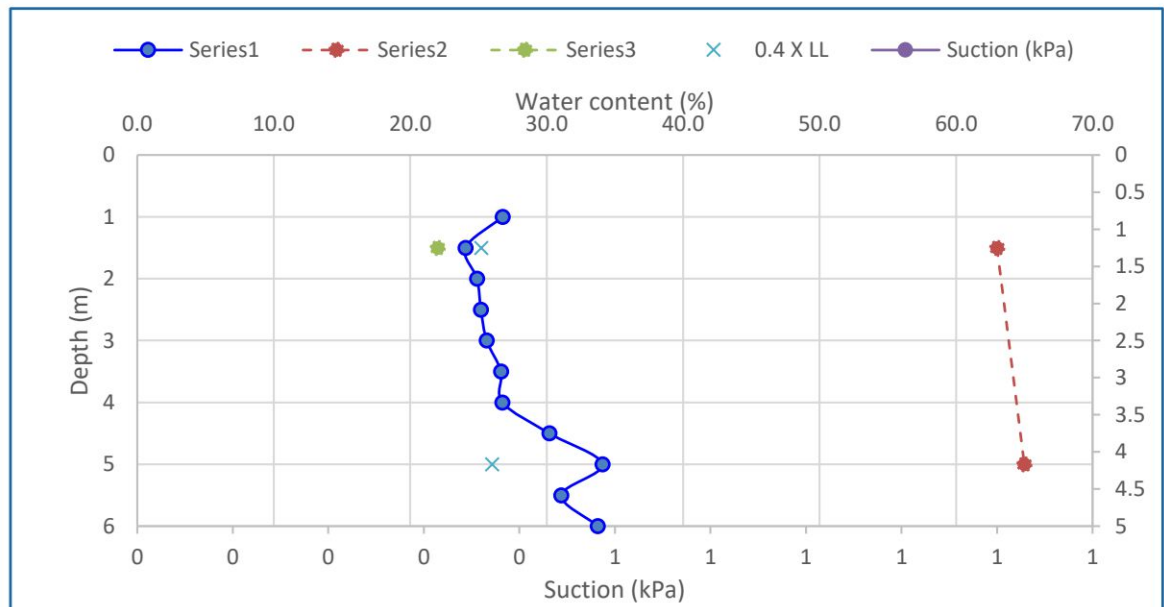
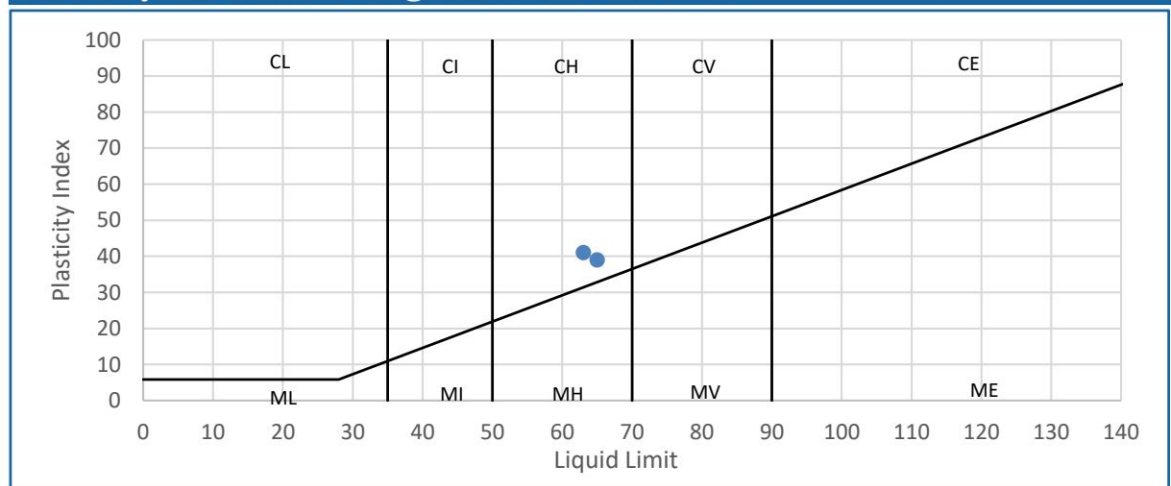
Plasticity Chart for Casagrande Classification

Samples from BH2

Lab Ref	Depth (m)	WC (%)	LL (%)	PL (%)	PI (%)	.425 mm(%)	mod. PI (%)	Av. Suc. (kPa)	Description
12	1	26.8							Firm brown/orange-brown/light grey veined CLAY with rare gravel and sand. Gravel is fine
13	1.5	24.1	63	22	41	100	41		Firm to stiff brown CLAY with rare gravel and sand. Gravel is fine
14	2	24.9							Firm brown CLAY with rare gravel and sand. Gravel is fine
15	2.5	25.2							Firm brown CLAY with rare gravel and sand. Gravel is fine
16	3	25.6							Soft to firm brown CLAY with rare gravel and sand. Gravel is fine
17	3.5	26.7							Soft to firm brown/orange-brown/light grey veined CLAY with rare gravel and sand. Gravel is fine
18	4	26.8							Firm brown/orange-brown/light grey veined CLAY with rare gravel and sand. Gravel is fine
19	4.5	30.2							Firm to stiff brown/orange-brown/light grey veined CLAY with rare gravel and sand. Gravel is fine
20	5	34.1	65	26	39	100	39		Soft to firm brown/orange-brown/light grey veined CLAY with rare gravel and sand. Gravel is fine

21	5.5	31.1							Firm to stiff brown/orange-brown/light grey veined CLAY with rare gravel and sand. Gravel is fine
22	6	33.7							Firm brown/orange-brown/light grey veined CLAY with rare gravel and sand. Gravel is fine

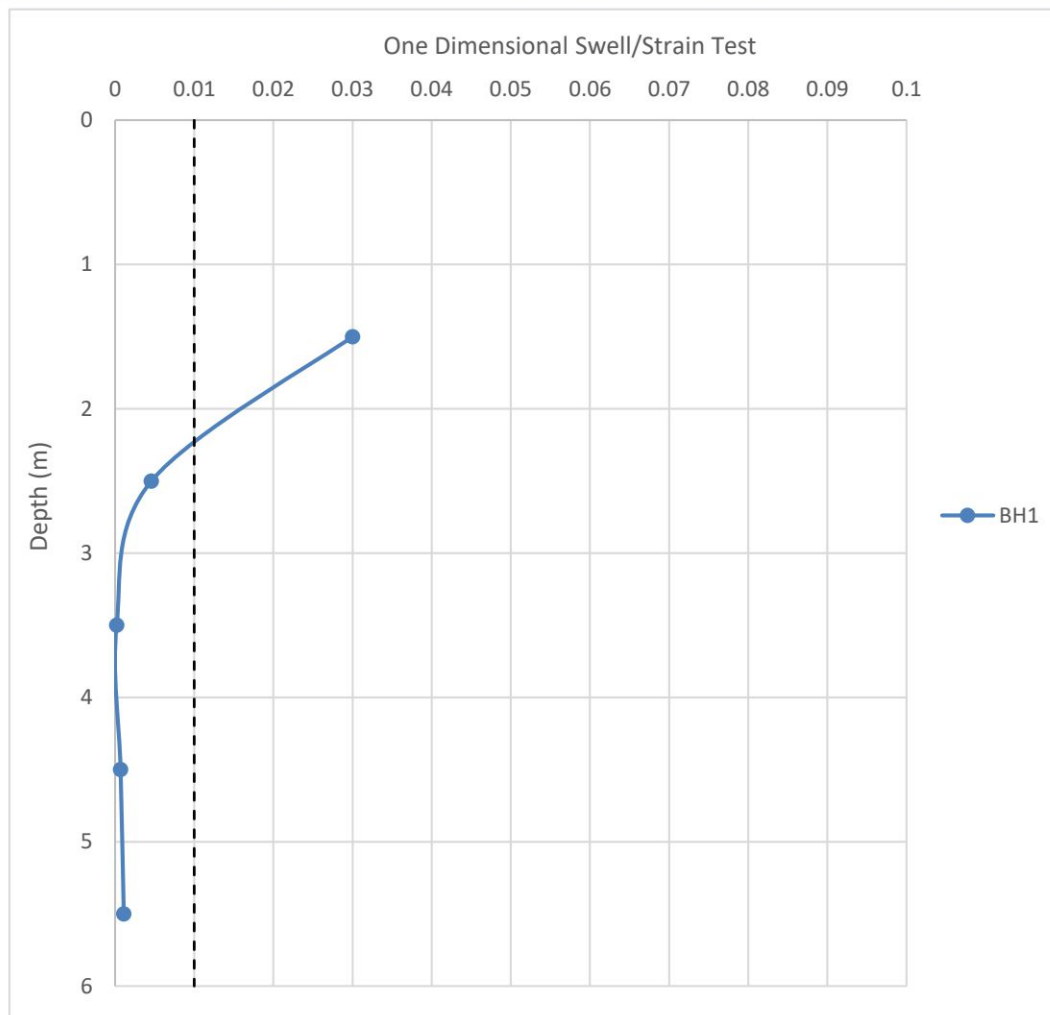
Summary of Oedometer Testing for BH1

Lab Ref	Depth (m)	Strain	Heave (mm)	Remarks
1	1			
2	1.5	0.03	0	
3	2			
4	2.5	0.0046	0	
5	3			
6	3.5	0.0002	0	
7	4			
8	4.5	0.0007	0	
9	5			
10	5.5	0.0011	0	
11	6

BH 1 estimate of heave 0mm

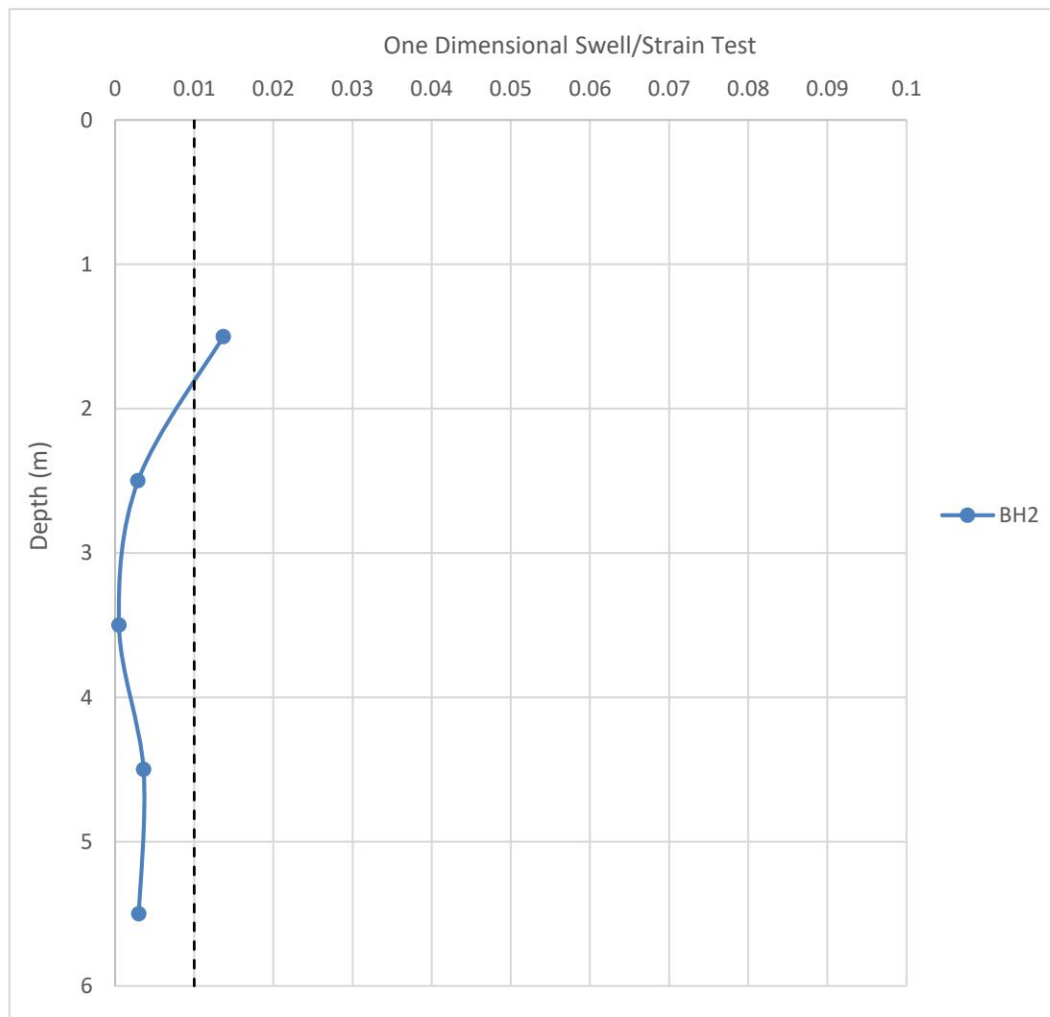
Summary of Oedometer Testing for BH2

Lab Ref	Depth (m)	Strain	Heave (mm)	Remarks
12	1			
13	1.5	0.0137	10.3	
14	2			
15	2.5	0.0029	0	
16	3			
17	3.5	0.0005	0	
18	4			
19	4.5	0.0036	0	
20	5			
21	5.5	0.003	0	
22	6

BH 2 estimate of heave 10mm
