**Tree Protection Plan TPPV1
Trewithen Estate (Home Farm)**

SCALE : 1 : 500 @ A1 DATE : 05/08/2023

MAP FILENAME : TPPV1

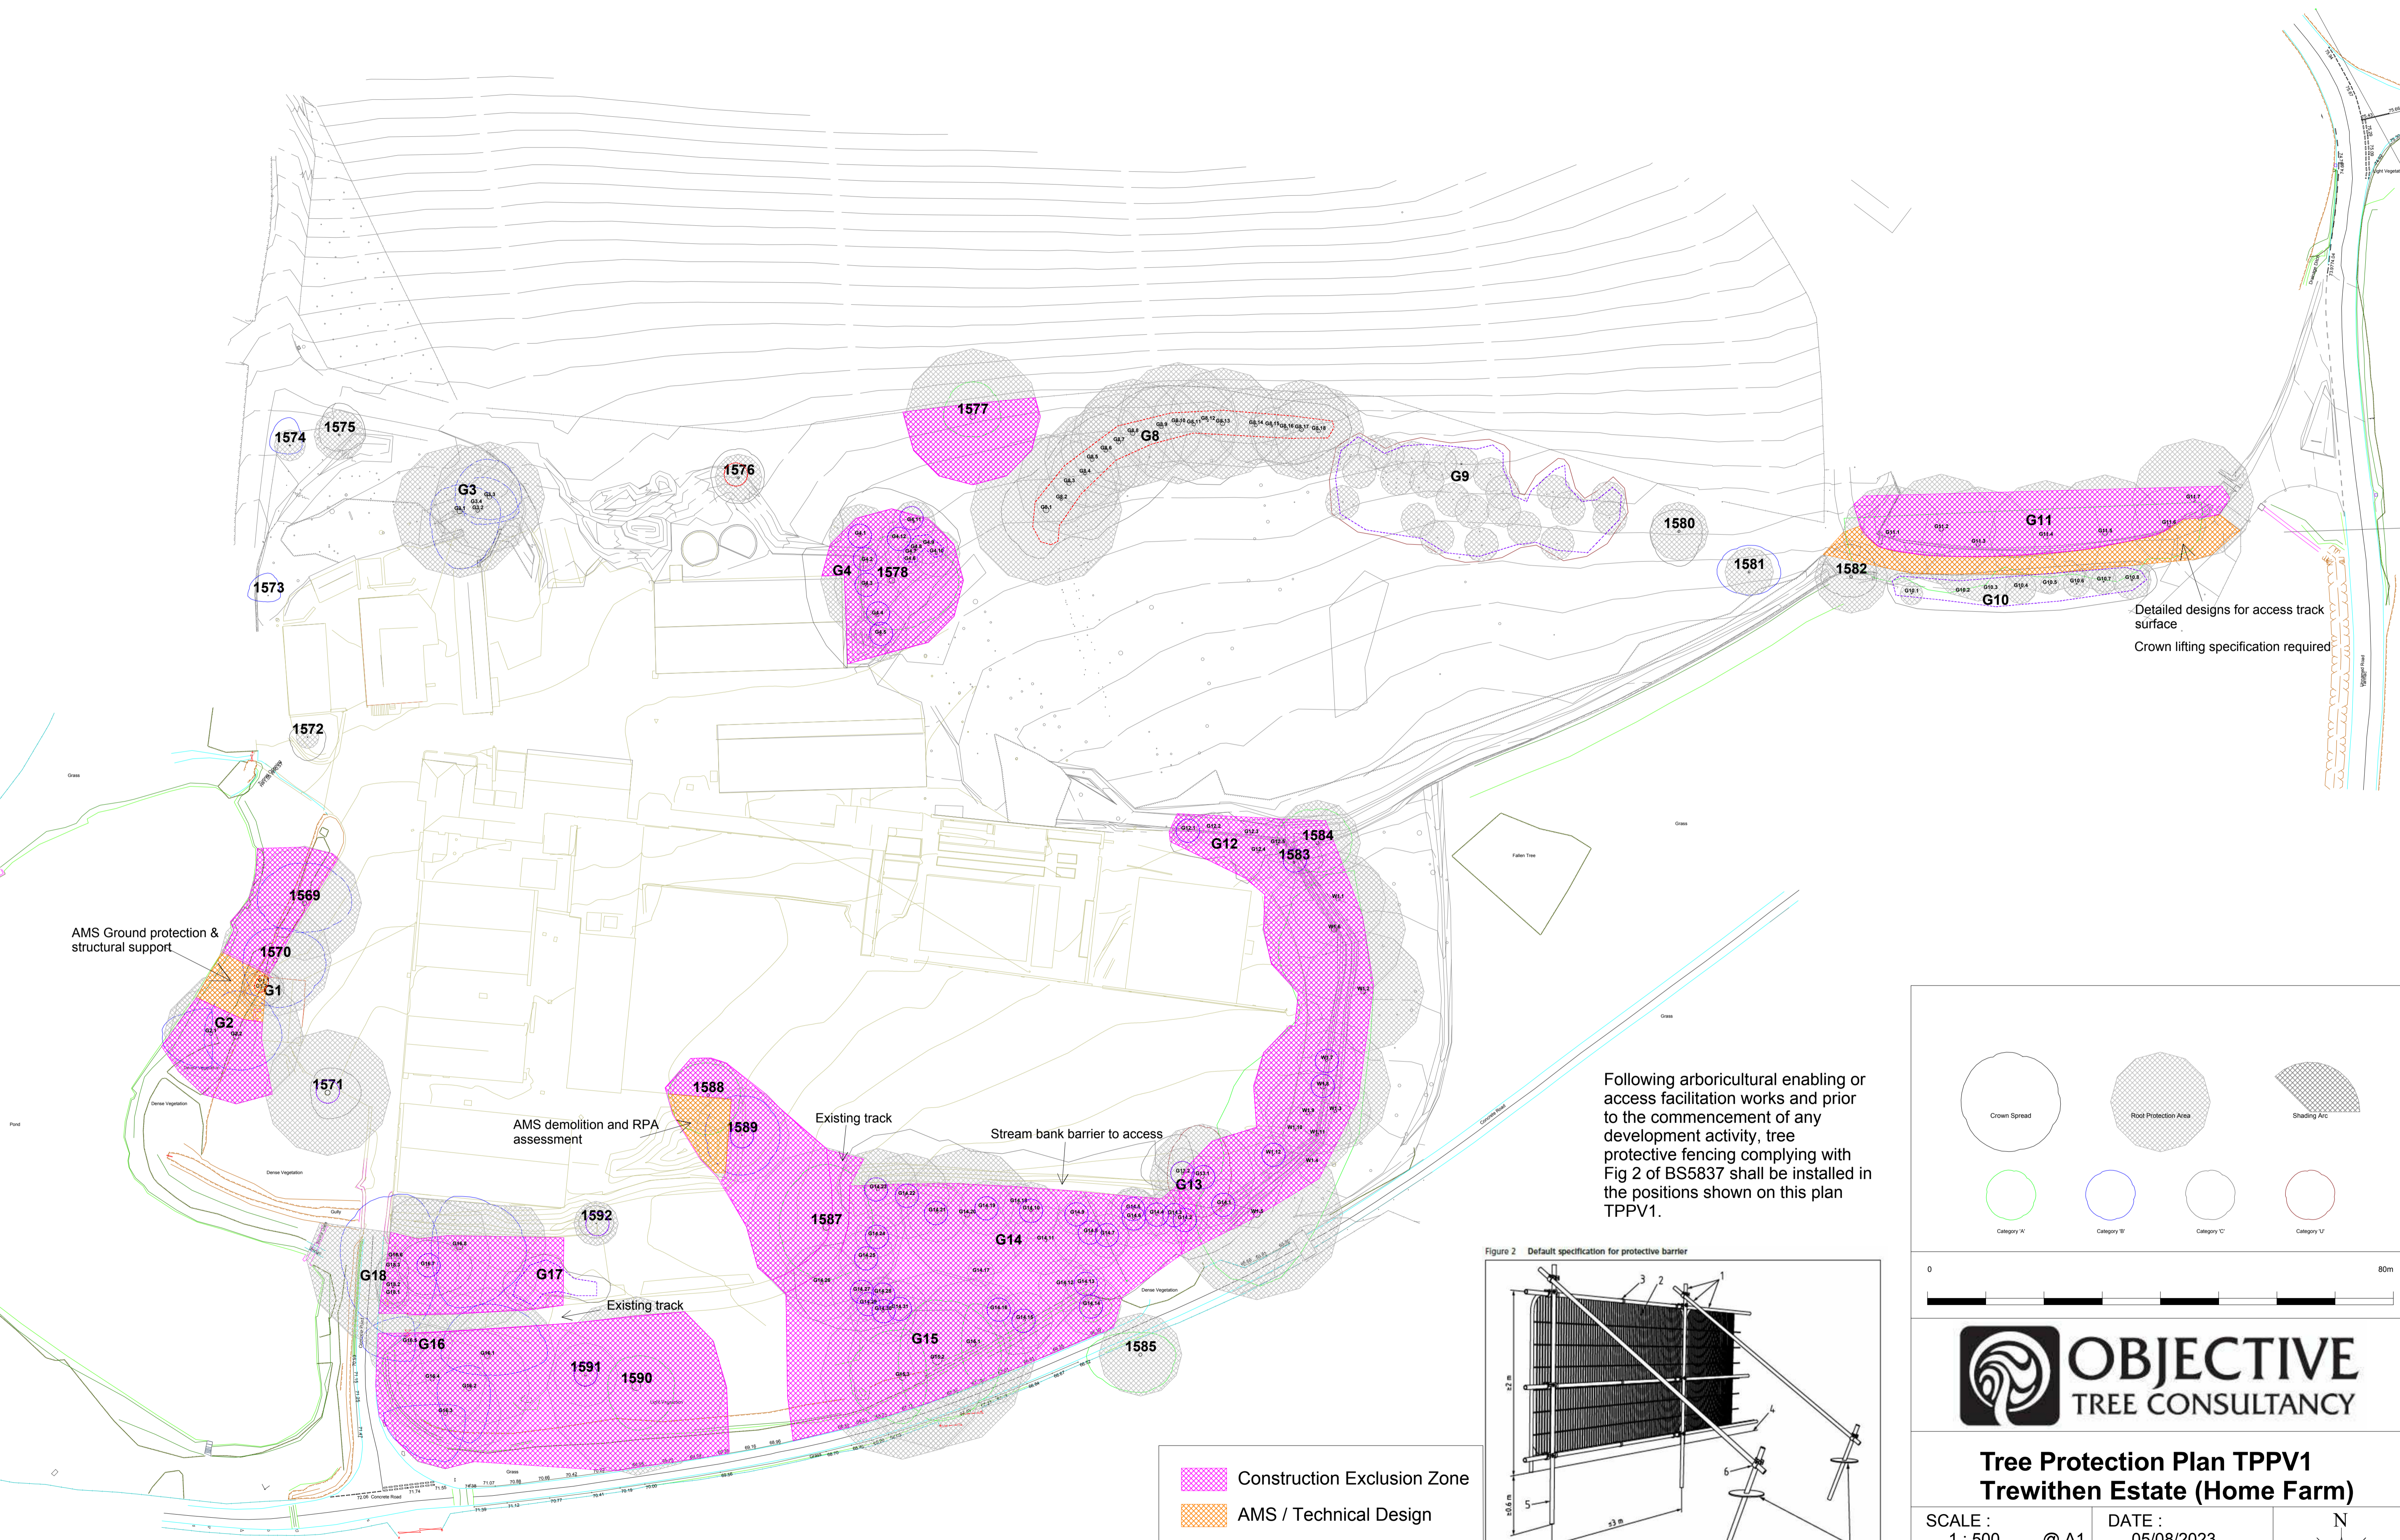
Detailed designs for access track surface
Crown lifting specification required

AMS Ground protection & structural support

AMS demolition and RPA assessment

Existing track

Stream bank barrier to access

Following arboricultural enabling or access facilitation works and prior to the commencement of any protective fencing activity, tree protective fencing complying with Fig 2 of BS5837 shall be installed in the positions shown on this plan TPPV1.
