# **04 Dukes Meadow, Funtington, West Sussex**

## **Preliminary Ecological Appraisal Preliminary Roost Assessment**

Site Reference: EE-23-09250-01

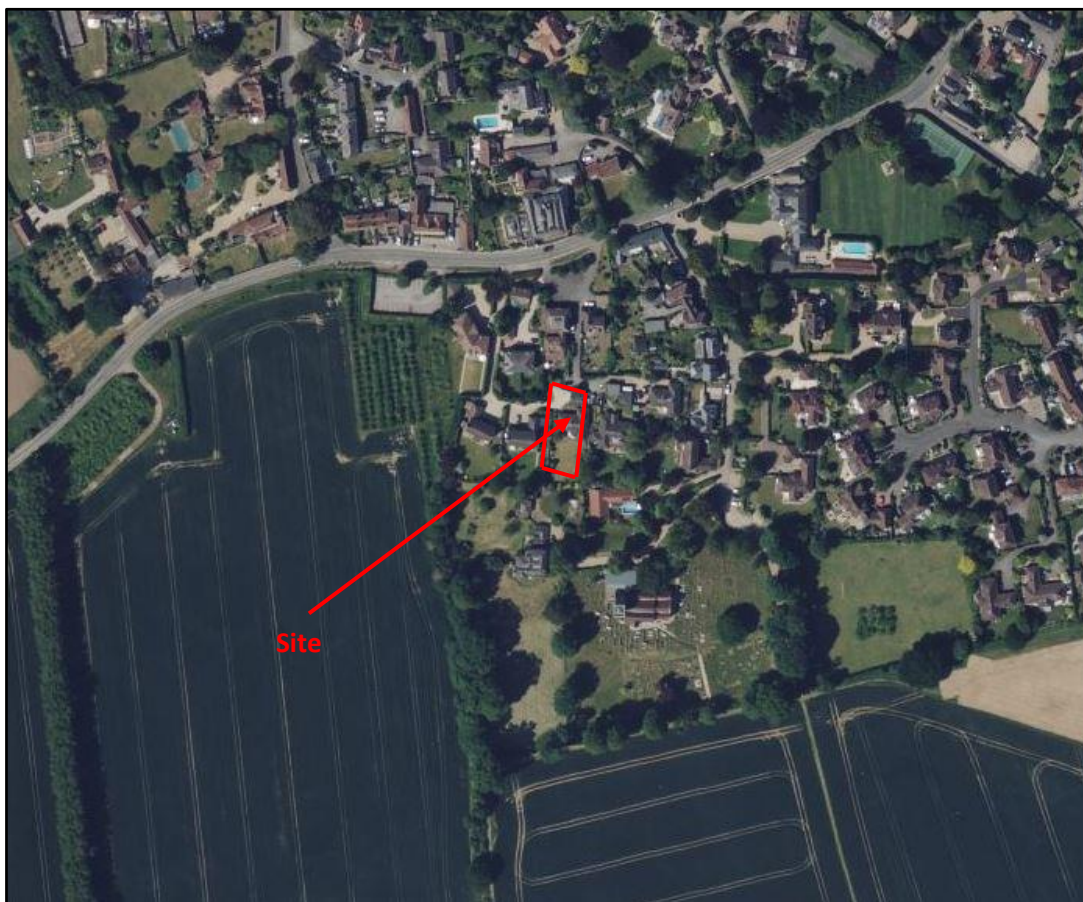
**Plate 1: 04 Dukes Meadow, Funtington (October 2023)**

- 1.6 The site was comprised of one small structure set within a small amount of residential land (c. 0.1ha), comprised of a well-tended garden and a hardstanding drive for car parking. The plot is roughly rectangular in shape and there is very minimal border/garden vegetation. The site is located along the western edge of Funtington village and, at the time of the survey, was fully occupied by the owner/occupier.

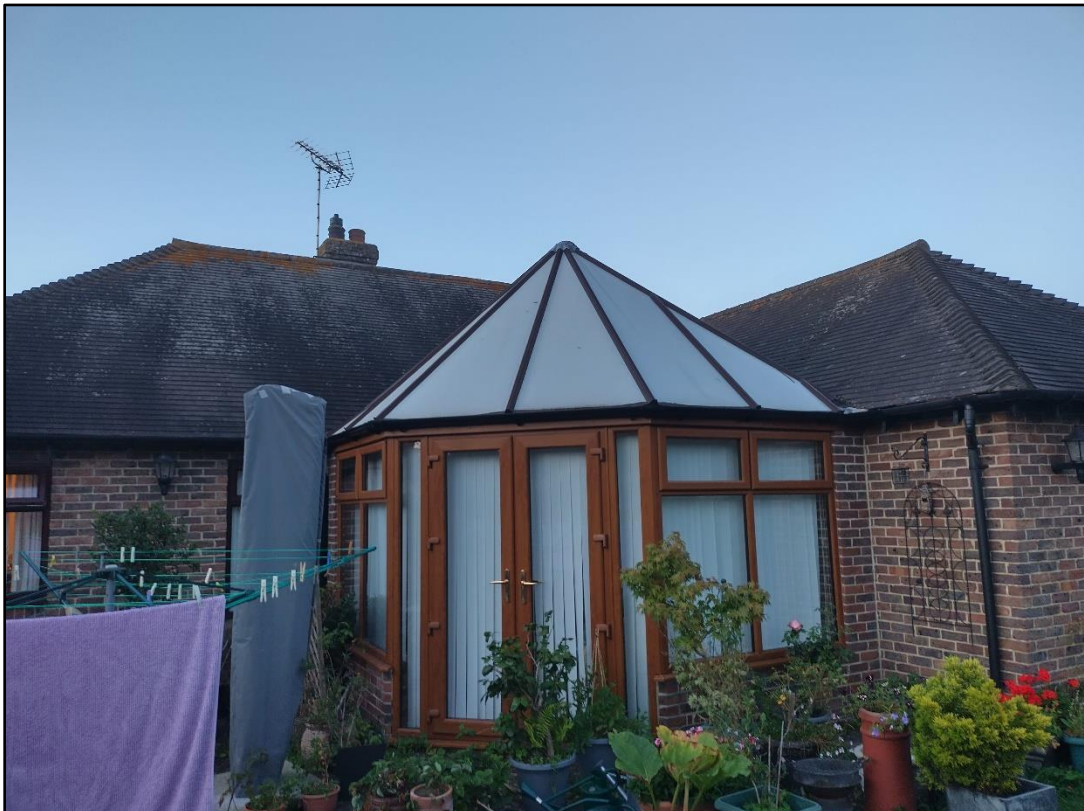
**Plate 3: Main Structure (Southern Elevation). Small Conservatory (centre) proposed for demolition. Extension proposed from left side of structure in photograph to reflect that on the right side of the photograph.**

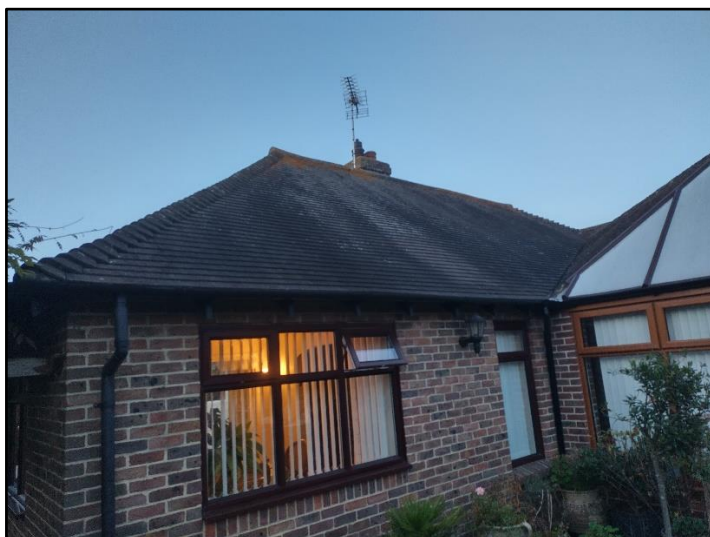
**Photograph 1**

TN	Description	Species/Habitat	Potential	Photo No.
01	<p>Location of proposed extension. A small number of tiles will be removed to allow the connection of the proposed roof structure to the existing roof structure. The only potential impact from this would be to roosting bats, however, the Bat Roost Potential (BRP) is negligible. The BRP to the whole roof was in fact negligible. There were no potential bat access points therefore the likelihood of bats roosting within the impacted area is negligible.</p>	Bats	Negligible	1

Western section of the southern elevation and the location of the proposed extension.

This area was considered to have negligible potential for bats/nesting birds.

- 5.4 The development will necessitate the removal of a small amount of tiles on the western section of the southern elevation of the existing structure which has been assessed to represent 'negligible' bat roost potential. The local landscape is considered moderate/high quality for bats; however, this is irrelevant when the site features impacted by the development proposals were so poor i.e. no points of ingress/egress.
- 5.5 It will not be necessary to investigate the site for bats as part of this planning application.

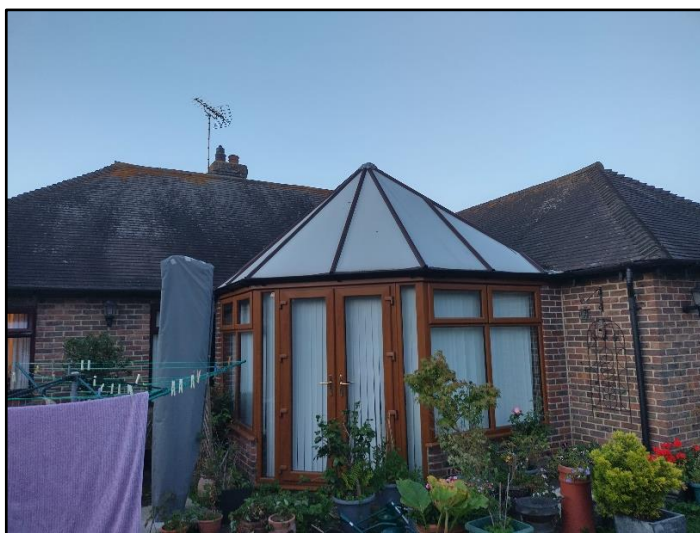
**Photograph 2**

TN	Description	Species/Habitat	Potential	Photo No.
02	Small conservatory proposed for demolition.	Bats	Nil	2

The conservatory proposed for demolition was considered to represent negligible BRP. No other protected species will be impacted by its removal.

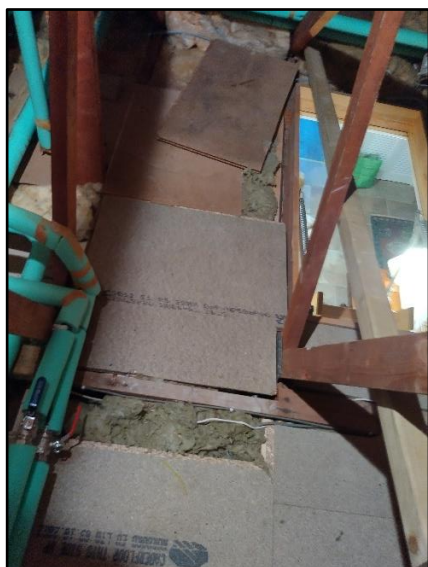
**Photograph 4**

No signs of bat activity with the loft of the main structure.

This area was considered to have negligible potential for bats/nesting birds.
