**GEO-ENVIRONMENTAL SITE INVESTIGATION
REPORT**

**FORMER FIVE BELLS INN
BURES ROAD
GREAT CORNARD
CO10 0HU**

**Reference Number 3035/Rpt 4v1
July 2023**

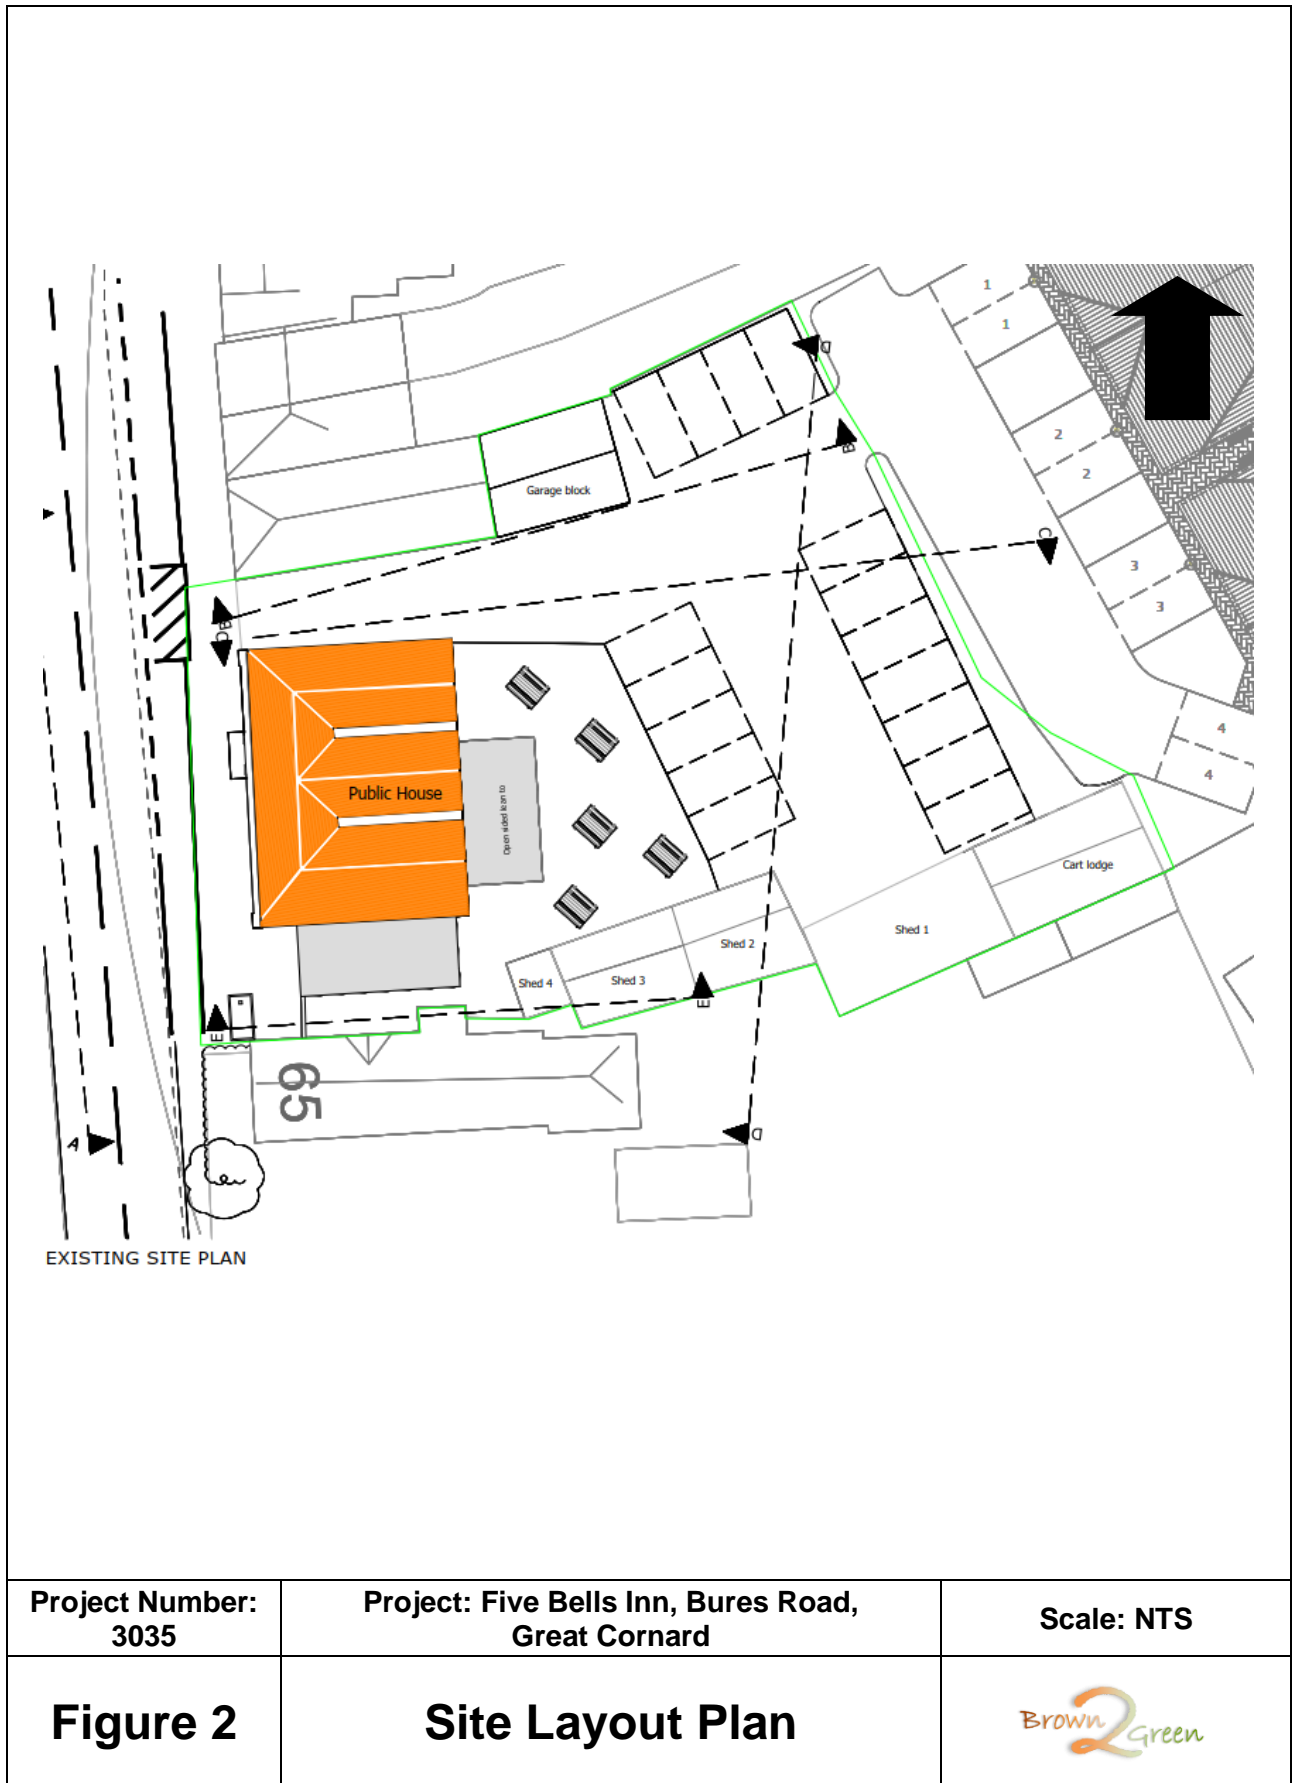
The site layout is presented in Figure 2.

At the time of the site walk-over the western side of the site was occupied by the former Five Bells Inn building and fronts onto Bures Road. The building is two-storey with a slate roof. The building has been stripped of all internal fittings. The former public house including the surrounding area were being used as a construction compound for the development of the houses at the rear of the former car park.

Along the southern boundary there the two derelict buildings, one being an open fronted cart lodge and the other an outbuilding (Shed 1) for the public house. The buildings were being used for the storage of construction materials. Immediately west there is the footprint of three sheds (Shed 2, 3 and 4) that have been demolished.

The remainder of the site was the former car park that is paved with asphalt and the access driveway to the car park. The site that is currently under development was the former pub garden.

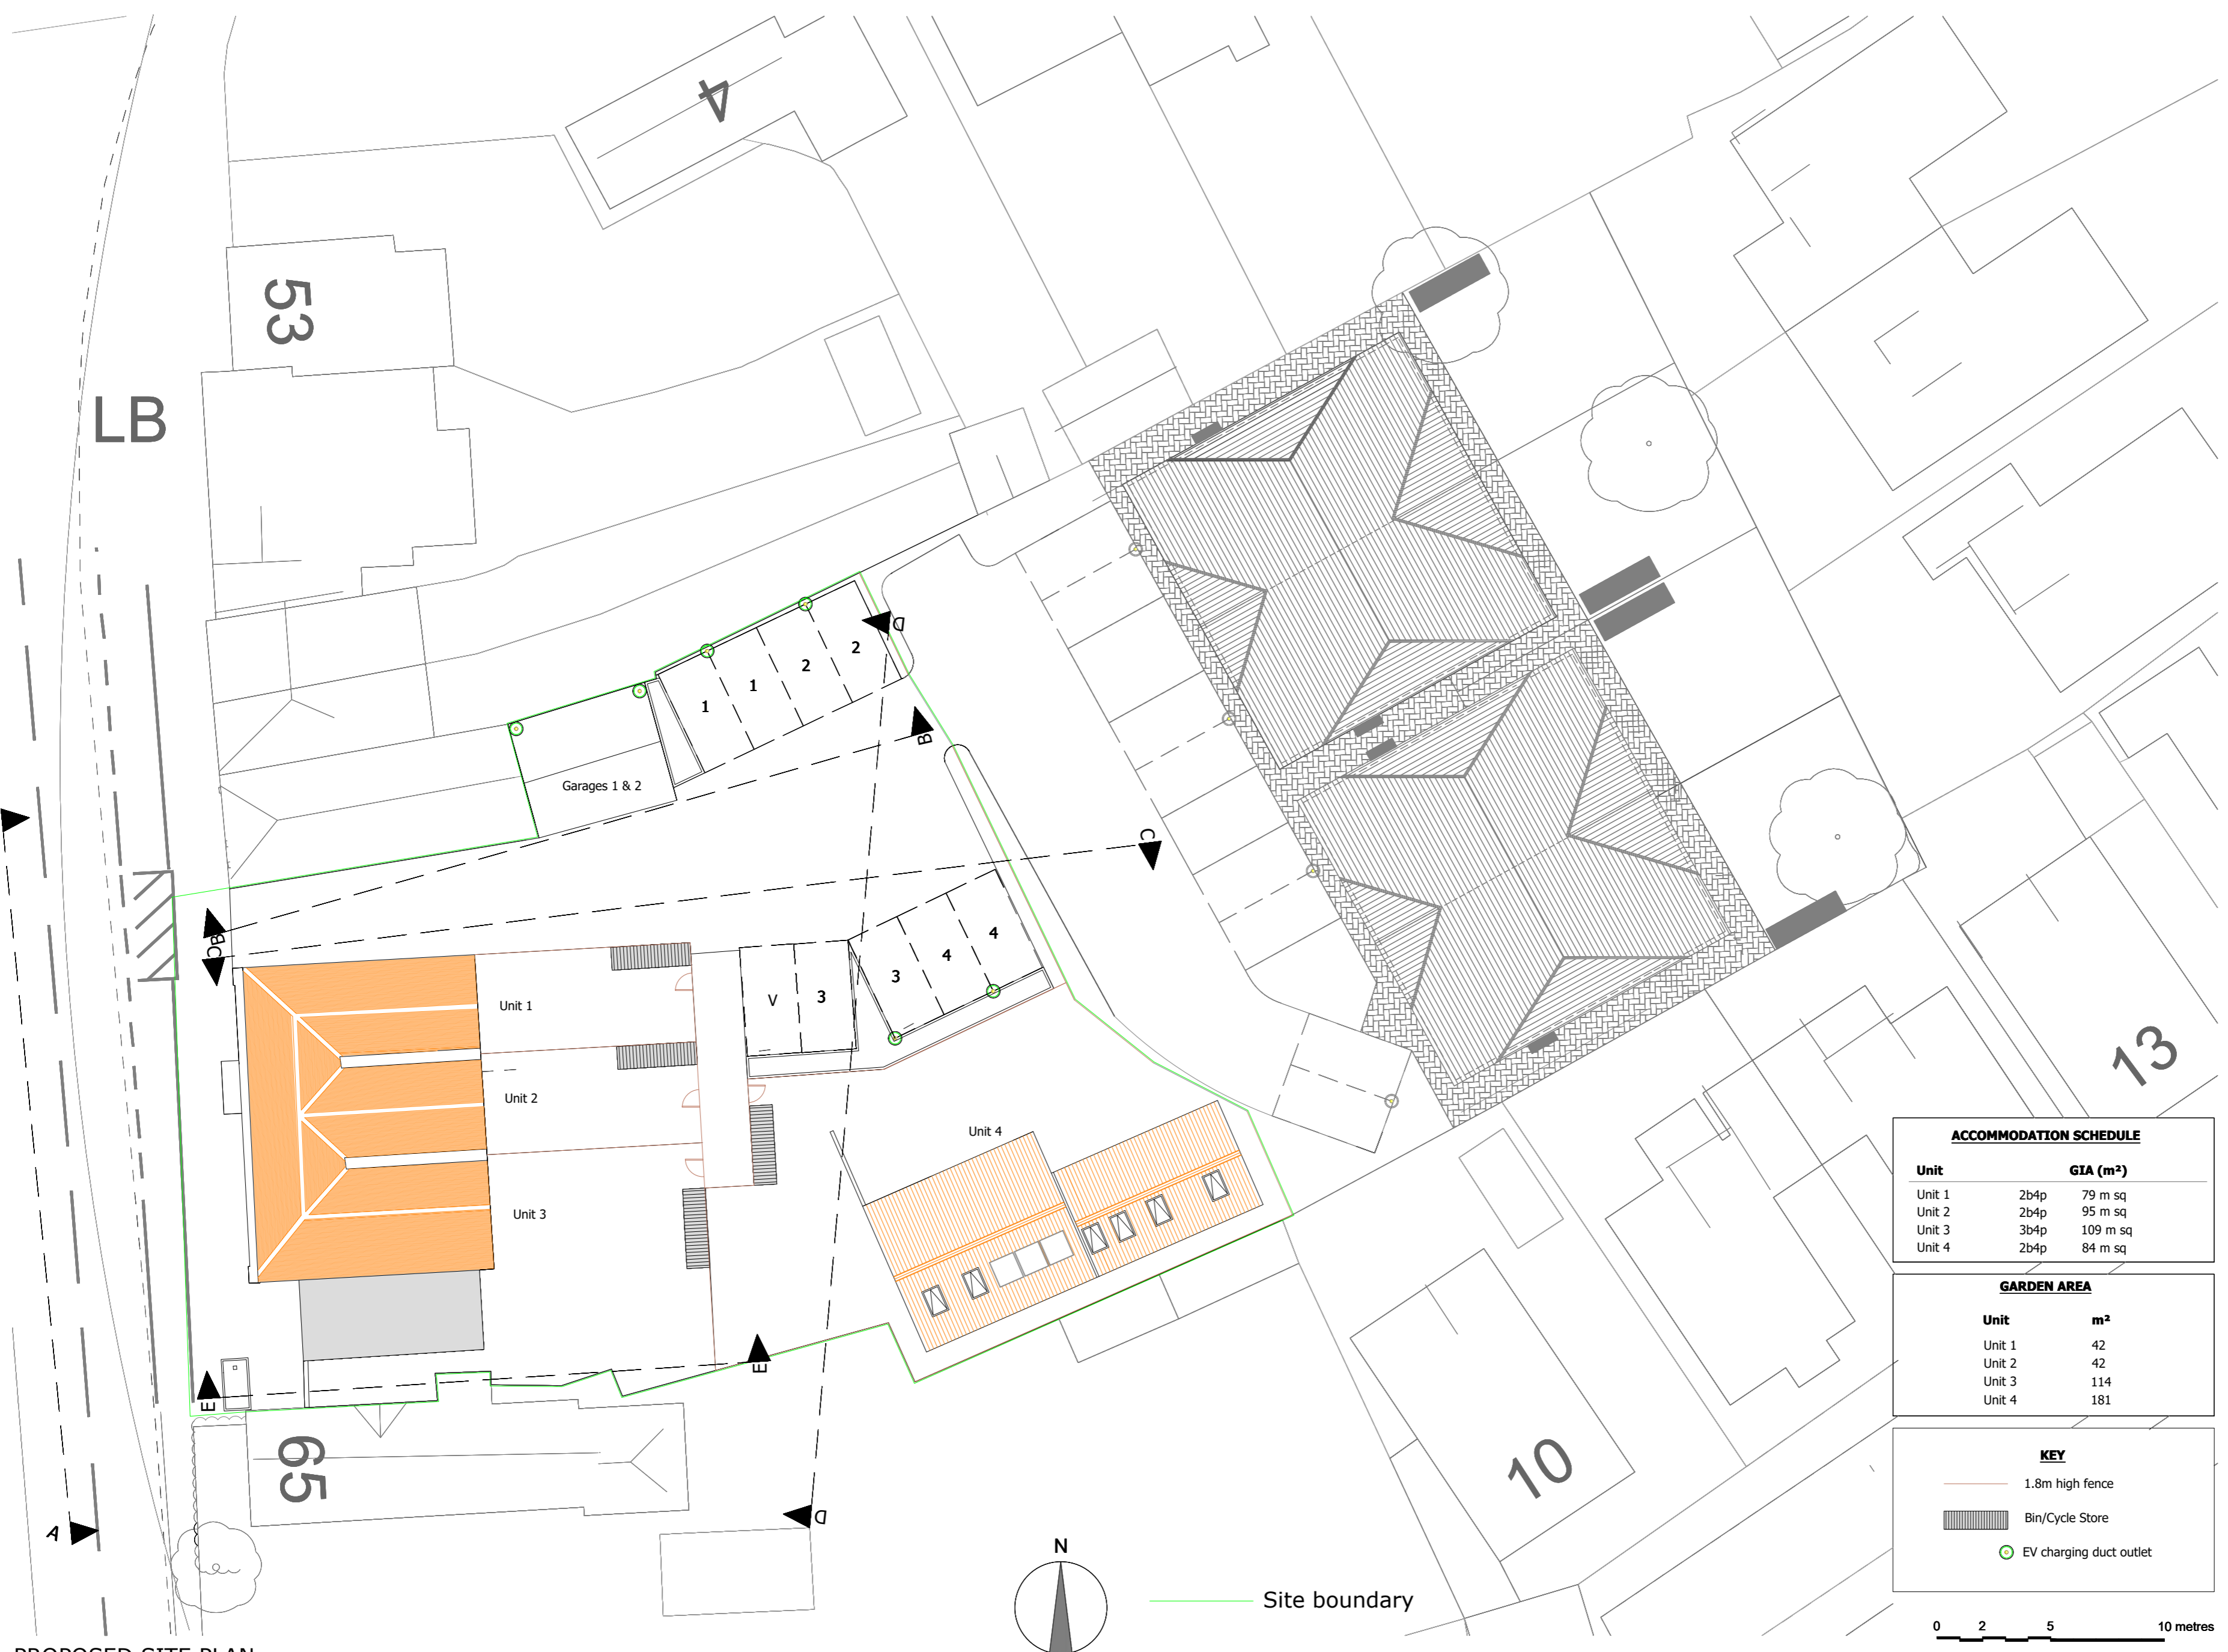
The work was commissioned to provide information for a planning application to convert the existing former public house building and an outbuilding to residential usage. Each property will have a private garden. The proposed development is shown on drawing number D011.002.01 prepared by 20 Gainsborough Ltd. The proposed development layout is presented in Appendix II.

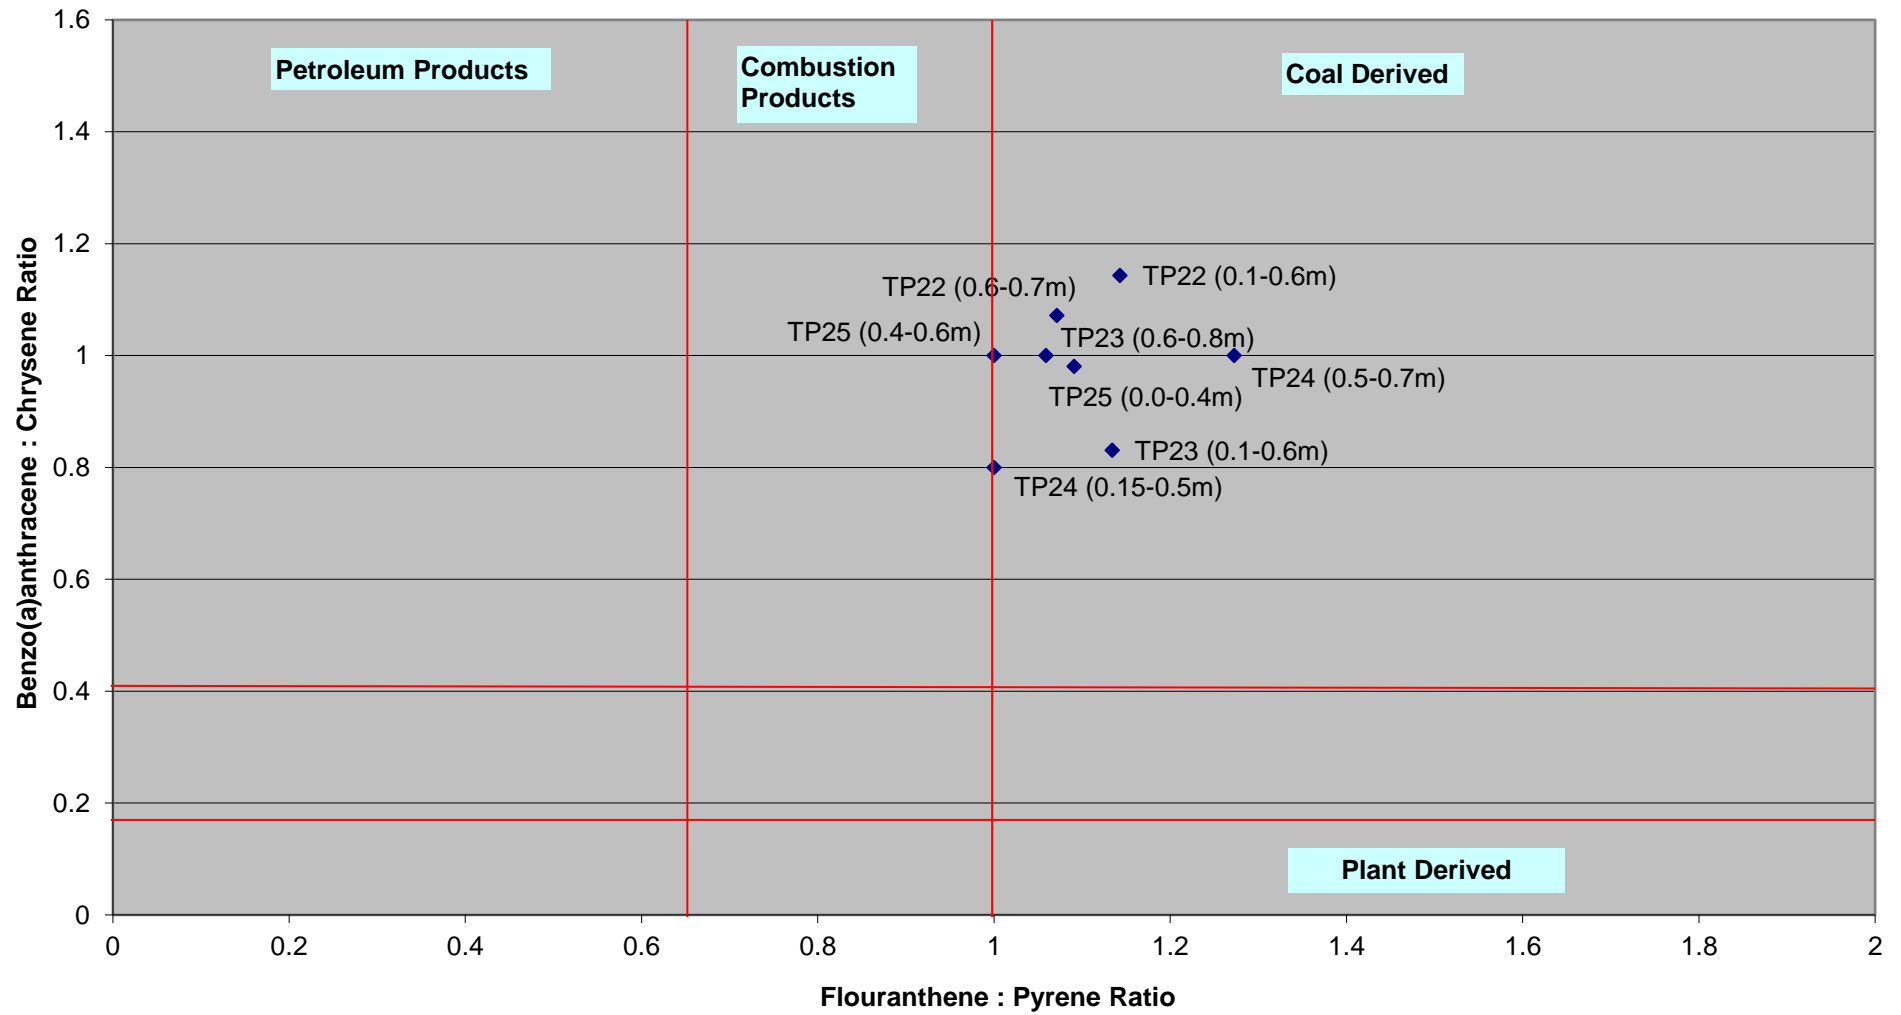
APPENDIX V
DOUBLE RATIO PLOT

Polycyclic Aromatic Hydrocarbons Plotted on a Signature Double Plot
