## **BS5837:2012 Arboricultural Survey Impact Assessment & Arboricultural Method Statement**

**Site Address:  
Wynchmoor  
Pursers Lane  
Peaslake  
Surrey  
GU5 9RE**

**Robert Toll  
HND Urban Forestry - ND Forestry - MArborA  
Ref: RMT897  
Site inspection date: 12<sup>th</sup> September 2023  
Date draft report published: 21<sup>st</sup> September 2023  
Prepared for John and Sara Dean**

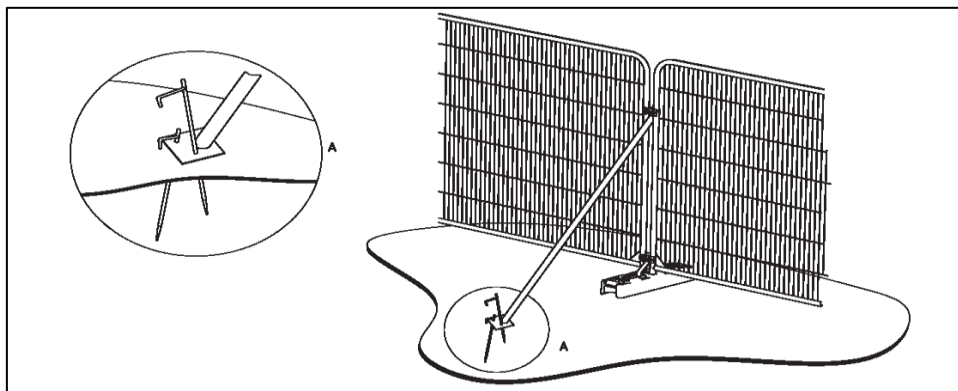
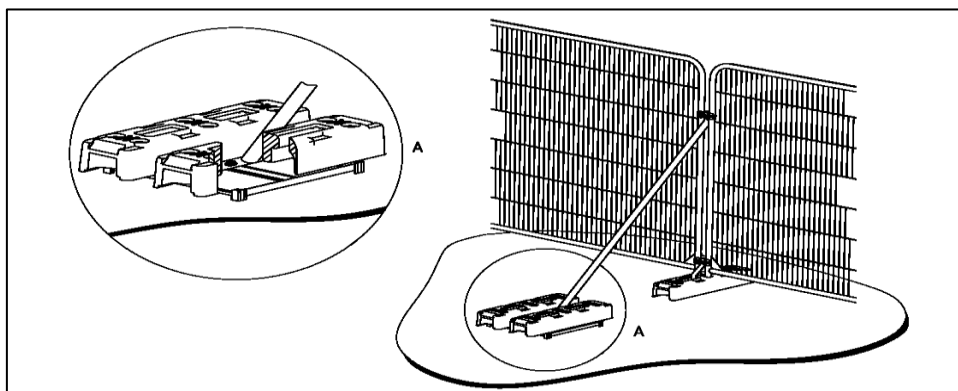
**Figures 2 and 3** – Examples of above-ground stabilizing systems

a) Stabilizer strut with base plate secured with ground pins

b) Stabilizer strut mounted on block tray

- 5.3 All tree protection barriers will be erected in the positions shown in **Appendix 4** and in accordance with the specifications detailed in Figures 2 and 3.

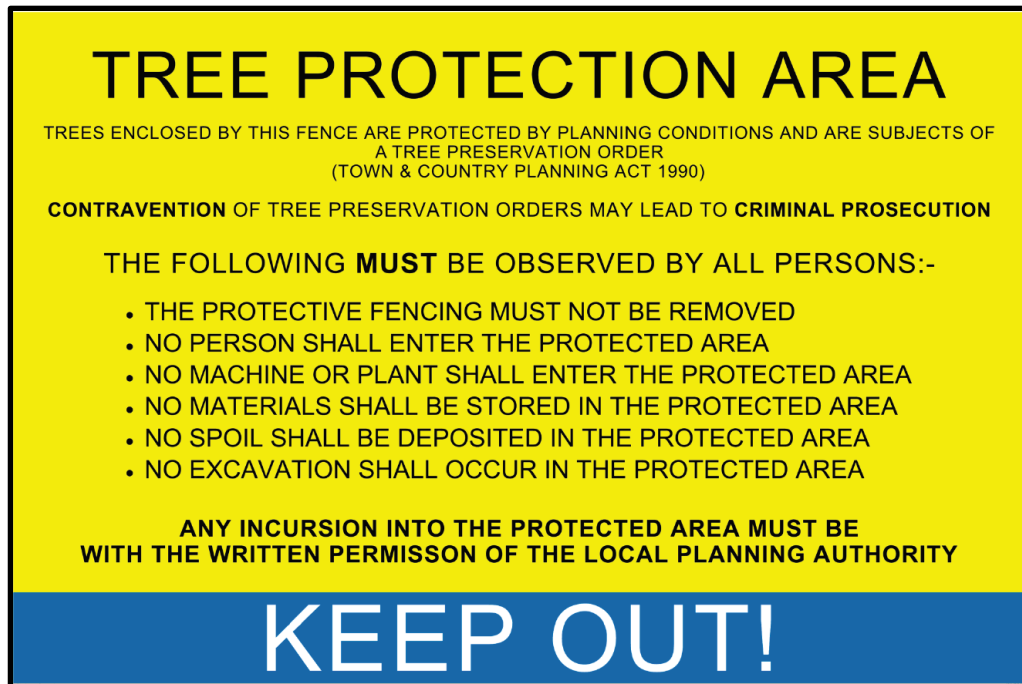
Figures 4 – Examples of tree protection warning sign.

5.4 All weather notices will be attached to the tree protection fencing.

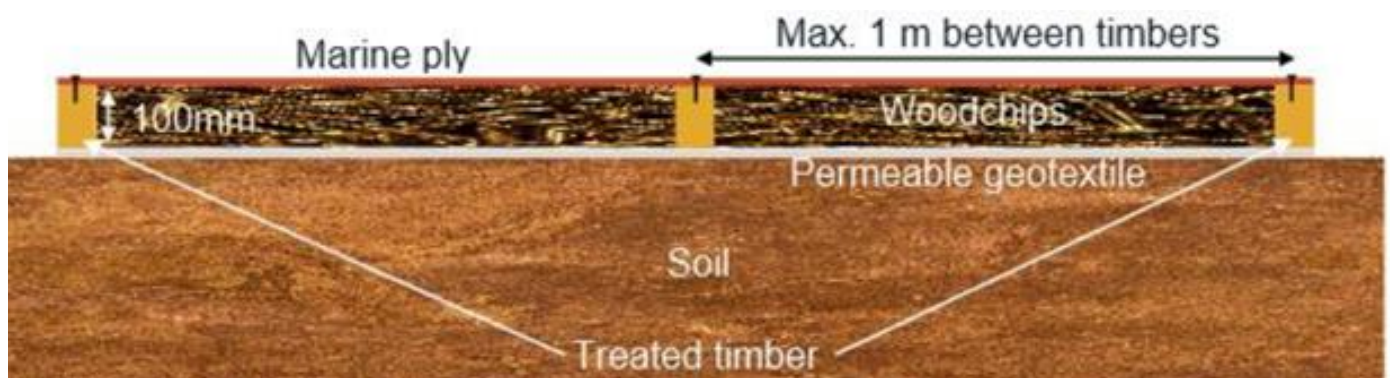
Figure 5 – Specification for ply board ground protection

5.6 A permeable geotextile such as Terram will be laid and onto this will be placed treated timber (100 mm x 80 mm) at spacings of no more than 1m. The area between the timber bearers will be filled with a compressible material such as woodchips and will then be covered by 20 mm thick marine ply which will be screwed down onto the timber (Figures 5 and 6). The plywood may need to be coated with a non-slip paint.

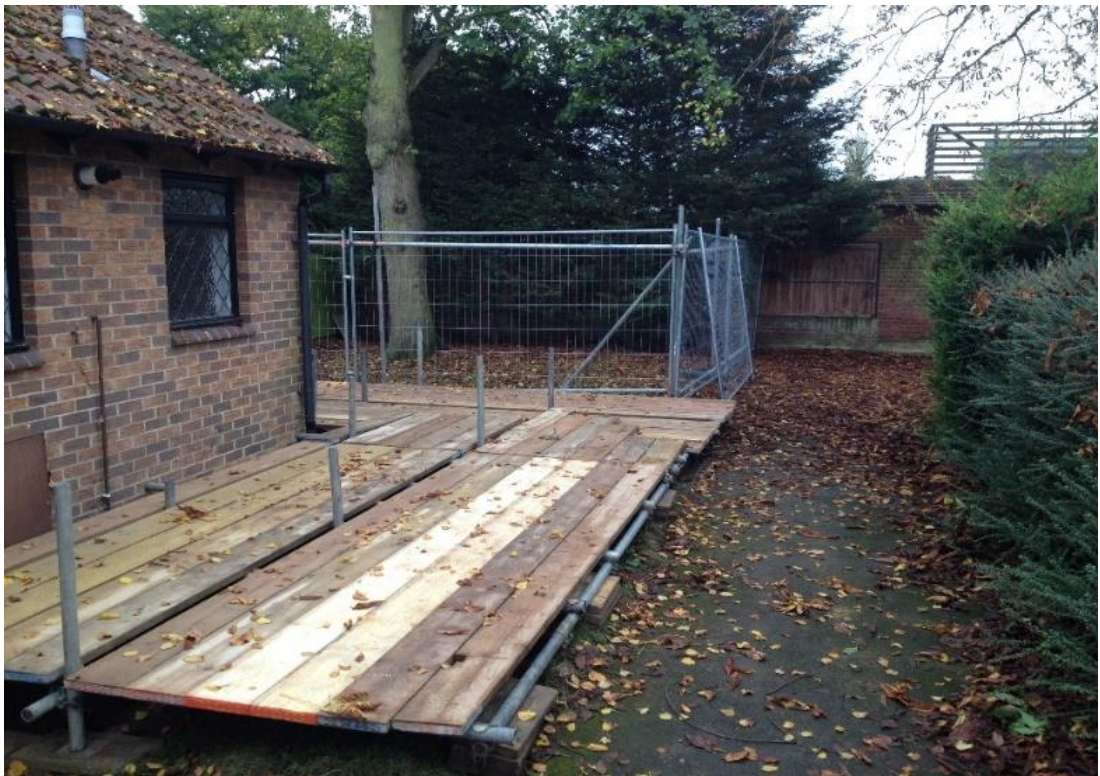
**Figure 7 – Specification for scaffold ground protection.**

5.7 Single thickness of scaffold boards placed on top of driven scaffold frame to form a suspended walkway (Figure 7)
