23/24 Church Road, Tattingstone, Suffolk

Historic Building Record

May 2023

This report provides an archaeological record and analysis at Historic England (2016) Level 3 of a semi-derelict grade II-listed cottage at TM 13794 37083. The adjoining grade II-listed cottage in the same ownership is included for context. The report includes a full photographic record of 50 images, but the buildings are not of sufficient scale or significance to warrant an additional archive of digital images. Where possible each photograph includes a 2 m scale rod with half-metre divisions in red and white. The site was inspected on 17th April 2023.

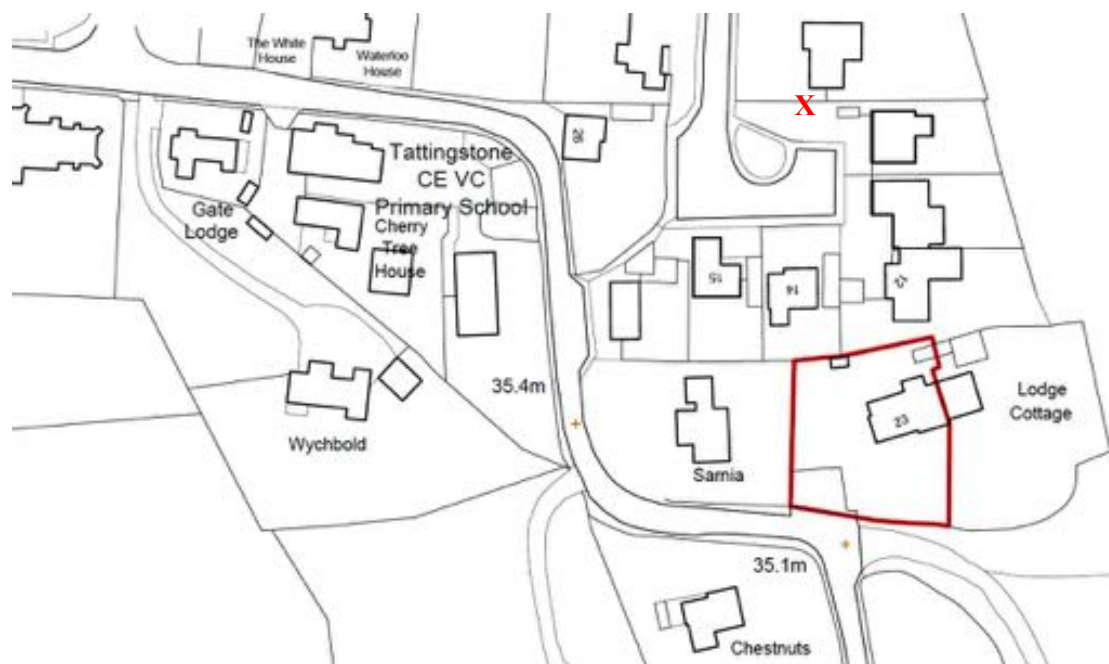
Figure 2. A current site plan outlining the combined site boundary of nos. 23 and 24 in red with Lodge Cottage to the east. 'X' marks the site of a Mock Tudor garden gateway.

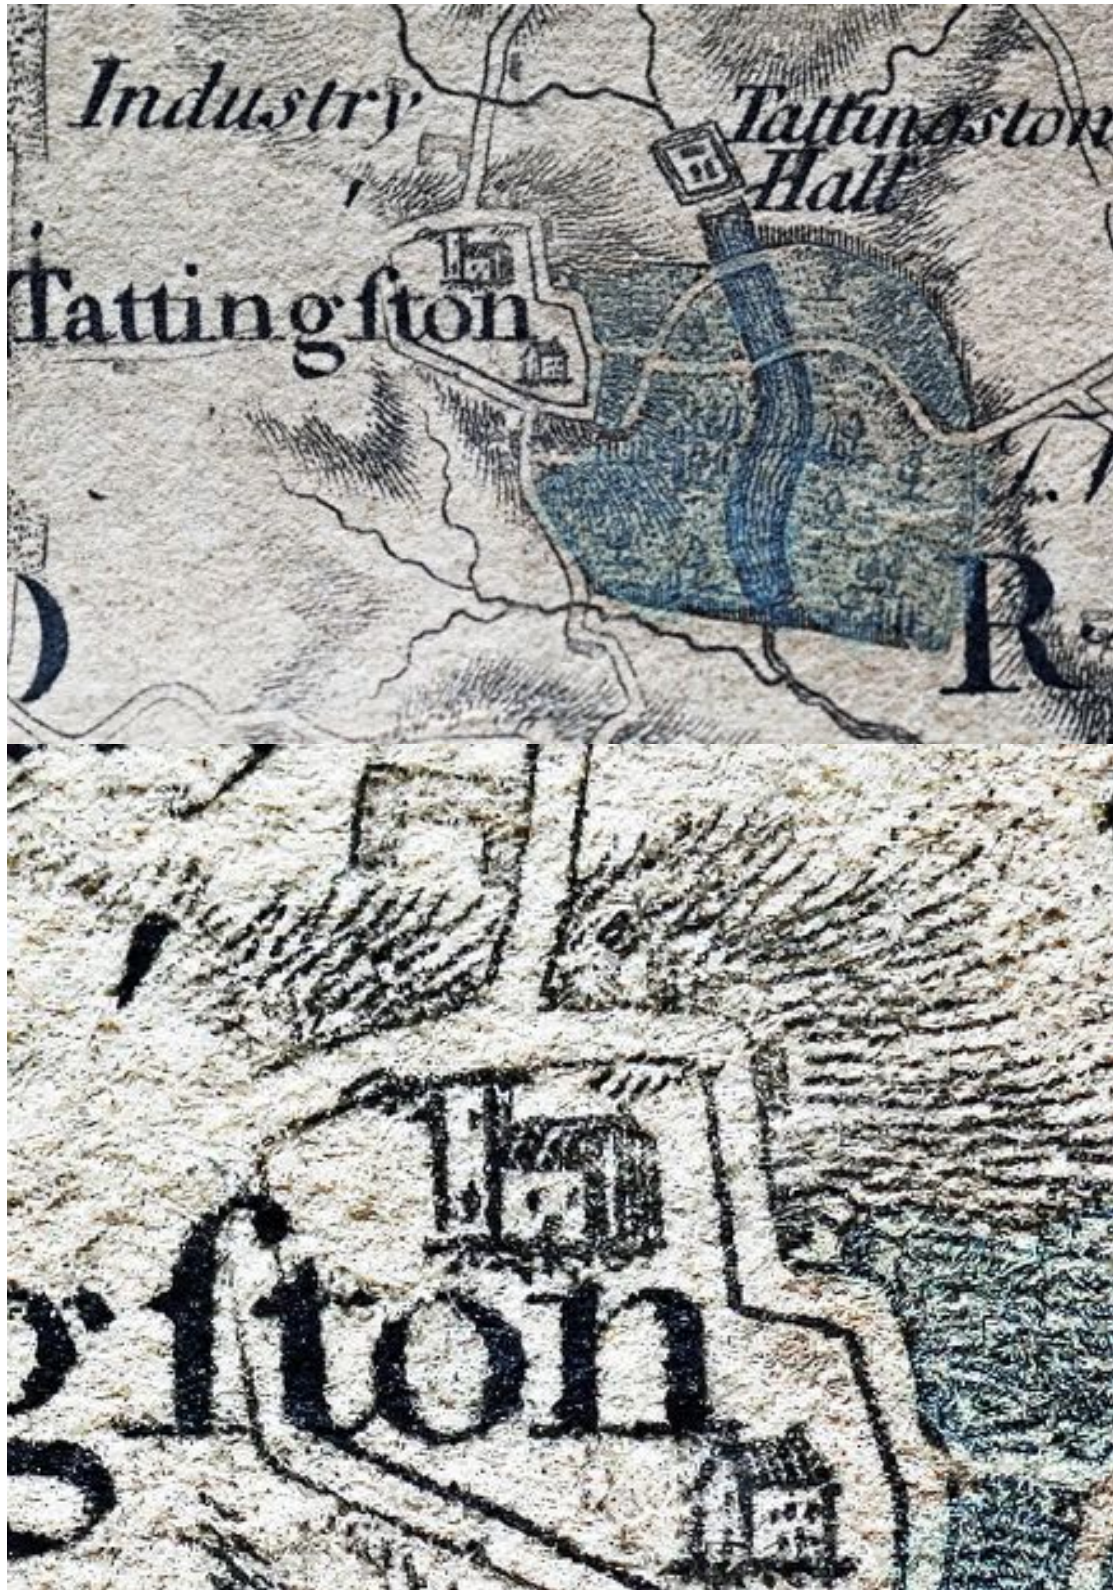
Figure 3. Details of Hodskinson's map of Suffolk published in 1783 showing the park and linear lake with a building on the site of 23 Church Road. The building is aligned at right-angles to the road, and may represent the predecessor of the present cottages. The park was not present at the time of Kirby's 1735 map but appeared on his 1766 revision and is probably contemporary with Tattingstone Place, which was described as newly built in 1764. The linear lake was described as 'fish ponds' by the 1837 tithe survey.

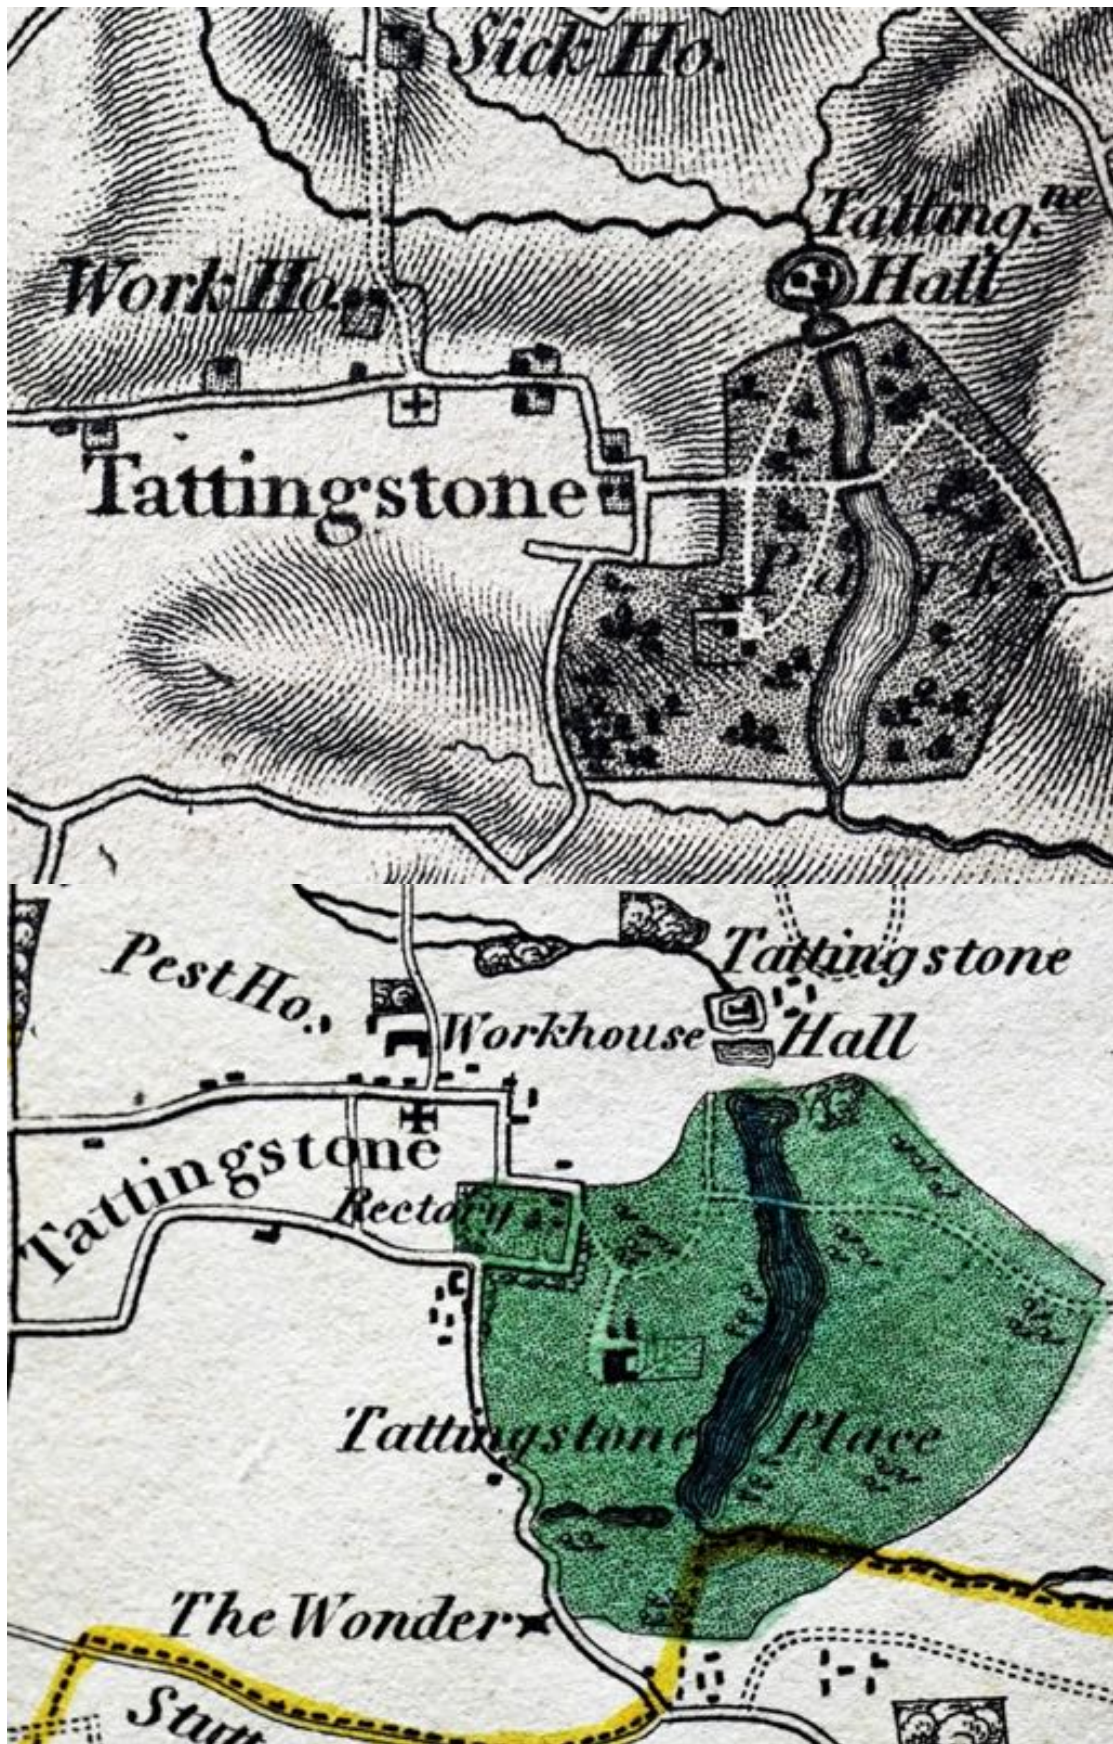
Figure 4. The First Edition one-inch Ordnance Survey of 1805 by Col. Mudge (top) and Bryant's map of 1826. Both show buildings on the approximate site of 23 Church Road.

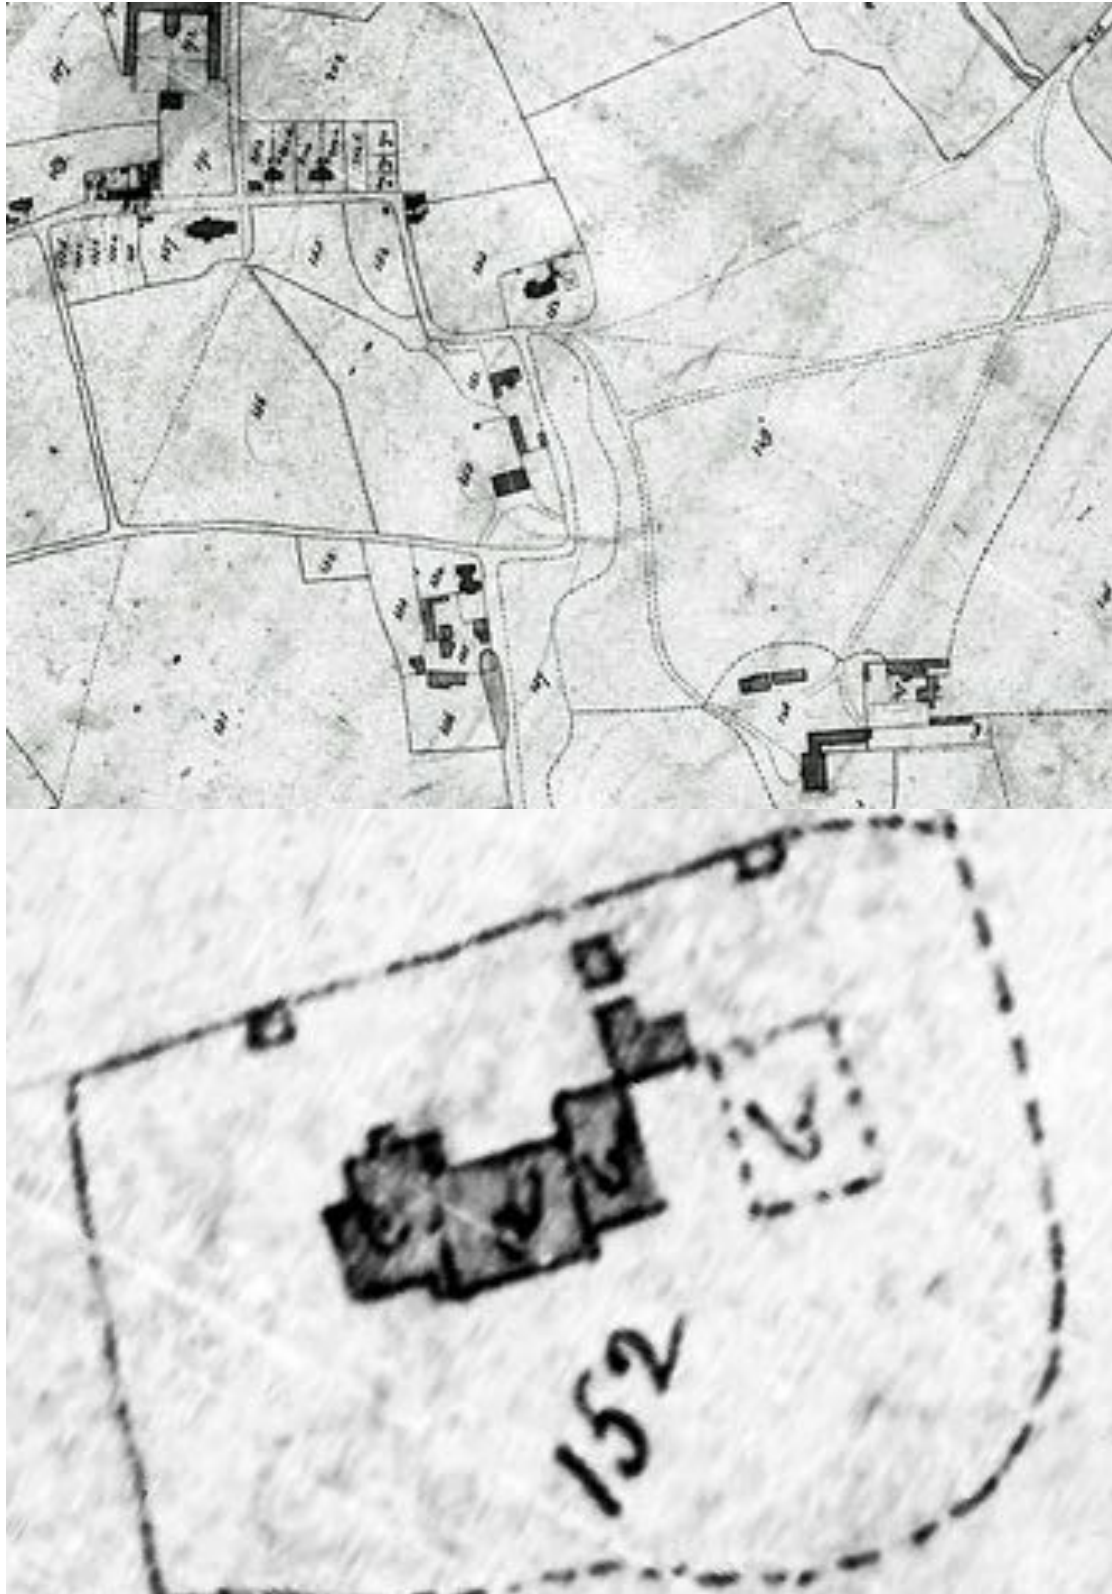
Figure 5. The Tattingstone tithe map of 1837, with a detail below. The three cottages are depicted much as today, with the central section at no. 23 projecting to the south, but Lodge Cottage on the right was significantly smaller. A lean-to with a small chimney adjoined the rear wall of no. 24 on the left. The apportionment records the owner of plot 152 as Thomas Western of Tattingstone Place in the south-eastern corner of the general view, but wrongly describes it as a shrubbery with a kitchen garden to the north. The section of the park leased to the farmer of Tattingstone Hall lay to the east (plot 149).

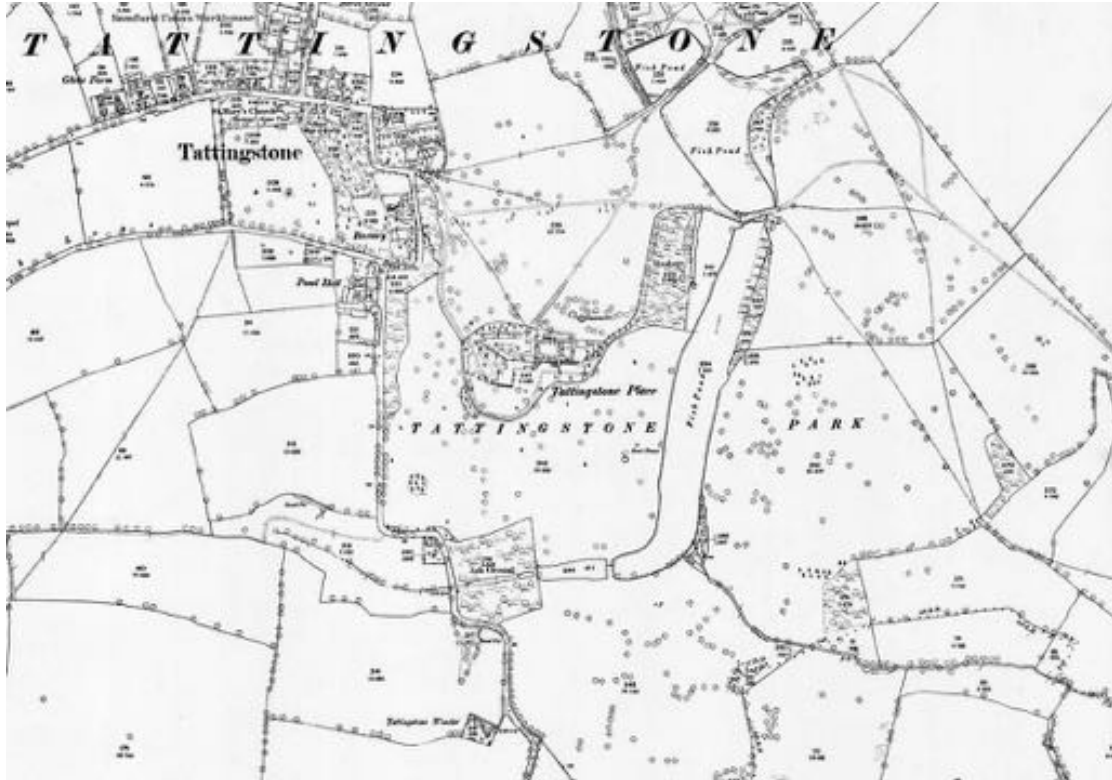
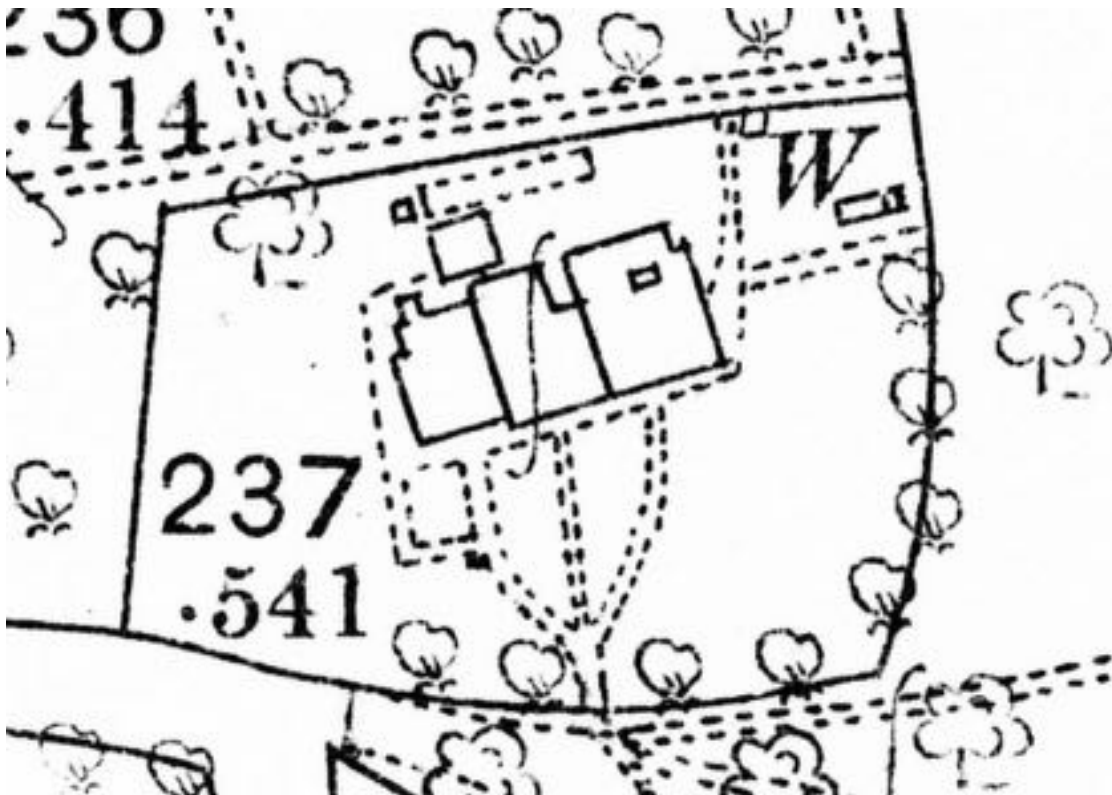
Figure 6

The highly accurate 25 inch Ordnance Survey of 1881. No. 24 on the left retained the same outline as in 1837, with a continuous rear lean-to and a small projection that must represent a chimney, while a new rear lean-to had been added to no. 23 in the centre.

Lodge Cottage had been enlarged to its present length, but its southern facade is depicted level with that of no. 23 – presumably in error.

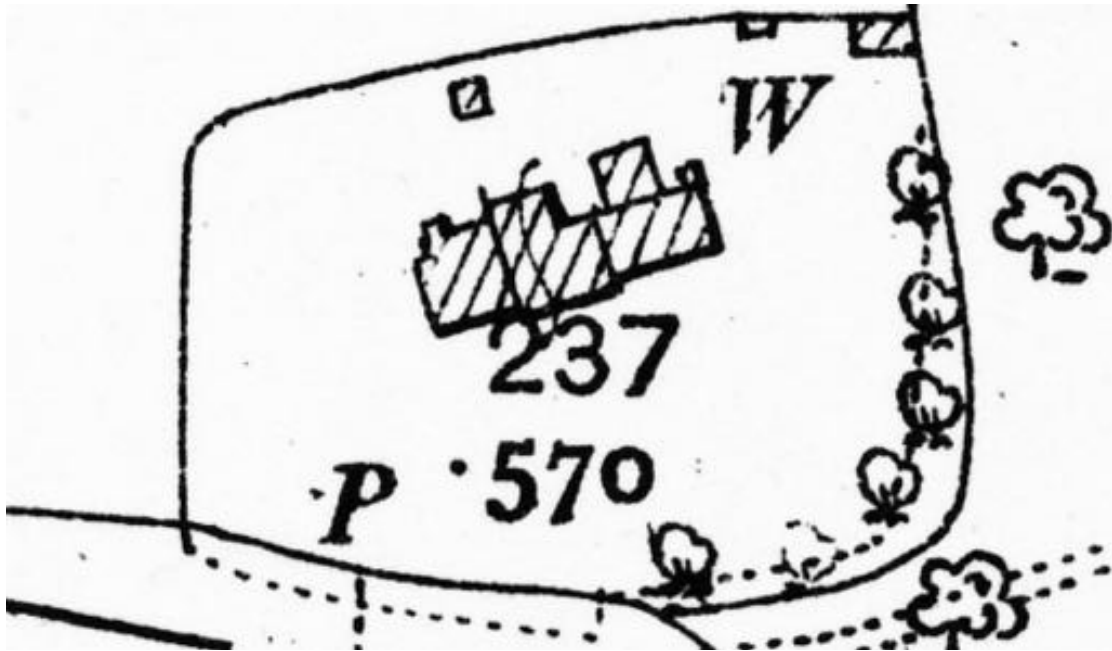
Figure 7. The 25 inch Ordnance Survey of 1902. The outlines of nos. 23-24 remained unchanged, but the detached outbuilding shown to the rear in 1881 had been demolished. The front wall of Lodge Cottage is shown recessed behind that of no. 23 as it remains and its rear additions had been altered.

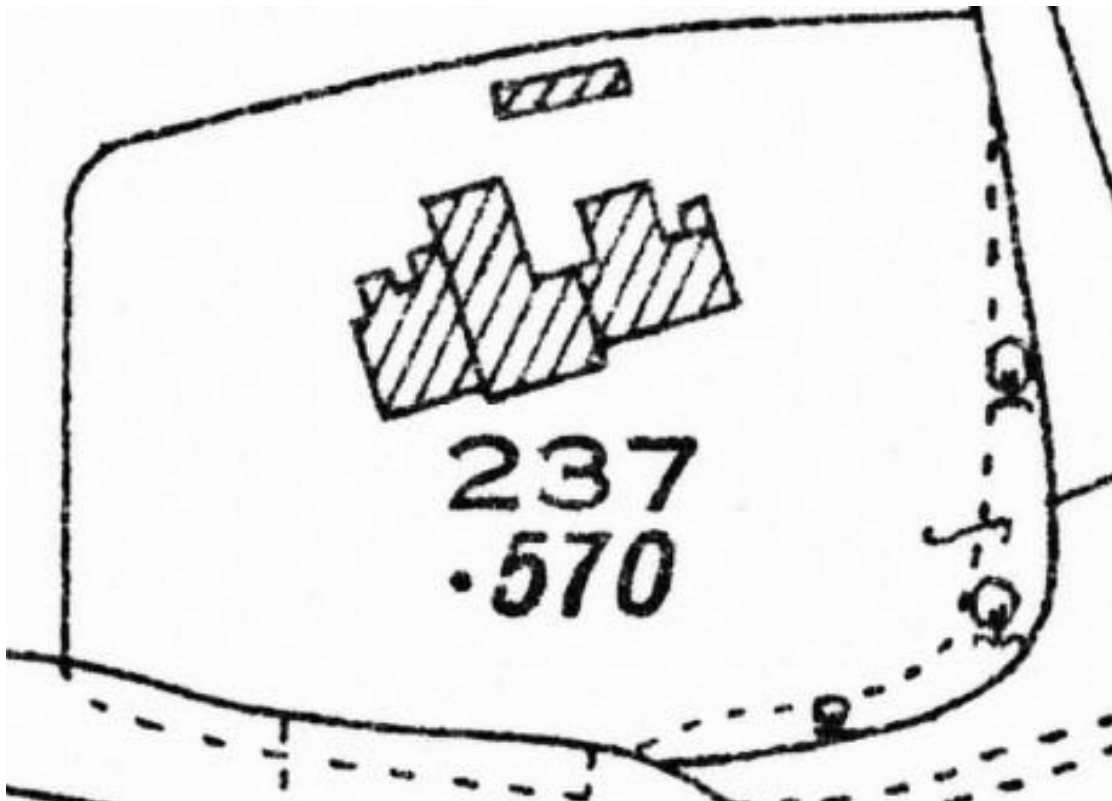
Figure 8. The 25 inch Ordnance Survey of 1924. Nos. 23-24 had acquired their current outlines after an extensive refurbishment since 1902, presumably by Roger Kerrison whose family bought the estate in 1893. The present two-storied extension had been added behind no. 23 and the rear lean-to at no. 24 had been rebuilt with an internal chimney and a small gap that divided it from the lean-to larder of no. 23 (illustration 9). The surviving detached linear outbuilding had also appeared to the rear.

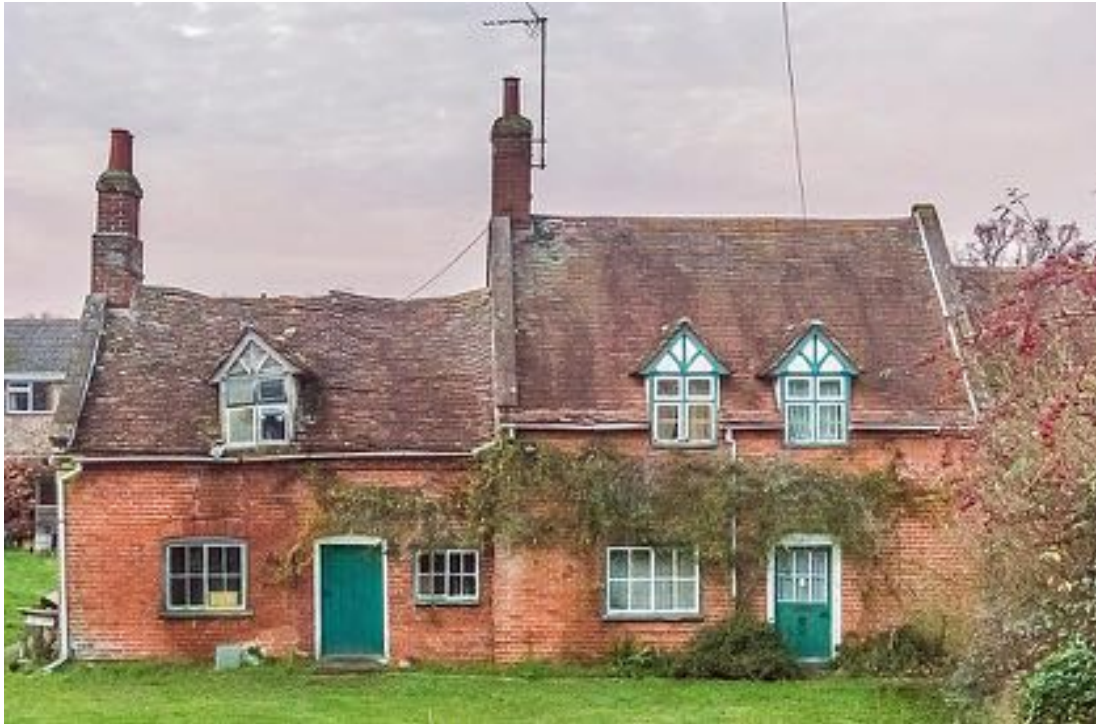
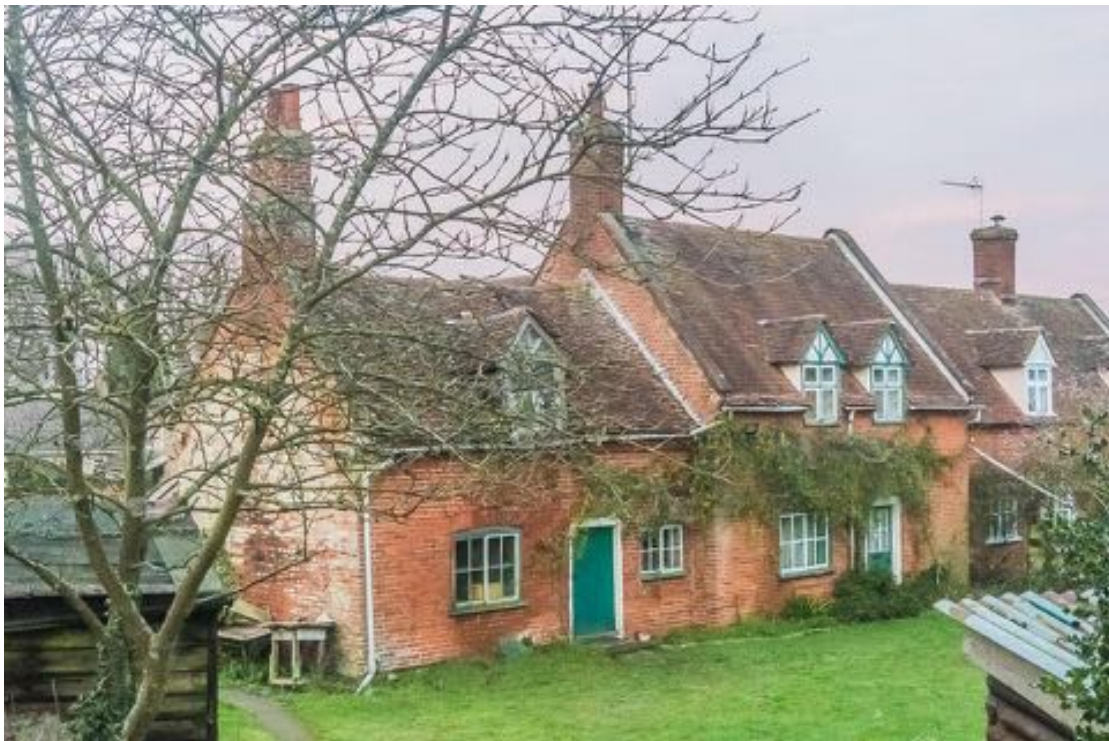
Figure 11

Images of the cottages from the south and south-west said to have been taken on March 3rd 2023 and uploaded to Historic England's website. Included to show the buildings without the scaffolding present at the time of inspection. Lodge Cottage on the right appears to have terminated originally at its axial chimney so the facade would have been more symmetrical in the past.

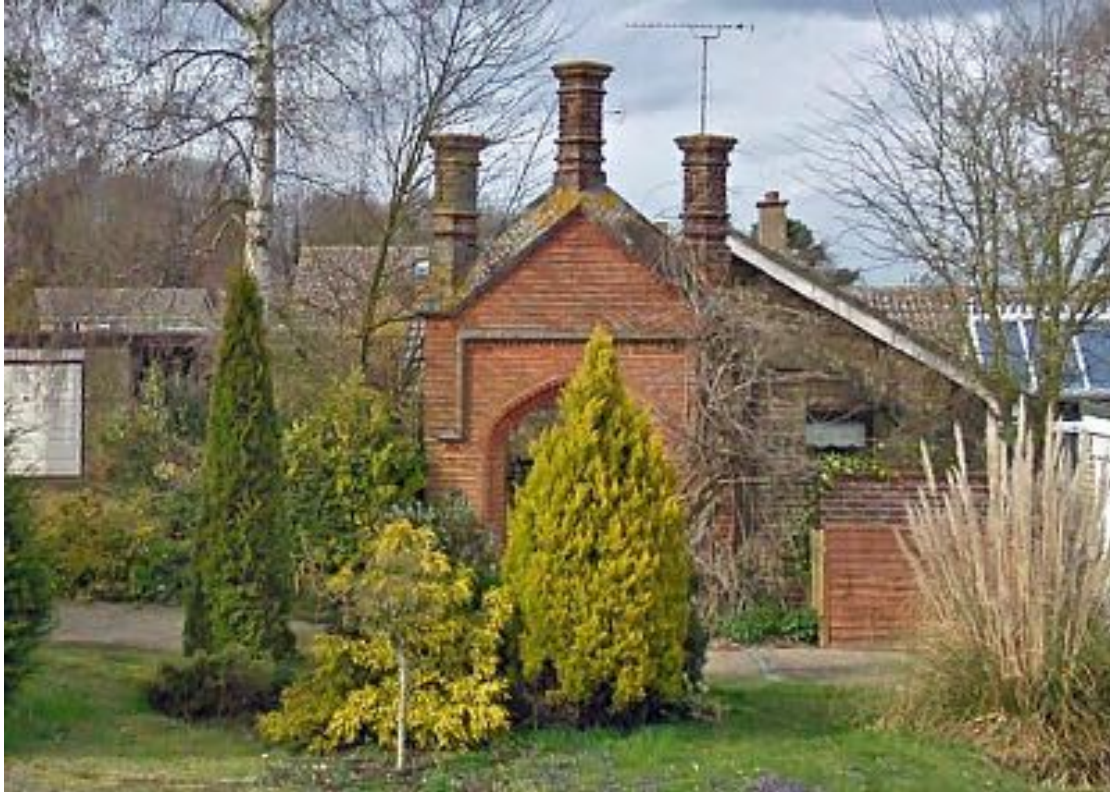
Figure 12

The isolated Victorian Mock Tudor gateway in the modern housing estate to the north (as seen from the south). This striking 19th century feature is all that remains of the boundary between the kitchen garden belonging to Tattingstone Place in 1837 and the orchard depicted on later maps to the north ('X' in figure 2). As one of the cottages was occupied by a gardener and his wife in 1911 he may well have worked here, so the structures can be regarded as historically linked.

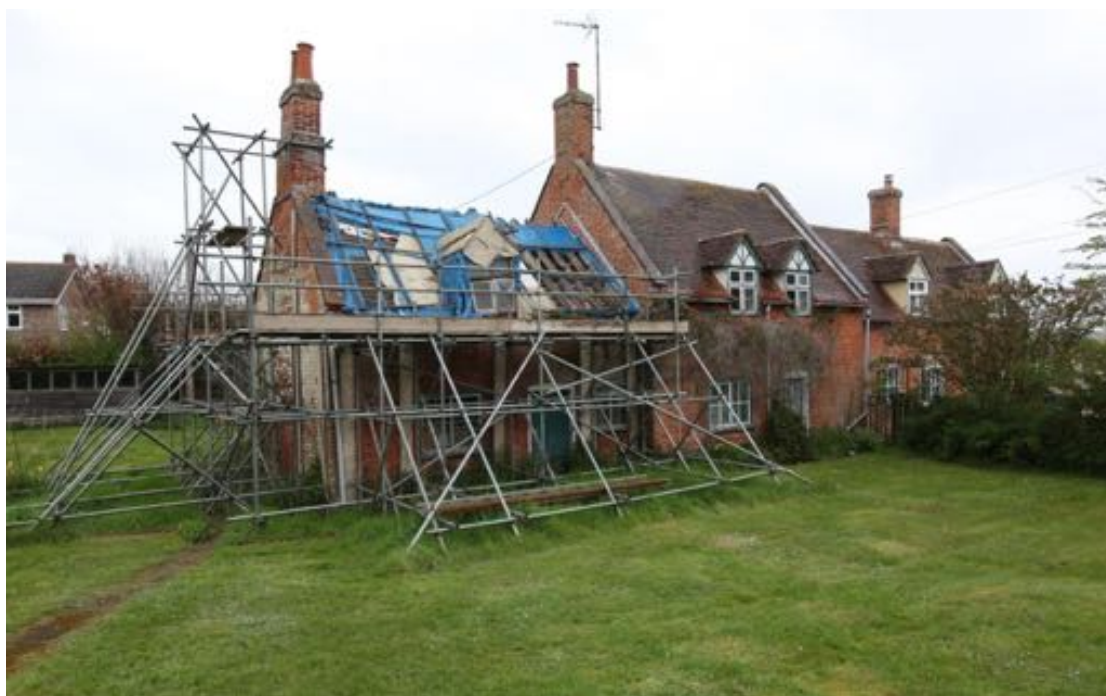
Illus. 1. The three cottages from the south-west, with the semi-derelict no. 24 on the left, no. 23 projecting in the centre and Lodge Cottage in separate ownership to the right. Lodge Cottage was not inspected for the purpose of this report, but the brickwork of its facade is identical to that of no. 23 and contains evidence of a vertical junction indicating the section to the right of its chimney was added later.

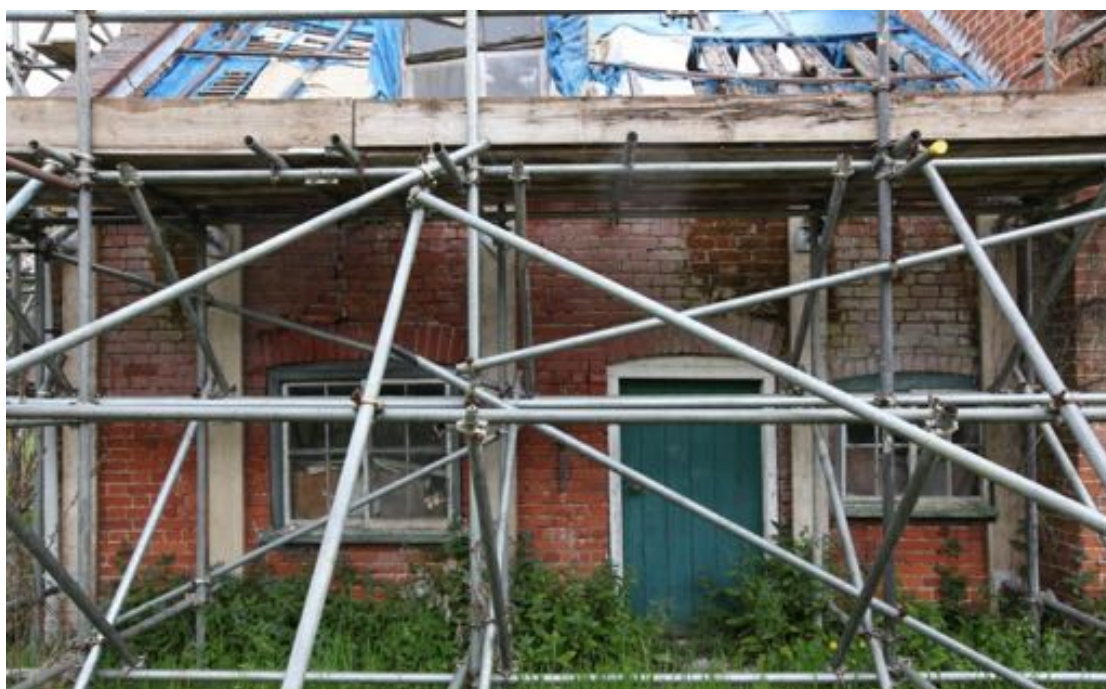
Illus. 2. The facade of no. 24 showing its entrance flanked by horizontal sash windows identical to those of no. 23. The segmental arches differ from the flat-topped arches of no. 23, indicating a slightly later date of construction, and the window on the right appears to be an early insertion as its arch consists of headers rather than stretchers. The Mock Tudor roof dormer is identical to those of no. 23 (see figure 10).

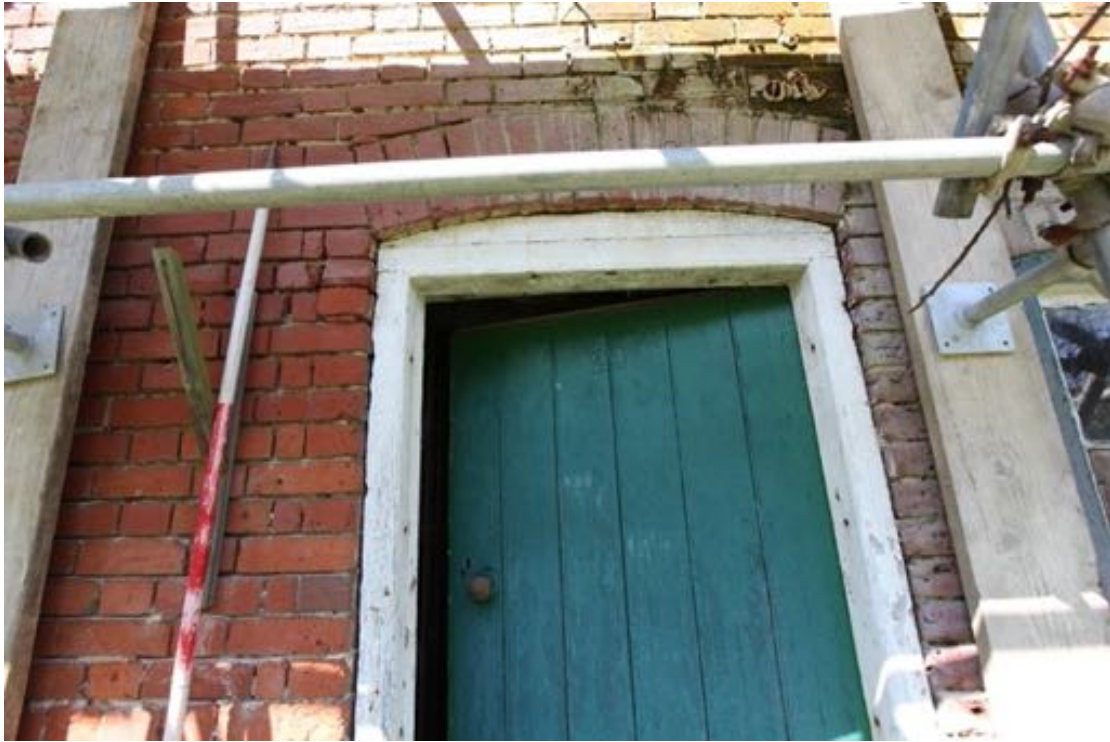
Illus. 3. A detail of what appears to be the original 19th century plank-and-batten entrance door in the southern facade of no. 24, lacking a letter box but with the house number applied in cast numerals. The segmental brick arch contrasts with the horizontal tops of those at no. 23 and Lodge Cottage (indicating two separate phases of construction).

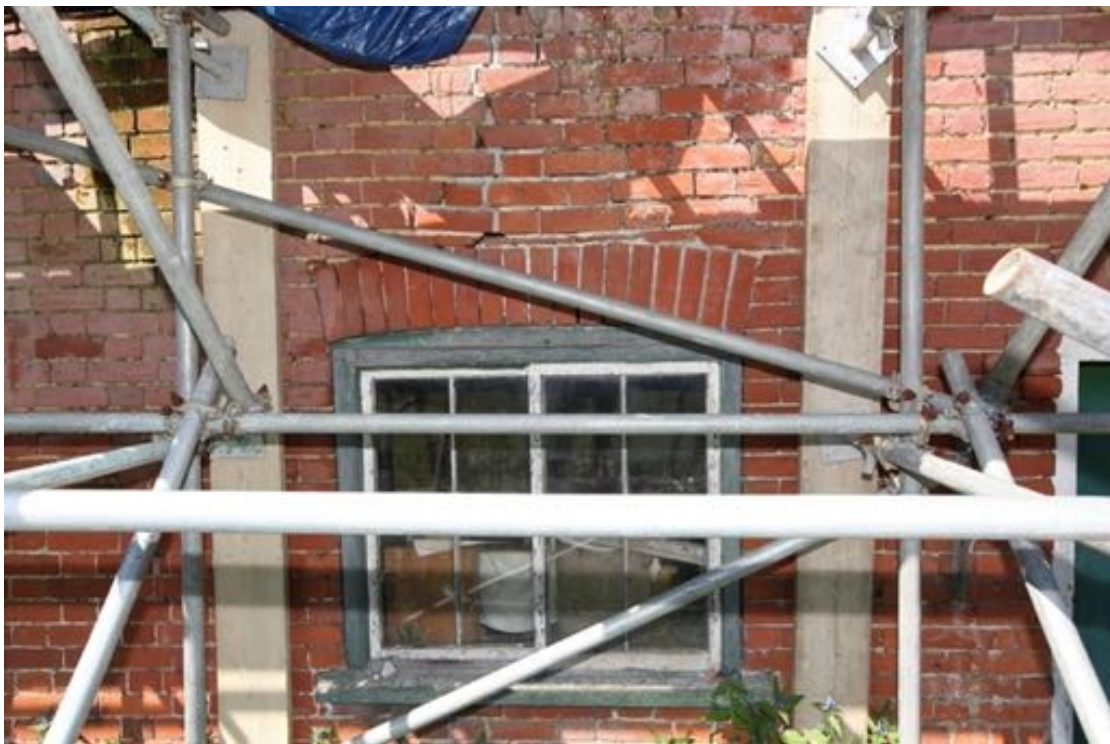
Illus. 4. A detail of the window to the left of the entrance door in illustration 2 showing its segmental arch and typically mid- to late 19th century horizontal sash window. The brickwork is defined by closers (quarter-bricks) behind the scaffolding planks.

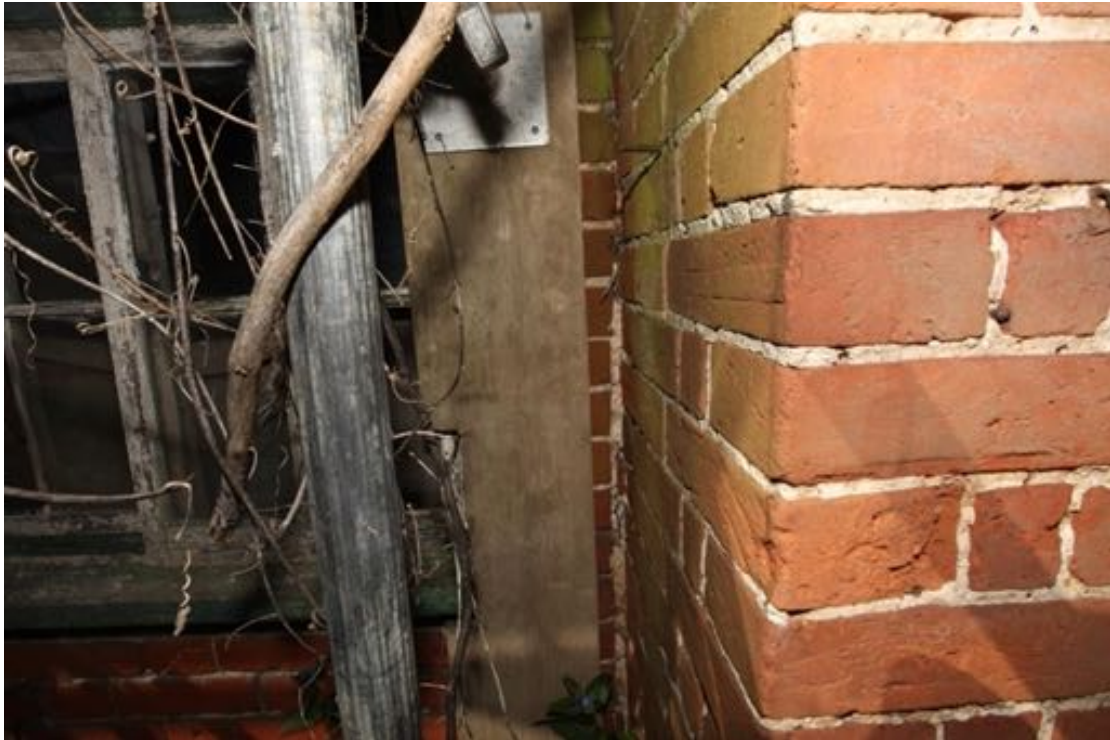
Illus. 5. A detail of the junction between nos. 24 on the left and 23 to the right, showing the mortar-filled vertical joint between their respective brick walls which demonstrates they were not built together. The 19th century horizontal sash window of no. 24 is visible to the left.

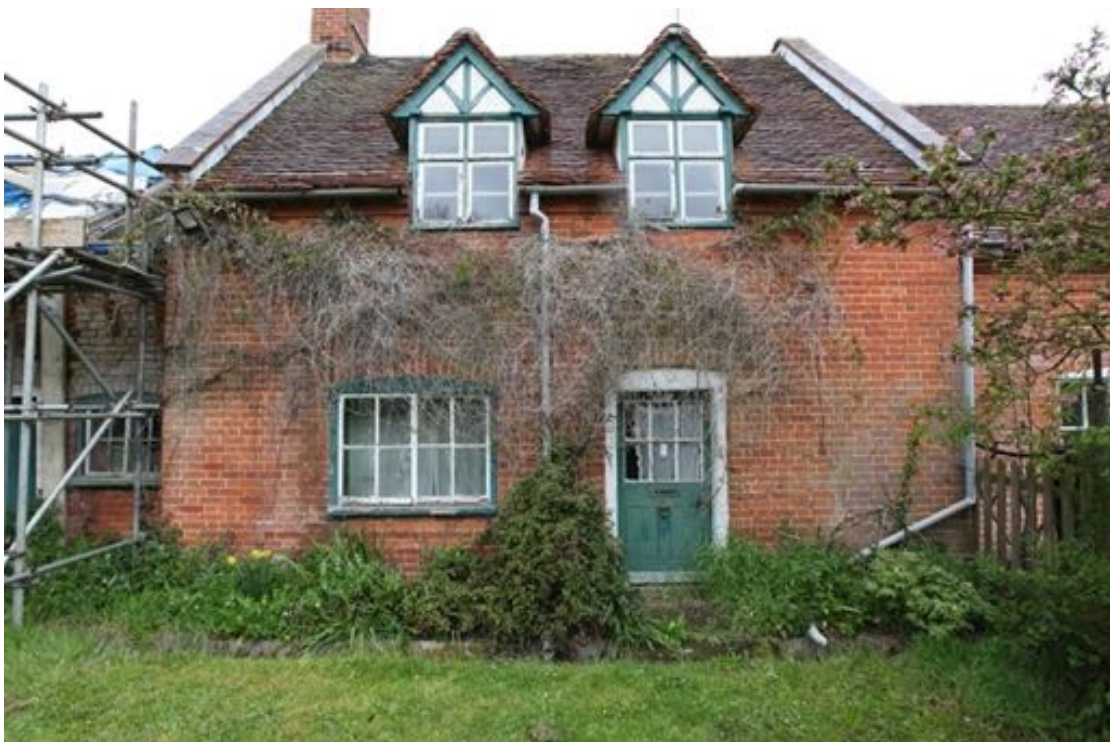
Illus. 6. The projecting or 'breakfront' southern facade of no. 23 showing the Mock Tudor dormer windows that probably date from the later refurbishment of *circa* 1910 that included the rear extension. The brickwork is identical to that of Lodge Cottage on the right but the flat tops of the brick arches above the ground-floor window and entrance door differ from their arched counterparts at no. 24.

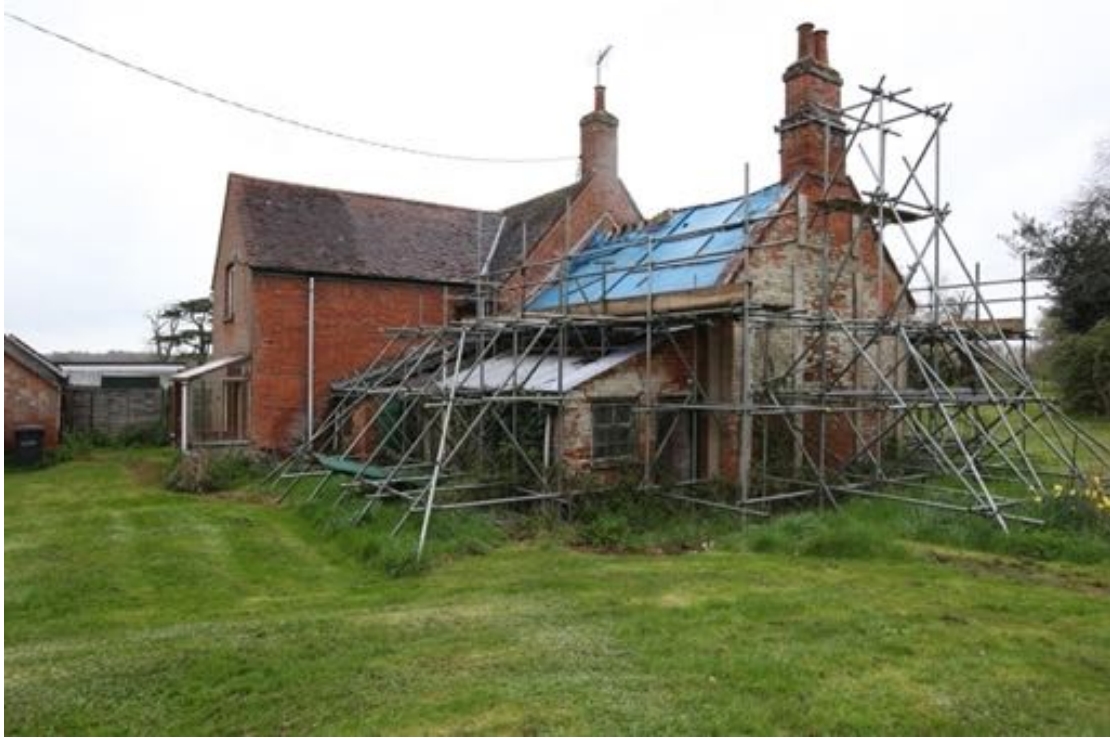
Illus. 7. The building from the north-west showing the brick lean-to 'garden room' behind no. 24 in the foreground and the two-storied rear extension of no. 23 added between 1902 and 1924. The 19th century brick shed on the left contains a small chimney and was probably a wash house for no. 23 shared with Lodge Cottage.

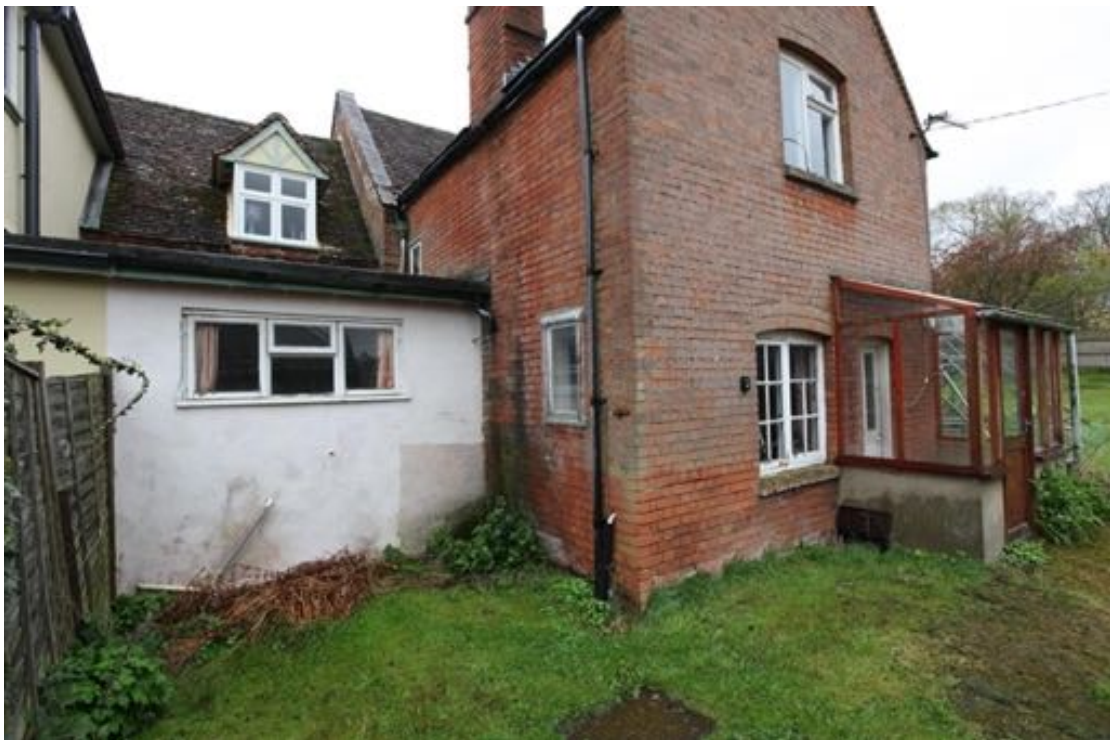
Illus. 8. The building from the north-east showing the large early-20th century two-storied extension of no 23 added between 1902 and 1924 with the flat-roofed extension behind Lodge Cottage that contains its modern kitchen (G9) to the left. The modern rear glazed entrance porch preserves the scar of a smaller, earlier porch with a pitched roof.

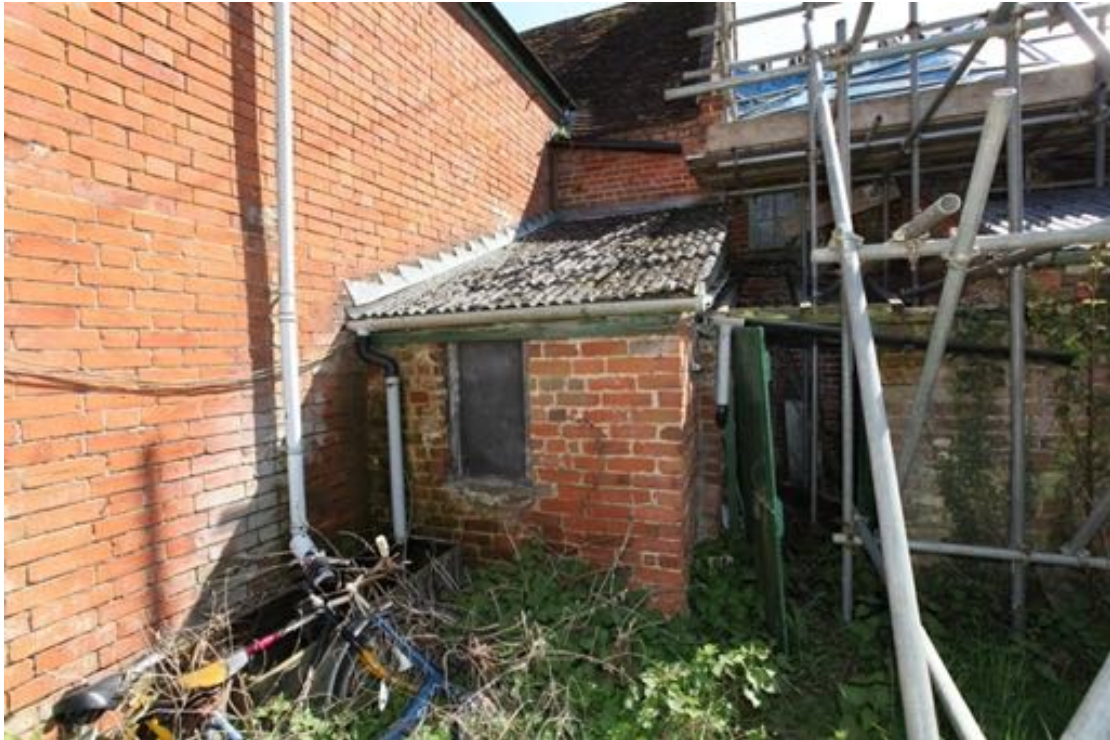
Illus. 9. The lean-to larder of no. 23 in the north-eastern angle of the southern range and its early-20th century rear extension (G7). This appears to represent a fragment of the mid-19th century lean-to that extended further to the left prior to the construction of the extension. It is adjoined on the right by a narrow gap, now enclosed by a door, with the lean-to of no. 24 to the extreme right.

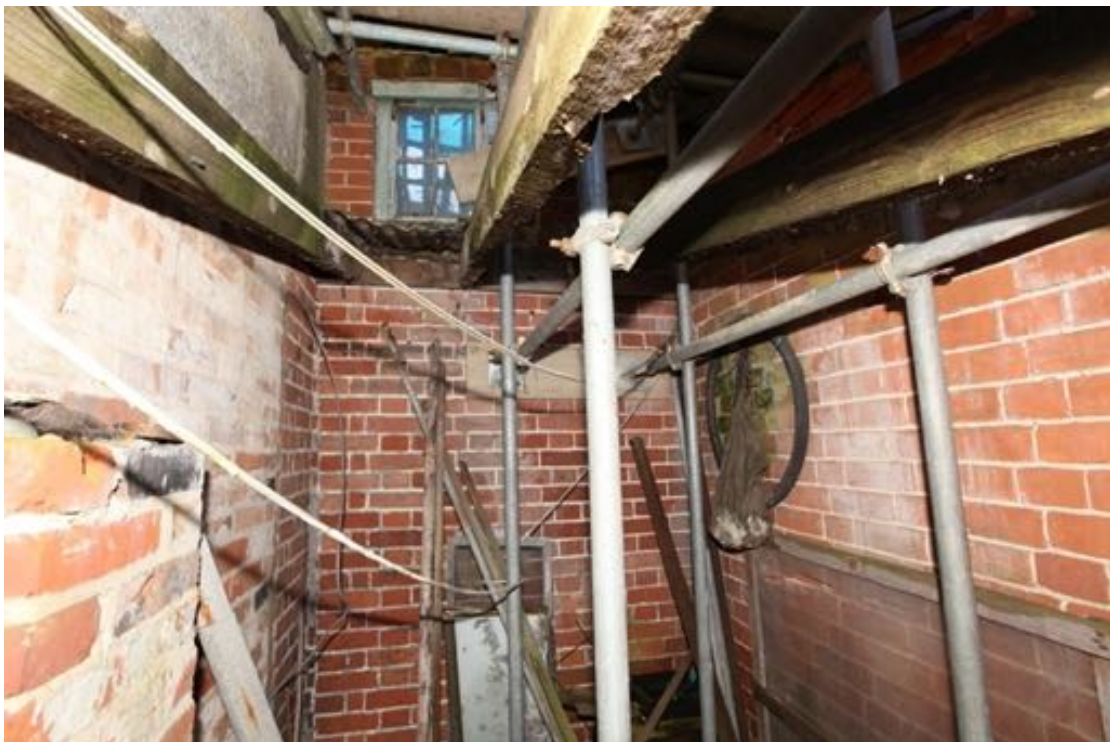
Illus. 10. The rear wall of no. 24 from the narrow gap between its rear lean-to and that of no. 23 on the left (G4). The corner of the brickwork is respected by closers on the left and is not integral with the fabric of no. 23 which projects by approximately 0.4 m to the north just as it does to the south. The stair window above is respected by the bonding.
