23/24 Church Road, Tattingstone, Suffolk

Historic Building Record

May 2023

This report provides an archaeological record and analysis at Historic England (2016) Level 3 of a semi-derelict grade II-listed cottage at TM 13794 37083. The adjoining grade II-listed cottage in the same ownership is included for context. The report includes a full photographic record of 50 images, but the buildings are not of sufficient scale or significance to warrant an additional archive of digital images. Where possible each photograph includes a 2 m scale rod with half-metre divisions in red and white. The site was inspected on 17th April 2023.

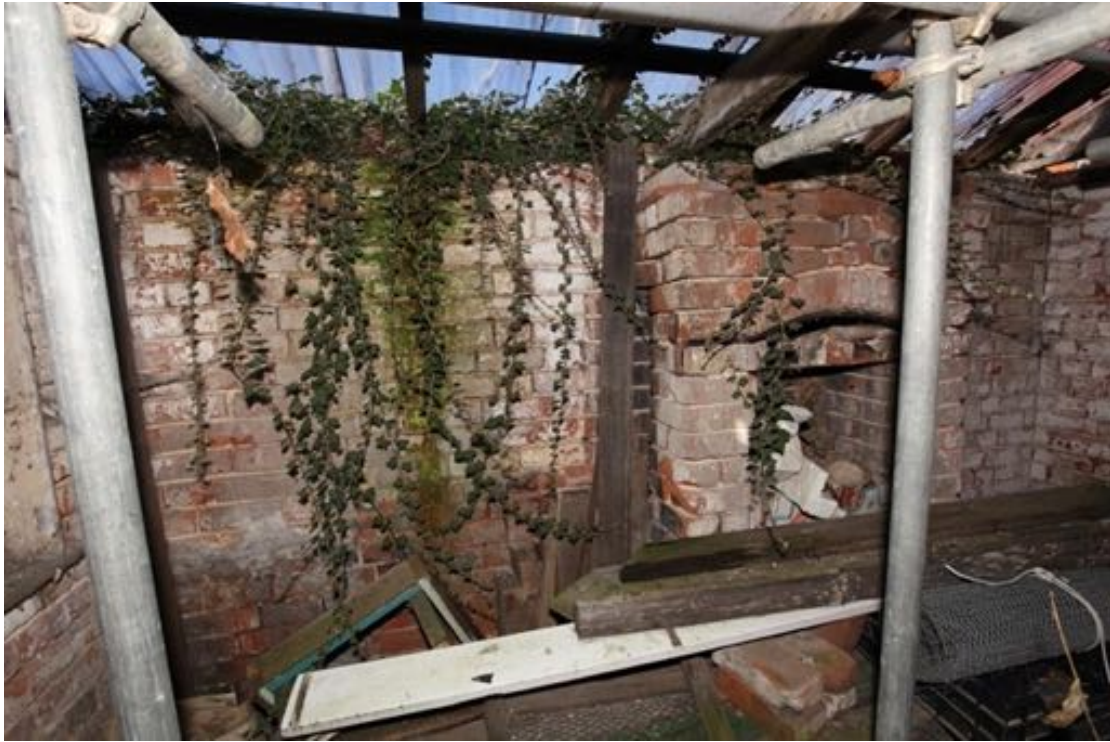
Illus. 11. The fireplace in the rear (northern) internal wall of the lean-to 'garden room' behind no. 24, which evidently operated as a wash house (G3). There is no evidence of a bread oven and the chimney has been lost. In its current form this structure was built between 1902 and 1924.

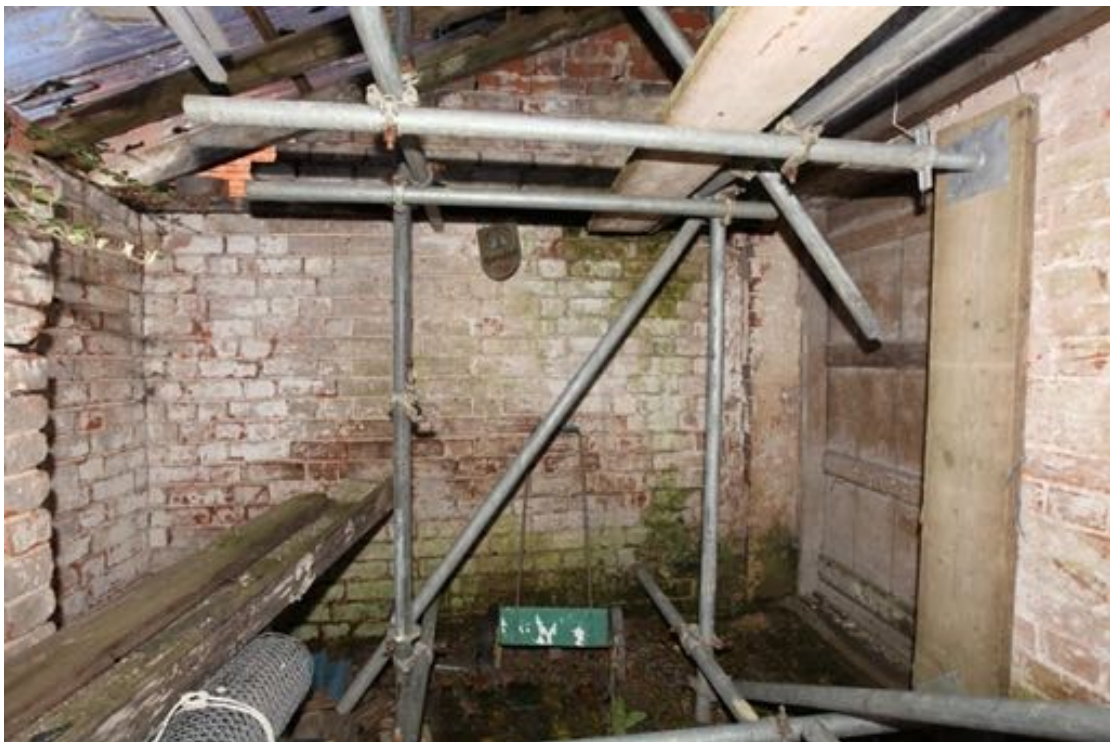
Illus. 12. The eastern internal gable of the lean-to 'garden room' showing the back door of no. 24 on the right and the northern chimney to the left (G3).

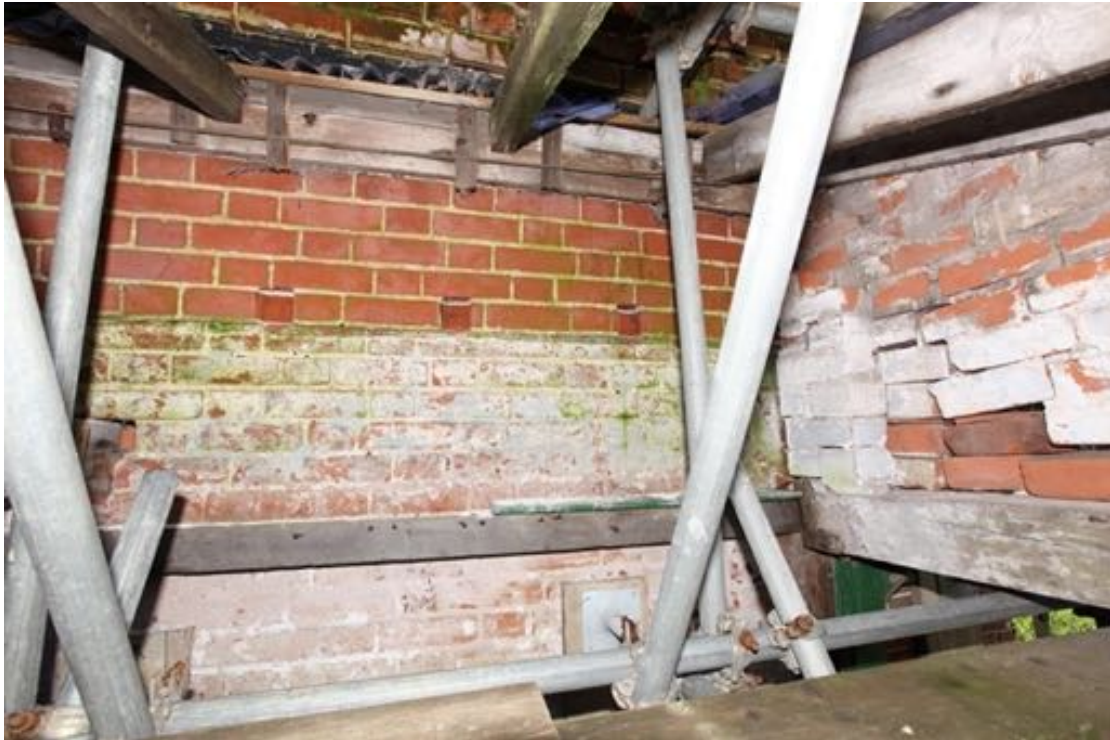
Illus. 13. The rear wall of no. 24 from its rear lean-to (G3) showing the windowless brickwork demonstrating that a lean-to existed in this position from the outset. The present western brick gable of the lean-to on the right is a later addition that is not keyed to the wall so the existing structure probably replaced a timber-framed predecessor.

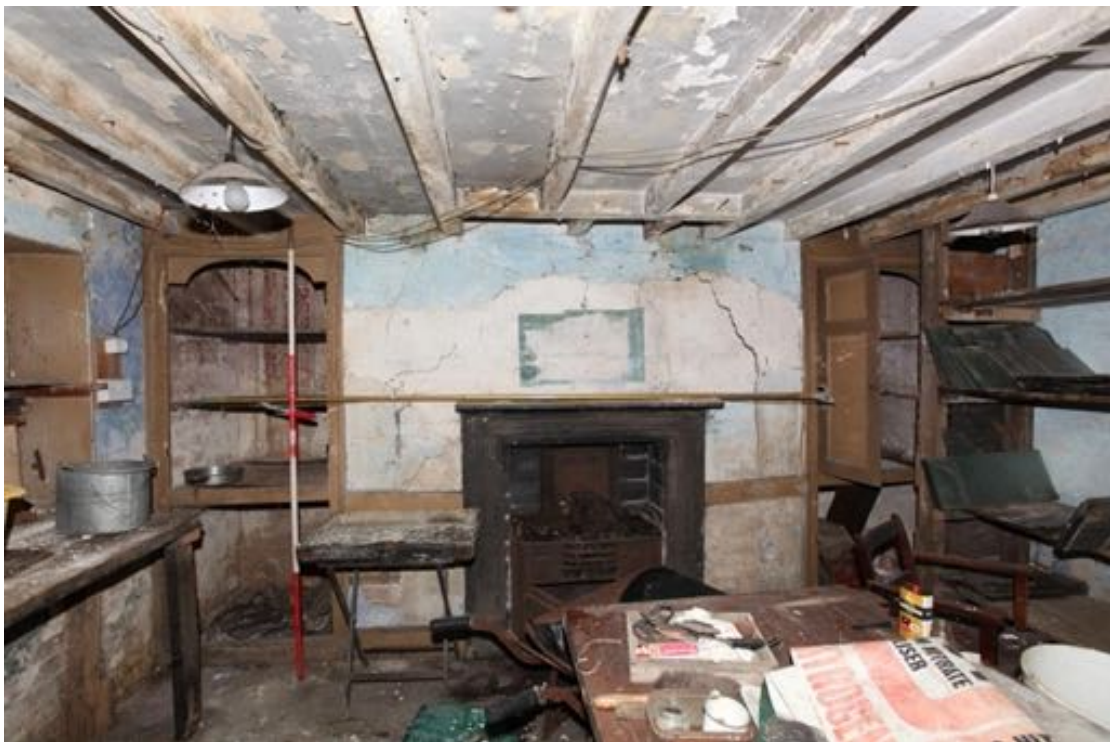
Illus. 14. The ground-floor fireplace in the western gable of no. 24 flanked by identical pairs of cupboards retaining their probably 19th century paint scheme of light and dark brown (G1). The original cupboard doors survive in part to the right and hinges remain on the left.

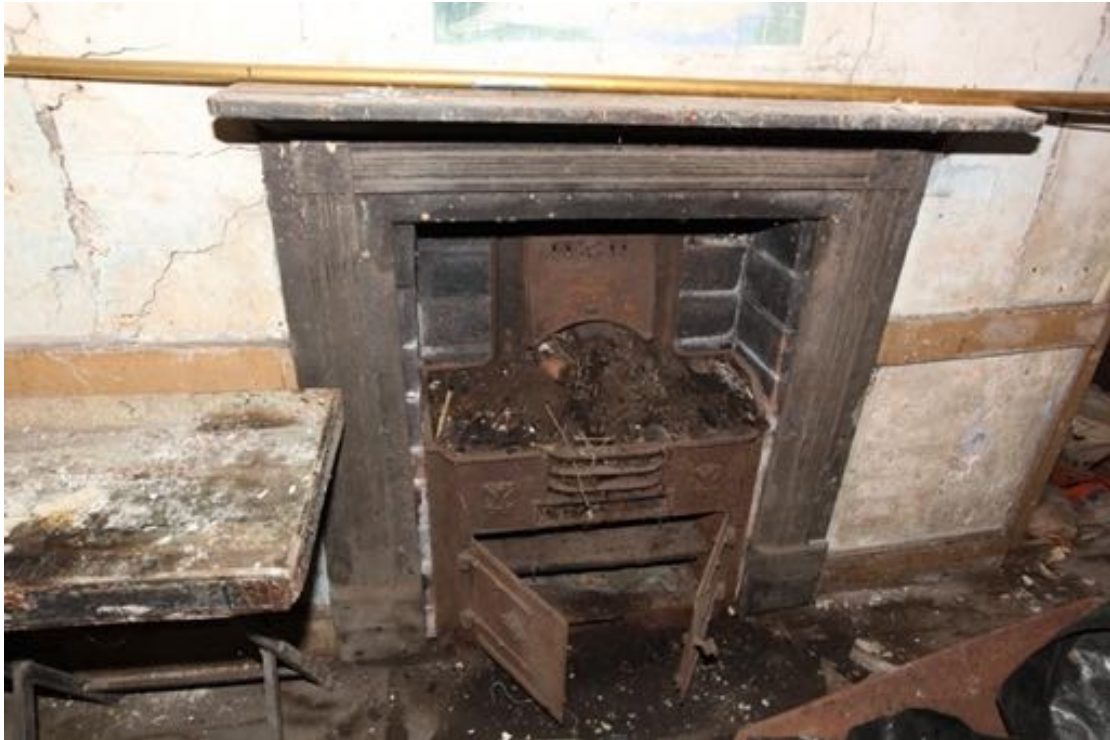
Illus. 15. A detail of the fireplace in illustration 14 showing its mid-19th century reeded wooden fire surround with a slightly later hob grate and oven. The register plate is cast with the name of the manufacturer 'Cocksedge & Co. Ipswich', founded in 1879.

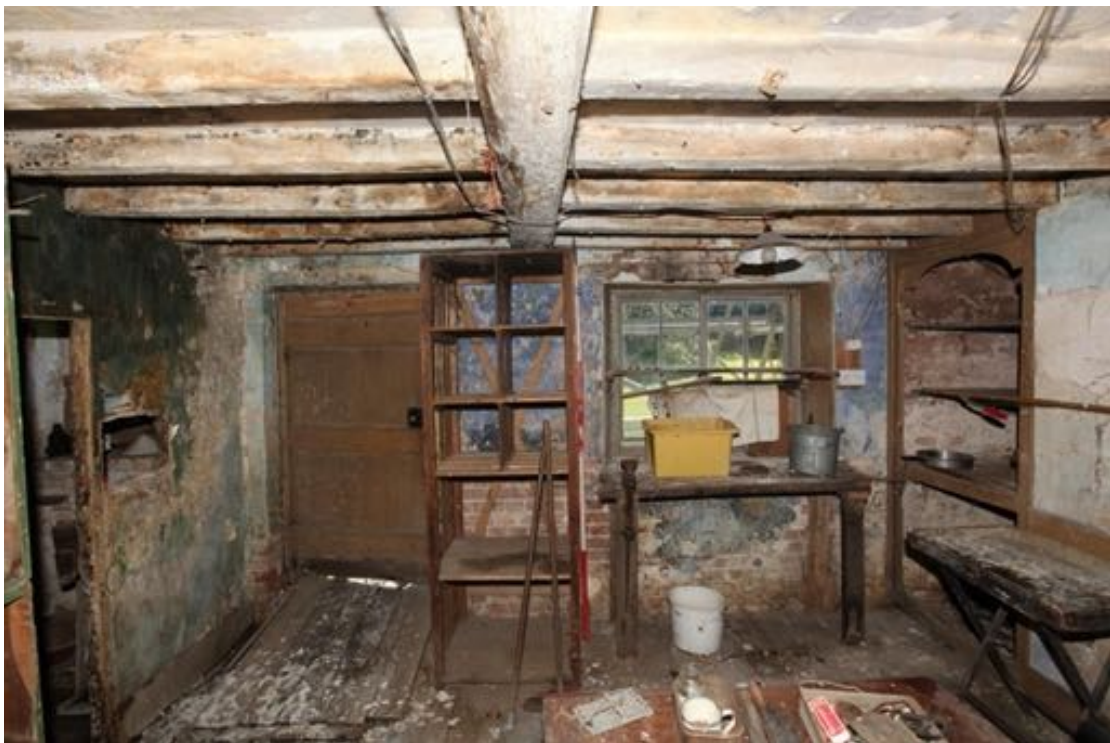
Illus. 16. The southern internal ground-floor wall of no. 24 showing the storage area in front of the stair (G2) and the entrance door on the left with the horizontal sash window and arched cupboard to the right (G1). The external walls consist entirely of 35 cm 19th century brickwork visible here beneath the window and there is no trace of earlier fabric.

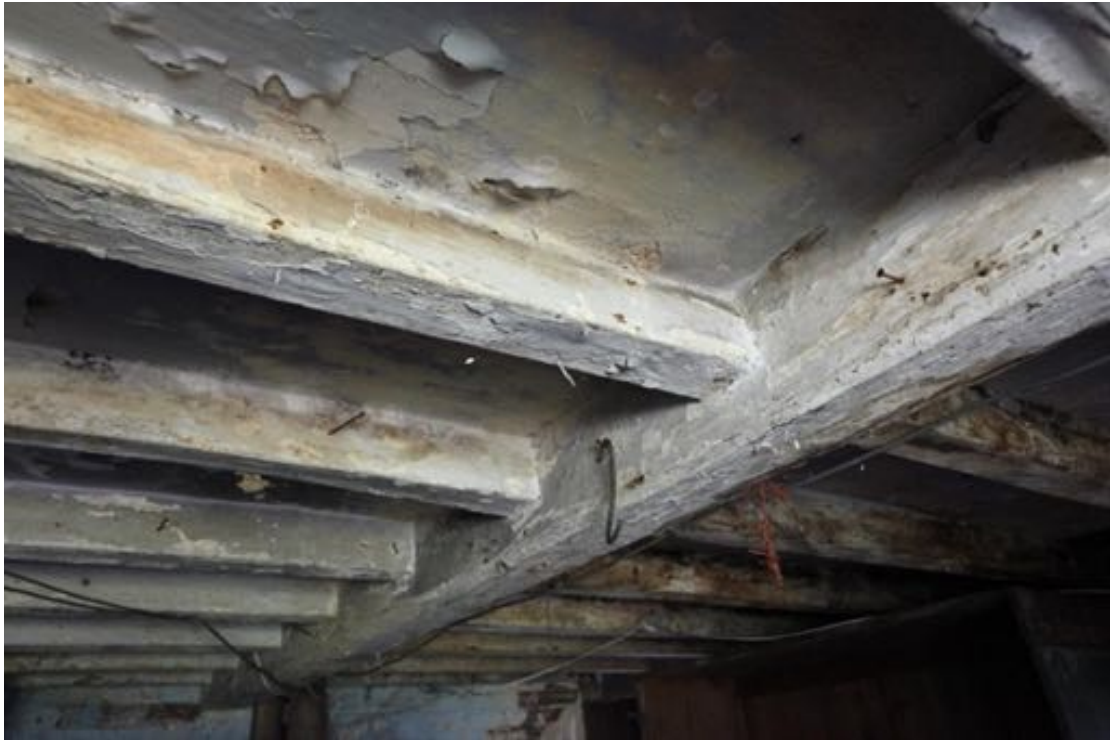
Illus. 17. A detail from the south-west of the original ground-floor ceiling joists of no. 24, showing the small chamfered edges that demonstrate they were intended to be visible as they remain (G1). The lath-and-plaster nailed to the undersides of the floorboards is also original. These narrow-sectioned joists of 4 ins by 3.5 are typical of the early- to mid-19th century, but would have been rendered in houses of higher status.

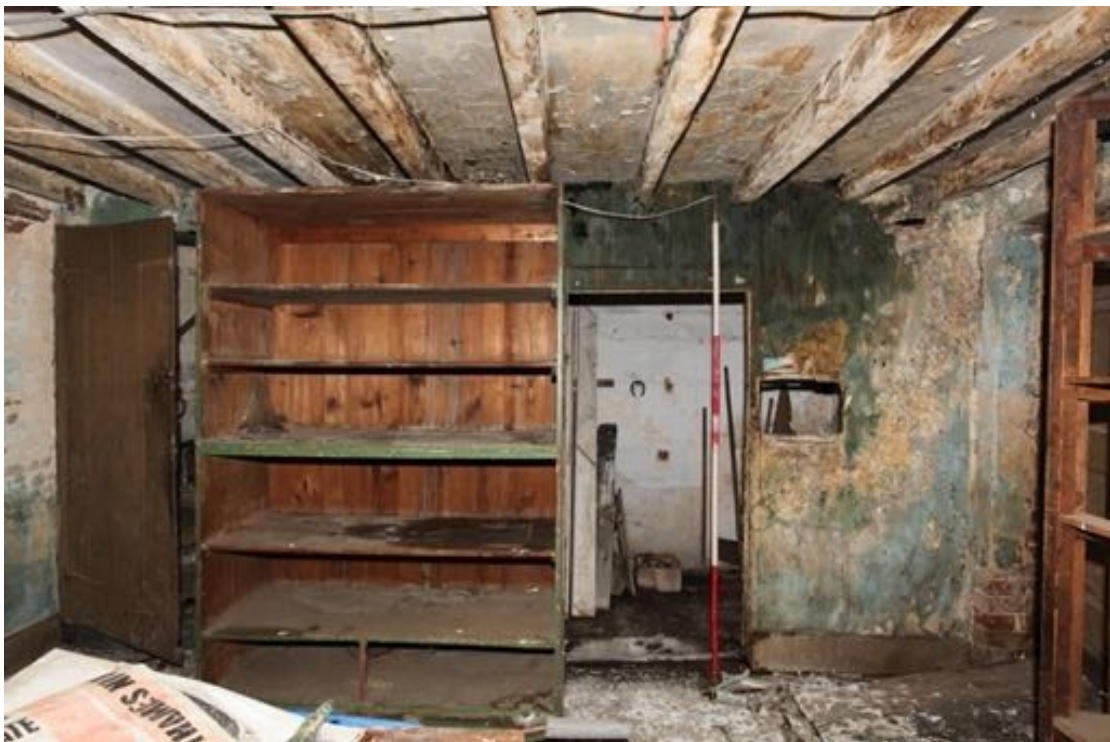
Illus. 18. The eastern wall of the sitting room at no 24 (G1) showing the stair door on the left and the entrance to the storage cupboard in front of the stair (G2). A set of storage shelves bearing old green paint divides the two.

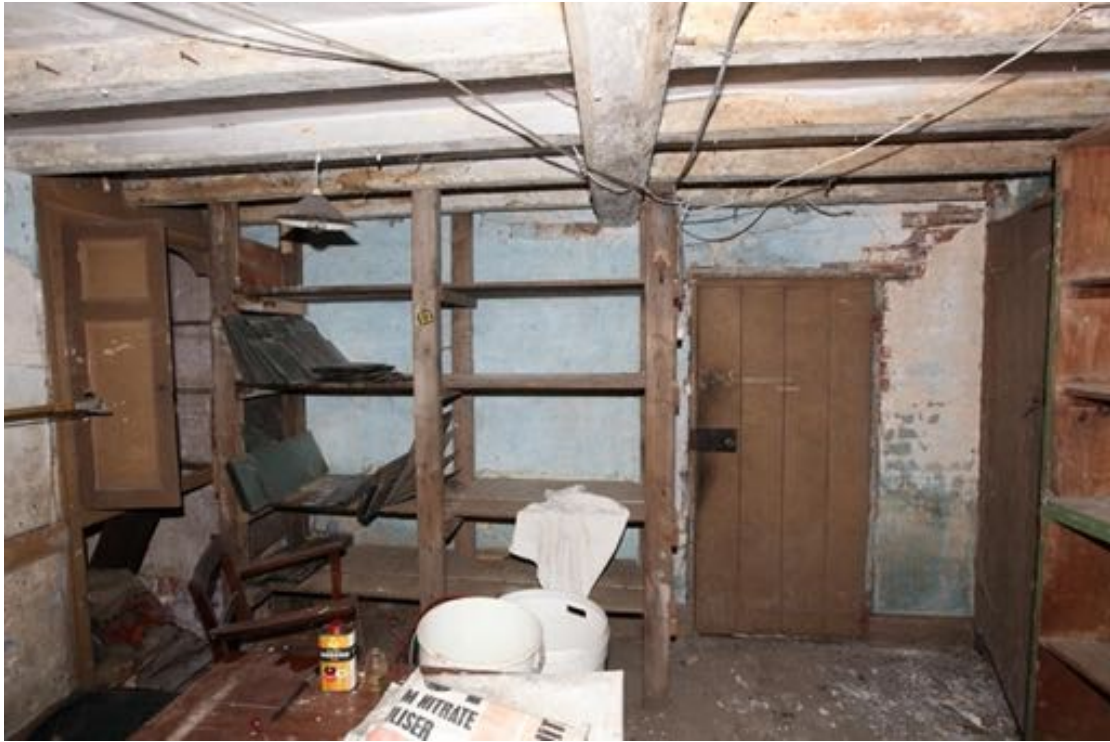
Illus. 19. The rear (northern) interior of the sitting room at no. 24 (G1) showing its lack of windows, exposed original brick fabric and the door to the lean-to 'garden room'.

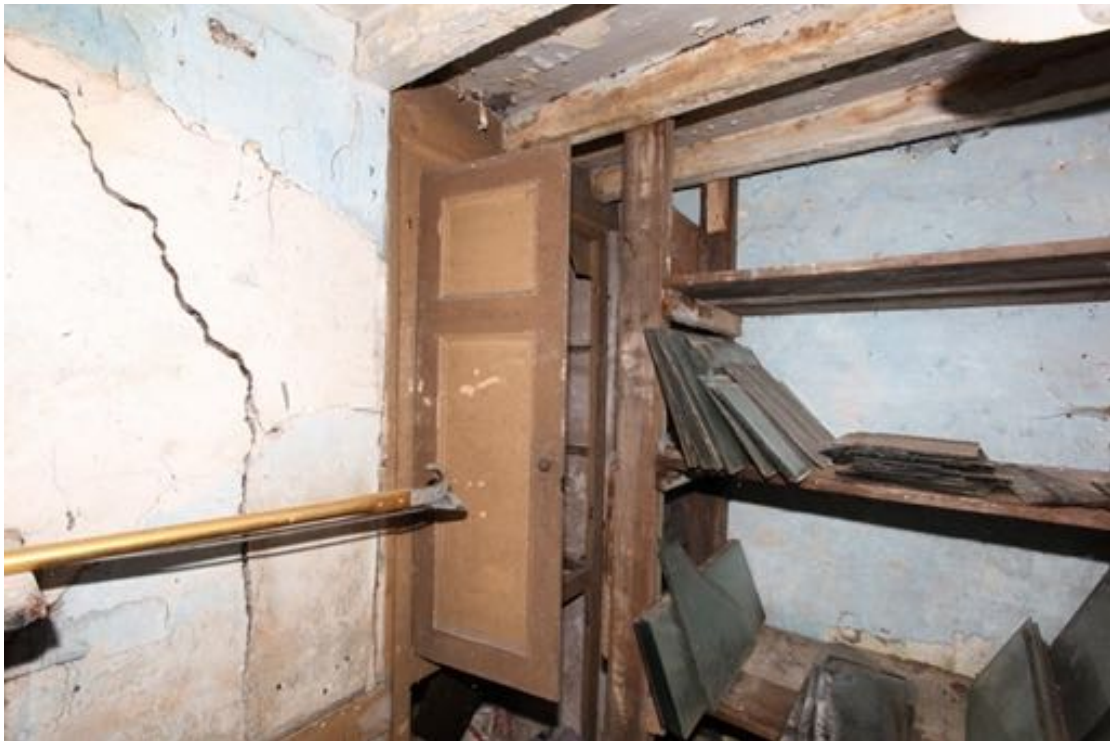
Illus. 20. The 19th century panelled doors of the cupboard to the north of the western fireplace in the sitting room at no. 24 (G1). Like the other doors of the room they retain what appears to be their original paintwork.

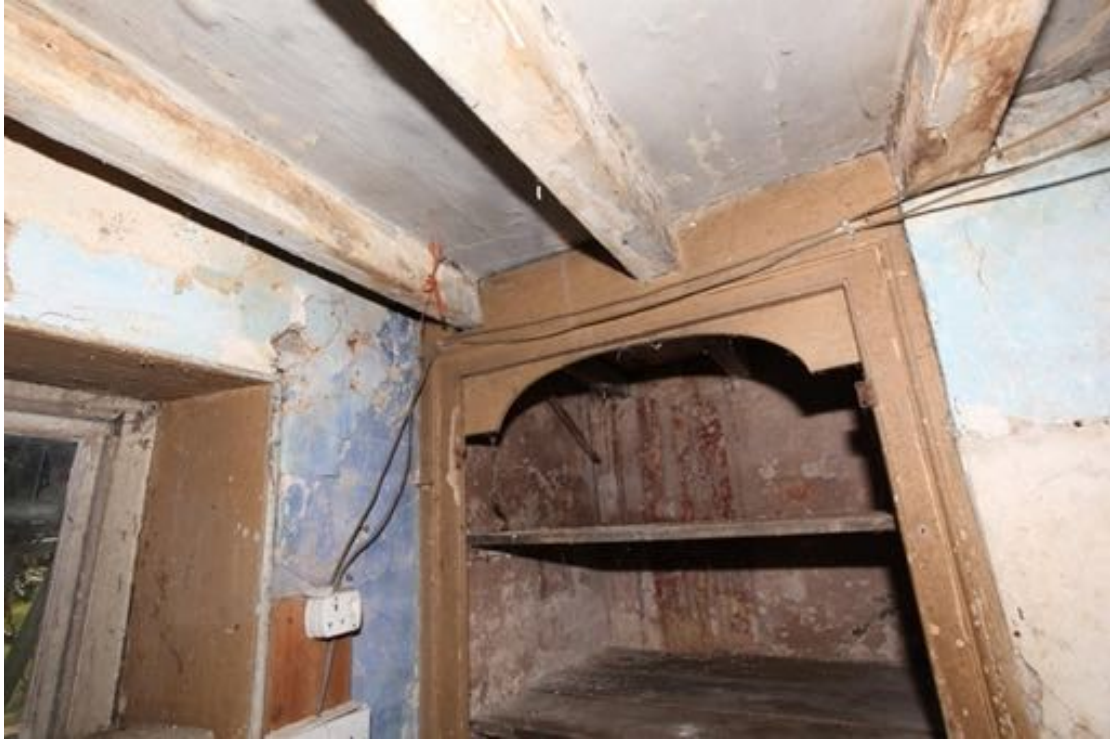
Illus. 21. A detail of the cupboard to the south of the western fireplace in the sitting room at no. 24 showing the hinges of its missing doors (G1).

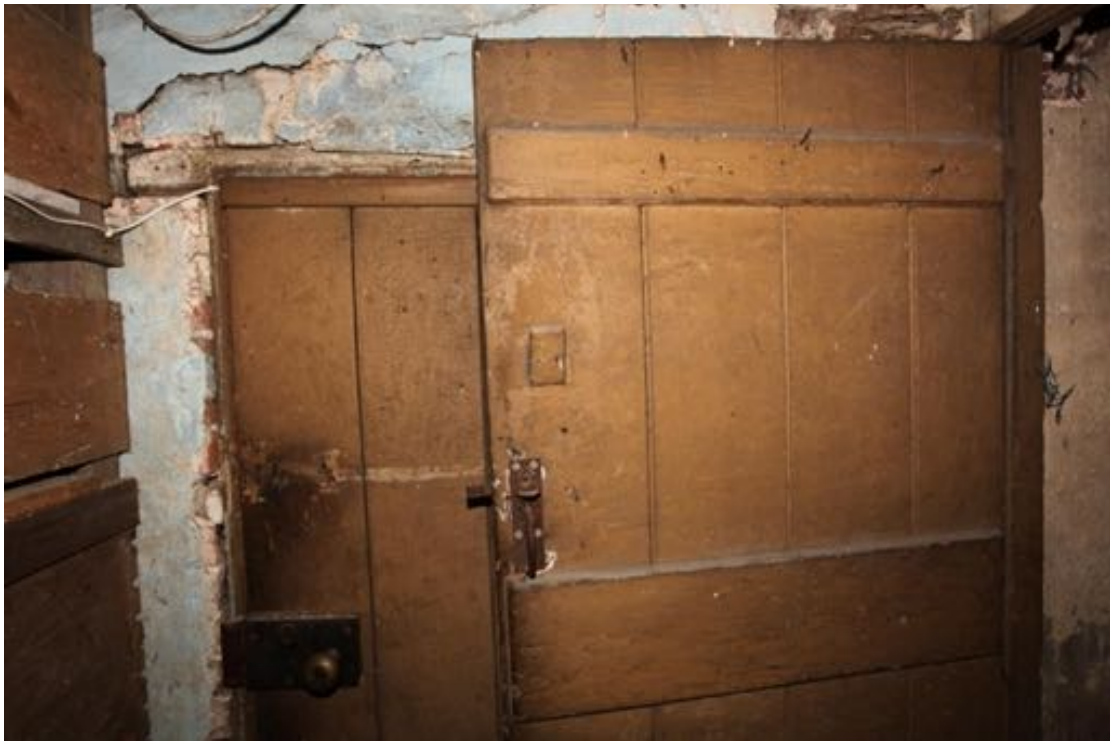
Illus. 22. A detail of the plank-and-batten stair door in the north-eastern corner of the sitting room at no. 24 with the door to the lean-to 'garden room' on the left (G1). Both retain original or early paintwork and an original wooden pull handle is visible above the latch of the stair door.

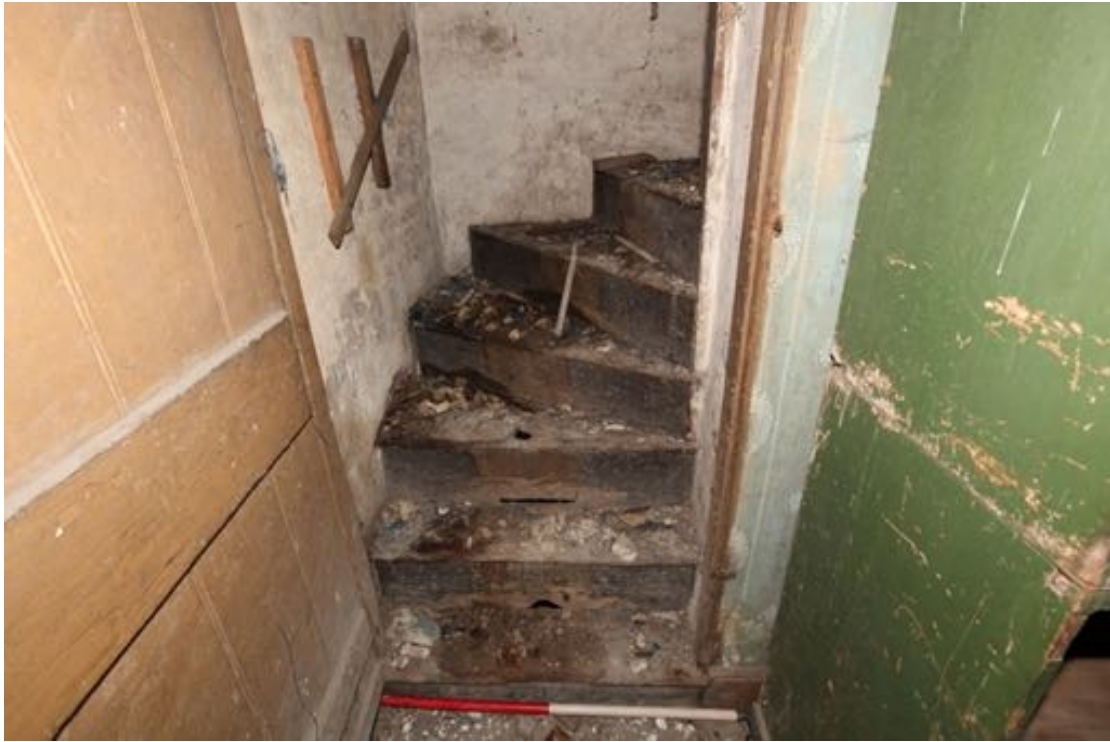
Illus. 23. The narrow original staircase of deal boards in the north-eastern corner of no. 24, as seen from the west (G1).

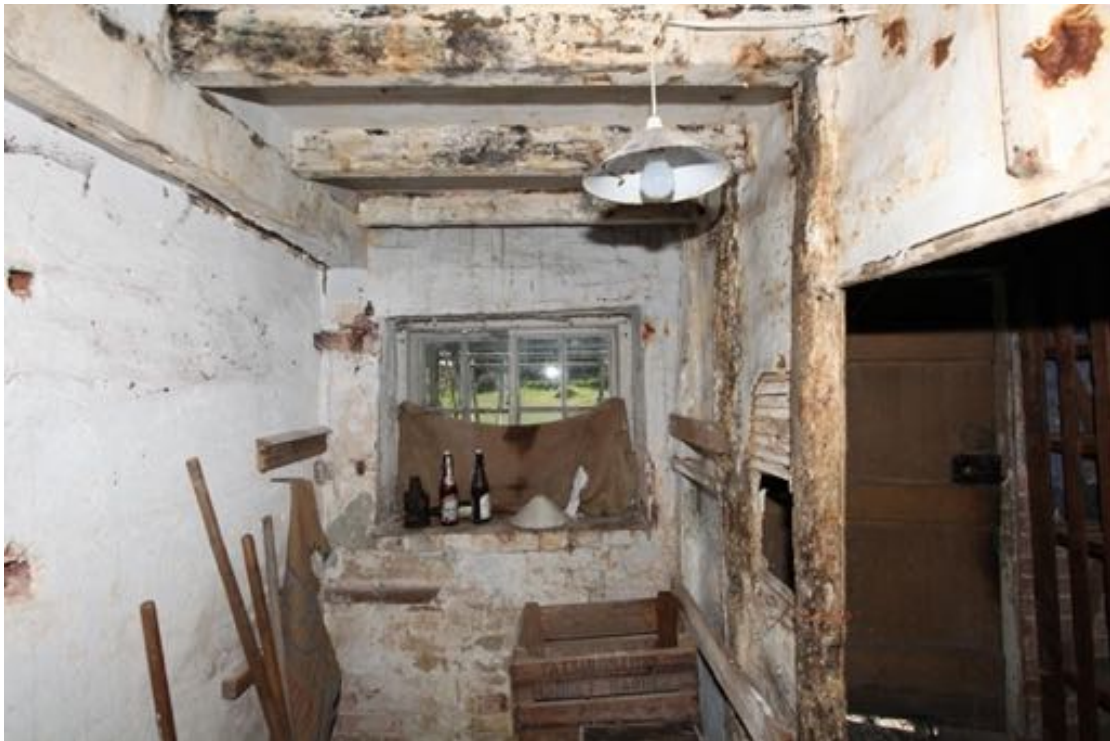
Illus. 24. The storage area in front of the staircase (G2) with the lath-and-plaster partition adjoining the sitting room of no. 24 on the right. This area may have been unlit initially as the horizontal sash window lies beneath a segmental arch that differs from the others of the southern facade and appears to be an insertion.

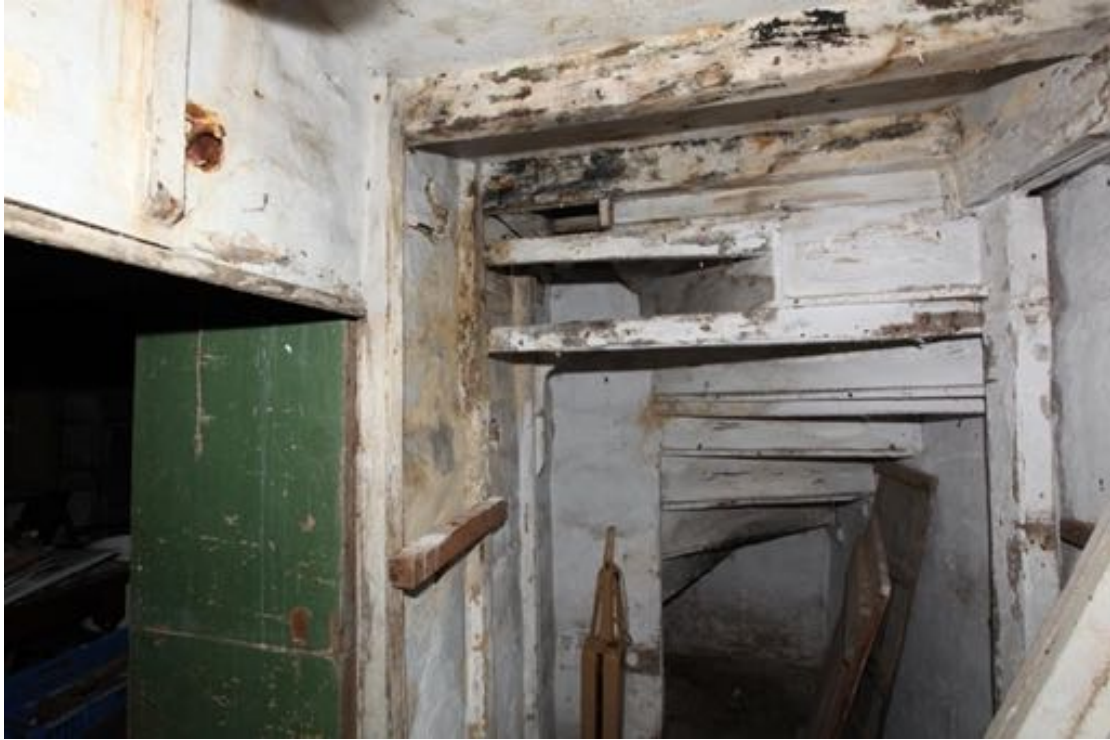
Illus. 25. The storage area in front of the stair at no. 24 (G2), as seen from the south with the partition adjoining the sitting room on the left. The shaped bracket of a missing shelf is nailed to a stud of the partition.

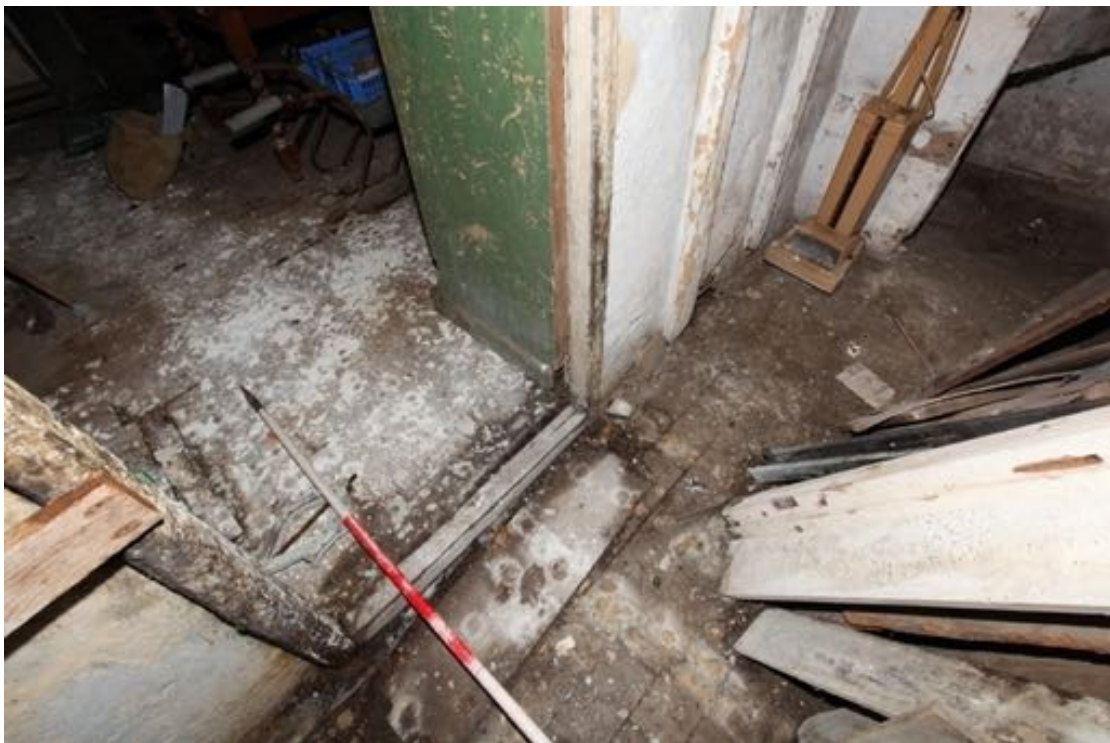
Illus. 26. A detail of the 19th century gault floor bricks in the storage area in front of the stair in no. 24 (G2), as seen from the south.

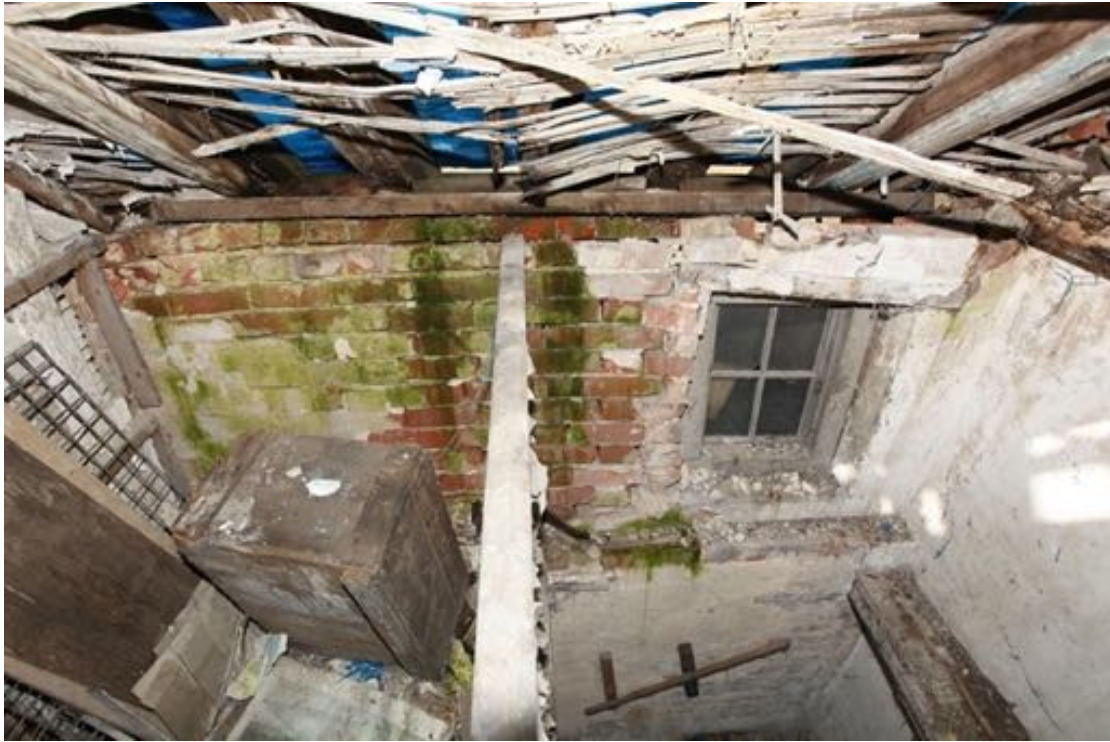
Illus. 27. The first-floor stair landing in no. 24 showing its window in the northern wall and the boarded partition framing the stair trap (F2).

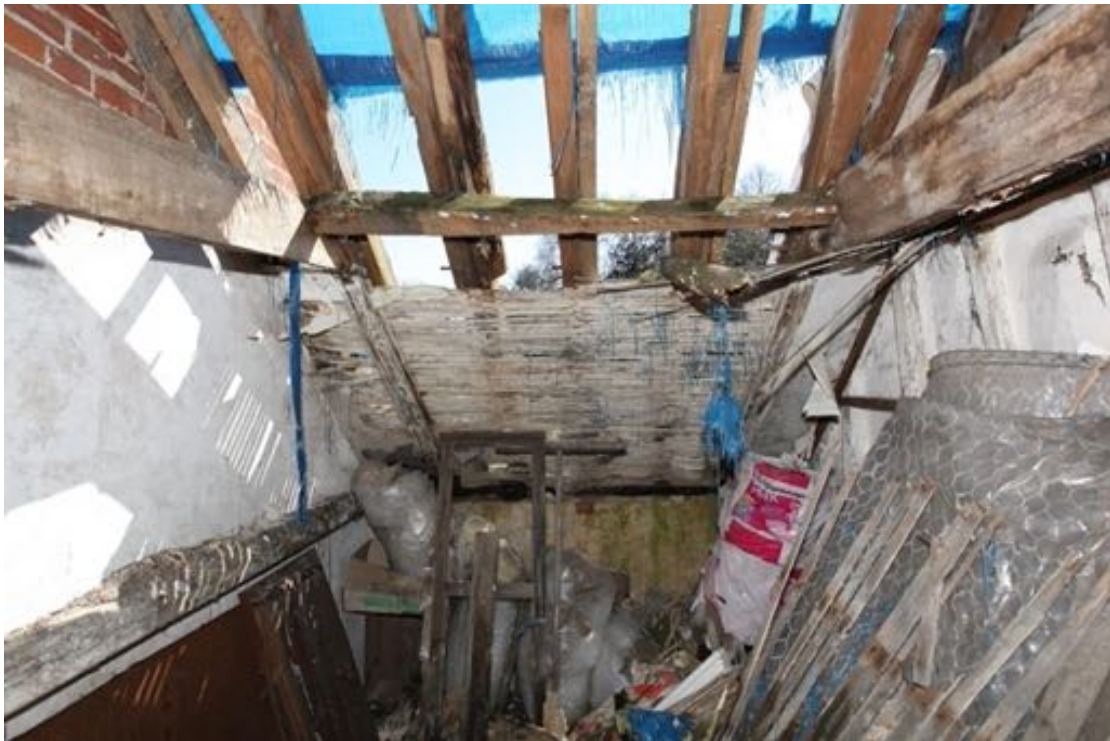
Illus. 28. The narrow stair landing of no. 24 as seen from the north (F2), showing the structure's clasped-purlin roof with pegged collars and narrow-sectioned purlins. The remains of a lath-and-plaster ceiling that extended to the collars survive on the rafters.

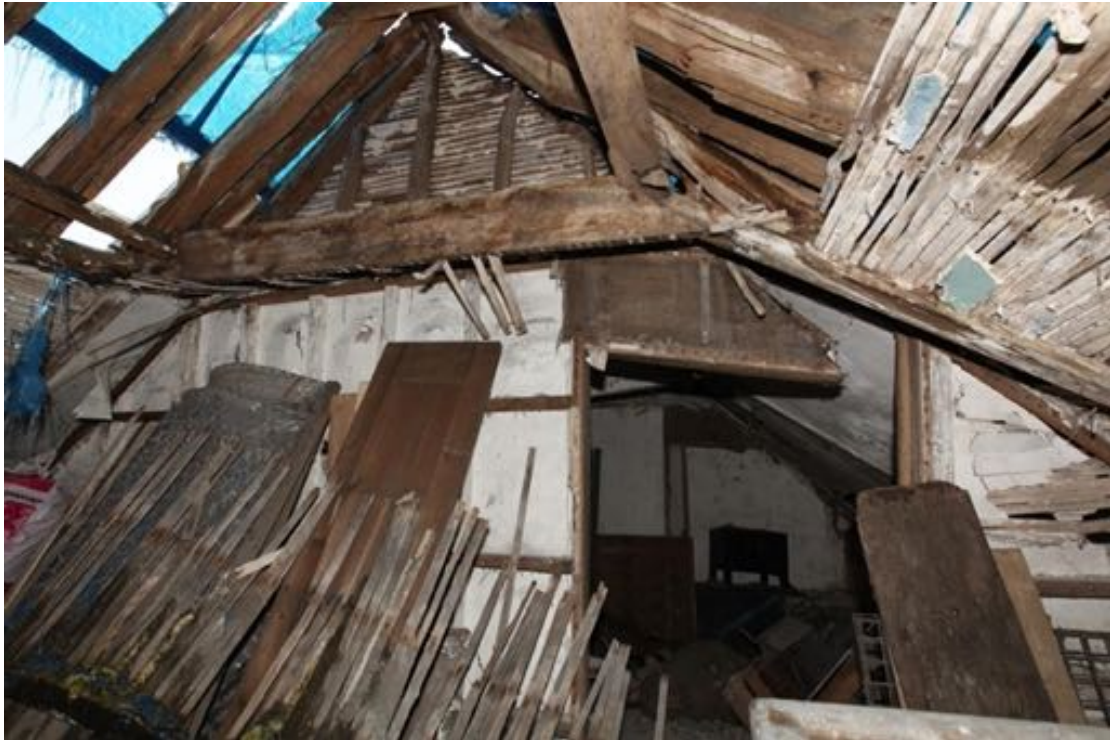
Illus. 29. The upper storey of no. 24 from the stair landing to the east (F2) showing the lath-and-plaster partition of the bedroom (F1) adjoining the clasped-purlin roof truss in the foreground. Much of the lower lath-and-plaster ceiling on the landing has collapsed.

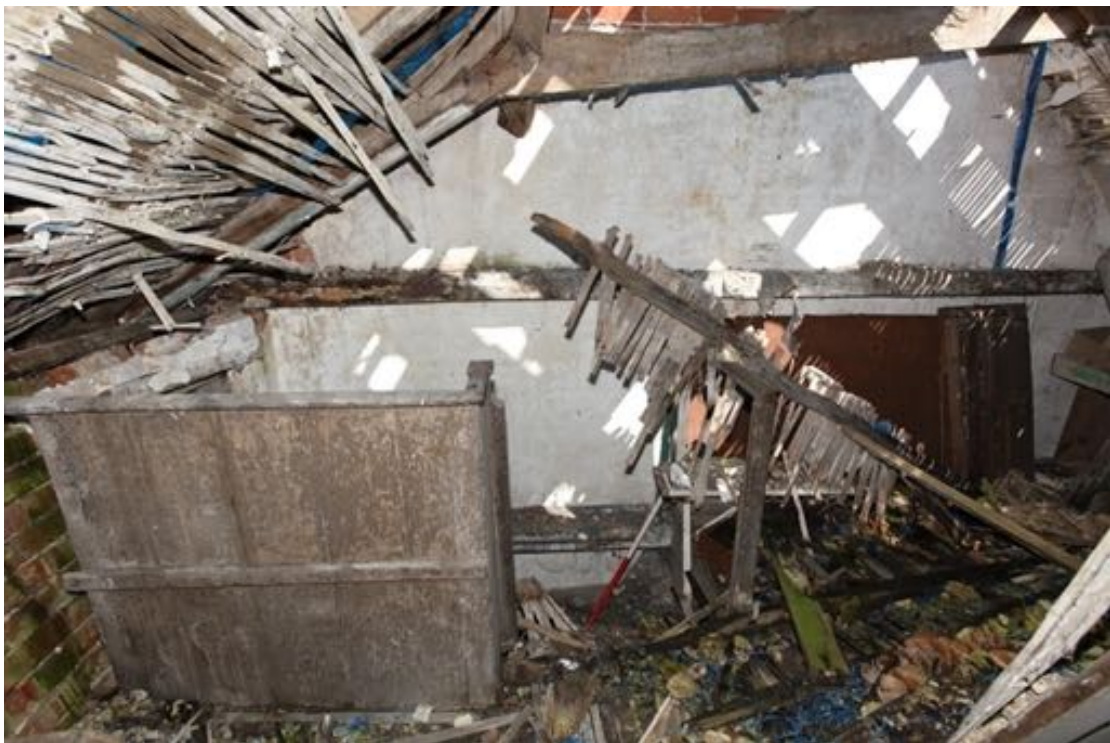
Illus. 30. The stair landing of no. 24 from the west showing the boarded partition against the corner stair on the left and the tie-beam abutting the rendered eastern gable in the rear (F2). The structure of no. 23 effectively borrows the brickwork of no. 24 and possesses no eastern gable of its own.

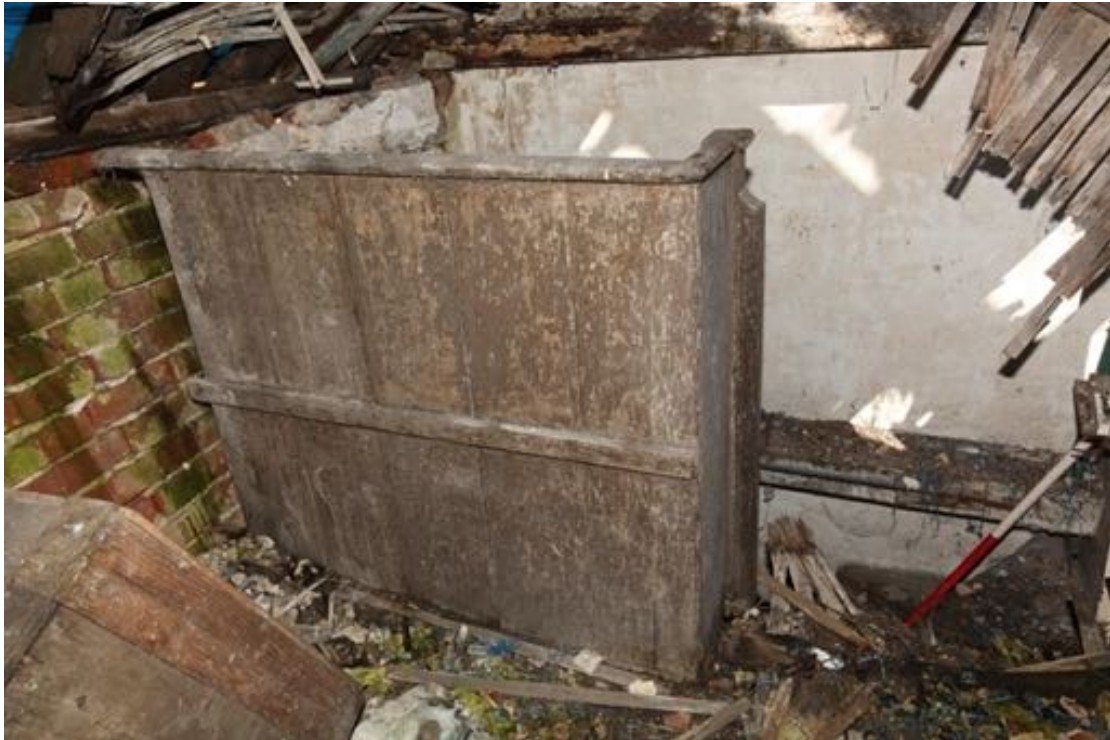
Illus. 31. A detail from the west of the 19th century plank-and-batten partition adjoining the corner stair of no. 24 showing its original or early brown paintwork with the exposed 19th century brickwork of the northern wall on the left (F2).

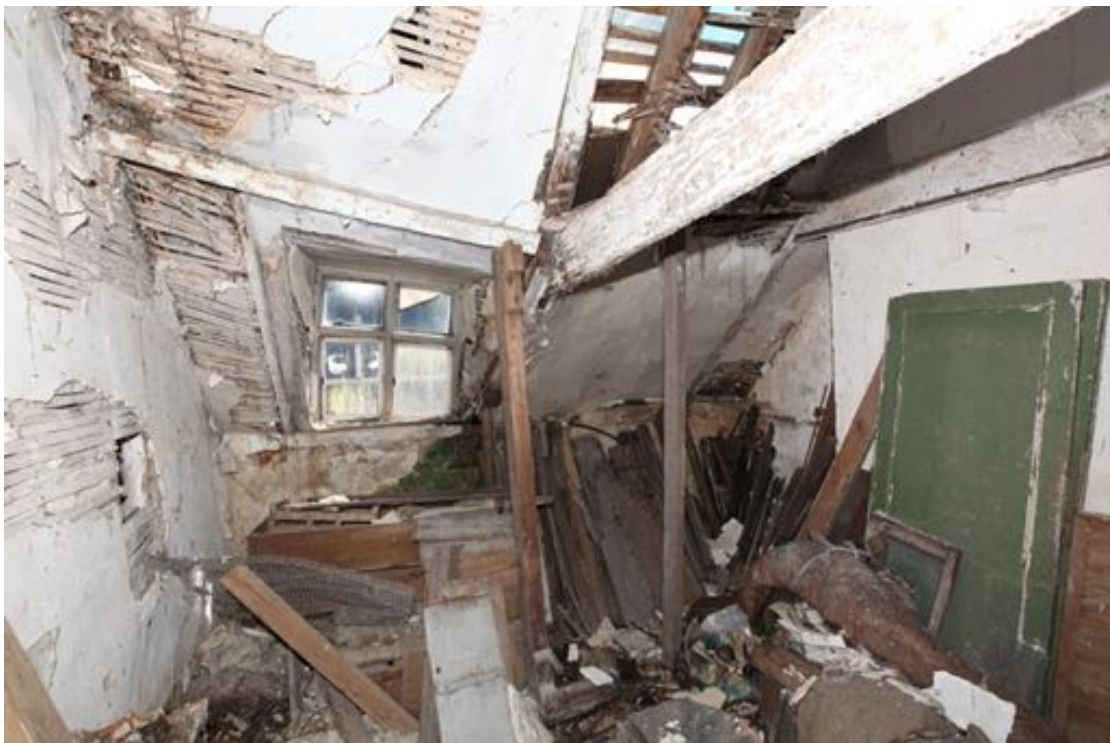
Illus. 32. The first-floor bedroom at no. 24 from the north (F1), showing its dormer window and the lath-and-plaster ceiling which extends to the apex of the roof. Nails in the underside of the roof collar indicate that an earlier lower ceiling matched that of the stair landing to the east.

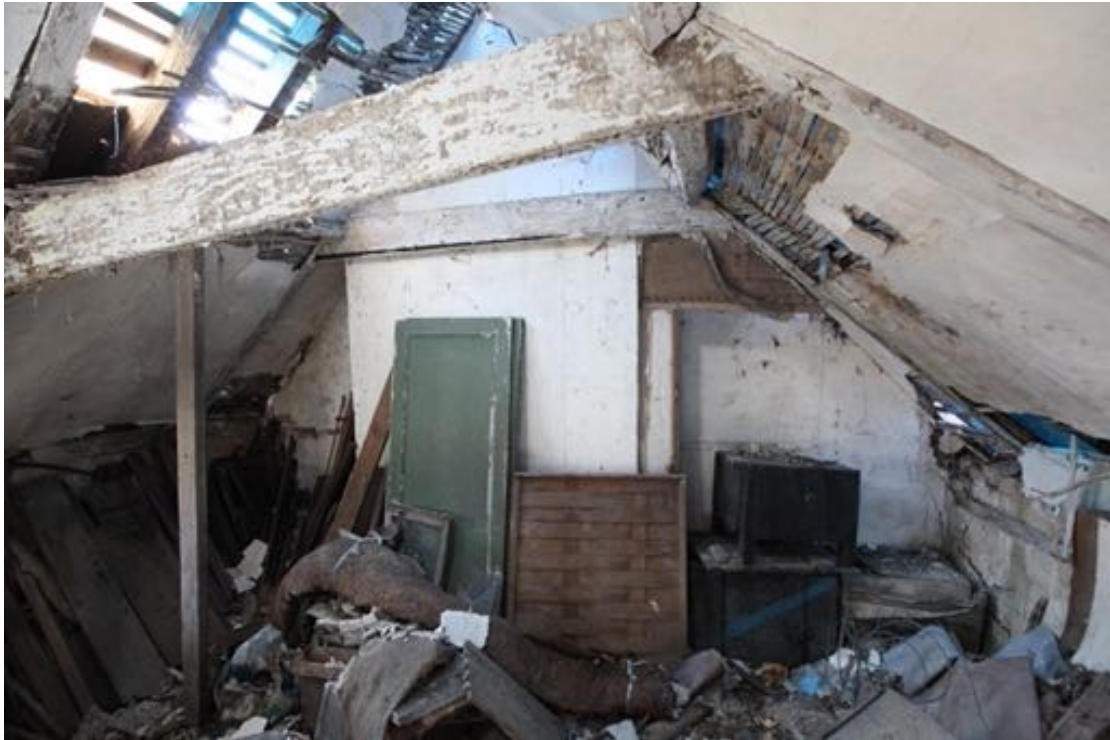
Illus. 33. The first-floor bedroom at no. 24 from the east showing the rendered chimney breast against its western gable (F1).

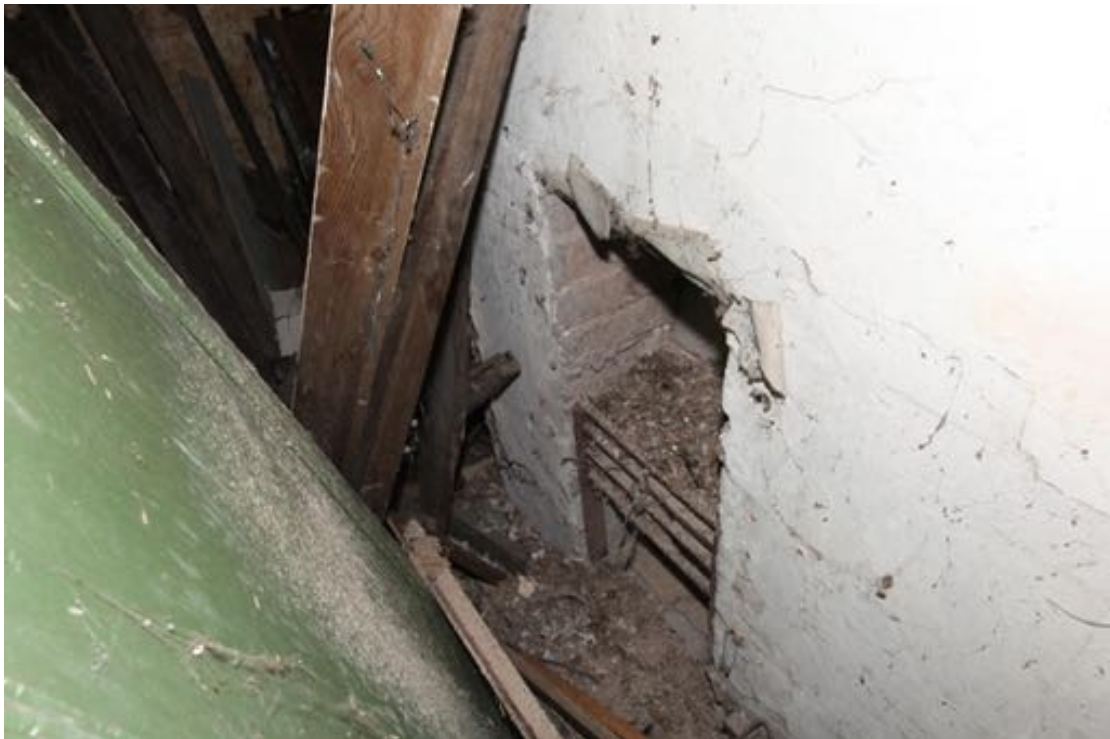
Illus. 34. A detail of the wrought iron basket grate in the western gable of the first-floor bedroom at no. 24 (F1).

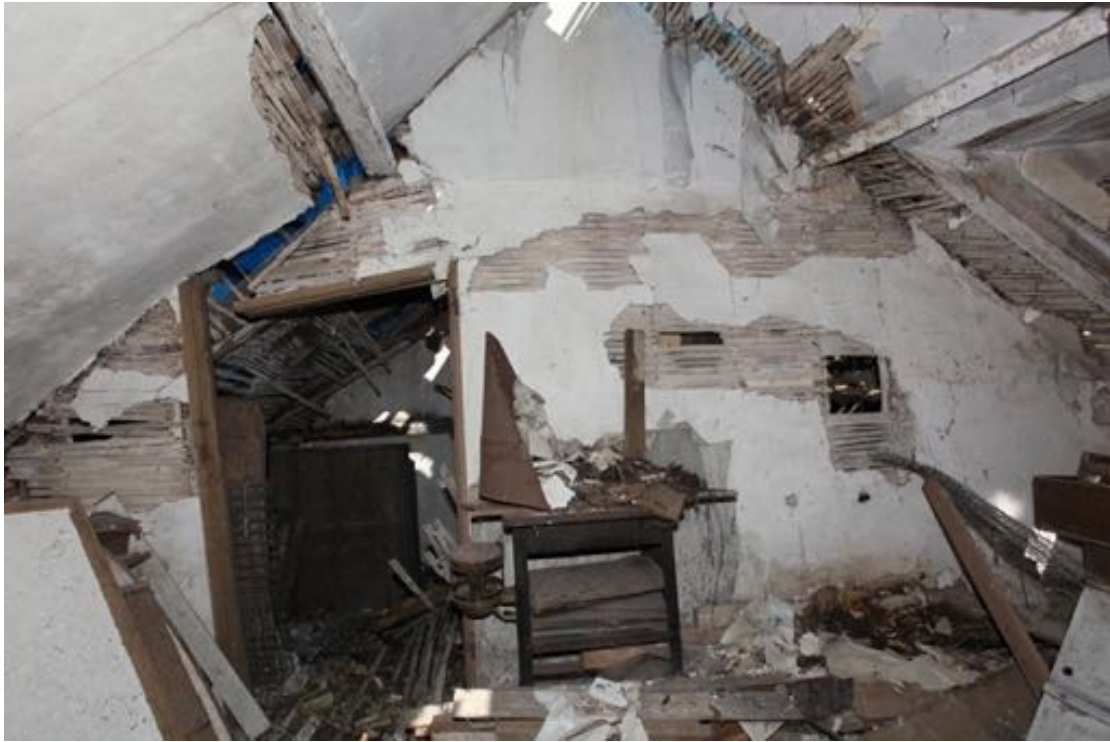
Illus. 35. The lath-and-plaster partition to the east of the first-floor bedroom in no. 24 showing the doorway to the stair landing on the left (F1).

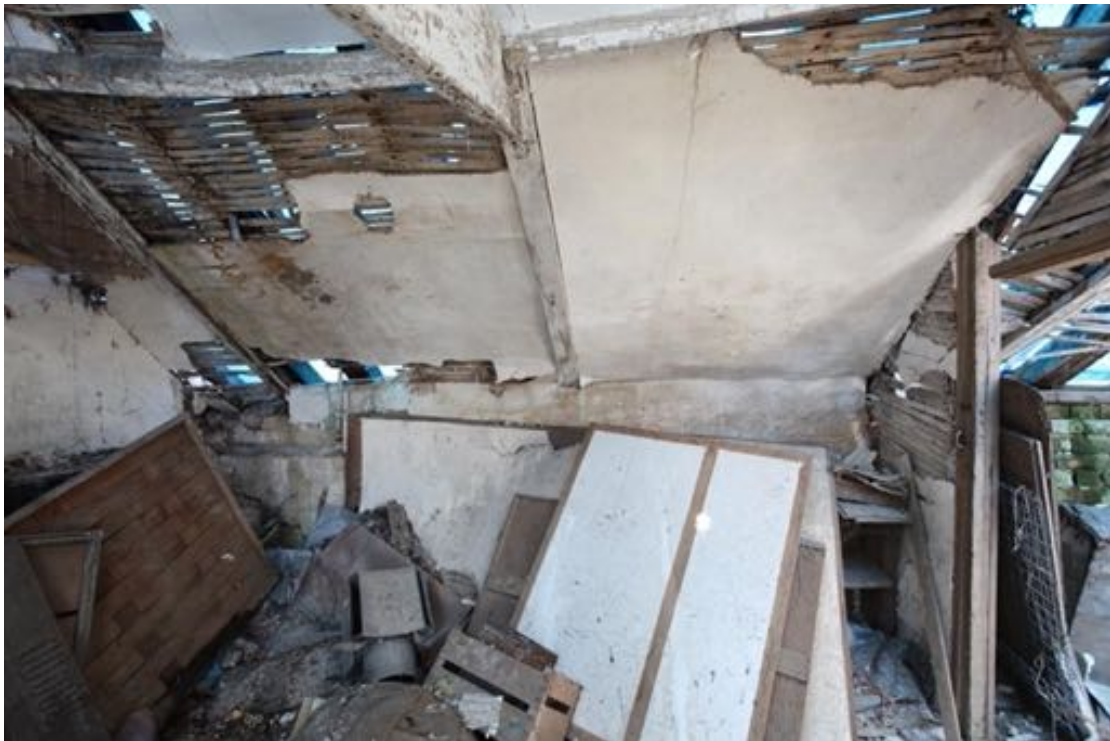
Illus. 36. The northern internal wall of the first-floor bedroom at no 24 showing its lack of windows and the structure of its clasped-purlin roof (F1).
