23/24 Church Road, Tattingstone, Suffolk

Historic Building Record

May 2023

This report provides an archaeological record and analysis at Historic England (2016) Level 3 of a semi-derelict grade II-listed cottage at TM 13794 37083. The adjoining grade II-listed cottage in the same ownership is included for context. The report includes a full photographic record of 50 images, but the buildings are not of sufficient scale or significance to warrant an additional archive of digital images. Where possible each photograph includes a 2 m scale rod with half-metre divisions in red and white. The site was inspected on 17th April 2023.

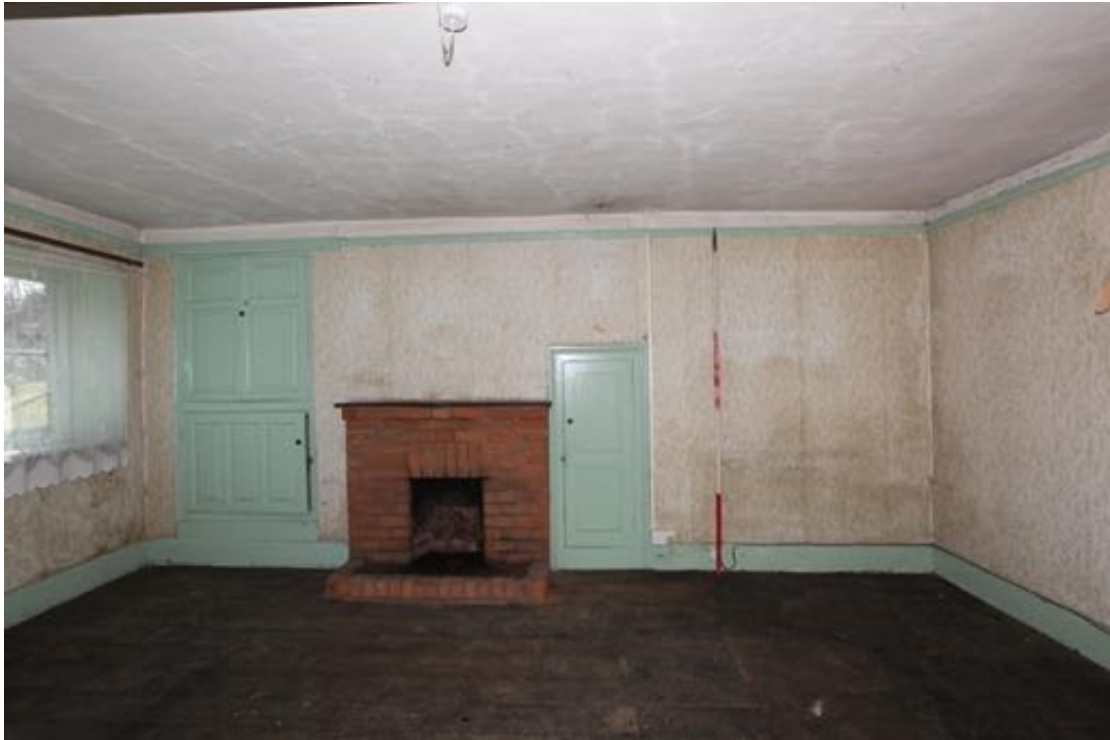
Illus. 37. The 20th century brick fireplace in the western gable of the sitting room at no. 23 flanked by 19th century cupboards with panelled doors (G5). The fireplace and right-hand cupboard occupy the position of a wider 19th century fireplace.

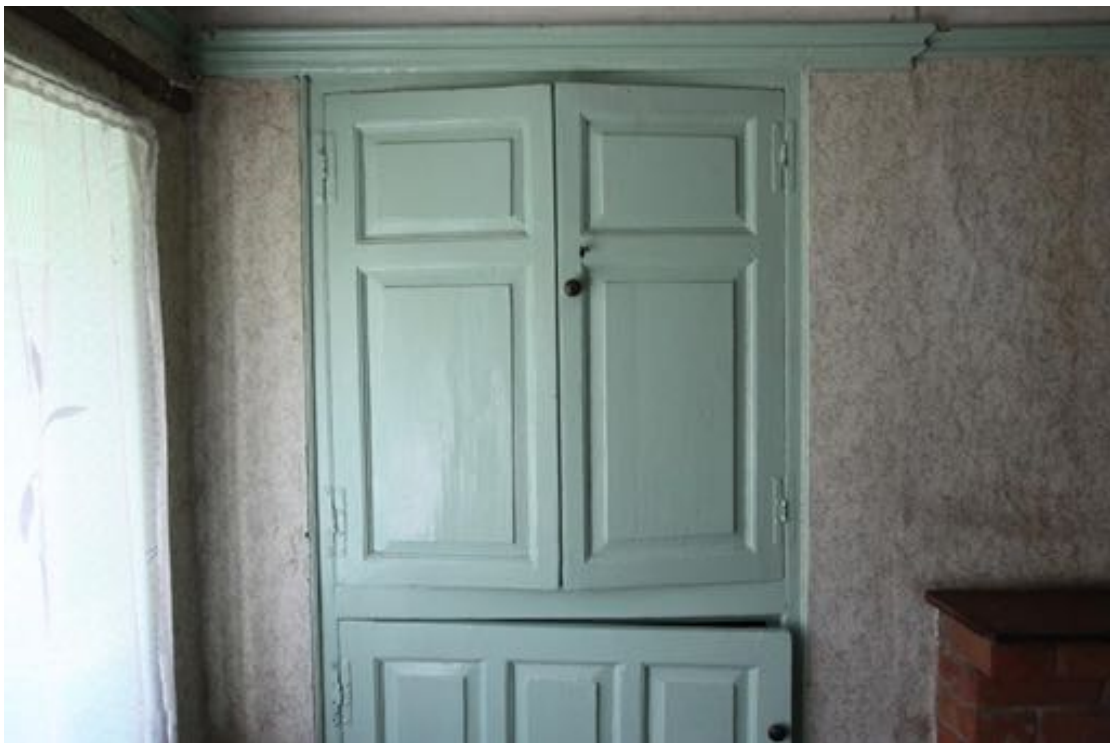
Illus. 38. A detail of the early- to mid-19th century cupboard doors with fielded panels to the left of the fireplace in illustration 37 showing their Georgian H-hinges (G5). The plain panelled cupboard door to the right of the fireplace is a late-19th century insertion with rectangular butterfly hinges.

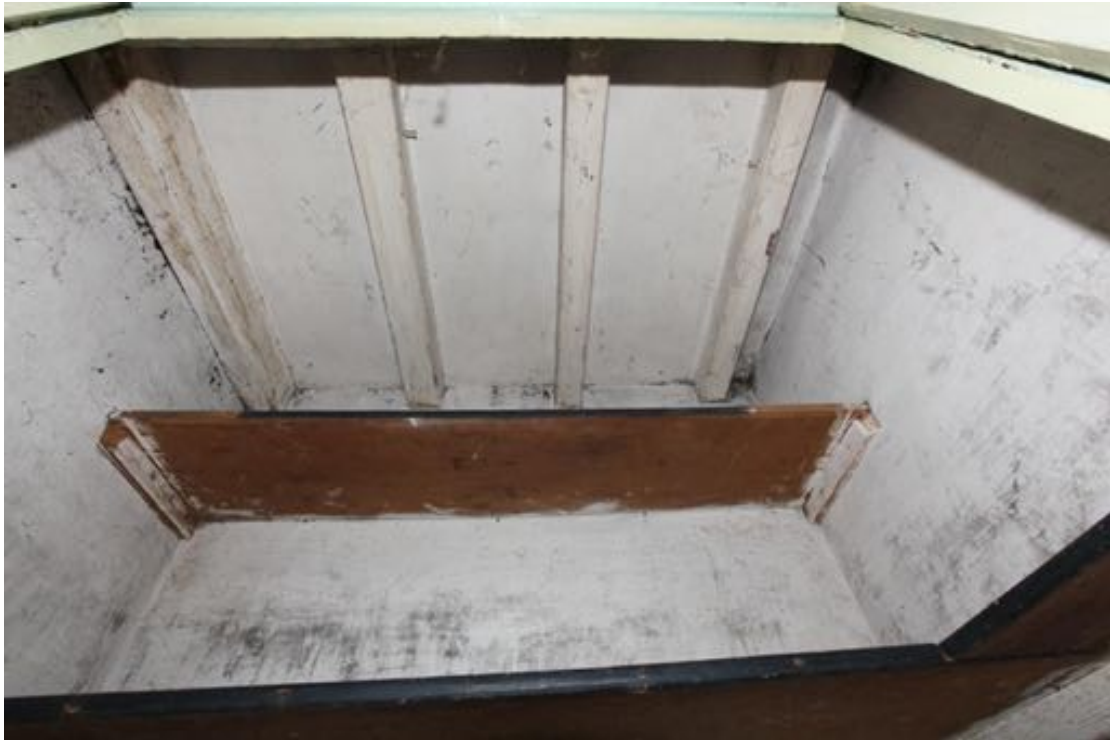
Illus. 39. The ceiling joists exposed in the cupboard shown in illustration 38 (G5). Their small chamfers and lack of lath nails indicate they were intended to be exposed like those in no. 24 and presumably extend to the rest of the sitting room where they are now concealed by later plaster.

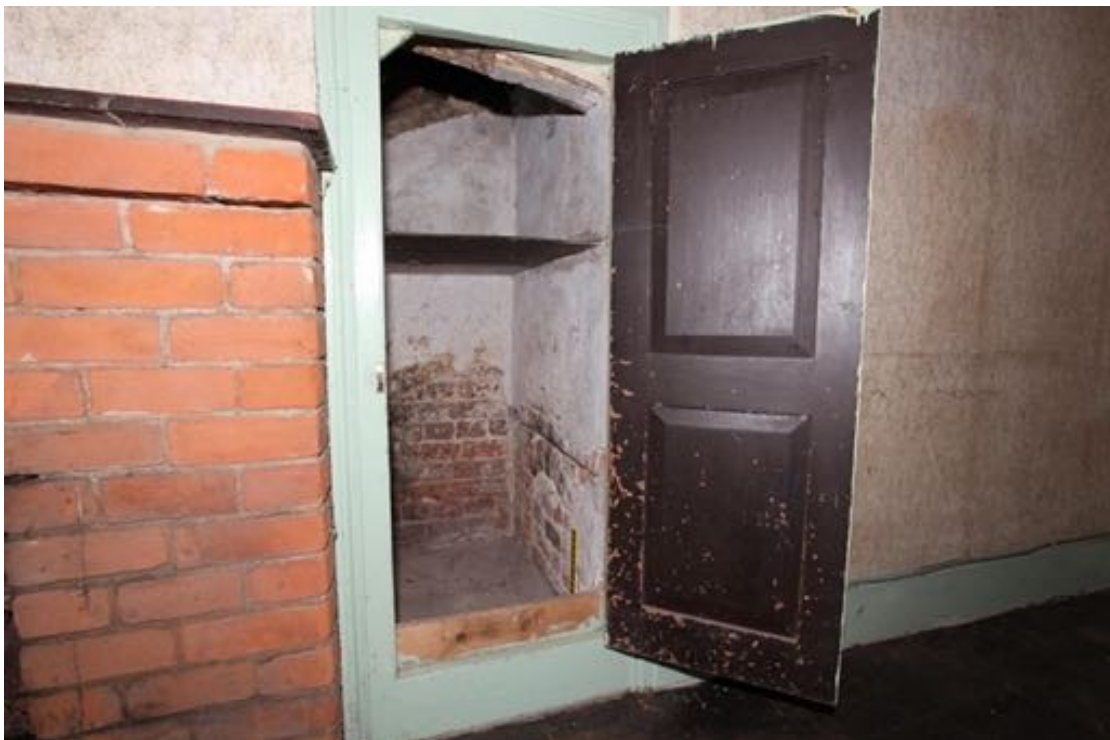
Illus. 40. The cupboard door to the right of the fireplace in illustration 37 opened to reveal its 19th century brown paint and the side of the wider original fireplace with evidence of a bread oven (illustration 41).

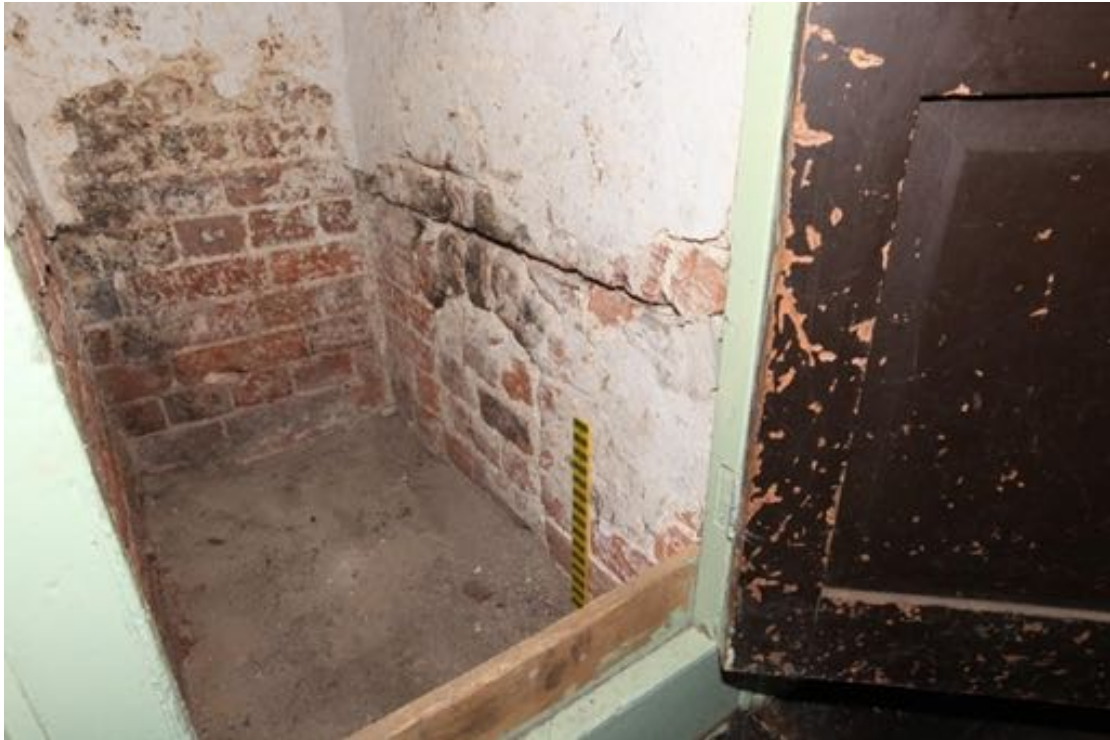
Illus. 41. A detail of the right-hand pier of the original wider fireplace in illustration 40 showing the blocked arch of an ash hole under a bread oven (into which the hot ashes of the faggots would have been raked after heating the oven). The soldier course above formed the oven floor but its aperture is hidden by plaster above. The position of the oven is now occupied by the storage cupboard in illustration 45.

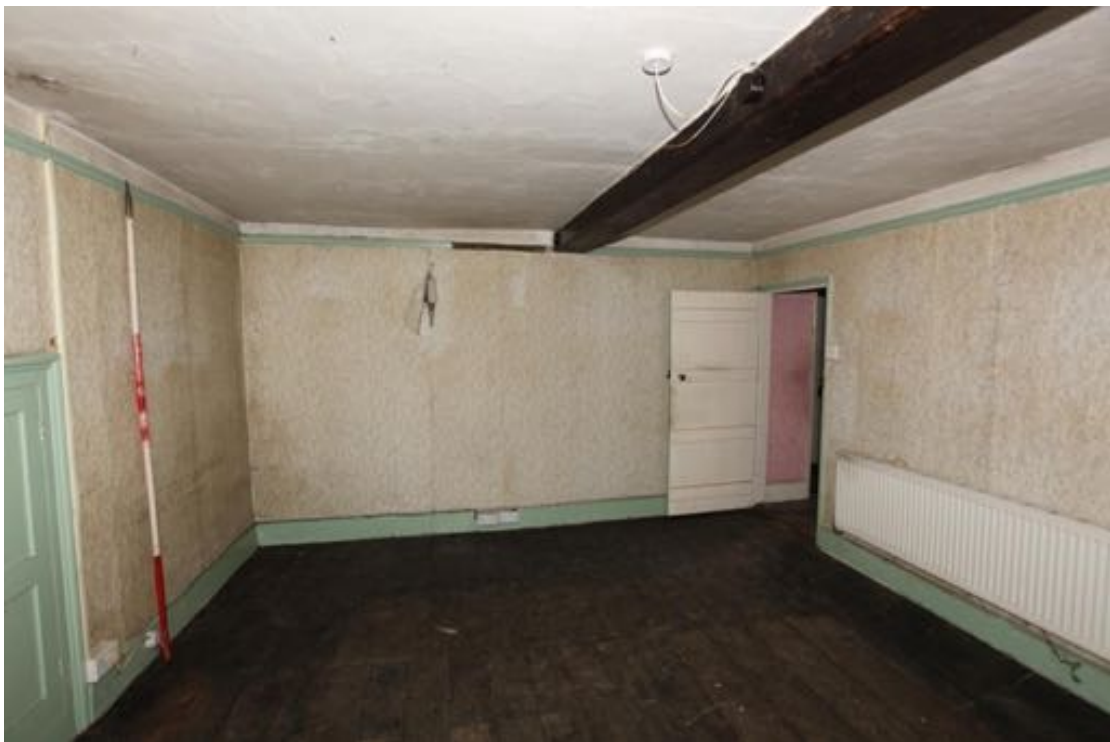
Illus. 42. The rear (northern) wall of the sitting room at no. 23 (G5) showing the chamfered pine binding joist of the original ceiling and the outline of a blocked door to its left. This doorway is likely to have opened into the lean-to that pre-dated the present kitchen extension and is also indicated by an insert in the skirting board.

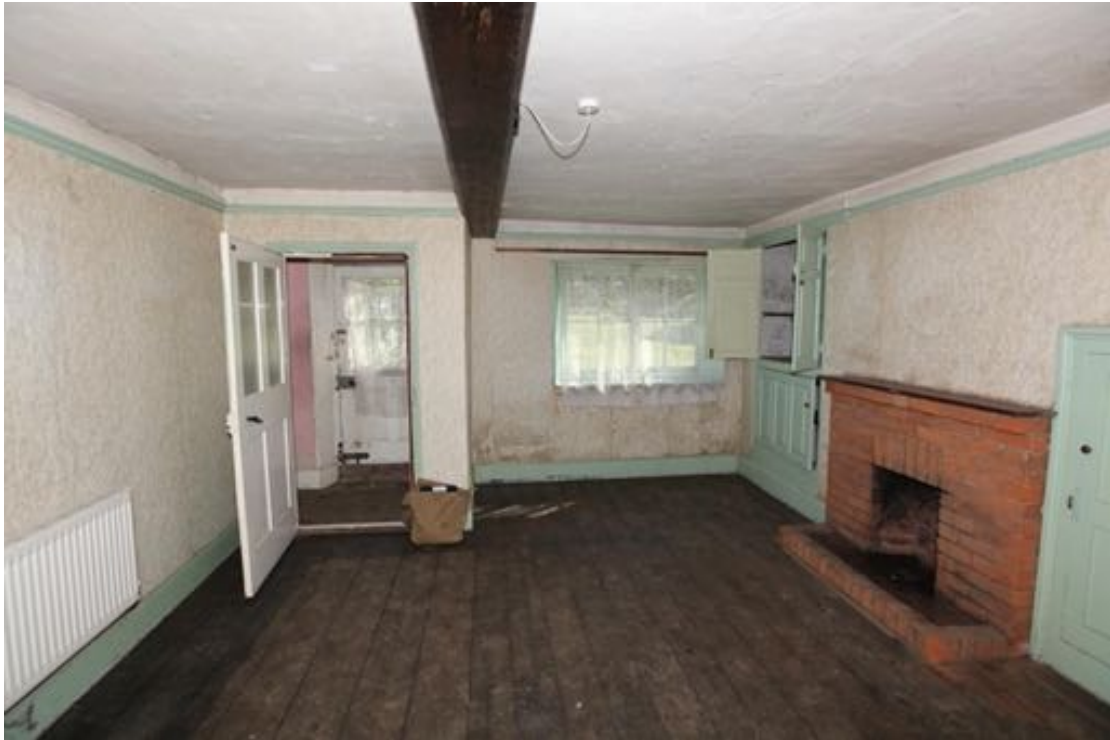
Illus. 43. The front (southern) interior of the sitting room at no. 23 showing its internal porch, horizontally sliding sash window and wide deal floorboards (G5).

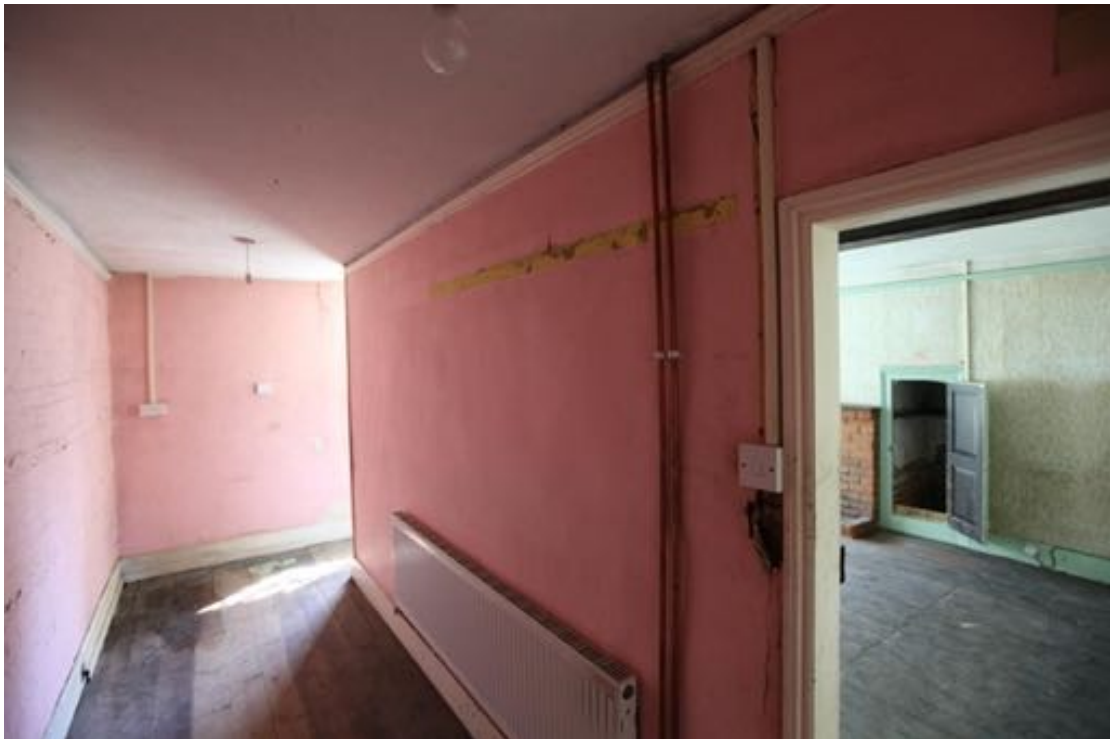
Illus. 44. The entrance passage to the east of no. 23 as seen from the rear (north) with the door to the sitting room on the right (G6). This passage now connects the southern door with the early-20th century kitchen extension but originally contained the staircase in a similar manner to no. 24. A section of later infill to the first-floor floorboards indicates that the stair lay in the front corner as opposed to the rear, and the outline of a blocked door in the centre of the internal partition on the right indicates the entrance to a storage area in the foreground.

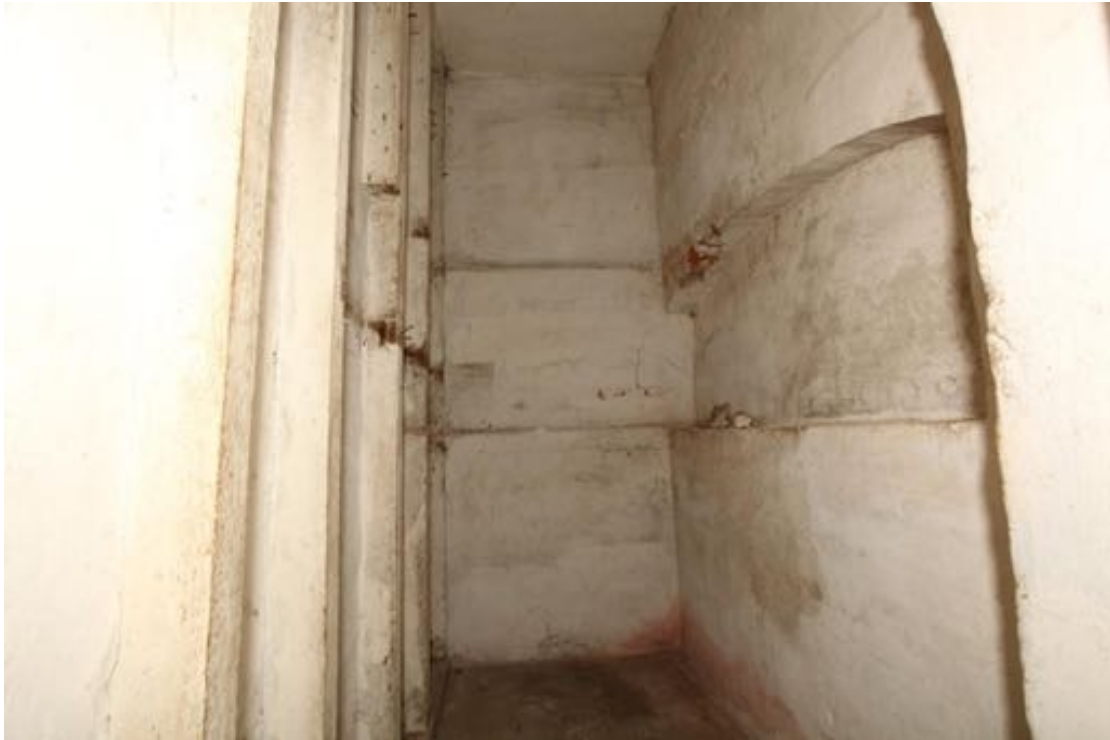
Illus. 45. The interior from the north of the cupboard that now occupies the position of the original bread oven with inserted narrow-sectioned studs adjoining the sitting room of no. 23 on the left. Any evidence of the oven is hidden by plaster. The arched shelf in the brickwork to the right adjoins the rear corner stair of no. 24.

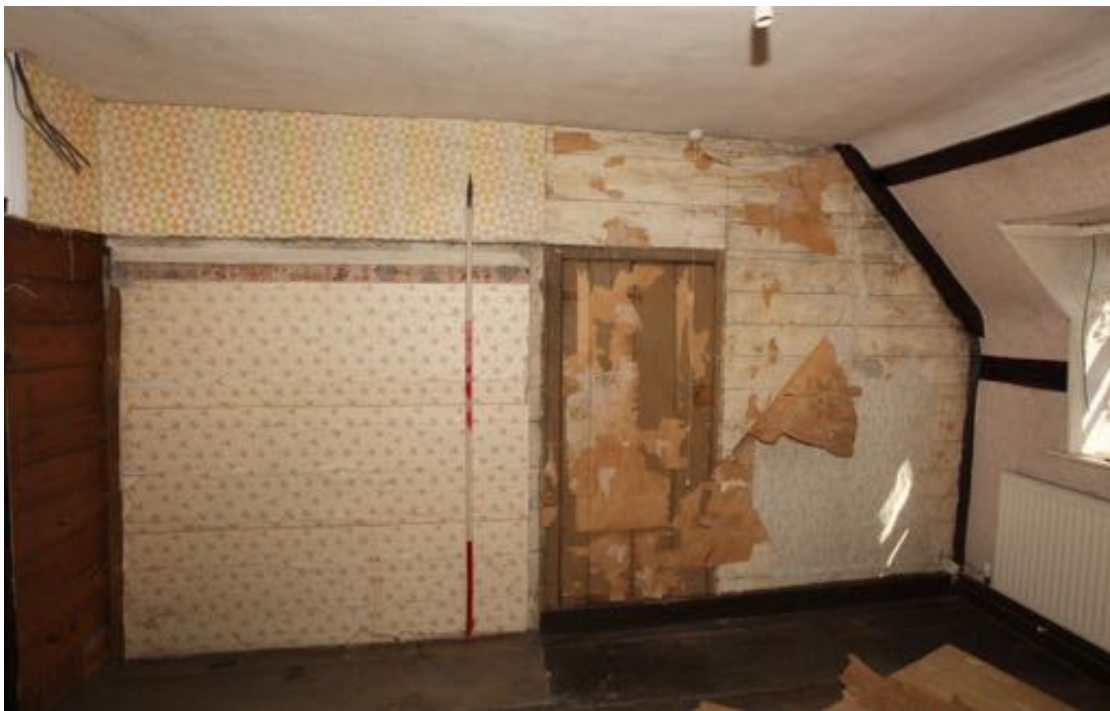
Illus. 46. The probably original first-floor partition between the western bedroom in no. 23 in the foreground and its counterpart to the east (F3). The horizontal deal boards are plain and the partition retains an original plank-and-batten door that was nailed shut and hidden behind wallpaper when the new staircase and extension were built. The door retains its probably original brown paint, matching that of no. 24.

The original structure of no. 23 extends to 5.6 m in length internally by 5.1 m in width, excluding its 35 cm or 14-inch thick brick walls (18.25 ft by 16.75). It now contains a single ground-floor sitting room of 4.1 m in length on the west (G5) with an entrance passage to the east (G6) that connects the front door directly to the staircase and kitchen in the rear (G8). This layout dates from a major refurbishment of *circa* 1910 that included the addition of the two-storied rear extension containing the stair and kitchen that was depicted on the Ordnance Survey of 1924 but not that of 1902. The distinctive late-Victorian or Edwardian dormer windows with their Mock Tudor false timbers are likely to have been added to all three cottages at the same time, along with the internal porch in no. 23, the cupboard to the right of its late-20th century brick fireplace in illustration 37 and probably the lath-and-plaster ceiling. The original room contained a wider fireplace with a bread oven to its right as demonstrated by its arched ash-hole in illustration 41 and the surviving early-19th century cupboard to its left. The ceiling joists were probably exposed to match those of no. 24 as the visible examples preserved within the cupboard bear neatly chamfered edges. The stair evidently lay in the south-eastern corner to the right of the entrance, as indicated by the only area of renewed floorboards visible from above, and a roughly central door in the rear wall opened into a rear lean-to that pre-dated the present kitchen (shown in figure 6). The outline of a second door is visible in the boarded partition of the present entrance passage, and this is likely to have opened into a storage area behind the stair in much the same manner as no. 24 (albeit in reverse). A matching door with its original brown paint has been re-exposed in the early boarded partition that divides the two first-floor bedrooms (illustration 46).

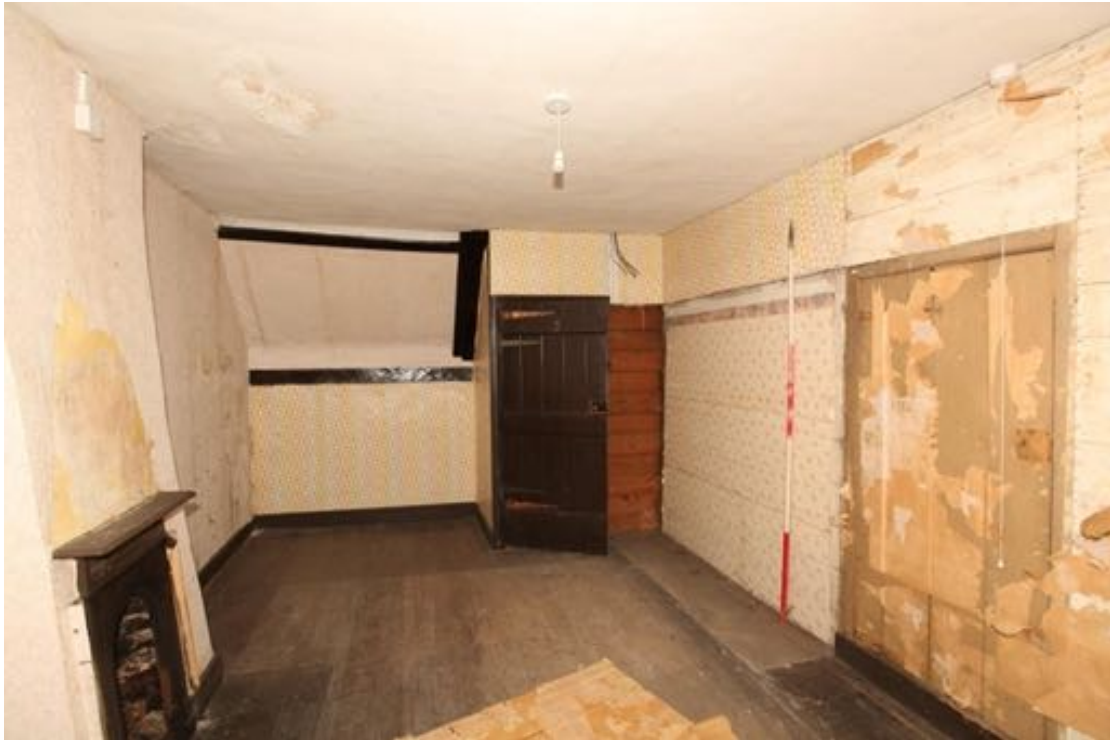
Illus. 47. The western bedroom of no. 23 seen from the south (F3), with the blocked door of the original internal boarded partition on the right and the late-19th or early-20th century cast iron coal grate of its western fireplace on the left. The roof-structure of staggered butt-purlins is visible to the left of the early-20th century internal porch which opens onto the new stair and rear bedroom of the same period.

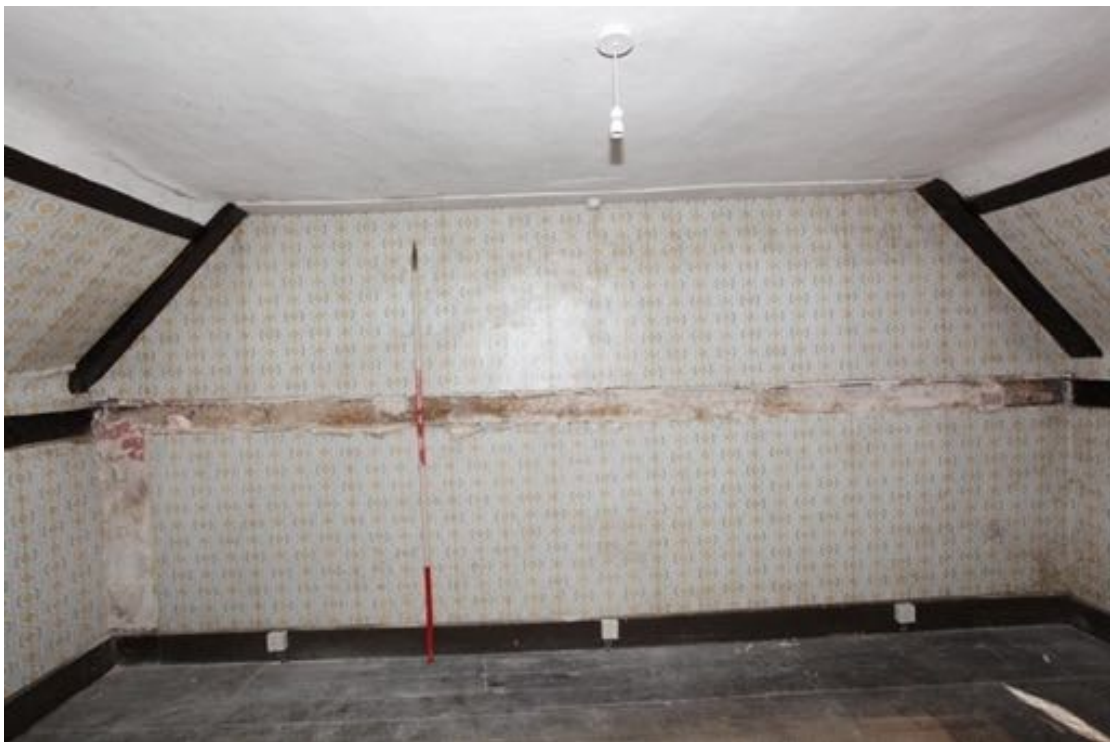
Illus. 48. The eastern internal gable of the eastern bedroom in no. 23 (F4) showing the lower of the two tiers of staggered butt-purlins and a tie-beam that is notched over the narrower walls of Lodge Cottage (illustration 49).

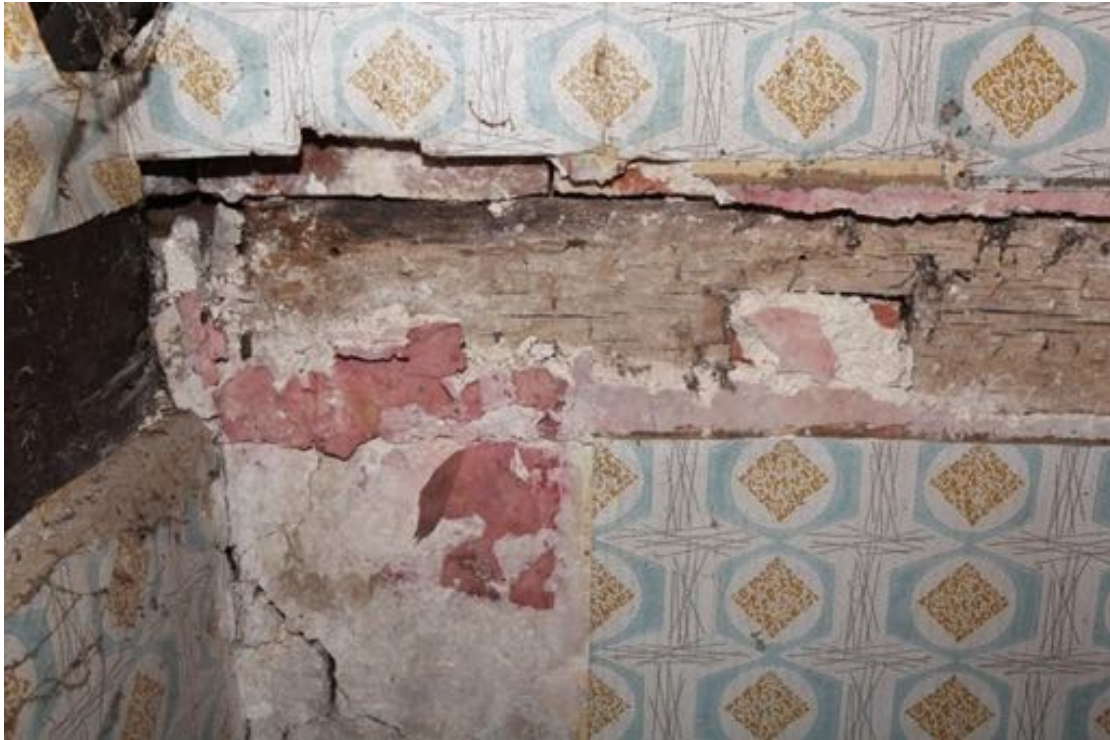
Illus. 49. A detail of the tie-beam in illustration 48 showing original or early red pigment and the notch that accommodates the brick rear wall of Lodge Cottage (F4). An identical notch is visible at the southern end of the same timber to the right in illustration 48, indicating the two cottages were built together. The tie-beam is tenoned to the roof-plates in a manner not seen prior to the 19th century when such timbers were usually dovetailed.

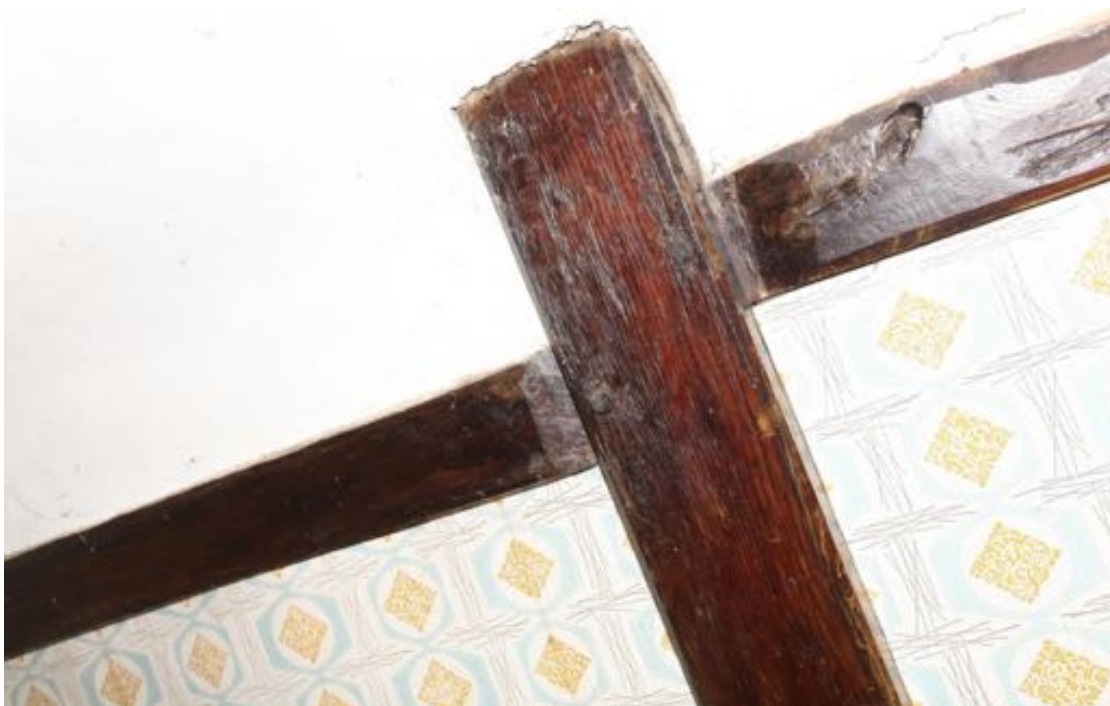
Illus. 50. A detail of the staggered butt-purlins with chamfered ends and pegged joints in the southern elevation of the eastern bedroom in no. 23 (F4). A second tier of matching purlins is hidden above the ceiling. The use of pine timber and the butt-purlin structure is typical of the early- to mid-19th century.
