Phase 1 Habitat Survey:

Site at Newhouse Farm, Hall Road, Great Bromley. CO7 7TP

20 March 2020

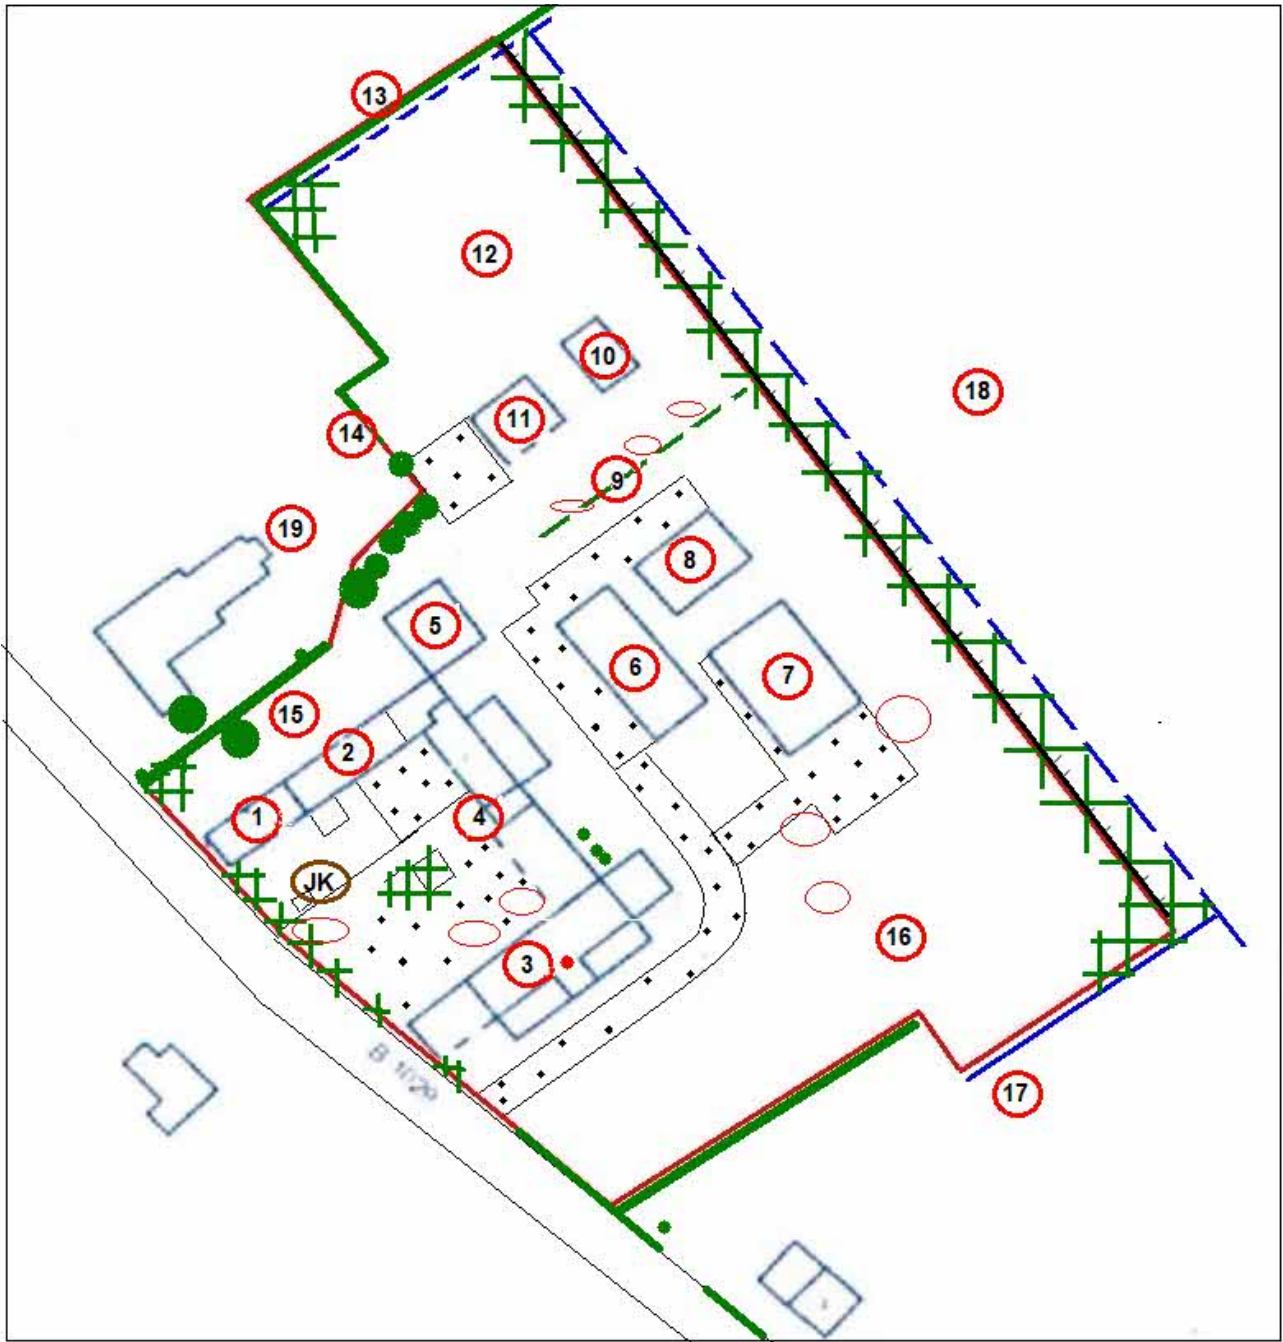
APPENDIX 1: Site Habitat Map.

1.4.1 A site habitat map is included at Appendix 1. This is adapted from Phase 1 habitat survey methodology (JNCC 2007) and depicts habitats present and the locations of target notes referred to in the report text.

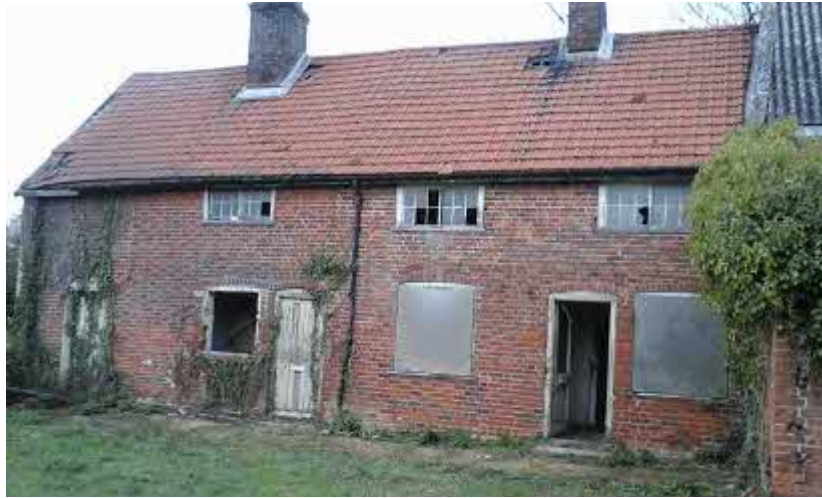
Tn 1. Farm worker cottages

Pair of semi-detached red brick cottages with clay tiled roof and attached single-storey outbuilding containing toilet and traditional wash-room. The garden area includes a second outside toilet building, a fire-site, non-native shrubs, patches of dense Ivy and Bramble scrub, disturbed ground and a red-brick wall to the road boundary.

The cottages are uninhabited and in a state of disrepair with broken and boarded up windows, missing roof tiles, damage to the roof structure and chimney.

Internal inspection was restricted due to a collapsed staircase and section of roof to the northern most cottage, and the absence of a loft access to the southernmost cottage.

Signs indicative of bat activity (droppings, feeding debris, dead bats etc) were not found but opportunities for bat roosting are present to cottage and outbuilding roof structures, chimneys and behind boarding to the cottage windows.

Old (inactive) bird nests (including wren, blackbird and jackdaw) were present to cottage kitchens, the wash-room and toilet buildings, and debris present to the cottage fireplaces indicating past use of the chimneys for nesting.

- Bat activity surveys are required to determine use prior to works.
- Active bird nests are likely to be present at certain times of the year, and survey or mitigation measures are required to prevent disturbance during site works.
- Survey or mitigation measures are recommended prior to clearance of habitats with potential to contain hedgehog.
- Suspected presence of Japanese knotweed to the cottage gardens, requiring re-survey when plants are fully emerged (April). *NB. This assessment does not include a comprehensive survey for Japanese Knotweed within the site.*

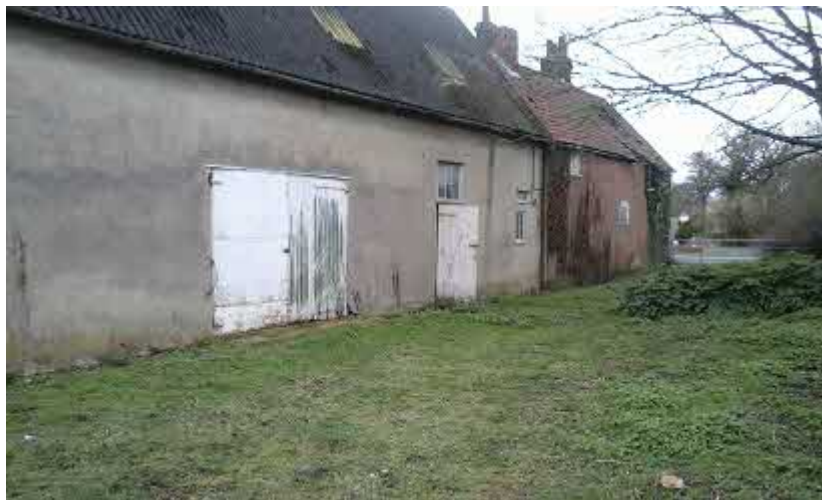
Tn 2. Traditional barn-rendered exterior; also showing rear of Tn 1 and area Tn 15.

Older style barn with traditional timber-frame and weather-board construction, with cement render to exterior walls and the roof tiles replaced with corrugated mineral-sheeting which includes 2 x roof lights.

- Detailed surveys are required to determine bat activity.
- Active bird nests may be present at certain times of the year and survey and / or mitigation measures are required to prevent disturbance during site works.

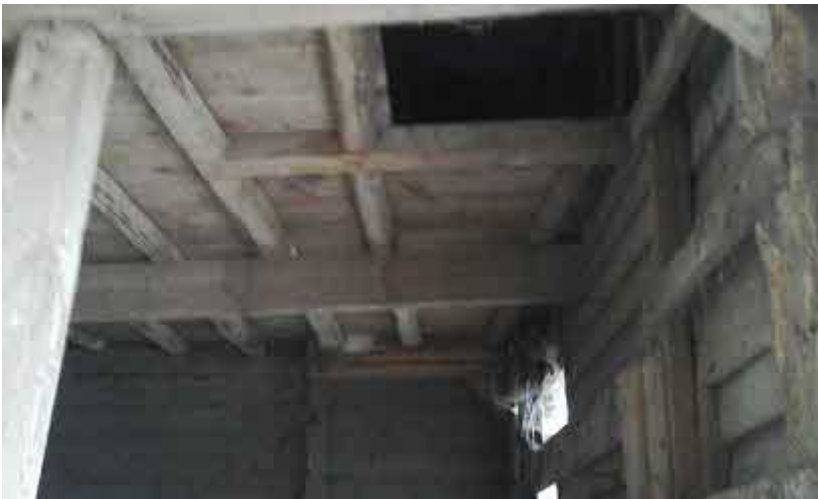
Tn 2. Traditional barn interior: stable loft and main structure.

The barn is divided into 2 parts: a main section consisting of an open 2 storey space with exposed rafters and jointed timbers; and a purpose built stabling area with a loft space above. Both parts are accessible to bats via gaps to roof structures and have opportunities for bat roosting.

These areas were inspected for signs of bat activity, although this was restricted to ground level to the main section. Possible bat feeding debris (moth wings) and 2-3 old and friable bat droppings were found to the floor of the main barn, along with rodent (mice and rat) droppings and feeding debris; the loft area had no indications of bat use but frequent mouse droppings and feeding debris were present.
